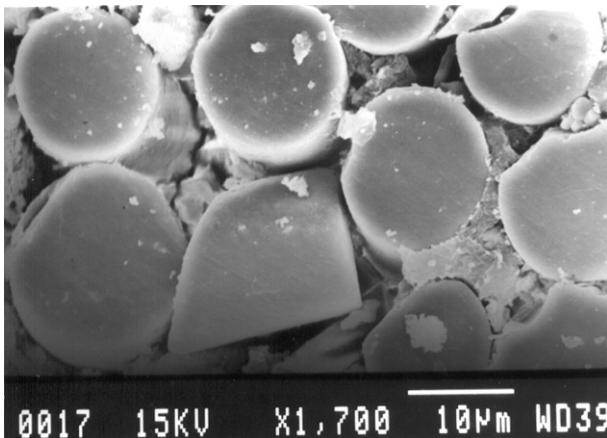
2.2.3.1. Sheet conditioned for three months. Samples have been made out of the sheets removed from the three months conditioned beams. The portions of the sheets near the central crack formation of the beams have been selected for the tests. Fig. 4 shows the magnified (895 X) view of the sheet fibers near the surface of the sheet. It can be seen that only a few fibers have degraded. The fibers seem to have segregated from the matrix. The magnification (552 X) is reduced to show the distribution of damage to the matrix in Fig. 5. The matrix appears to have disintegrated all through the scanned micrograph. Most of the fibers are intact in the scanned specimens. In three month of conditioning the matrix is clearly damaged. The reduction in the strength of the sheet was around 20.32%. All the specimens were scanned for damages. The major portions of the areas in the all the four sheet specimens remained unaffected. Only a few spots appeared to be damaged and they were local in nature. At the locations of degradation the matrix got damaged first and subsequently the fibers disintegrated.

Fig. 4. Damages in the fibers of sheet (SB3-470).

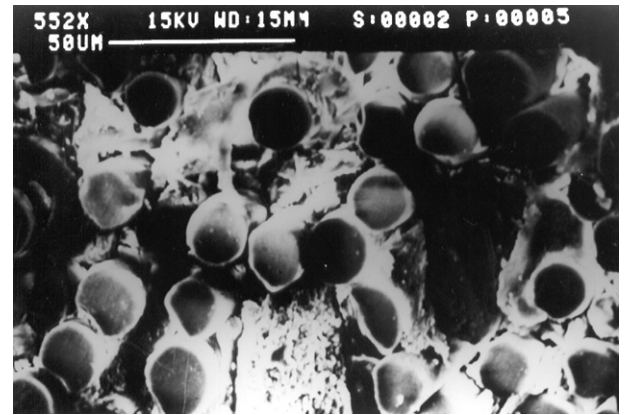
Fig. 5. Enlarged view of damages in the matrix of sheet (SB3-470).

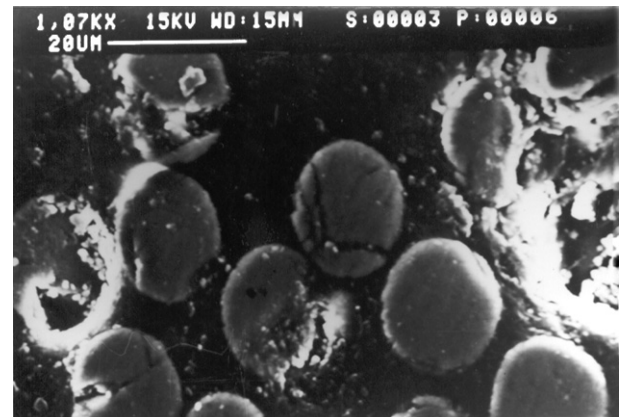
2.2.3.2. Sheets conditioned for six months. The cross section of the sheet after six months of conditioning is magnified (1070 X) to view the damages (Fig. 6). The maximum size of the voids in the damaged matrix is around 40 μm . The fibers are getting disintegrated in larger numbers. A few fibers appear to have completely dissolved making voids in the matrix. An enlarged view in Fig. 7 (1530 X) near fibers shows that matrix is progressively getting damaged. One fiber is completely disintegrated in the matrix. The matrix around other fibers is slowly getting damaged. The fibers are still intact here. It can be concluded that in the sheets first the matrix gets damaged and then the fibers in it slowly disintegrate. The surfaces around the fibers are getting segregated and this is likely to affect shear transfer between the matrix and the fibers. A few spots where matrix did not segregate the fibers also remained unaffected. Gradual disintegration of the fibers in the matrix can be seen in Fig. 8. The fibers are getting disintegrated in flakes. The total strength reduction in the sheet composite was around 33% due to localized damage to large numbers of fibers.

Fig. 6. Nature of damages in the sheet (SB6-470).

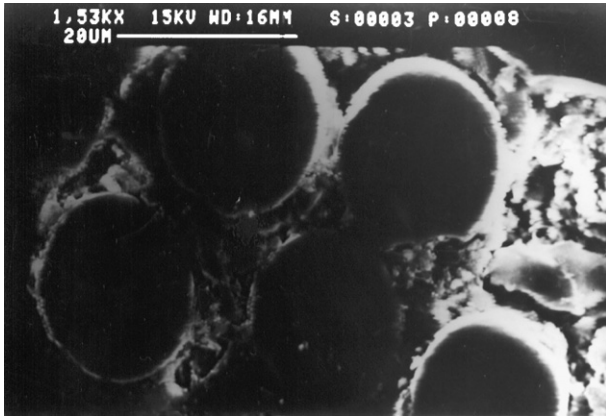
Fig. 7. Enlarged view of damages in the matrix of sheet (SB6-470).

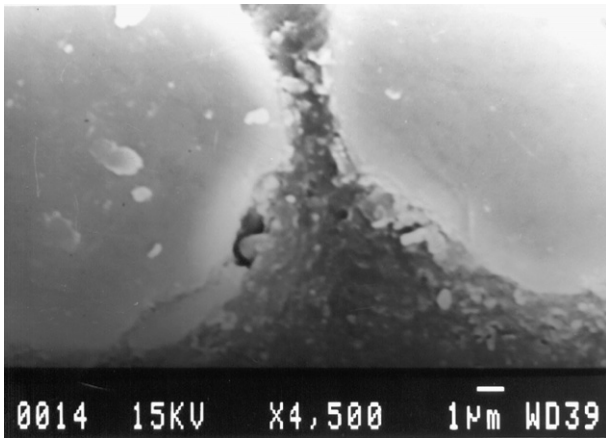
Fig. 8. Enlarged view of progressive damages in the fiber and the matrix of sheet (SB6-470).

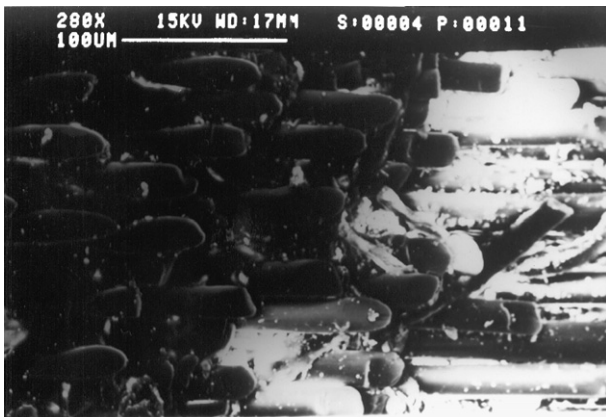
comparative damages in the matrix and fibers near to the rupture (Fig. 9). The reduction in the strength of the sheet was 36%. In the specimen all the fibers have snapped and no pull out of the fibers could be seen due to damages at surfaces between fibers and matrix. A magnified view showing the damages in the matrix along the length of

Fig. 9. Micrograph showing rupture of conditioned sheet (SB9-470).

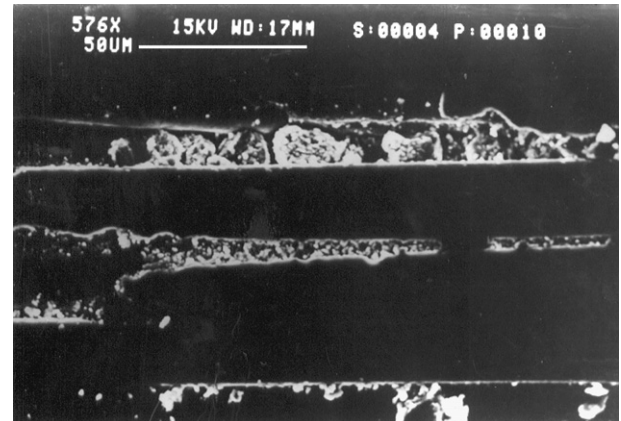
fibers is shown in Fig. 10. The matrix gets damaged along the fibers which are around 250–300 μm in length in the micrograph. This damage does not prevent the fibers to take load till rupture of individual fibers. The fibers reduced in cross section in the damaged zones. The micrograph showing the localized nature of damages to fibers and matrix is given in Fig. 11. In the damaged zone both matrix and fibers have completely disintegrated. It may be noted that the fibers and matrix next to the damaged zone is totally unaffected due to conditioning. If the matrix is not damaged the fibers remain totally unaffected due to conditioning. Hence, the matrix plays a vital role in protecting the fibers and enhancing the life of the sheet composite on concrete. The sheets after nine months of conditioning absorbed moisture in a short span of time. This is mainly because the matrix has disintegrated completely resulting in powdery structure which absorbs moisture instantly.

Fig. 10. Micrograph showing damages in matrix along the fibers of conditioned sheet (SB9-470).

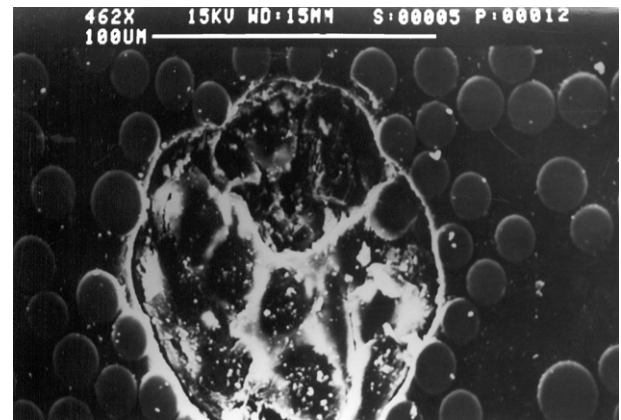
Fig. 11. Micrograph showing localized damages of fibers and matrix of conditioned sheet (SB9-470).

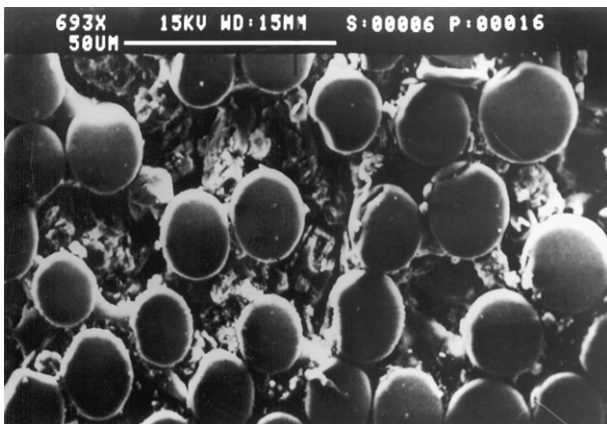
months. The sheets did not loose their strength but surprisingly showed an increase of about 6%. Most of the areas in the scan showed no sign of degradation of both matrix and fibers as seen in the Fig. 12. Very few spots could be located where damages could be observed as shown in Fig. 13. Here the matrix has started disintegrating with partial or negligible damages to the fibers. The increase in the strength of the sheet composite was 29.5% in six months of outdoor conditioning in comparison to 6% in nine months of conditioning outdoor. This can happen only when the strength of the epoxy as a whole increases due to cross linking [21] in outdoor conditioning. The over all strength of composite sheet reduced due to local disintegration of the matrix and fibers with time. More outdoor conditioning time is likely to deteriorate the strength of the sheet. Eight specimens were scanned and it was seen that the nature of the damage is same but quantum of damage is negligible at 12 months.

Fig. 13. Micrograph of damaged area of specimen taken from sheet bonded to conditioned beam ASB12-470.

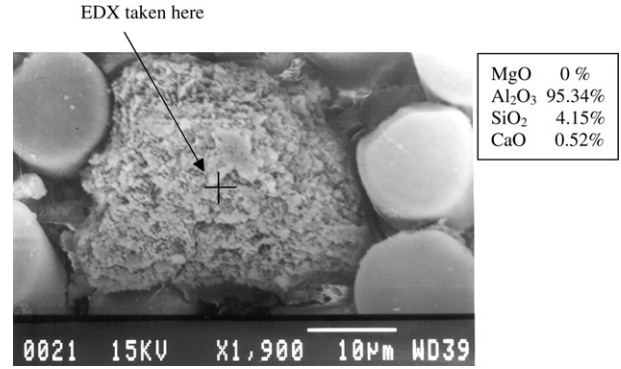
Fig. 14e. EDX done on damaged area of specimen taken from sheet bonded to conditioned beam SB9-470.

parison with average values of 69.11% and 16.9% in the undamaged fiber (Figs. 14a(a)–(c)). Thus, silica and calcium content in the damaged area is very much less than that in the undamaged fiber. This is only possible if the molecular structure of the fiber gets broken wherever it is coming in contact with some degenerating agent. This agent displaces silica and calcium from the healthy fibers. EDX taken outside the damaged fiber showed calcium as 100 %. The free calcium can only originate from alkali. The alkali, Ca(OH)₂, is formed due to hydration of cement and is in free form in the voids of the concrete. This suggests that the sheet matrix is penetrated by the alkali.

The EDX test was also done in the damaged zones. The epoxy, matrix, is an organic substance. Hence, it becomes easy to assess the elements present in the damaged zones. The EDX test in Figs. 14d and 14e gives the average composition of silica as 12.15% and calcium as 0.58% in com-

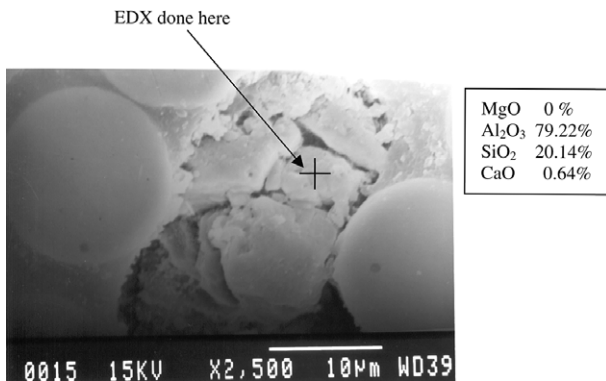
Fig. 14d. EDX done on damaged area of specimen taken from sheet bonded to conditioned beam SB3-470.
