STRENGTH AND FRACTURE STUDIES OF STEAM TURBINE BLADE

**A Thesis Submitted in partial fulfillment of requirement for the award of the
degree of**

Master of Technology

Materials Science and Engineering

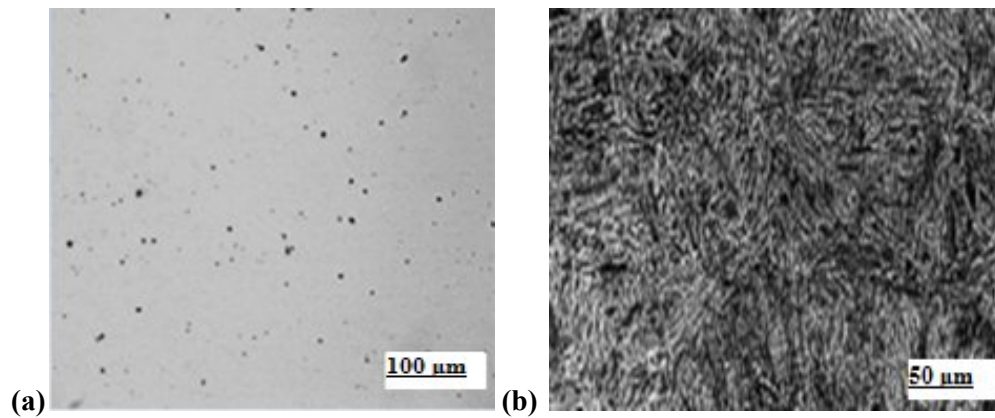
Figure 4.1 Optical micrographs of sample 1

Figure 4.1(a) shows the optical micrographs of unetched sample at 100x where the large number of inclusions was present. While the figure (b) of etched sample with Villella's etchant at 200x shows the tempered martensitic structure with some inclusions (dark spots).

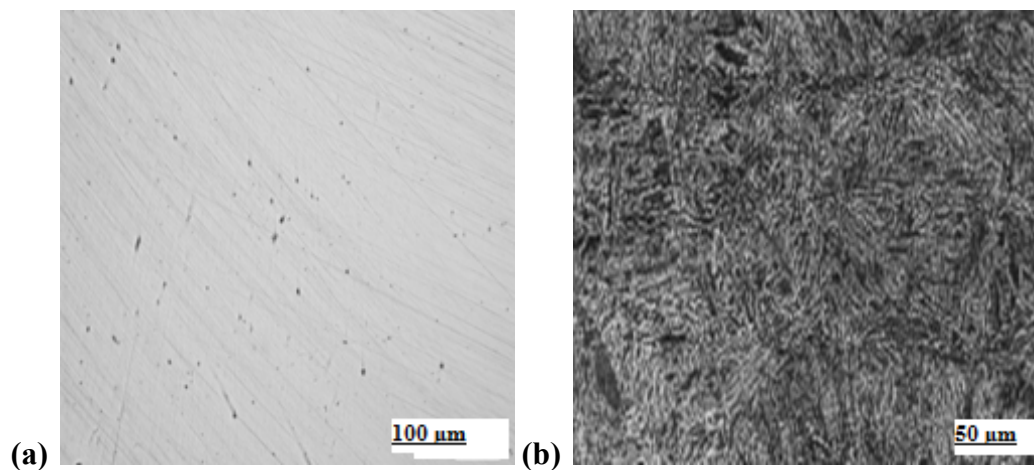
Figure 4.3 Optical micrographs of sample 2

The optical micrographs of unetched sample at 100x the figure (a) shows the presence of inclusions. Though the value fraction of inclusions is not much but it exhibits the features of oxide inclusion. While the figure (b) of etched sample with Vilella's etchant at 200x shows the tempered martensitic structure with some inclusions and pits. These inclusions are elongated along the grain boundaries.

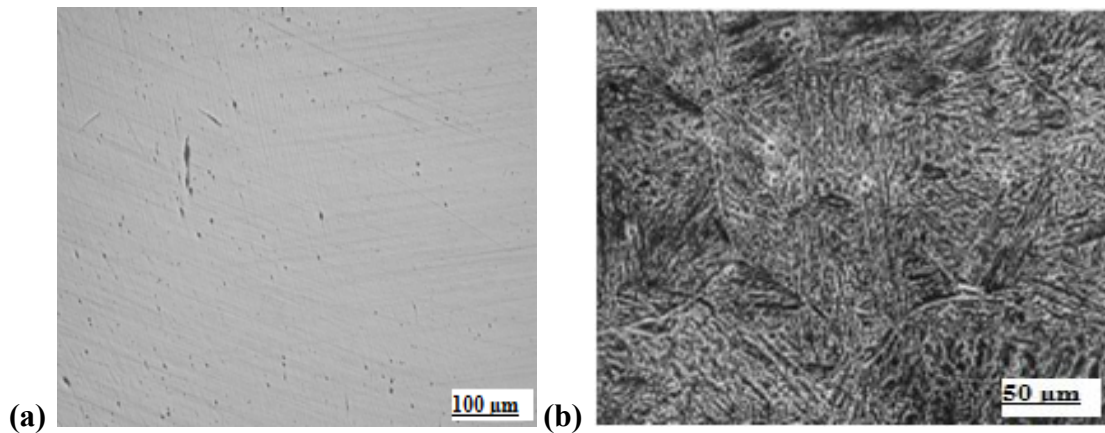
Figure 4.5 Optical micrographs of sample 3

The optical micrographs of unetched sample at 100x as shown in figure (a) shows the presence of inclusions. While the figure (b) of etched sample with Vilella's etchant at 200x shows the tempered martensitic structure with large number of inclusions and pits.

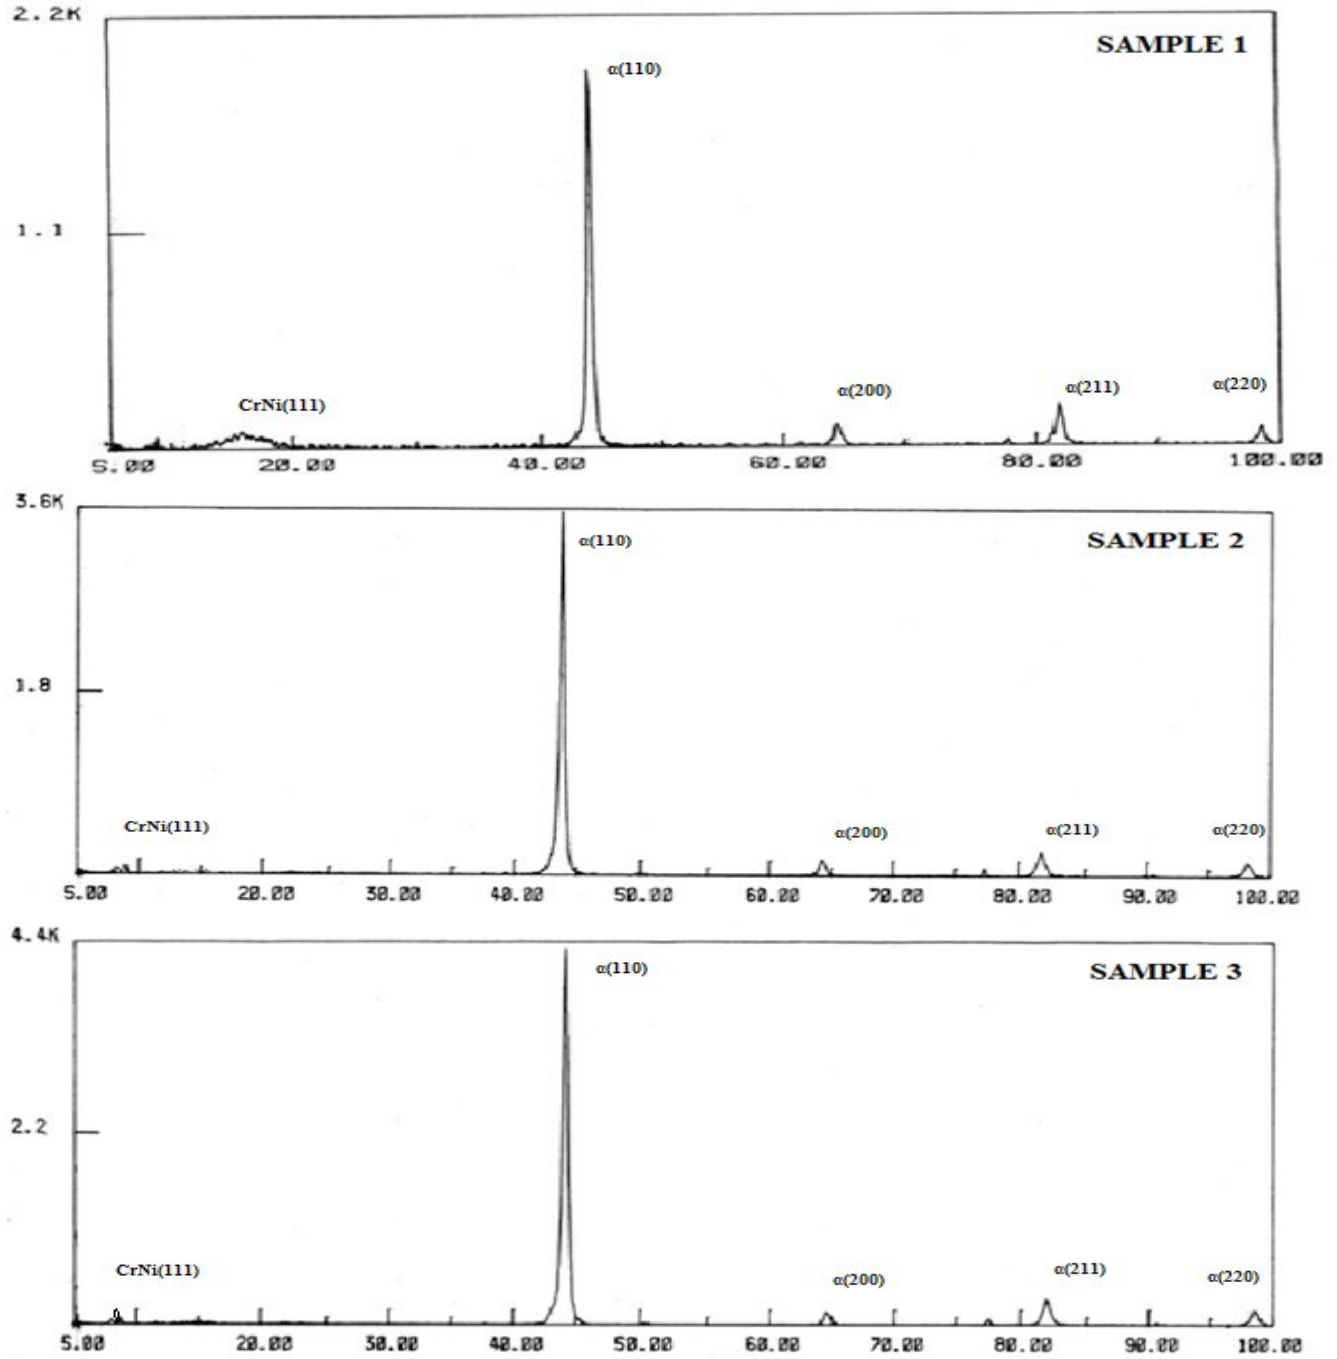
Figure 4.10 XRD pattern

From the XRD peaks of blade samples we observed that increased intensity of Iron at angle 44.67° , 65.01° , 82.32° at 98.47° , shows the excess of Iron and remaining peaks of Cr at angle 44.37° , 64.55° and 81.69° and Ni at angle 45.51° , makes an interference pattern, are shown in three samples and shows the presence of α -phase. The α (110) at angle 44.67 , α (200) at angle 65.01 , α (211) at angle 82.32 , and α (220) at angle 98.47° phases were present
