**NON-DESTRUCTIVE EVALUATION OF CORRODED AND CORROSION
REPAIRED RC BEAMS**

**MASTERS OF ENGINEERING
IN
STRUCTURAL ENGINEERING**

**DEPARTMENT OF CIVIL ENGINEERING
THAPAR UNIVERSITY,
PATIALA-147004
JULY 2016**

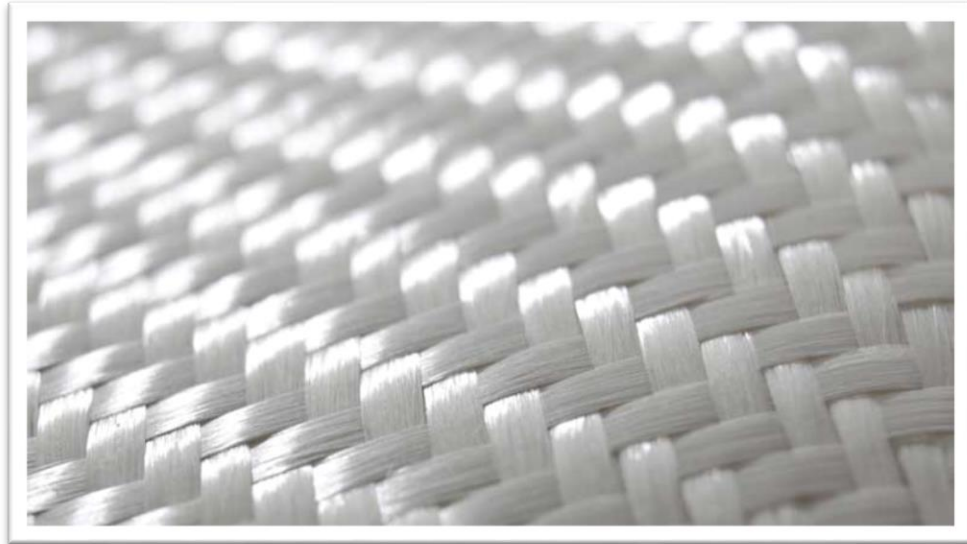
Figure 1.4: GFRP sheet [7]

- (i) **Glass Fibre Reinforced Polymer (GFRP):** The GFRP covering act as a physical barrier that hinders the ingress of aggressive species such as chlorides and carbon dioxide present in the environment and strongly delays the corrosion onset. The properties of GFRP are shown in **Table 1.1** and **Figure 1.4** shows GFRP sheets.

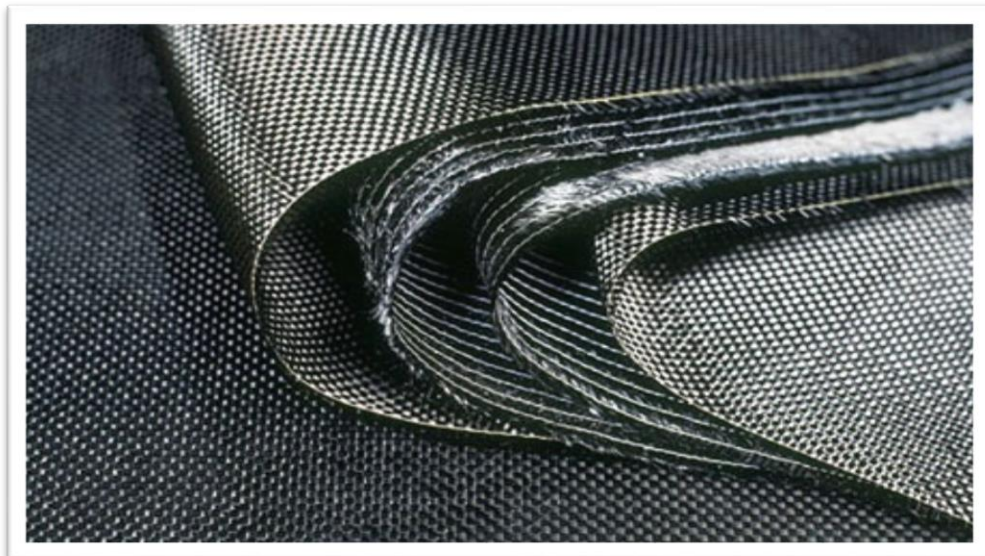
Figure 1.5: CFRP sheet [8]

- (ii) **Carbon Fibre Reinforced Polymer (CFRP):** CFRP sheets are thinner than GFRP sheets and exhibit a greater tensile strength, greater tensile modulus and lower ultimate strain. The properties of CFRP are shown in **Table 1.1**. **Figure 1.5** shows CFRP sheet.

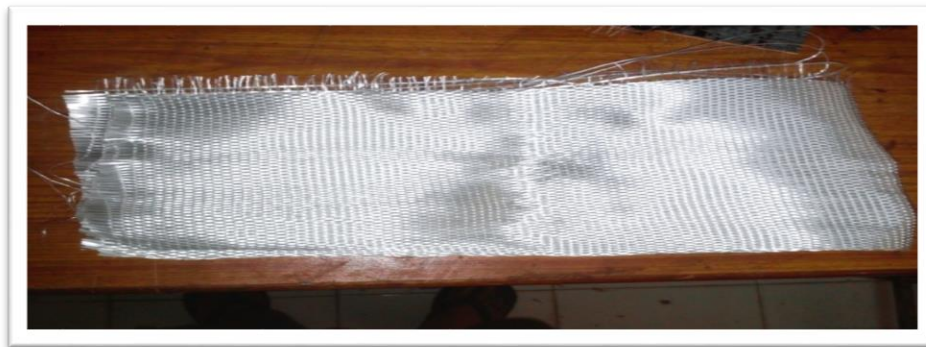
Figure 3.2: GFRP laminate

- **Fibre Reinforced Polymer:** The FRP materials used for repairing are GFRP (Glass Fibre Reinforced Polymer) as shown in **Figure 3.2** :

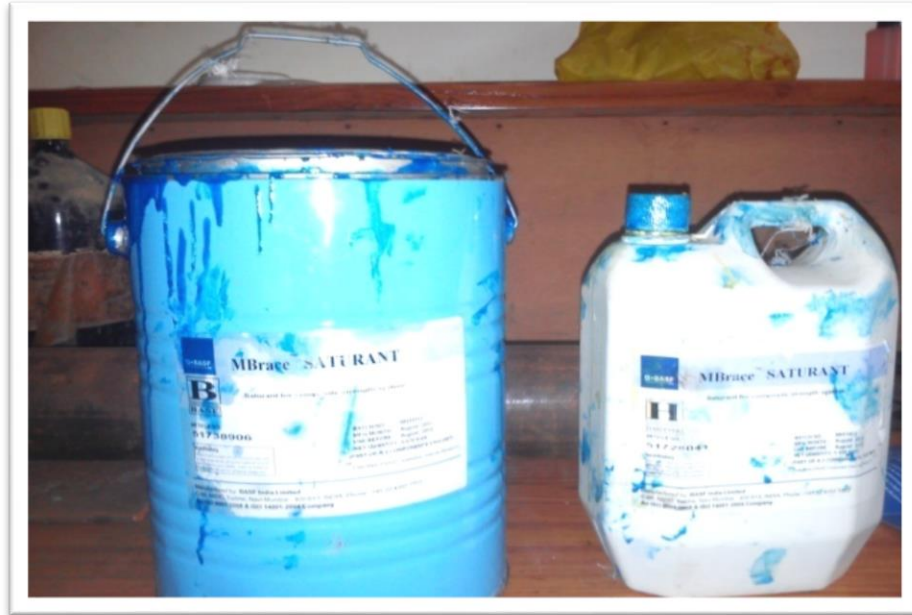
Figure 3.3: Adhesive used for bonding FRP with concrete

- **Adhesives:** The adhesive used for bonding FRP sheets with concrete is a compatible epoxy system (MBrace) as shown in **Figure 3.3**. It is blue pigmented resin for saturation of MBrace fibre sheet to form in-situ FRP composite. It is made by mixing base saturant and hardener in the ratio 100:40. Mixing of saturant and hardener is done thoroughly for five minutes until components are thoroughly dispersed. Properties of the epoxy are given in **Table 3.8**. as supplied by manufacturer.

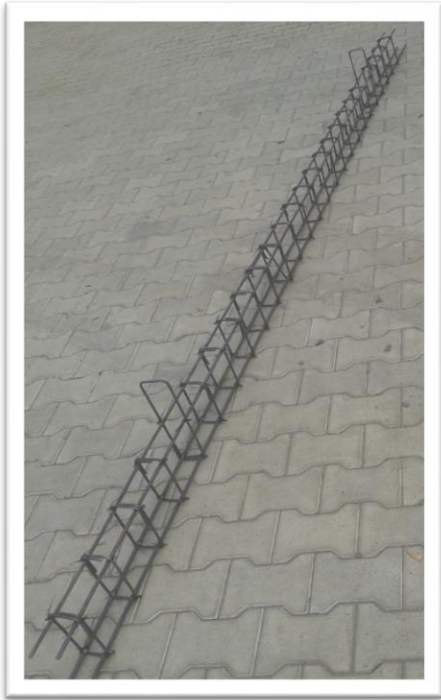
Figure 3.5 Reinforcement detailing

The casting of beams was done in single stage. The beams were cast in mould of size 127 x 227 x 4100 mm. Entire beam mould is first oiled so that the beam can be easily removed from the mould after 24 hours. Spacers of size 25mm are used to provide uniform cover to the reinforcement. When the bars have been placed in position as per design, concrete mix is poured in the mould and the beam is vibrated using a needle vibrator, to ensure the proper compaction. The vibration is done until the mould is completely filled and there is no gap left. The beams are then removed from the mould after 48 hours. After demoulding, the beams were cured for 28 days using jute bags.

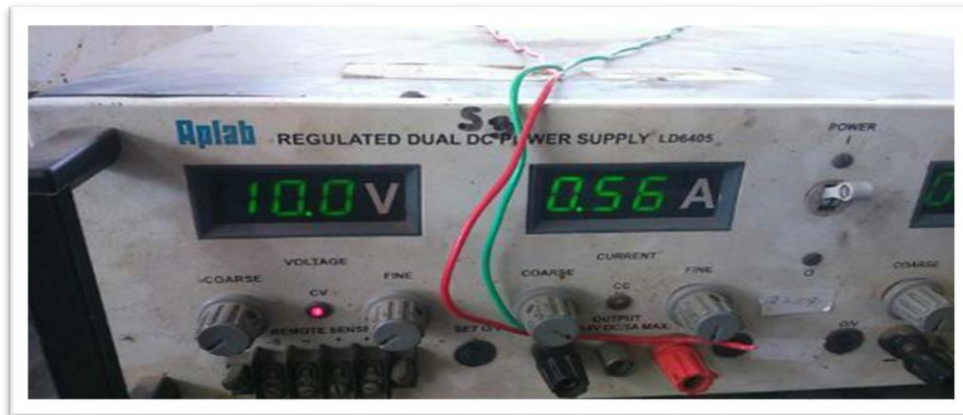
Figure 3.5 DC Regulated Dual Power Supply Source (constant voltage)

The corrosion of reinforcing steel was accelerated by impressed current technique. This was done through an integrated system incorporating a DC rectifier with a built- in ammeter to monitor the current and voltage to control the current intensity. Aplab Supply with a maximum output of 64V but the beams in our study were corroded at 10 V was used **Figure 3.8**. This method of corrosion was employed to reach advanced stages of deterioration in a relatively short time. At a time two beams were connected in series for corrosion process. Central 1.5 m portion of concrete beams were subjected to corrosive environment. It was done by continuous sprinkling of 3.5 % brine solution by water tank arrangement. This type of arrangement was selected to assure that the corrosion product formed is not washed away and cracks are formed in the concrete specimens. The direction of the current was adjusted so that the reinforcing steel became an anode and a

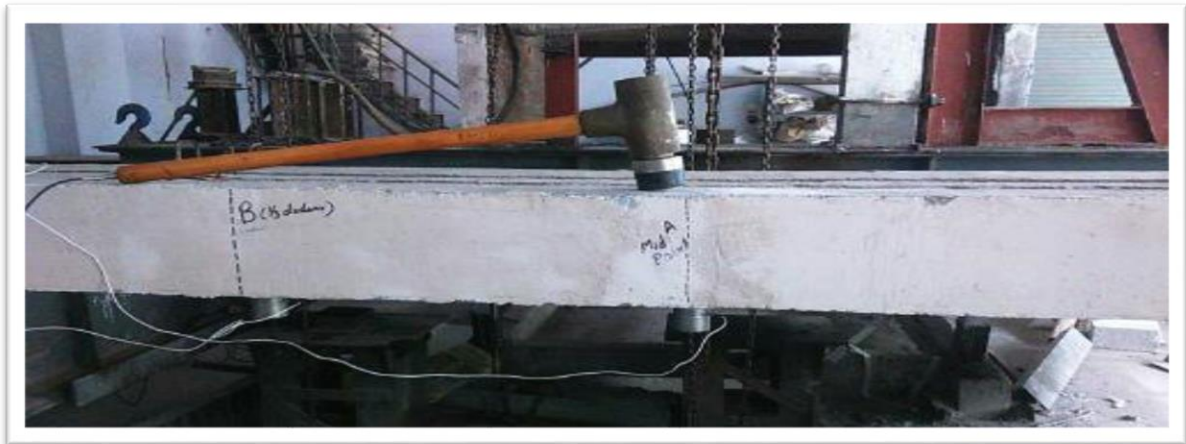
After all the beams subjected to different levels of corrosion, vibration characteristics of all beams were recorded using software OROS 8.0 using NV Gate solutions software. Vibration signatures were taken on C-0 and beam corroded to different level(C-20, C-30, C-40 and F-60). We recorded dynamic characteristics from FFT analyser by striking the hammer. The point for excitation were chosen as centre and one third of beam as shown in **Figure 3.10**

Figure 3.10 Accelerometer placed below at centre and one third position of beam

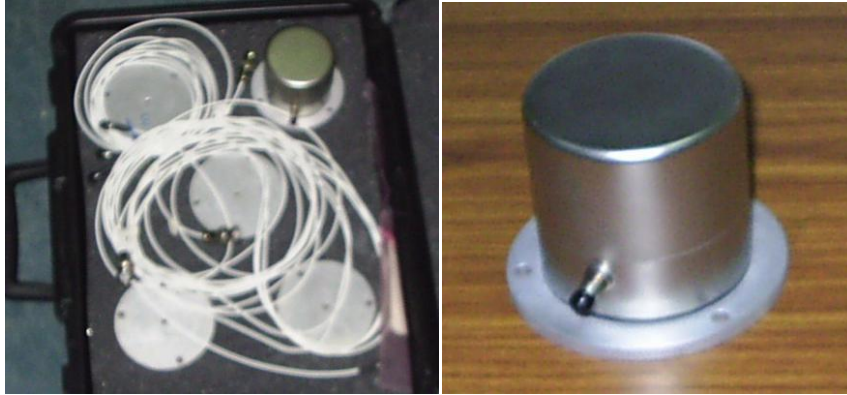
Accelerations was measured at center and one third of the specimen using DYTRON model 11197 and 11305 with a sensitivity of 1.055 V/g. The accelerometer is shown in **Figure 3.11**. The data signal for each accelerometer was recorded at several sensitivity levels to allow reasonable resolution at all times over the exponentially decaying vibration signal. High strength cement plaster was used for mounting the accelerometer to the surface of the test specimen.

Figure 3.11 Accelerometers

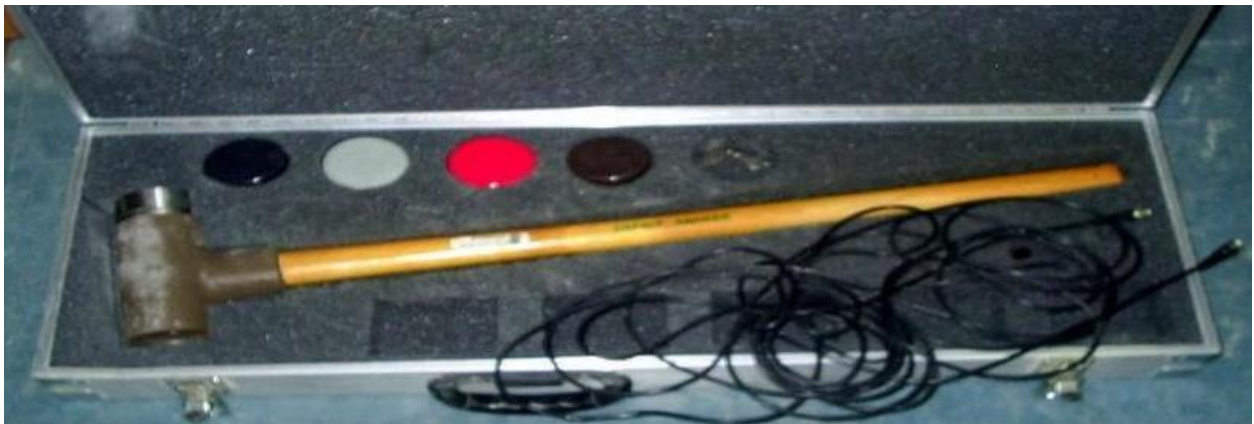
The vibration response was measured by performing impact testing on the structure. An impact hammer having a hard rubber impact tip was swung from a horizontal distance of approximately 50 mm from the specimen [29]. The hammer was model PCB 20135 with a sensitivity of 0.00225V/N, made by OROS instruments. A typical impact-force hammer like the one used is illustrated in **Figure 3.12**. The impact consisted of a nearly constant force over a broad frequency range and was capable of exciting all resonances in that range.

Figure 3.6 Typical impulse-force hammer

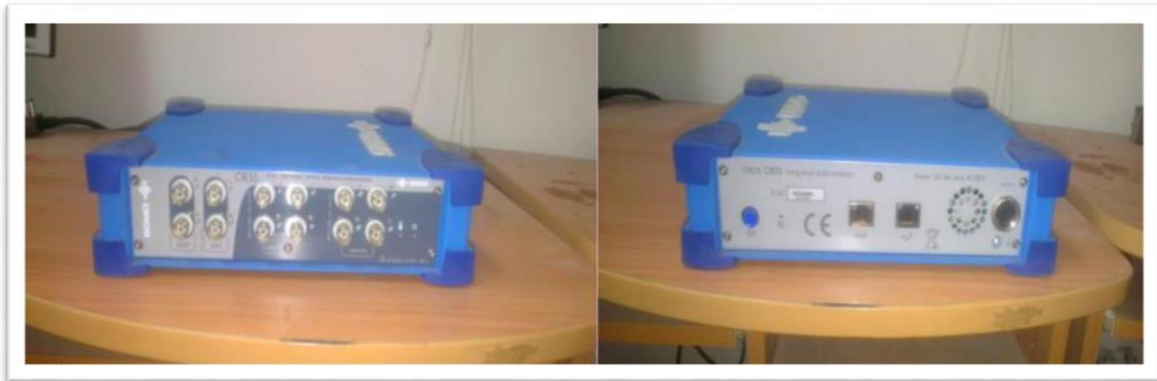
Figure 3.13: FFT Analyzer

the time domain signal obtained from vibration monitoring was subjected to FFT to get FRF (frequency response function). The NV gate did this transformation itself since it was an inbuilt function.

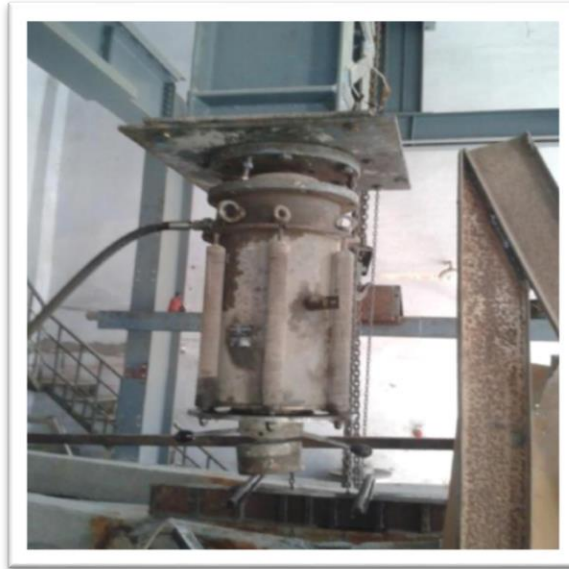
Figure 3.14 Hydraulic operated jack

Ultimate load **P- Δ tests** were performed in the laboratory to determine the load carrying capacity of the beam specimens. The loading arrangement used was two-point loading. This arrangement allows for a central region having virtually constant moment without any shear force. Hydraulic operated jack in **Figure 3.14** and corresponding Data acquisition system in **Figure 3.15** is shown below:-

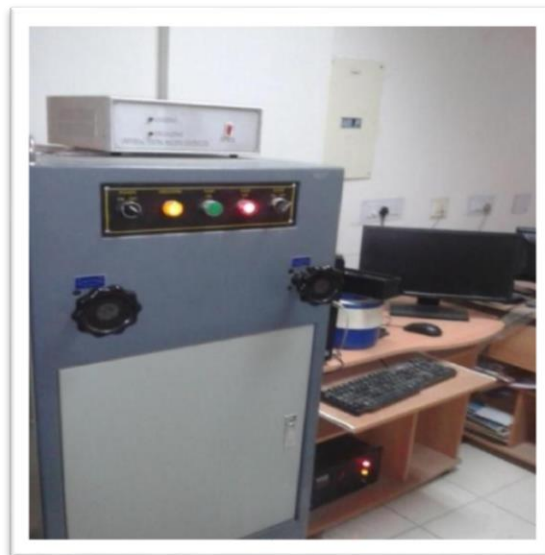
Figure 3.15 Data acquisition system

The load is applied to the beam with the help of load cell and load value is obtained from the data acquisition system, which is attached with the load cell .One LVDT's is placed at the center of the beams to record the deflection against the loading as shown in **Figure 3.16**

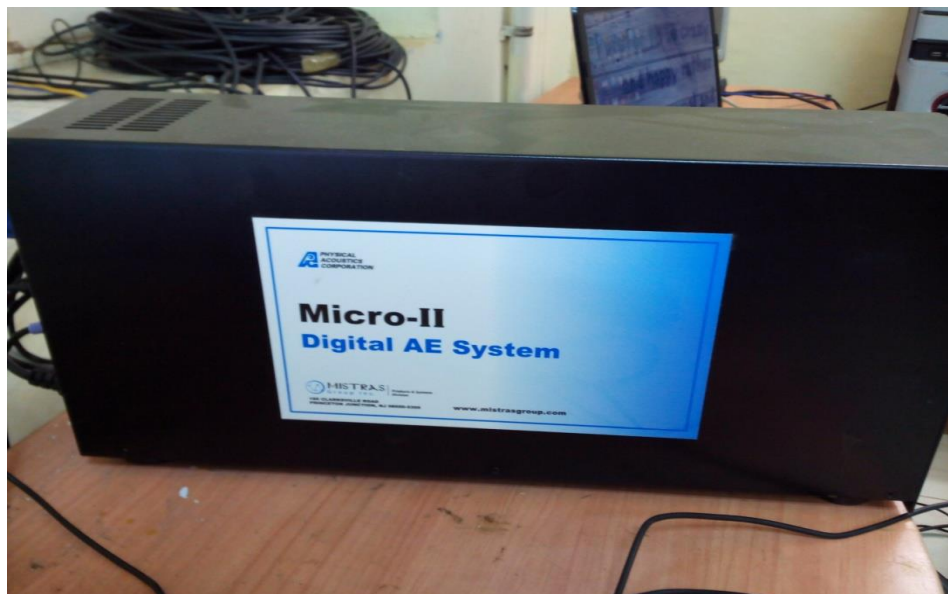
AE data acquisition system used for experimentation was Micro II digital AE system provided by PAC (Physical Acoustics Corporation) **MISTRAS GROUP** which is shown in the **Figure 3.18**.

Figure 3.18: Data acquisition set up used for the study

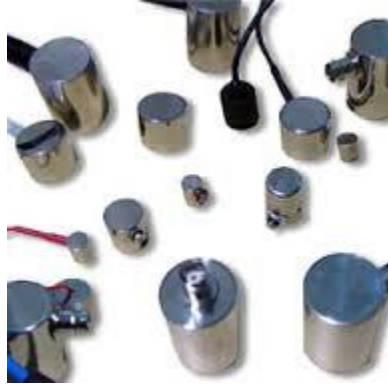
Figure 3.19: Acoustic Emission Sensors generally used

Sensors are placed on the surface of the structure to record acoustic emission signals. Sensors are available in wide range of shapes and sizes as shown in the **Figure 3.19**.

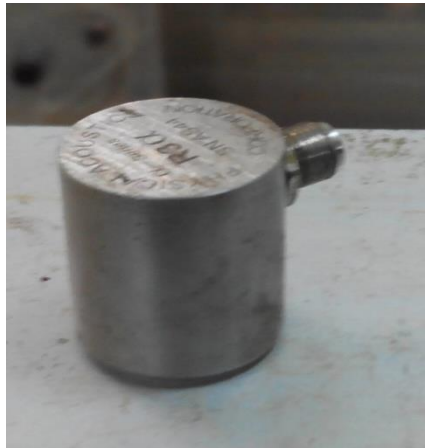
Figure 3.70: R3α Sensors for AE Acquisition used in the study

Acoustic Emission sensors which were used for monitoring the corrosion in the present study are shown in the **Figure 3.20**.

Operating frequency range	35-100 KHz.
Resonant frequency	150 KHz
Physical Dimensions	19mm dia.× 22.4mm height
Weight	31 grams
Case Materials	Stainless Steel

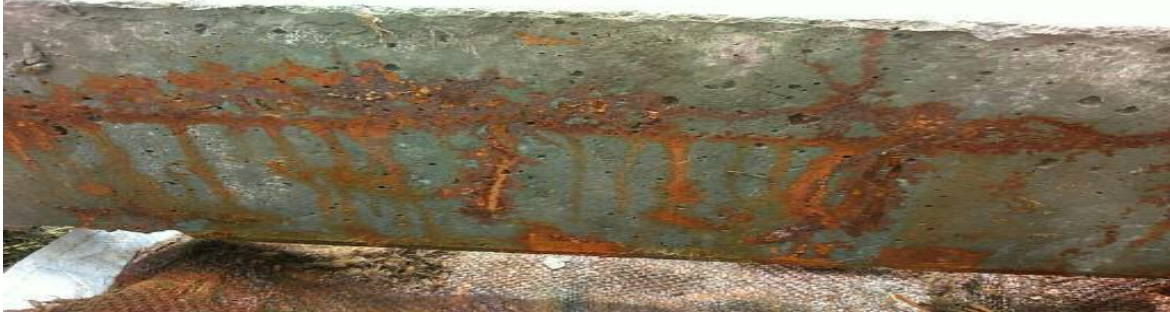
A beam undergoing accelerated corrosion for 20 days at a constant voltage supply of 10 V shows reddish brown patches of corrosion product on the three sides of beam at centre 1.5m portion of beam as shown in **Figure 4.1** It was noticed that no cracks were generated on surface of beam after 20 days corrosion. It was observed that at 20 days corroded beam shows small corrosion products with liquid ooze from the surface and no cracks as compared to badly corroded beams.

Figure 4.1 Red brownish products observed along the side

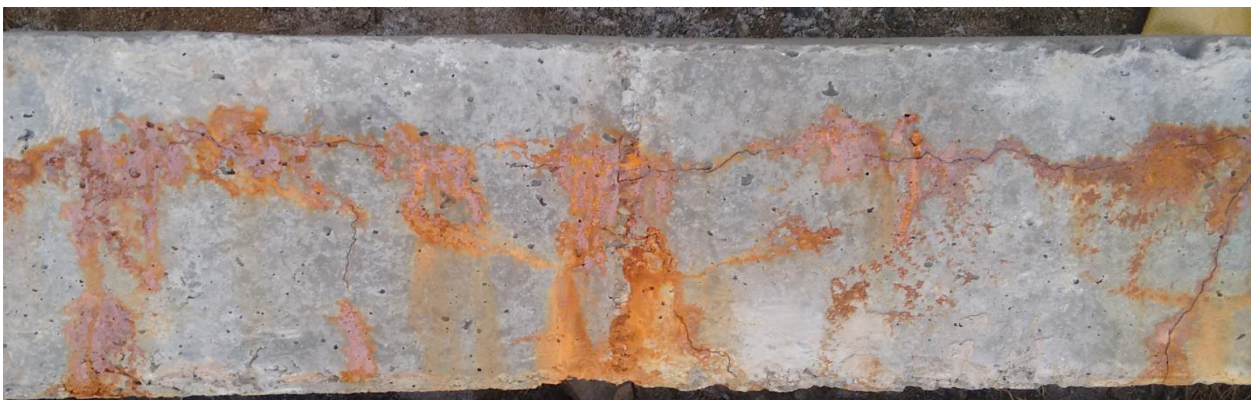
Beam undergoing corrosion for 30 days at a constant voltage supply of 10 V shows reddish brown patches on three sides at centre 1.5m portion of the beam along with cracks on bottom and side faces. At the bottom of the C-30 beam flexural crack at centre with bending of beam was observed along with red brownish colored corrosion products as shown in **Figure 4.2**. At the front side face of the beam vertical cracks were observed originating from tension face towards compression face as shown in **Figure 4.3**. At the back side face of the beam it was observed that full centre 1.5m portion of the beam was covered with reddish brown patches, and longitudinal crack was observed on the surface throughout the centre 1.5m portion of the beam. A reddish brown liquid ooze out from the sides of beam is observed on both face of beam.

Figure 4.2 Cracks on left face of C-30

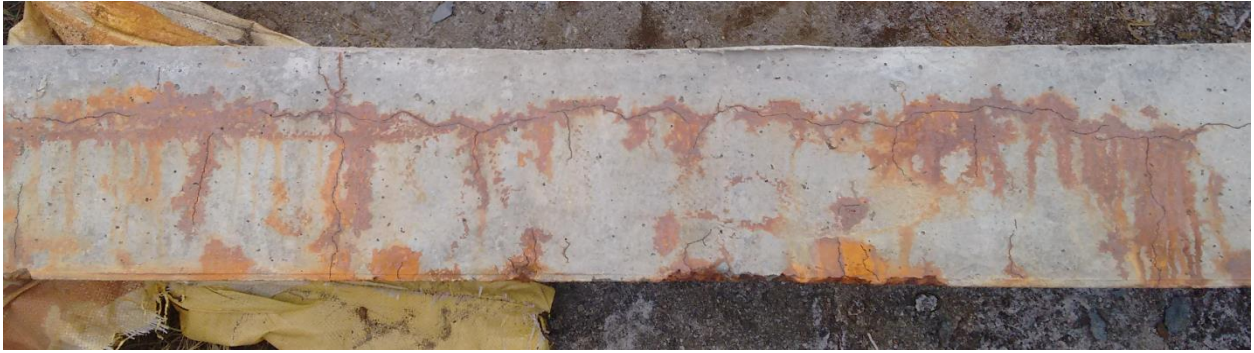
Figure 4.3 Longitudnal and tranverse cracks at right face of C-30

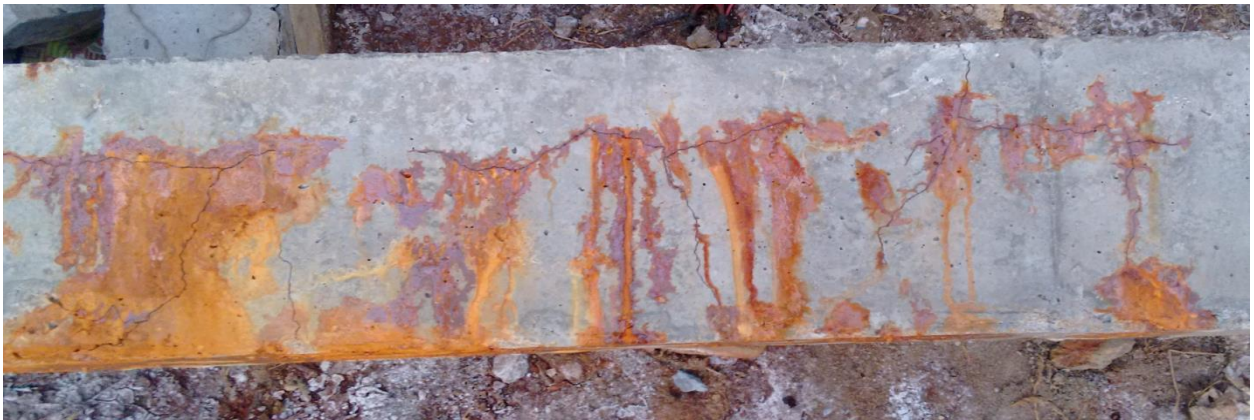
Beams undergoing corrosion for 40 days shows dark reddish brown corrosion products with reddish brown liquid oozes out from the cracks on three faces of the beam at centre 1.5m portion. Corrosion products formed in C-40 beam was in large volume than in other cases. At the front side face longitudinal crack was observed throughout the centre 1.5m portion along the tension bar as shown in **Figure 4.4**. At the back face small vertical and horizontal cracks were observed with major vertical crack at centre. At the bottom face of beam large corrosion products were noticed and minor cracks were generated.

Figure 4.4 Longitudnal and tranverse cracks at right face of C-40

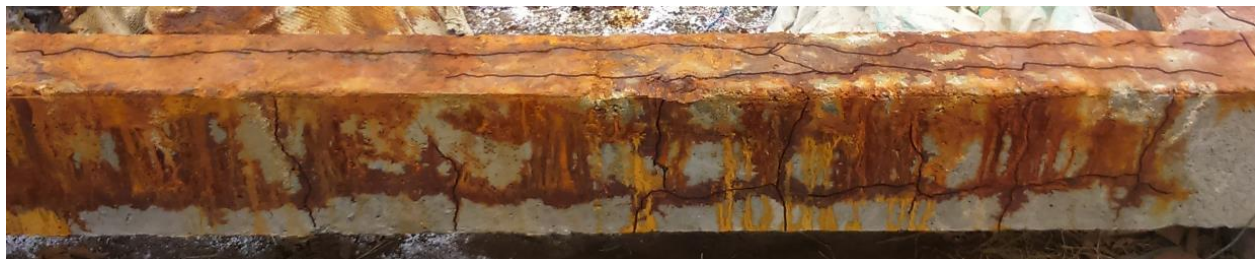
Beams undergoing corrosion for 60 days shows dark reddish brown corrosion products with reddish brown liquid oozes out from the cracks on all three faces of the beam at centre 1.5m portion. Corrosion products formed in C-60 beam was in large volume than in other cases. There were horizontal cracks at the bottom face of the beam and large vertical and horizontal cracks were observed on both front and back side of beam. Thus to reinforce this sample it was wrapped with GFRP and further test were performed.

Figure 4.6 Right and bottom side of C-60

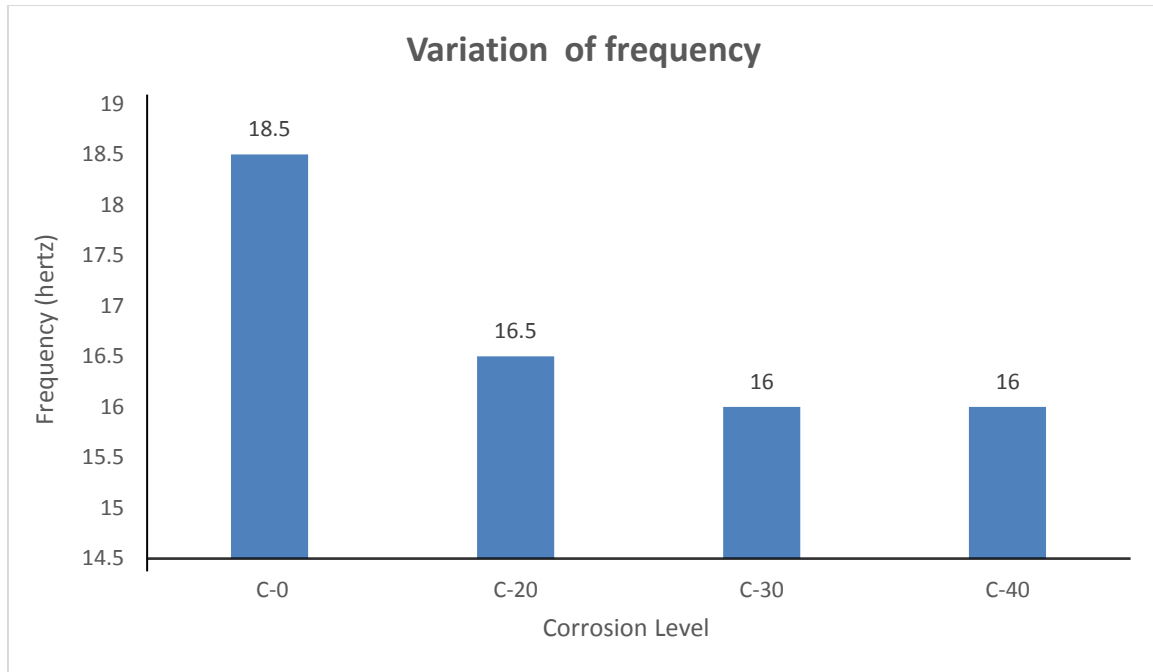
Figure 4.12 Bar chart showing relation between level of corrosion with frequency

Figure 4.12 shows graphically the variation of frequency with different levels of corrosion

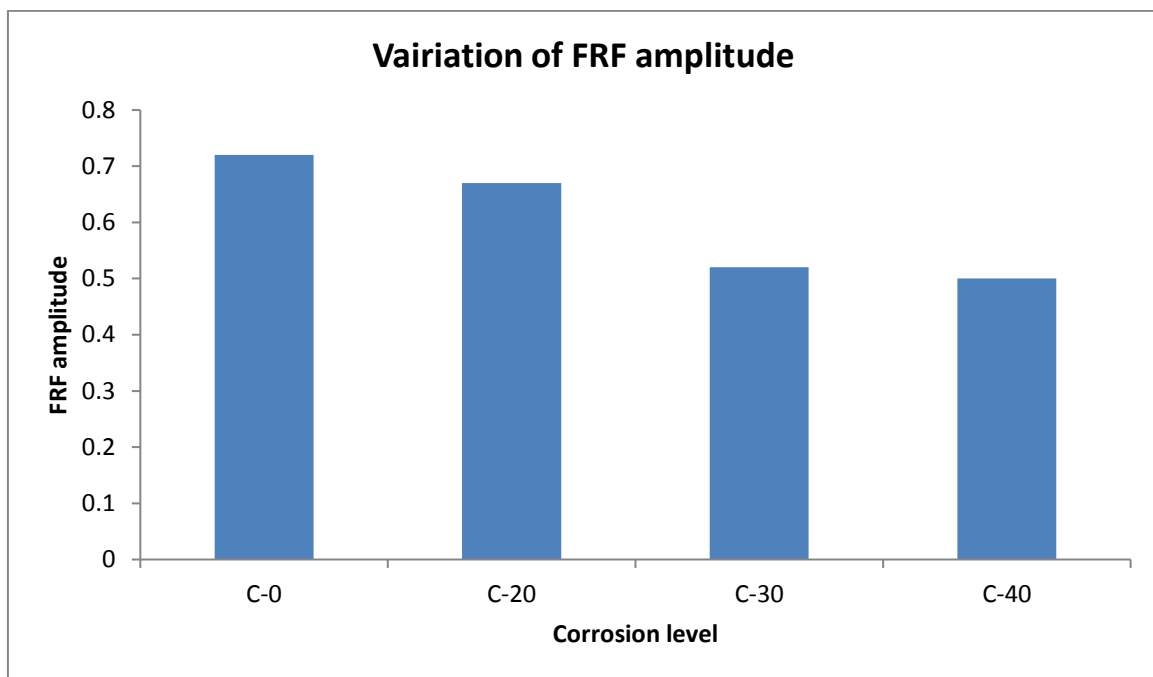
Figure 4.13 Bar chart showing relation between level of corrosion with FRF amplitude

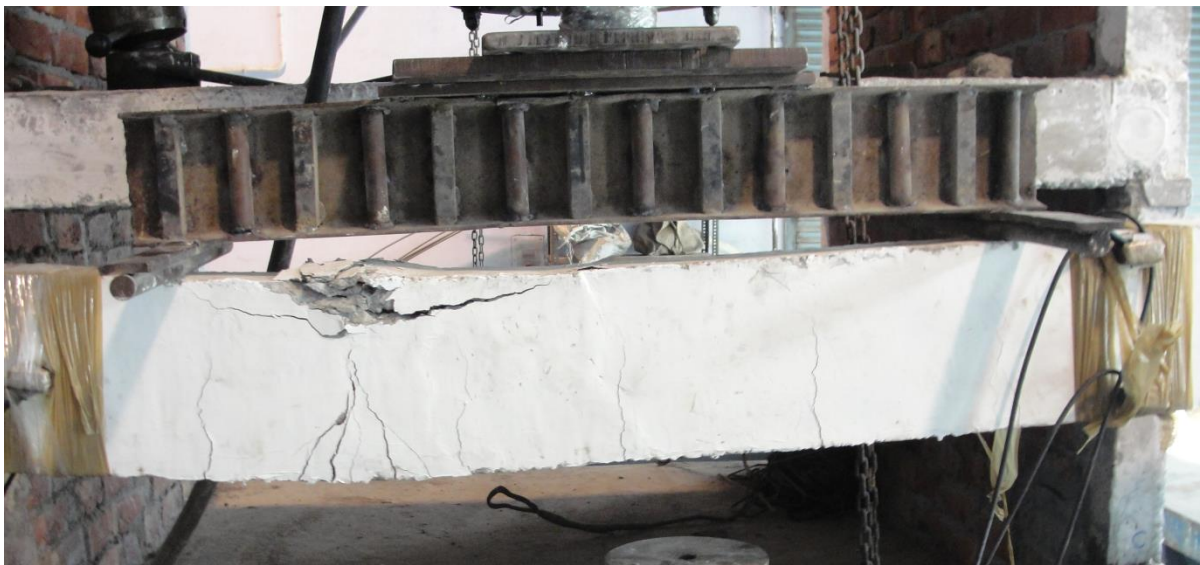
Fig 4.15 Flexure Cracks on side face of C-0 beam

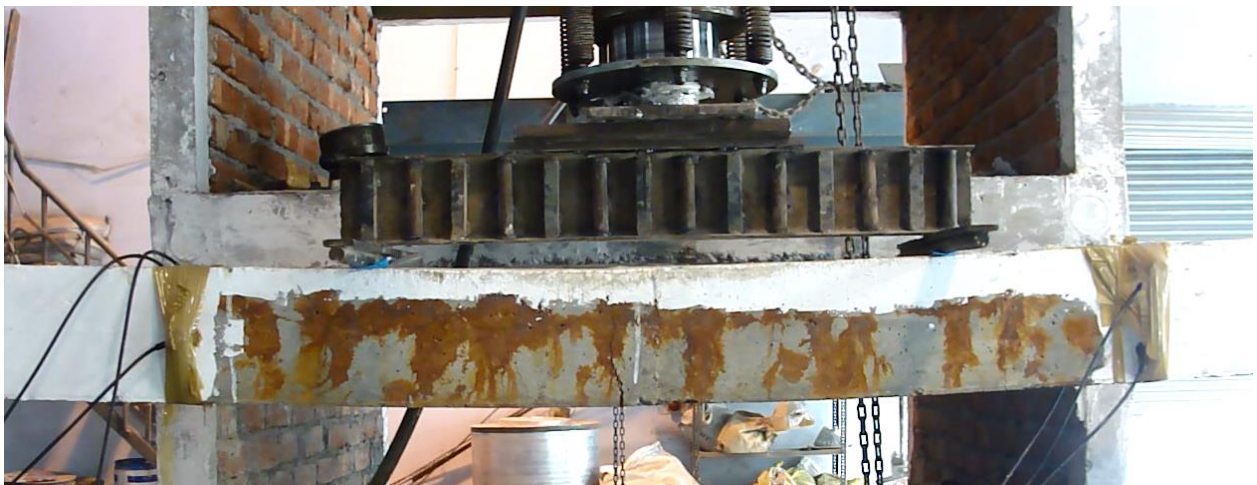
Figure 4.17 C-20 Beam showing large vertical crack near the centre of beam

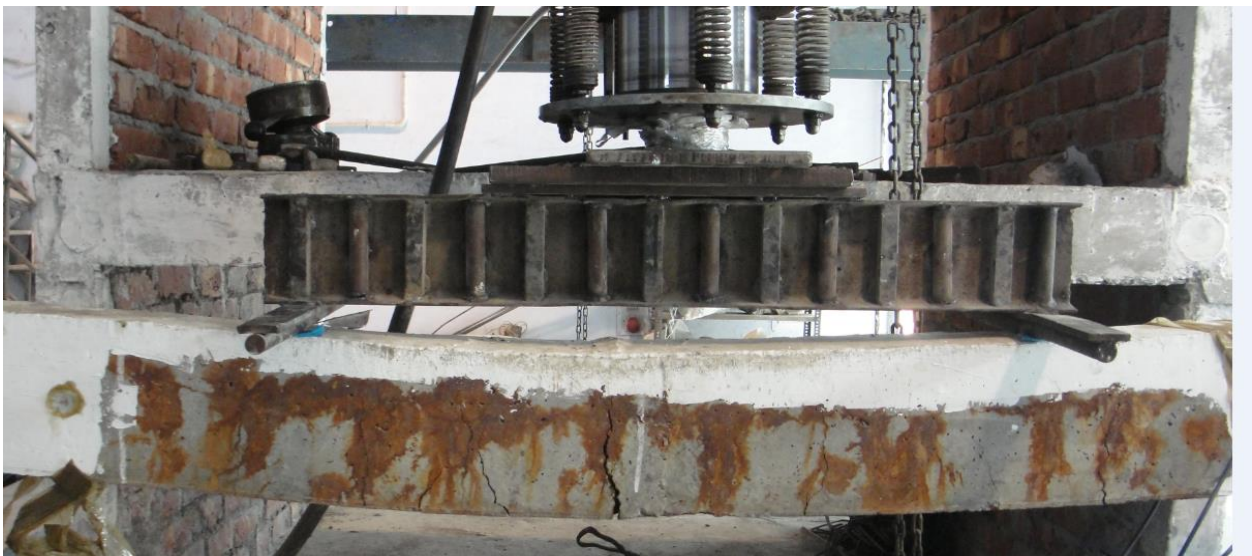
Figure 4.19 C-30 Beam showing large vertical crack near the centre of beam

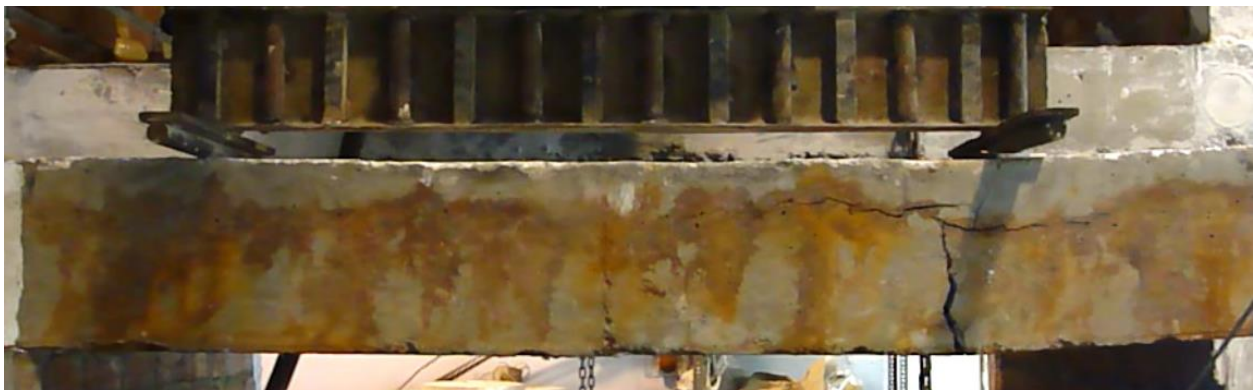
Figure 4.21 C-40 Beam showing large vertical crack

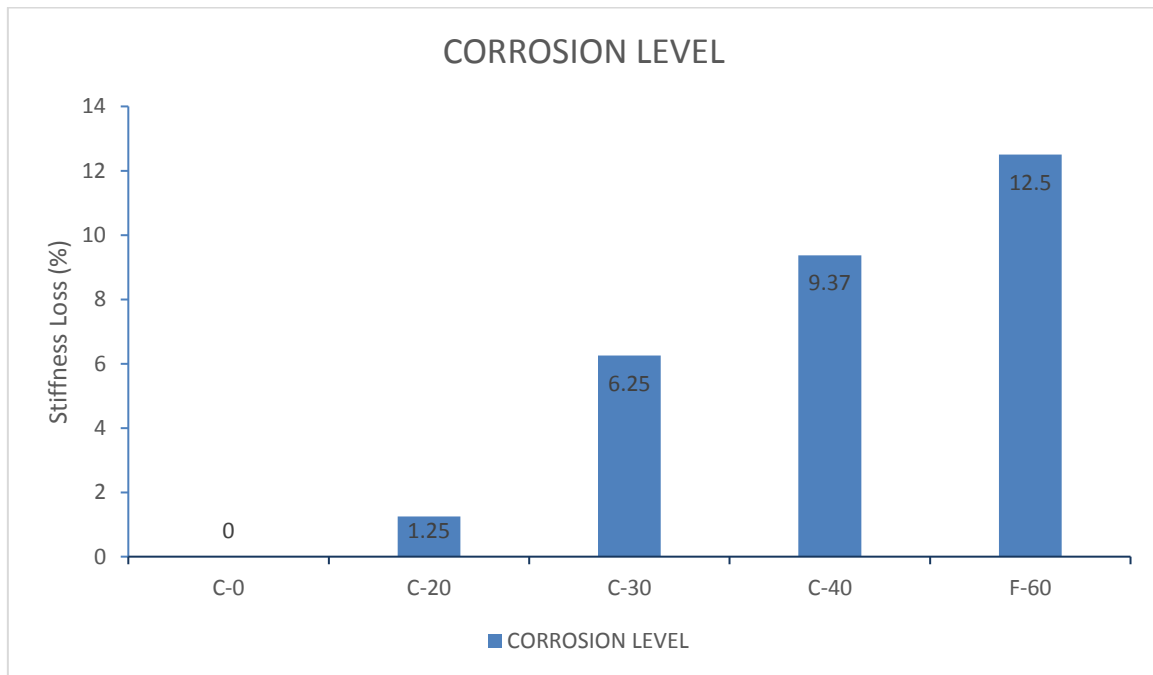
Figure 4.22 Bar chart showing stiffness loss with corrosion in beam

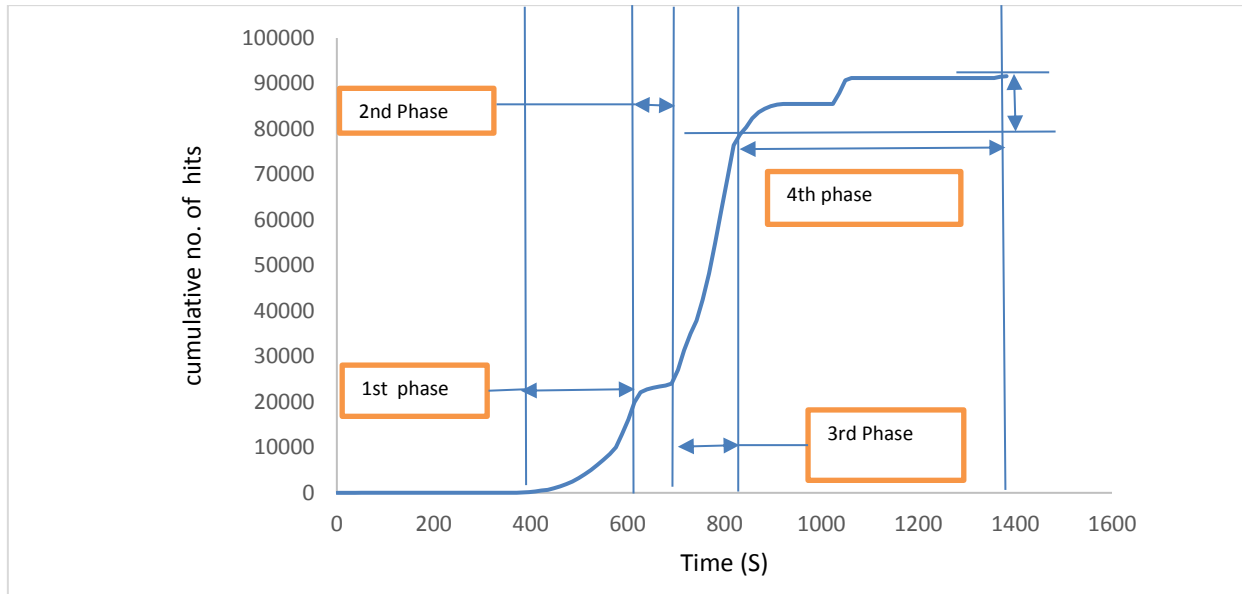
Figure 4.23 Cumulative AE hits Vs time (C-0)

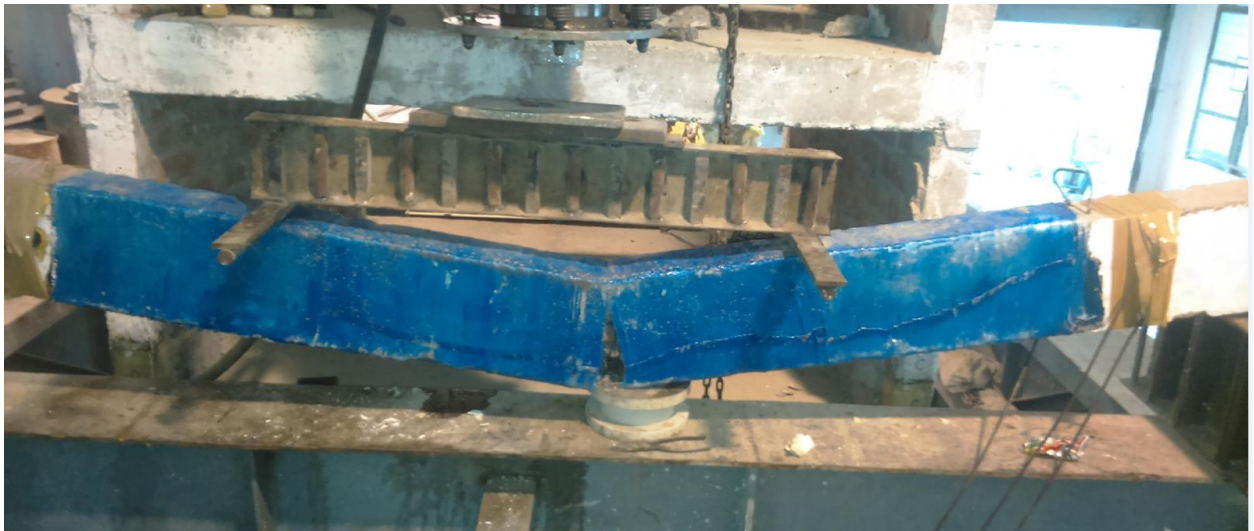
Figure 4.28 F-60 Beam cracked from the centre
