**EVALUATING THE PEDESTRIAN LEVEL OF
SERVICE FOR THE CITY OF PANCHKULA**

**MASTER OF ENGINEERING
IN
INFRASTRUCTURE ENGINEERING**

DEPARTMENT OF CIVIL ENGINEERING
THAPAR INSTITUTE OF ENGINEERING & TECHNOLOGY
(A DEEMED TO BE UNIVERSITY), PATIALA, PUNJAB.

AUGUST 2019

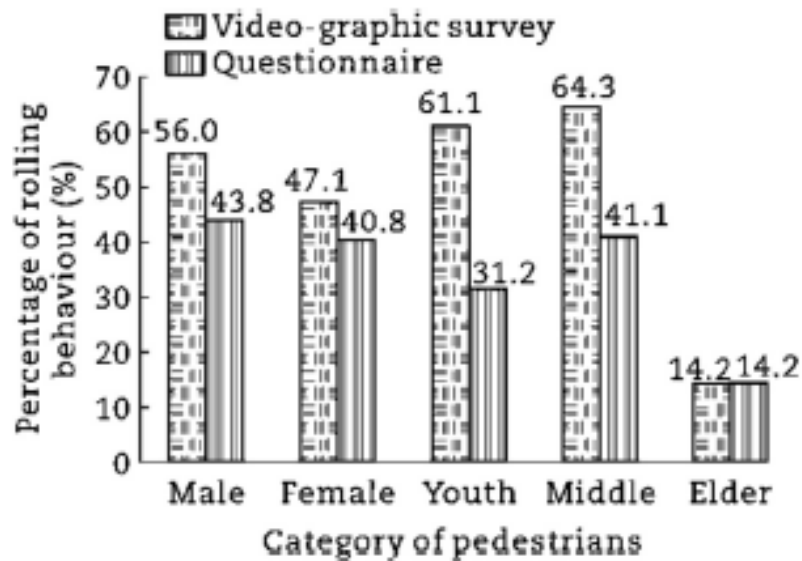
Figure 2.1 Comparison of Rolling Gap behaviour from surveys

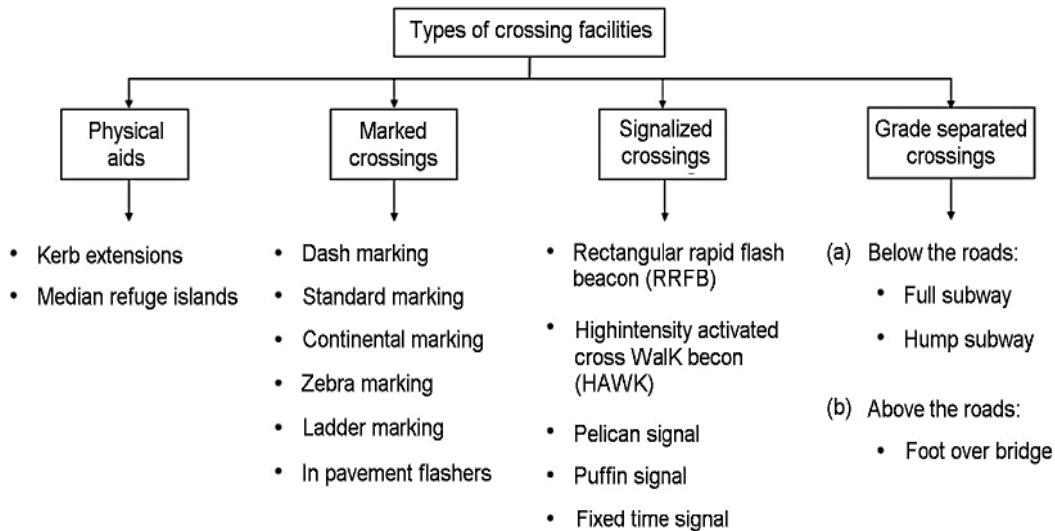
Figure 2.2 Types of Pedestrian Crossing Facilities.

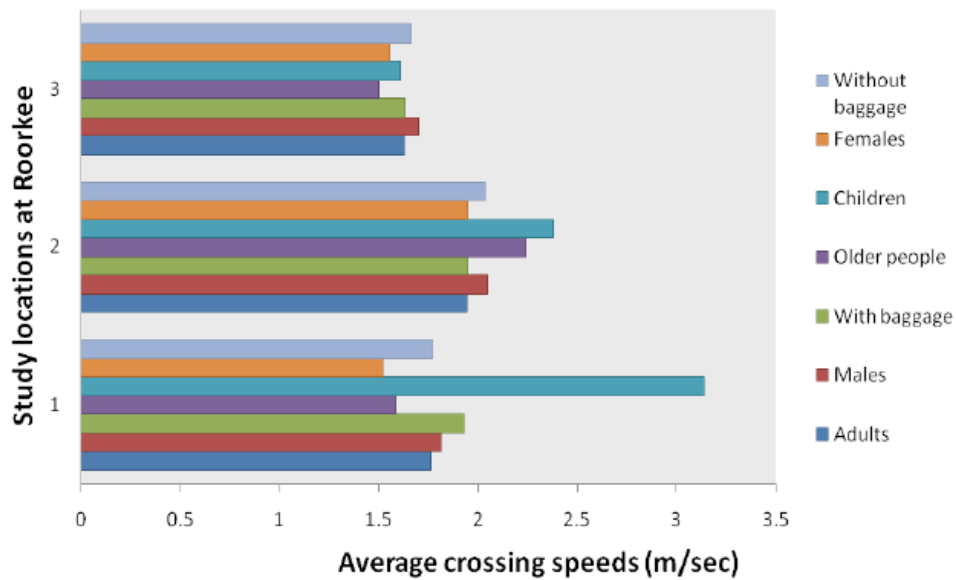
Figure 2.3 Variation of Pedestrian Crossing Speeds at study area.

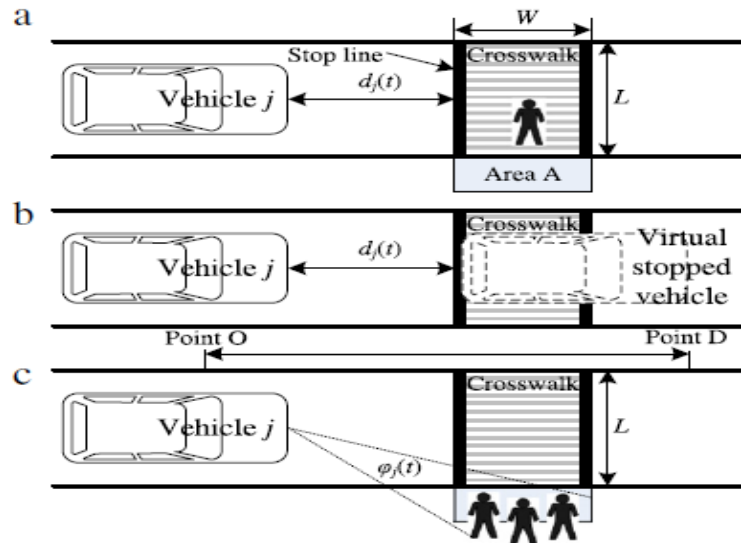
Figure 2.5 Illustration shows 3 scenarios of the study

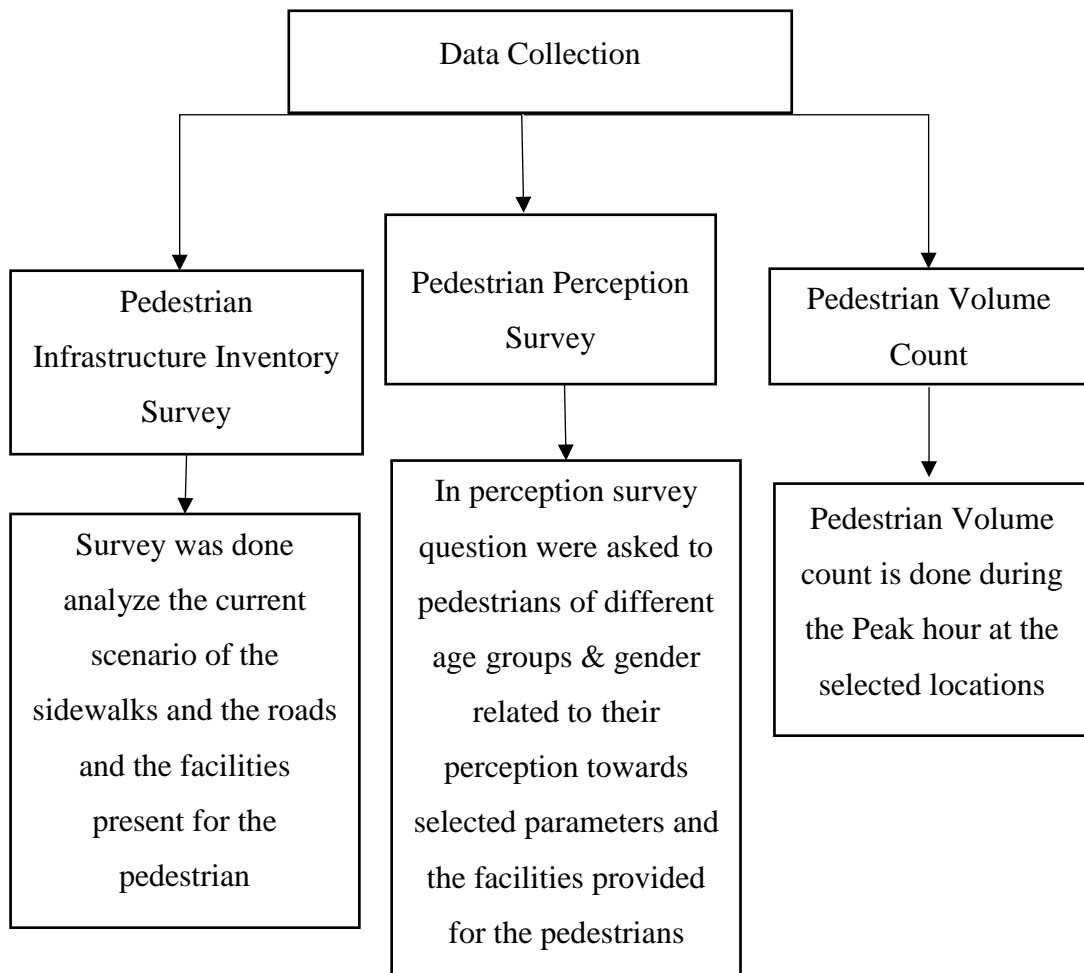
Figure 3.7 Methodologies of Data Collection Flowchart

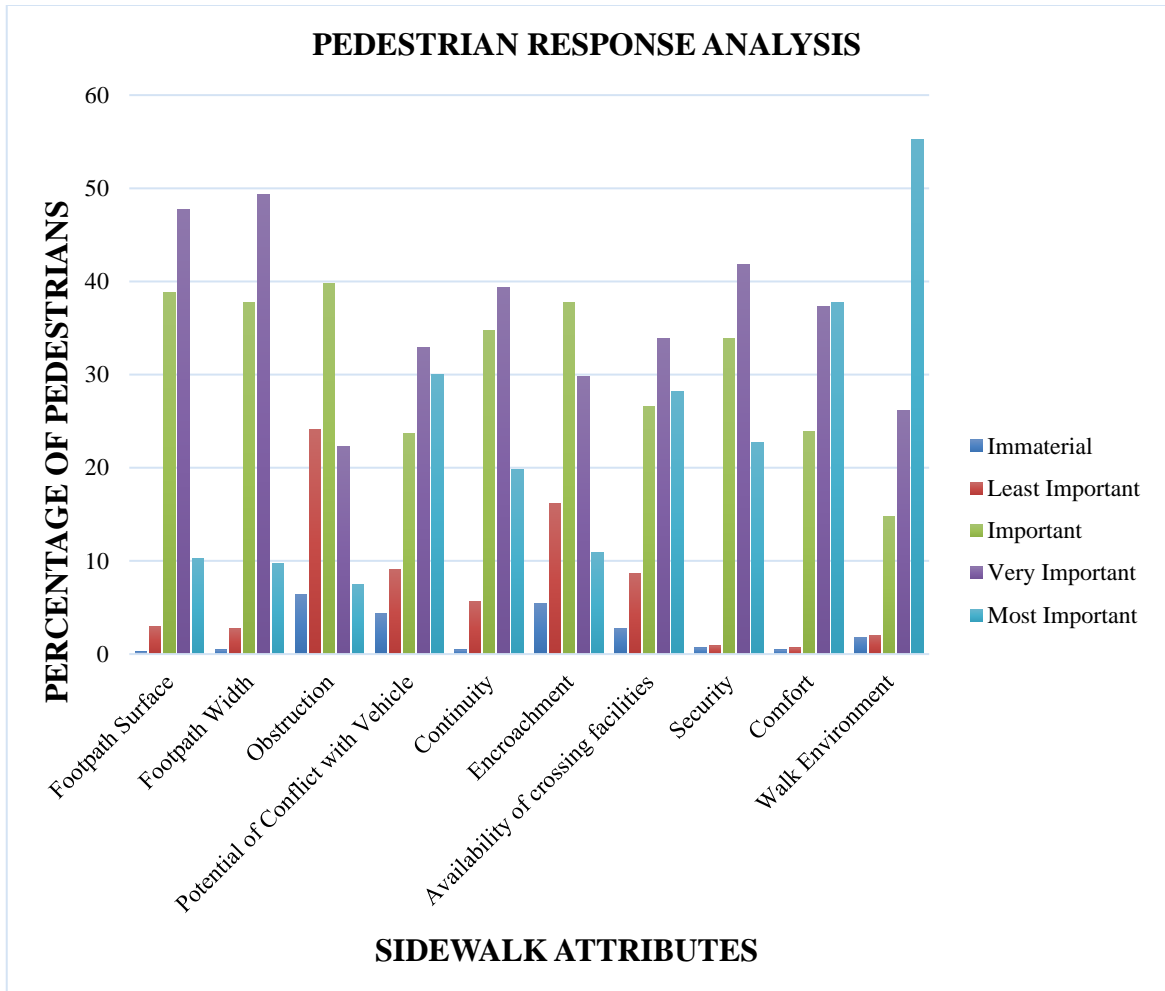
Figure 4.16 Response Rating of Pedestrians for Importance of Various Sidewalk Attributes

Service quality evaluation of sidewalks is based on characteristics of sidewalks and its walking environment. The response rates of pedestrians on the level of importance for various attributes are illustrated in Figure 4.16. Obstruction factor has got very least importance among all other factors, that is about 6.4% people rated it as 1, which signifies that factor ‘obstruction’ is immaterial for them. Footpath Width has been given very important as 49.3% pedestrians find it the most essential factor while walking. The Walking Environment has got highest importance rating of 5 (55.2%). ‘Walking Environment’ is the factor which pedestrians consider most important for walking on sidewalks.

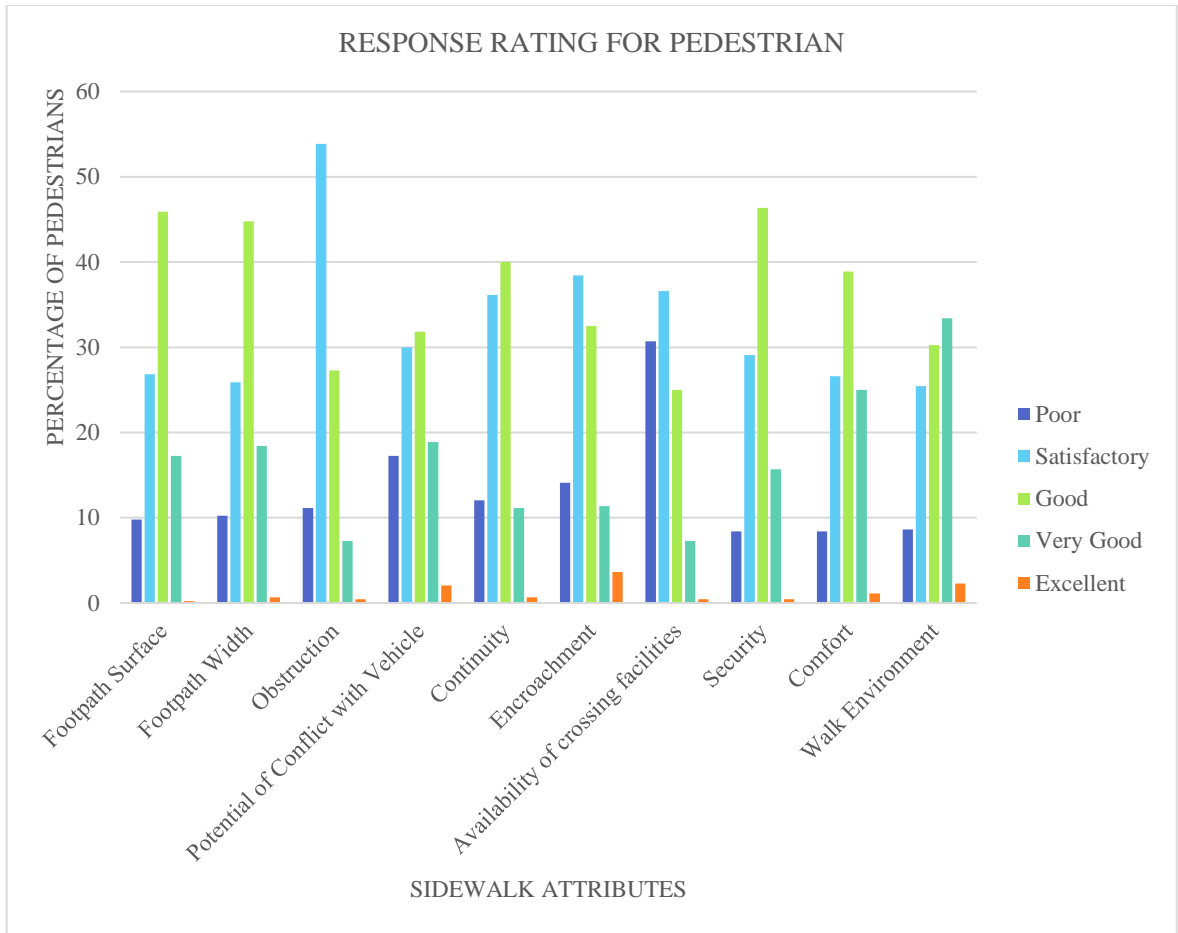
Figure 4.17 Response Rating of Pedestrians for Satisfaction on Various Sidewalk Attributes

Figure 4.17 illustrates the response rating for the level of satisfaction. Majority of pedestrians rated the attributes as satisfactory. Therefore, Security & Comfort factor has got very least satisfaction rating among all the other factors. It has been noted that satisfaction ratings are comparatively low for those factors that got the highest importance. For example, factors like ‘security’ and ‘comfort’ have got a maximum poor rating, which indicates the absence of security features like lighting, police patrolling etc. along sidewalks. So, in order to improve the Quality of Service of sidewalks, satisfaction rating of the most important parameters has to be improved which can be possible only by implementing suitable improvement strategies for that characteristic of sidewalk. There is a possibility that socio-demographic factors like age, gender, income, etc. could influence the perceptions of pedestrians. Future researchers can be conducted to explore potential perception variances resulting from such socio-demographic differences.

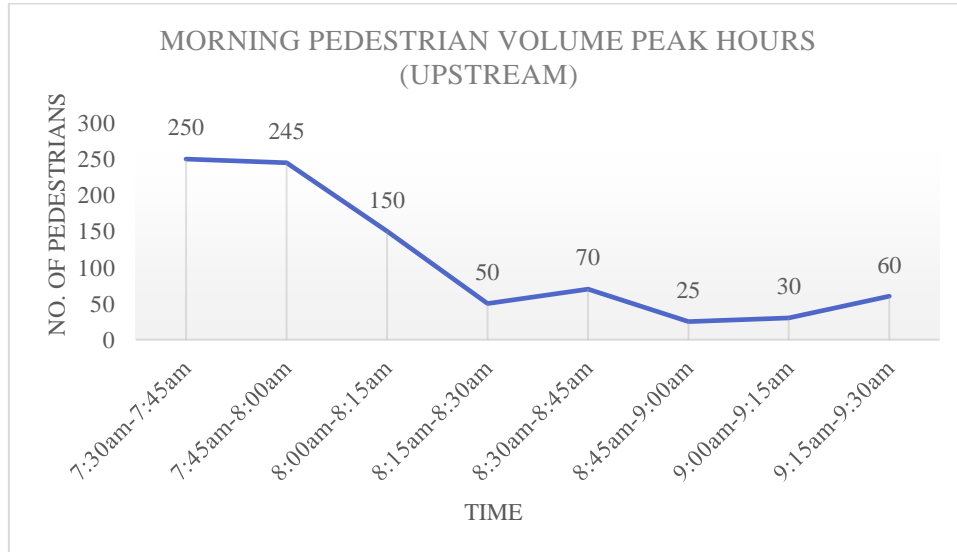
Figure 4.18 Morning Pedestrian Volume Peak Hours (Upstream) at Location 1

As it can be observed in the figure Max 15-min Pedestrian Peak flow rate is found at time 7.30am-7.45am as due to school area peak timings where some parents also use the sidewalk and the street segment for dropping off their children.

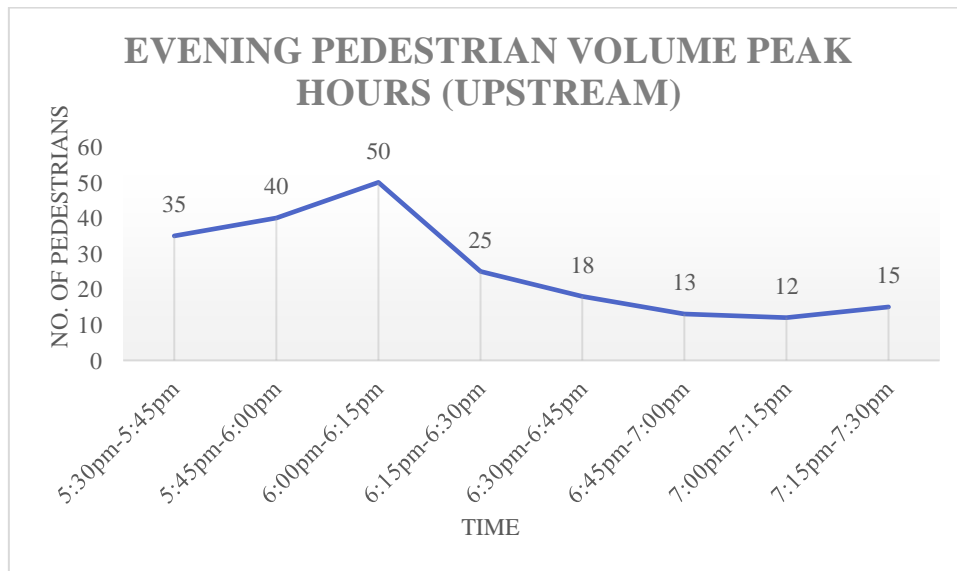
Figure 4.19 Evening Pedestrian Volume Peak Hours (Upstream) at Location 1

As it can be observed in the figure Max 15-min Pedestrian Peak flow rate is found at time 6.00pm-6.15pm as due to recreational and residential area as pedestrian come for walk at the park located opposite to School area.

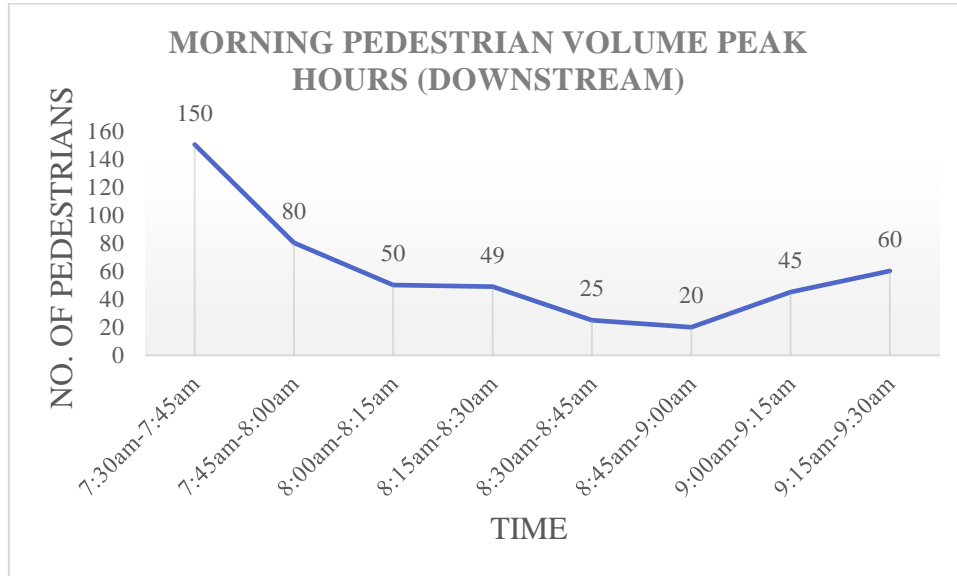
Figure 4.20 Morning Pedestrian Volume Peak Hours (Downstream) at Location 1

As it can be observed in the figure Max 15-min Pedestrian Peak flow rate is found at time 7.30am-7.45am as due to school area peak timings where some parents also use the sidewalk and the street segment for dropping off their children.

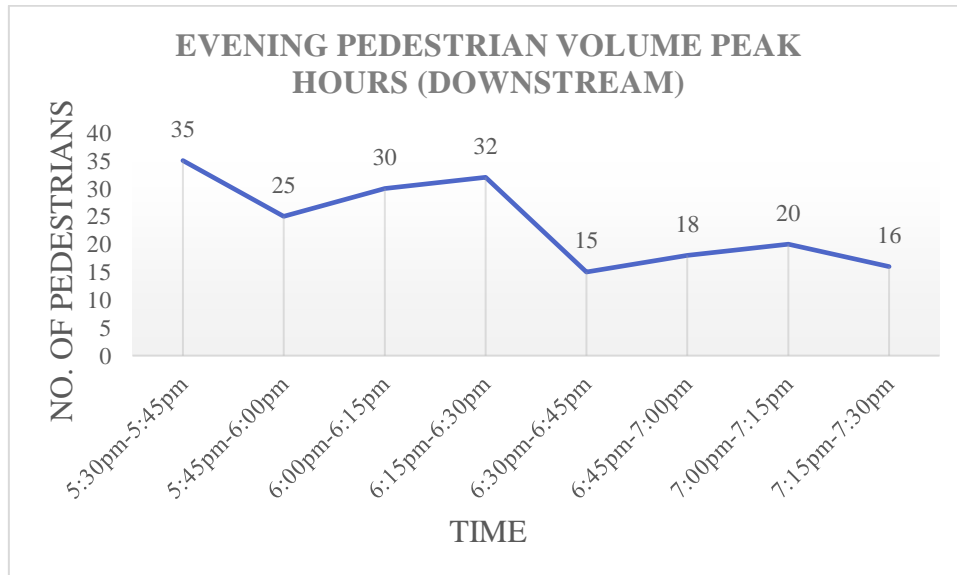
Figure 4.21 Evening Pedestrian Volume Peak Hour (Downstream) at Location 1

As it can be observed in the figure Max 15-min Pedestrian Peak flow rate is found at time 6.00pm-6.15pm as due to recreational and residential area as pedestrian come for walk at the park located opposite to School area.

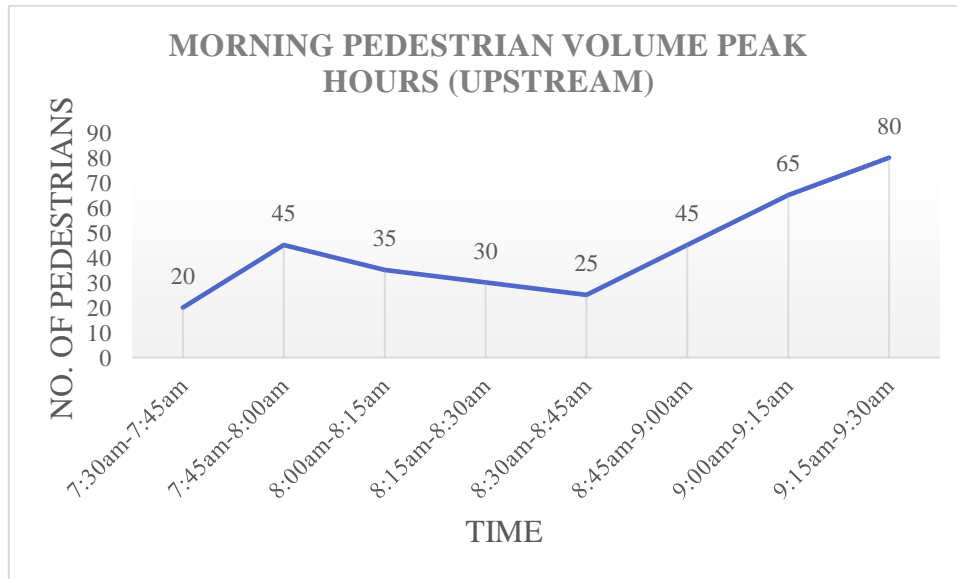
Figure 4.22 Morning Pedestrian Volume Peak Hours (Upstream) at Location 2

As it can be observed in the figure Max 15-min Pedestrian Peak flow rate is found at time 9.15am-9.30am as due to commercial area peak timings where people come for opening of their shops and some came for work purpose

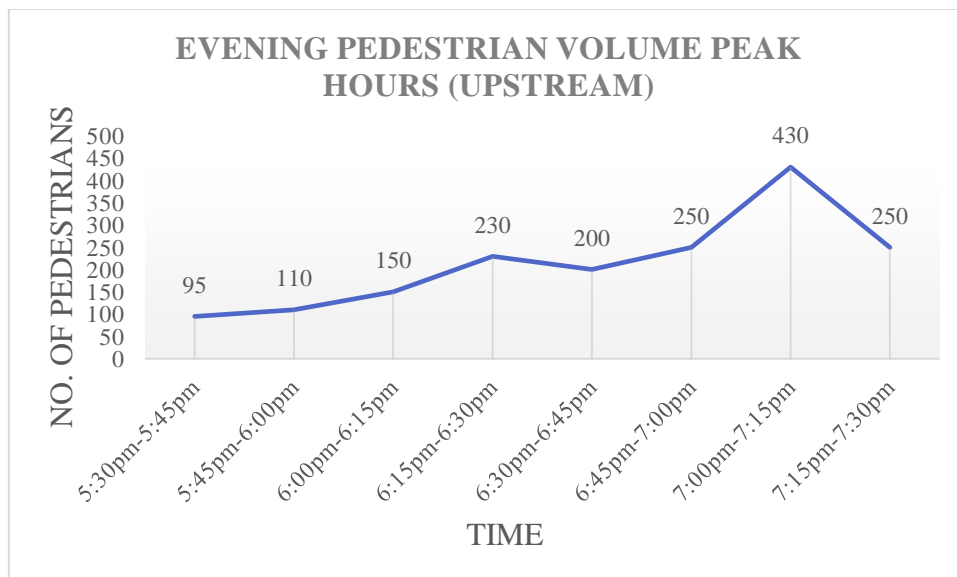
Figure 4.23 Evening Pedestrian Volume Peak Hours (Upstream) at Location 2

As it can be observed in the figure Max 15-min Pedestrian Peak flow rate is found at time 7.00pm-7.15pm which was very high because of people came for shopping and eating at food joints purposes

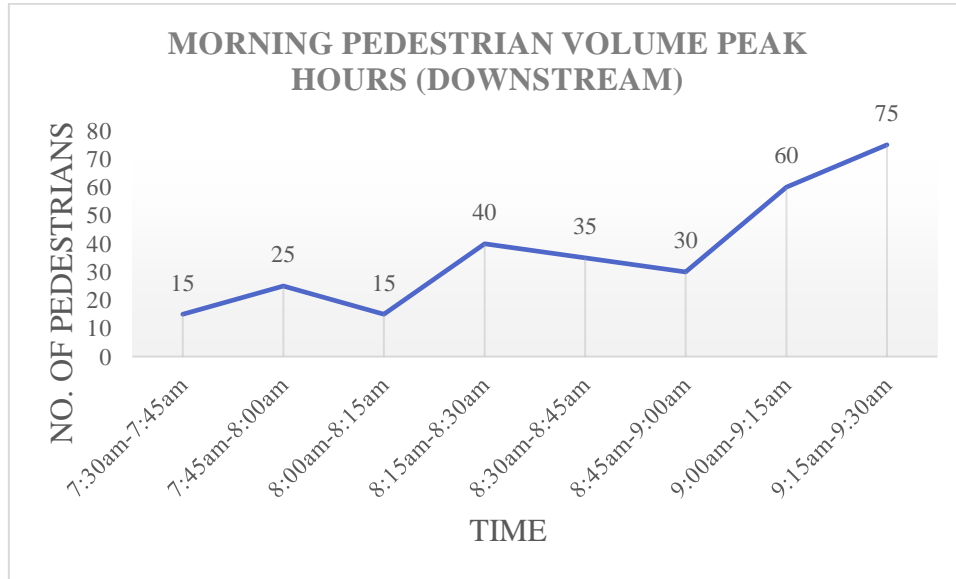
Figure 4.24 Morning Pedestrian Volume Peak Hours (Downstream) at Location 2

As it can be observed in the figure Max 15-min Pedestrian Peak flow rate is found at time 9.15am-9.30am as due to commercial area peak timings where people come for opening of their shops and some came for work purpose

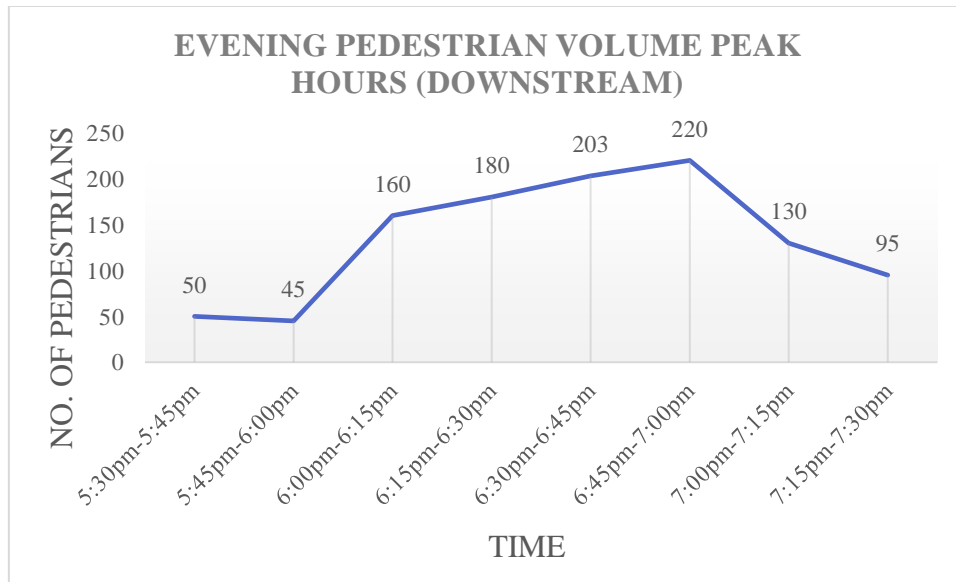
Figure 4.25 Evening Pedestrian Volume Peak Hour (Downstream) at Location 2

As it can be observed in the figure Max 15-min Pedestrian Peak flow rate is found at time 6.45pm-7.00pm which was very high because of people came for shopping and eating at food joints purposes

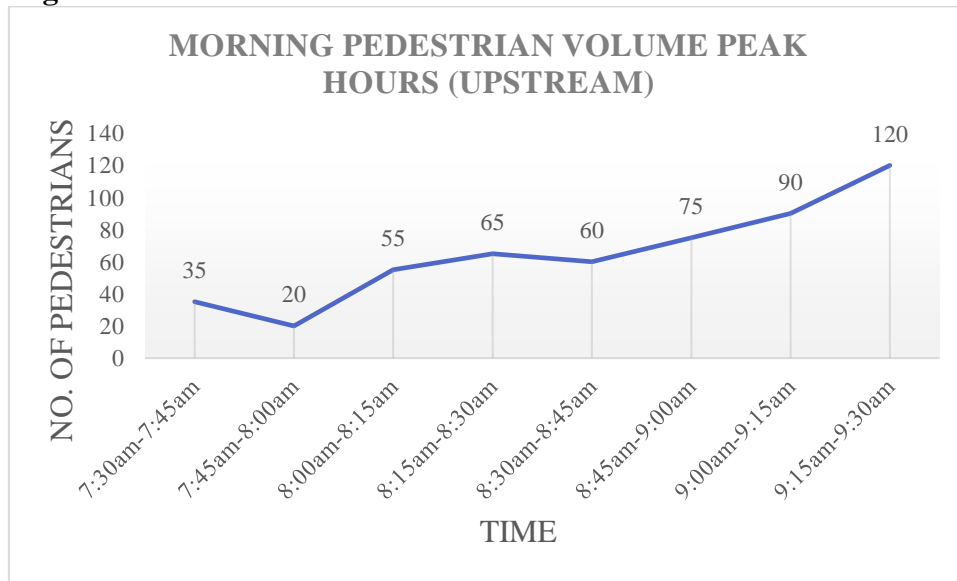
Figure 4.26 Morning Pedestrian Volume Peak Hours (Upstream) at Location 3

As it can be observed in the figure Max 15-min Pedestrian Peak flow rate is found at time 9.15am-9.30am which was due to commercial area peak timings where people come for opening of their shops and some came for work purpose.

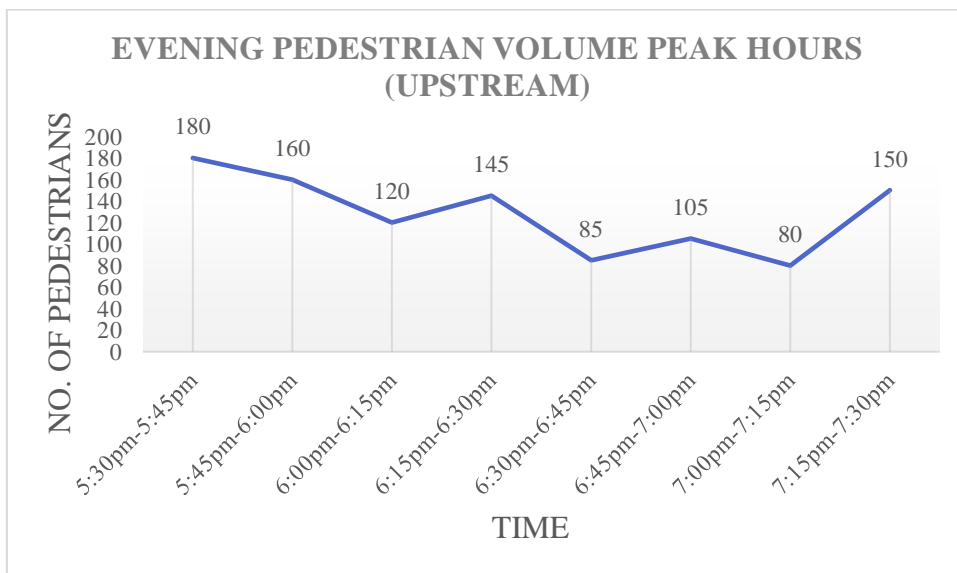
Figure 4.27 Evening Pedestrian Volume Peak Hours (Upstream) at Location 3

As it can be observed in the figure Max 15-min Pedestrian Peak flow rate is found at time 5.30pm-5.45pm which was due to Commercial area people came for Shopping and also for watching movies, etc.

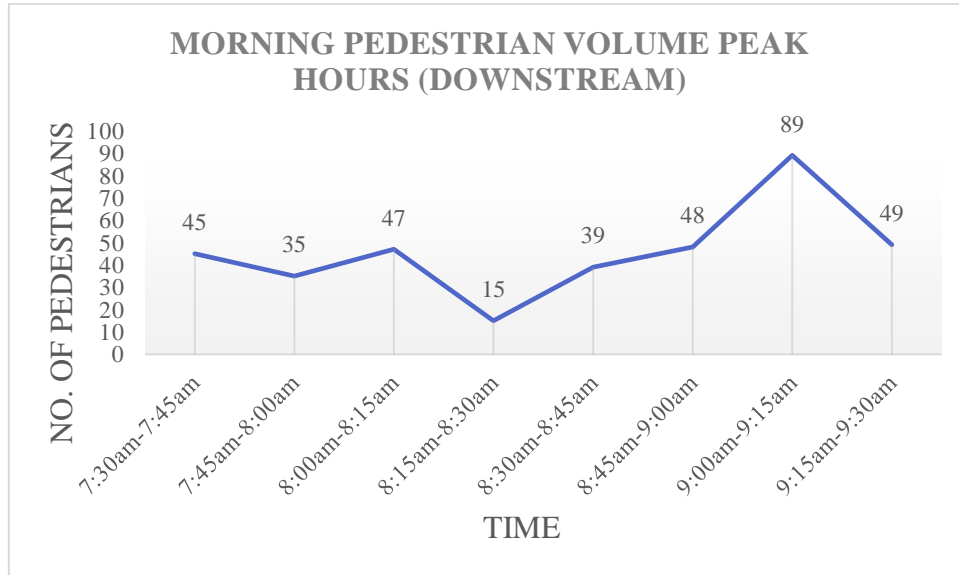
Figure 4.28 Morning Pedestrian Volume Peak Hours (Downstream) at Location 3

As it can be observed in the figure Max 15-min Pedestrian Peak flow rate is found at time 9.00am-9.15am which was due to commercial area peak timings where people come for opening of their shops and some came for work purpose.

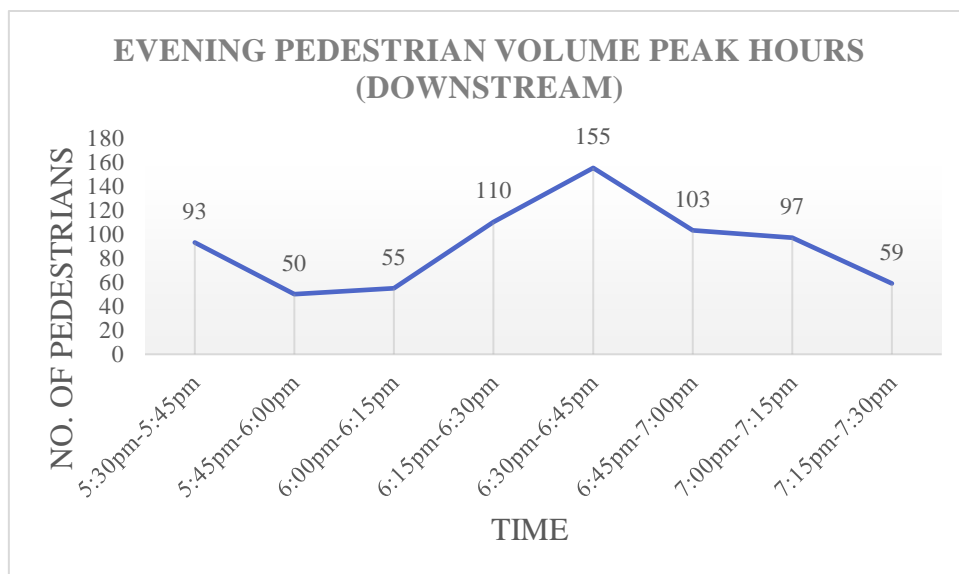
Figure 4.29 Evening Pedestrian Volume Peak Hour (Downstream) at Location 3

As it can be observed in the figure Max 15-min Pedestrian Peak flow rate is found at time 6.30pm-6.45pm which was due to Commercial area people came for Shopping and also for watching movies, etc.

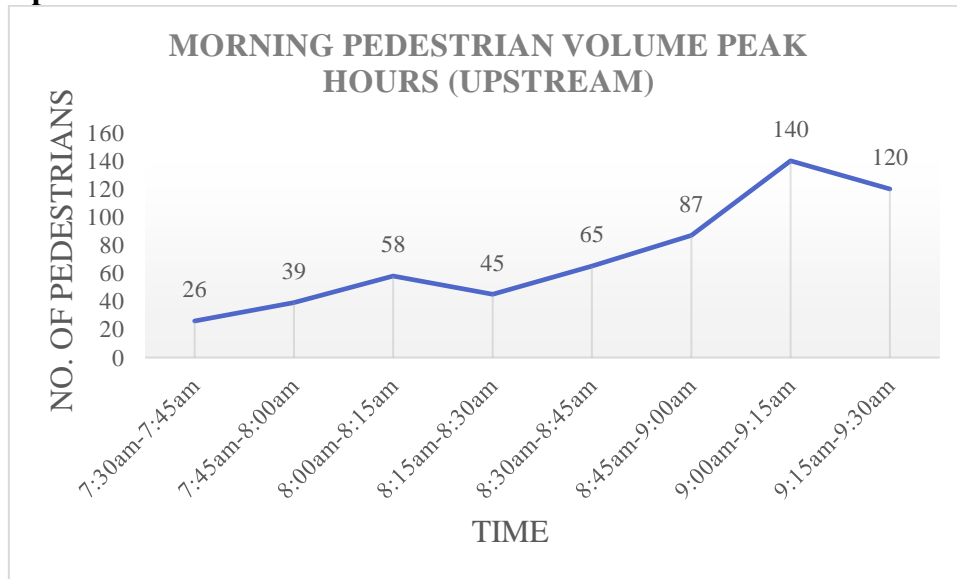
Figure 4.30 Morning Pedestrian Volume Peak Hours (Upstream) at Location 4

As it can be observed in the figure Max 15-min Pedestrian Peak flow rate is found at time 9.00am-9.15am which was due to Commercial area and Residential area the peak hour is at a obvious reason which is people leaving for their work purposes.

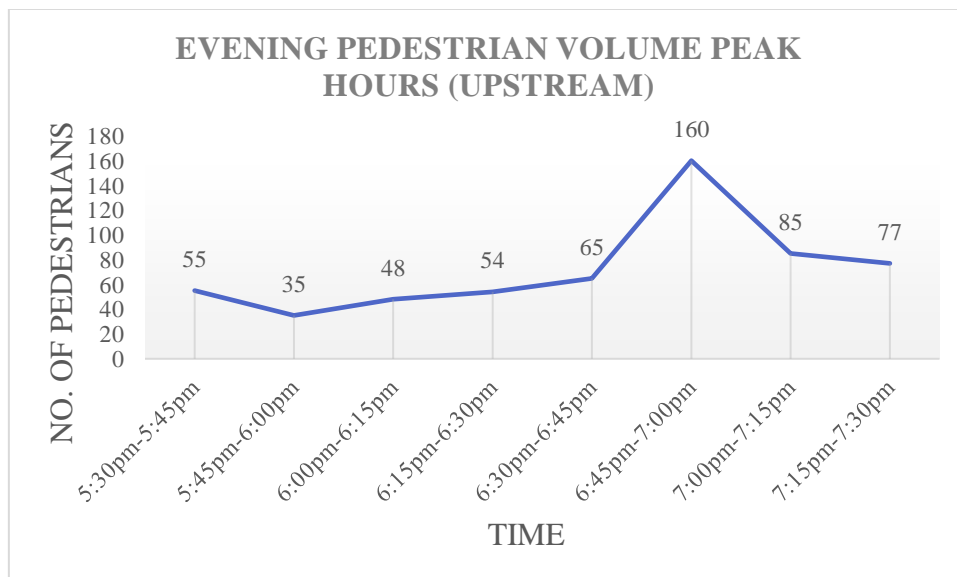
Figure 4.31 Evening Pedestrian Volume Peak Hours (Upstream) at Location 4

As it can be observed in the figure Max 15-min Pedestrian Peak flow rate is found at time 6.45pm-7.00pm which was due to Commercial area and Residential area the peak hour is at a obvious reason which is people coming back home from their work purposes.

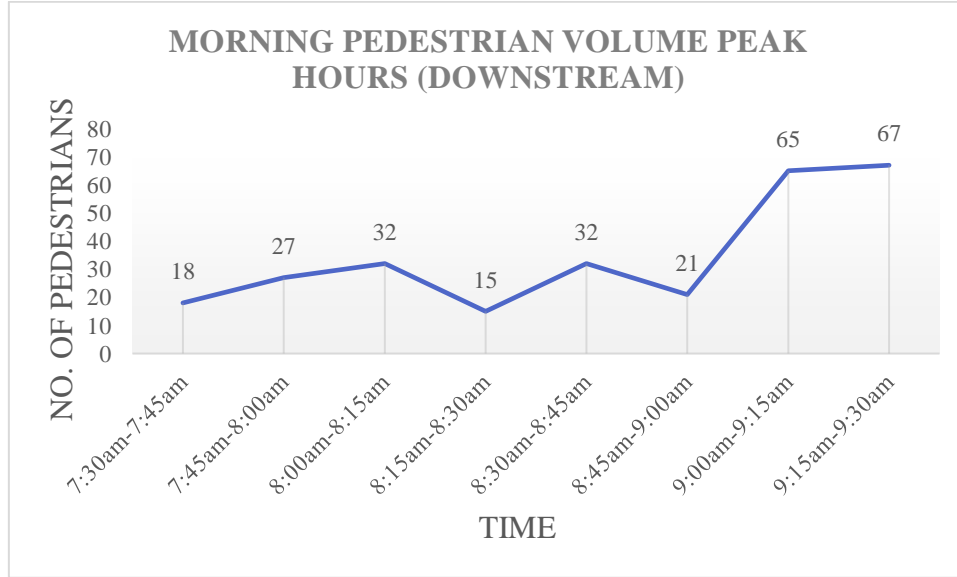
Figure 4.32 Morning Pedestrian Volume Peak Hours (Downstream) at Location 4

As it can be observed in the figure Max 15-min Pedestrian Peak flow rate is found at time 9.15am-9.30am which was due to Commercial area and Residential area the peak hour is at a obvious reason which is people leaving for their work purposes.

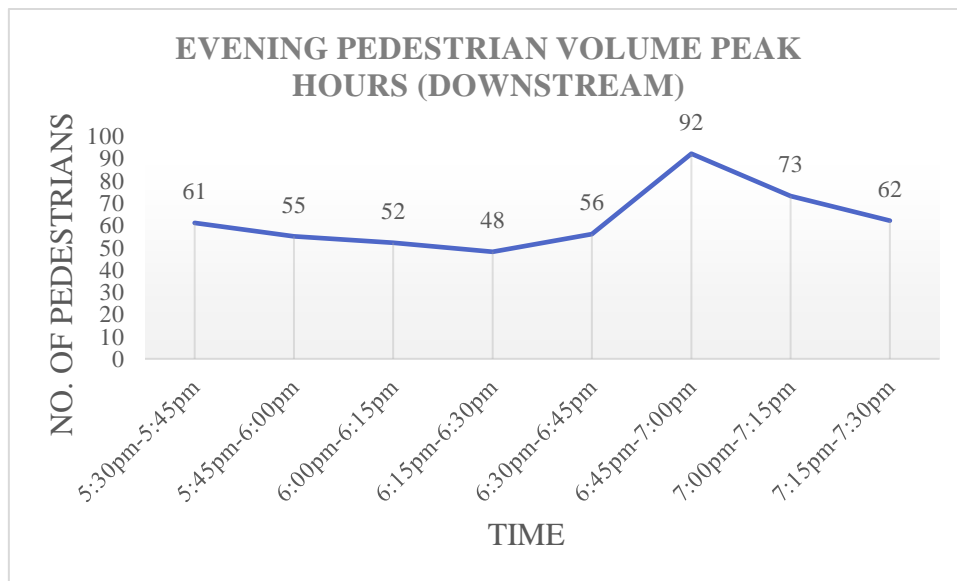
Figure 4.33 Evening Pedestrian Volume Peak Hour (Downstream) at Location 4

As it can be observed in the figure Max 15-min Pedestrian Peak flow rate is found at time 6.45pm-7.00pm which was due to Commercial area and Residential area the peak hour is at a obvious reason which is people coming back home from their work purposes.

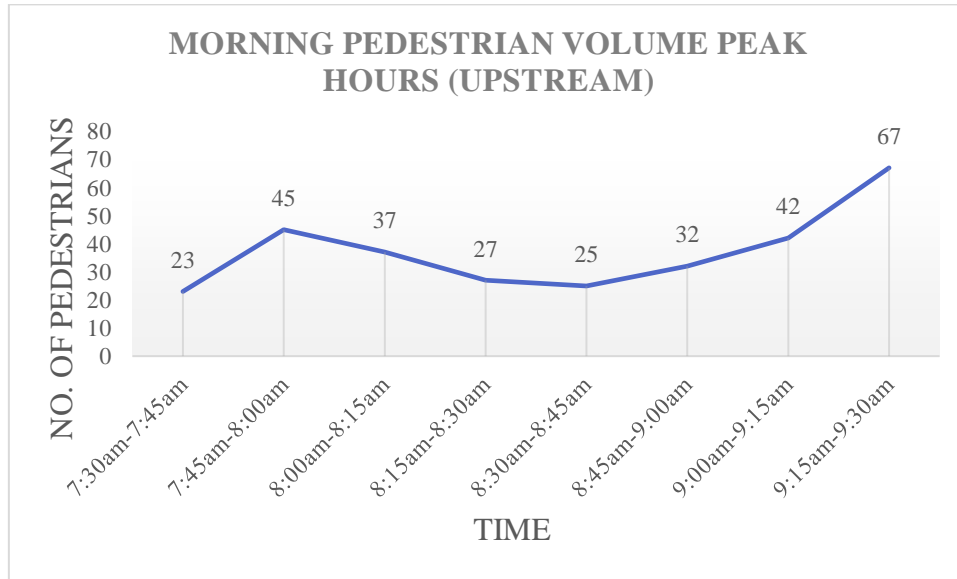
Figure 4.34 Morning Pedestrian Volume Peak Hours (Upstream) at Location 5

As it can be observed in the figure Max 15-min Pedestrian Peak flow rate is found at time 9.15am-9.30am. This area does not have much pedestrian count as it is used by pedestrians which travel for work purpose or any of the personal purposes.

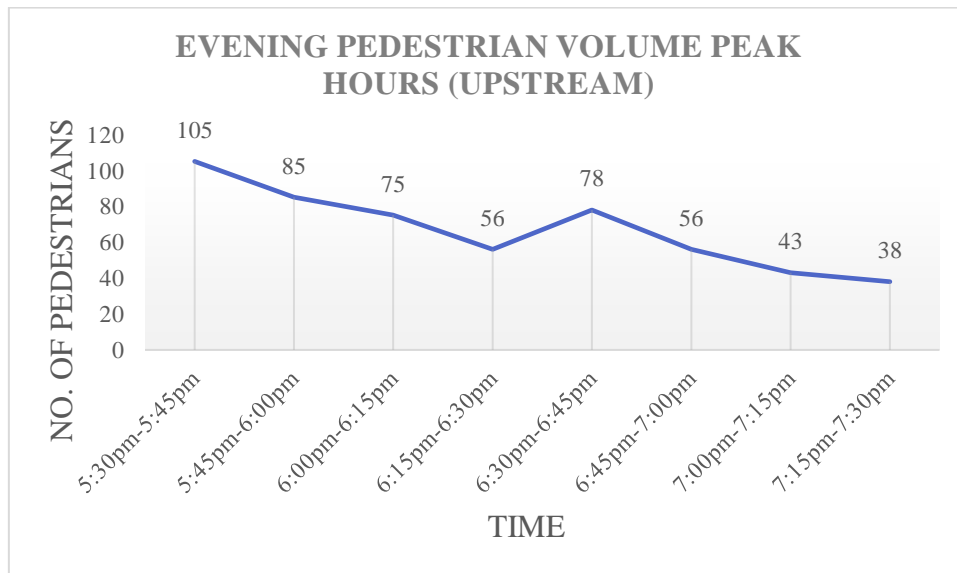
Figure 4.35 Evening Pedestrian Volume Peak Hours (Upstream) at Location 5

As it can be observed in the figure Max 15-min Pedestrian Peak flow rate is found at time 5.30pm-5.45pm. The people who left for work purposes in the morning were observed coming back.

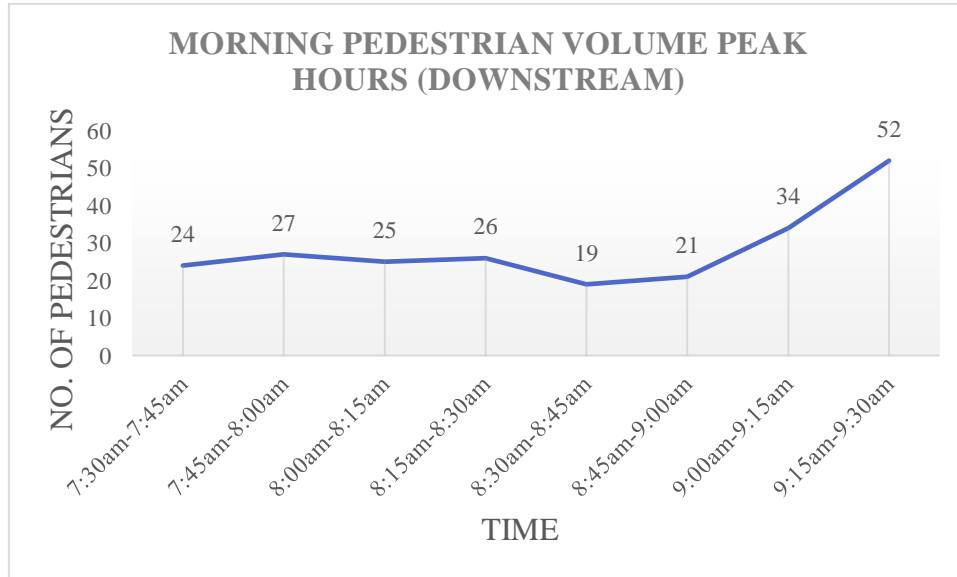
Figure 4.36 Morning Pedestrian Volume Peak Hours (Downstream) at Location 5

As it can be observed in the figure Max 15-min Pedestrian Peak flow rate is found at time 9.15am-9.30am. This area does not have much pedestrian count as it is used by pedestrians which travel for work purpose or any of the personal purposes.

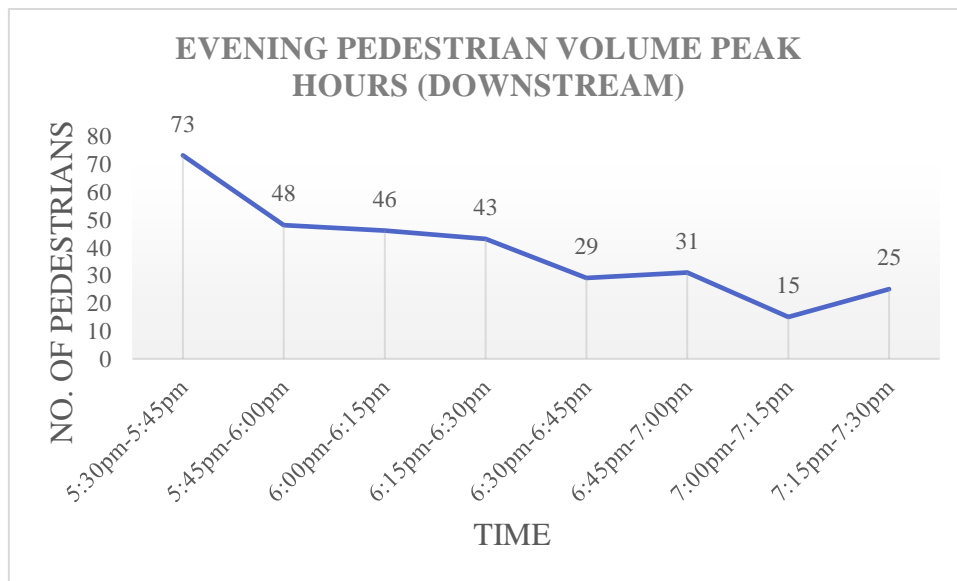
Figure 4.37 Evening Pedestrian Volume Peak Hour (Downstream) at Location 5

As it can be observed in the figure Max 15-min Pedestrian Peak flow rate is found at time 5.30pm-5.45pm. The people who left for work purposes in the morning were observed coming back.

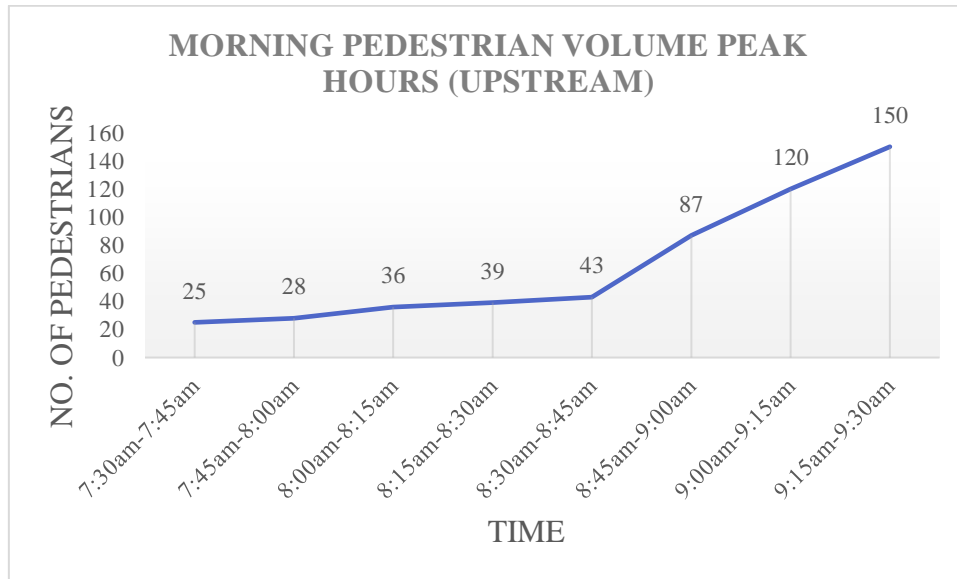
Figure 4.38 Morning Pedestrian Volume Peak Hours (Upstream) at Location 6

As it can be observed in the figure Max 15-min Pedestrian Peak flow rate is found at time 9.15am-9.30am. This area is an administrative type area which had pedestrian count during office hours only.

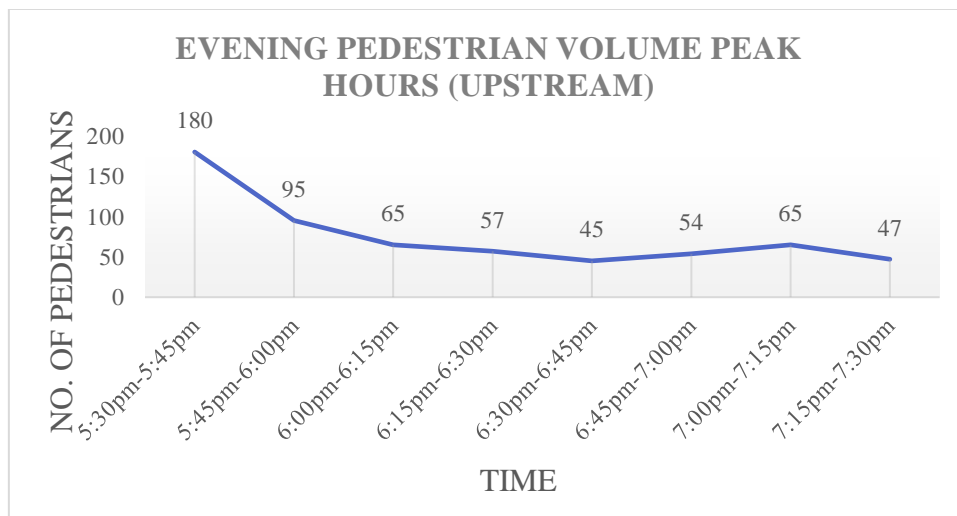
Figure 4.39 Evening Pedestrian Volume Peak Hours (Upstream) at Location 6

As it can be observed in the figure Max 15-min Pedestrian Peak flow rate is found at time 5.30pm-5.45pm. This area is an administrative type area which had pedestrian count during office hours only.

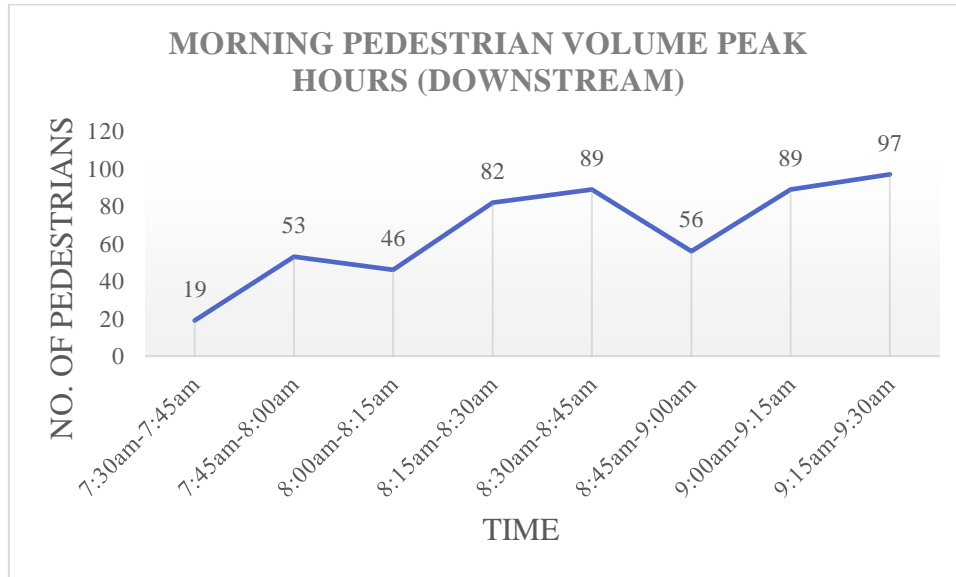
Figure 4.40 Morning Pedestrian Volume Peak Hours (Downstream) at Location 6

As it can be observed in the figure Max 15-min Pedestrian Peak flow rate is found at time 9.15am-9.30am. This area is an administrative type area which had variable pedestrian count at some time slots because of recreational area opposite to administrative area whereas in the morning people came for walk purposes also.

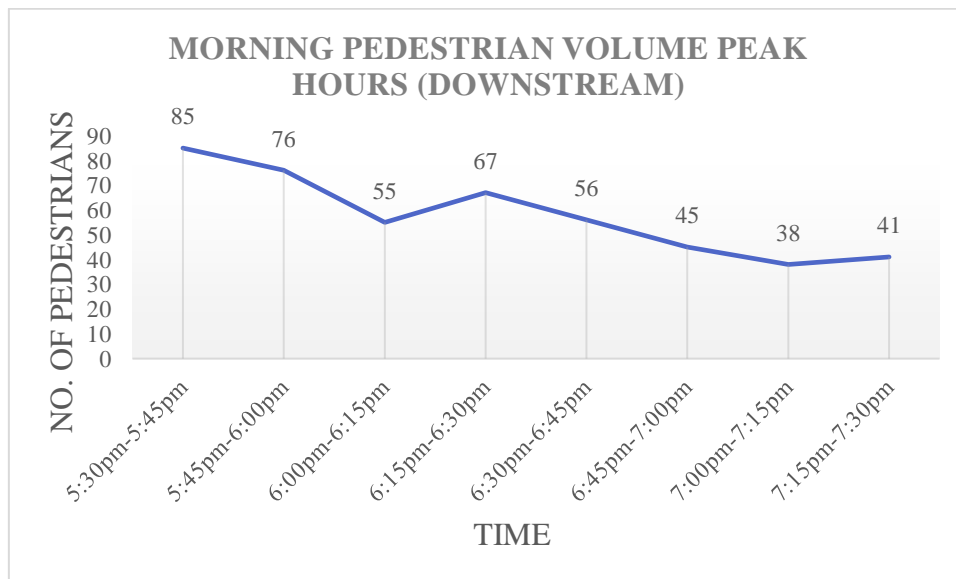
Figure 4.41 Evening Pedestrian Volume Peak Hour (Downstream) at Location 6

As it can be observed in the figure Max 15-min Pedestrian Peak flow rate is found at time 5.30pm-5.45pm. This area is an administrative type area which had pedestrian count during office hours only.

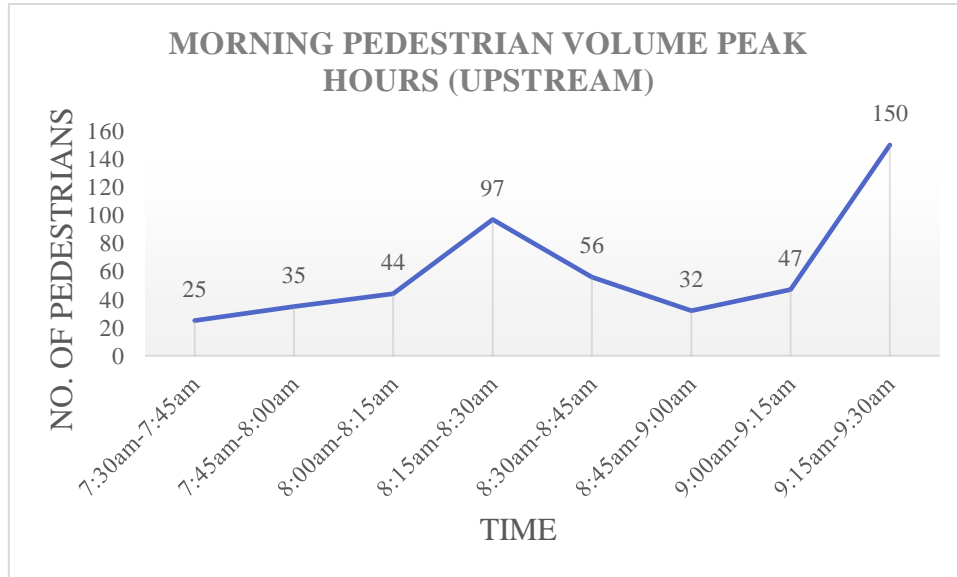
Figure 4.42 Morning Pedestrian Volume Peak Hours (Upstream) at Location 7

As it can be observed in the figure Max 15-min Pedestrian Peak flow rate is found at time 9.15am-9.30am. This area is a Bus terminal area which had pedestrian count at office hours and at institutional hours.

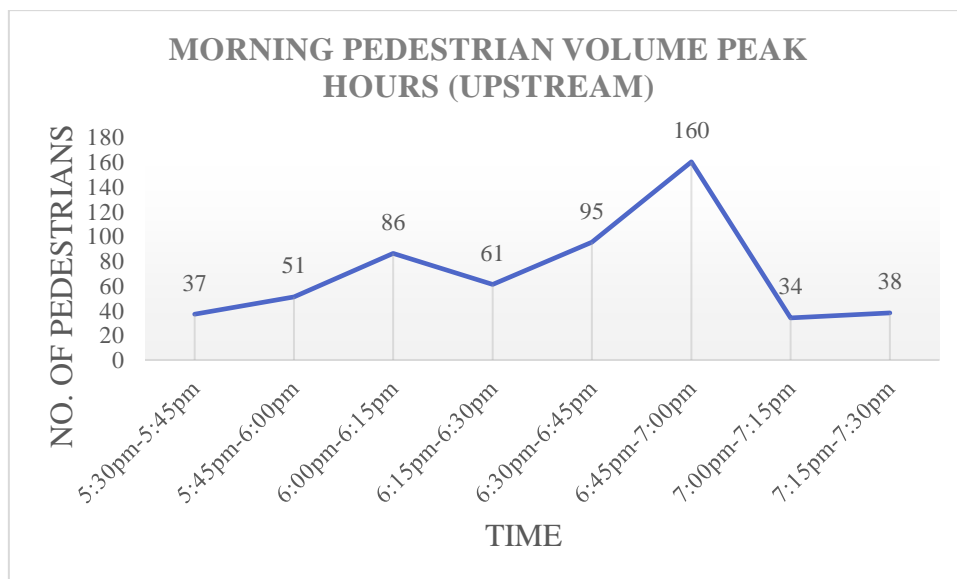
Figure 4.43 Evening Pedestrian Volume Peak Hours (Upstream) at Location 7

As it can be observed in the figure Max 15-min Pedestrian Peak flow rate is found at time 6.45pm-7.00pm. The people who left for work purposes in the morning were observed coming back.

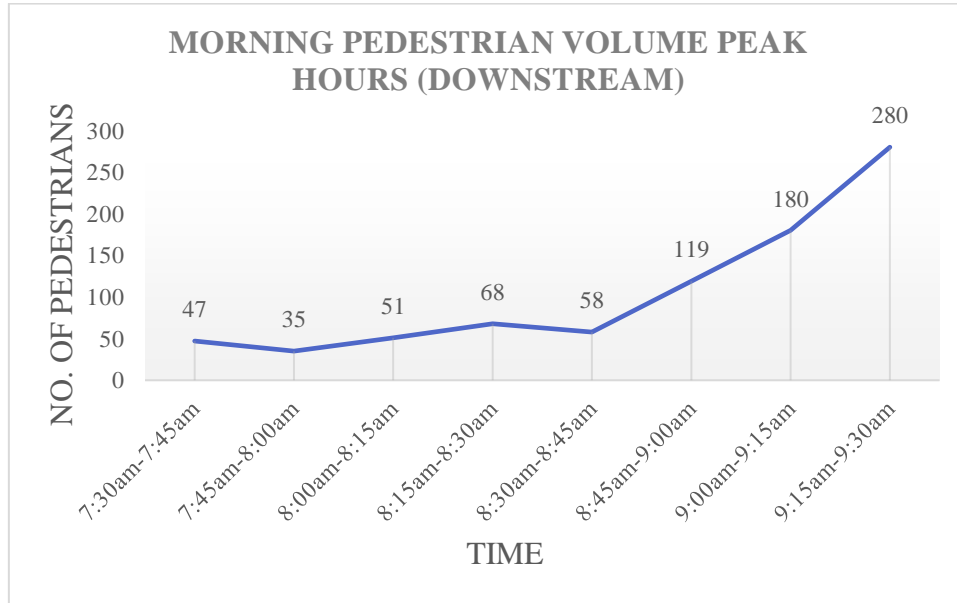
Figure 4.44 Morning Pedestrian Volume Peak Hours (Downstream) at Location 7
