**EVALUATING THE PEDESTRIAN LEVEL OF
SERVICE FOR THE CITY OF PANCHKULA**

**MASTER OF ENGINEERING
IN
INFRASTRUCTURE ENGINEERING**

DEPARTMENT OF CIVIL ENGINEERING
THAPAR INSTITUTE OF ENGINEERING & TECHNOLOGY
(A DEEMED TO BE UNIVERSITY), PATIALA, PUNJAB.

AUGUST 2019

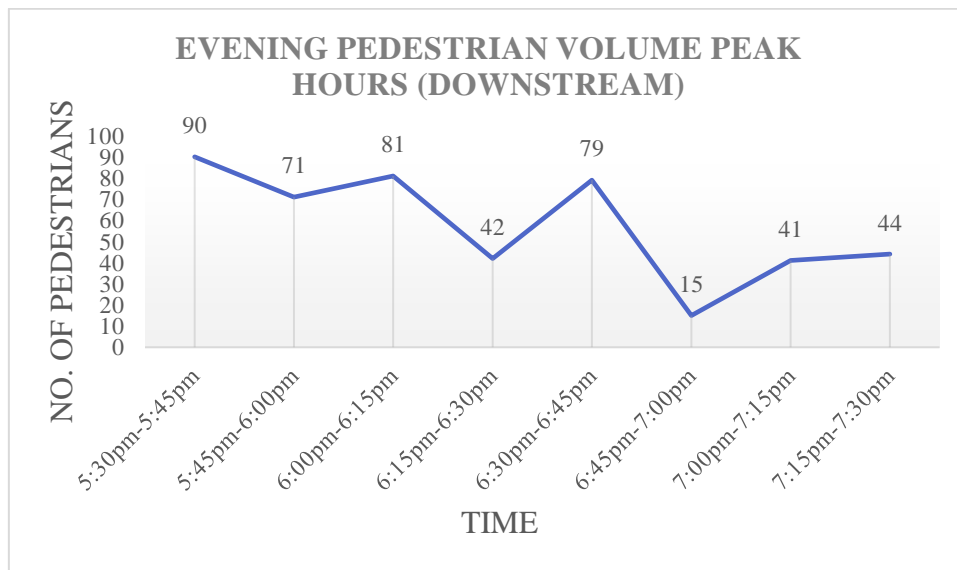
Figure 4.45 Evening Pedestrian Volume Peak Hour (Downstream) at Location 7

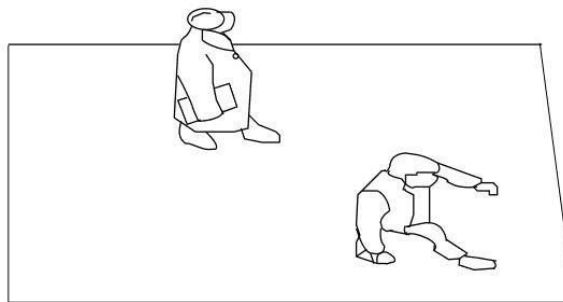
Figure 5.2 Pedestrian LOS B According to HCM

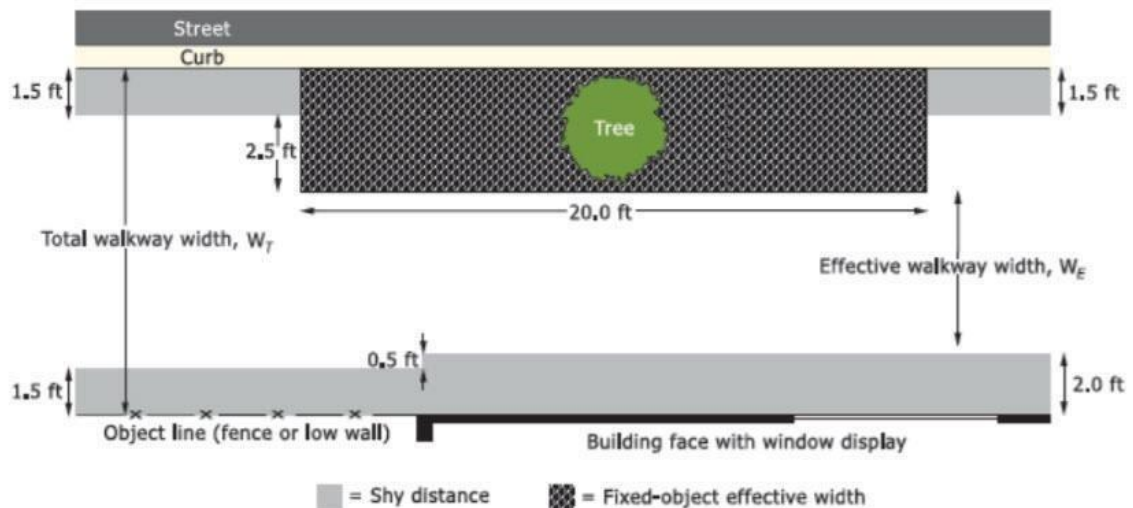
Figure 5.8 Figure Showing Effective Width of Sidewalk

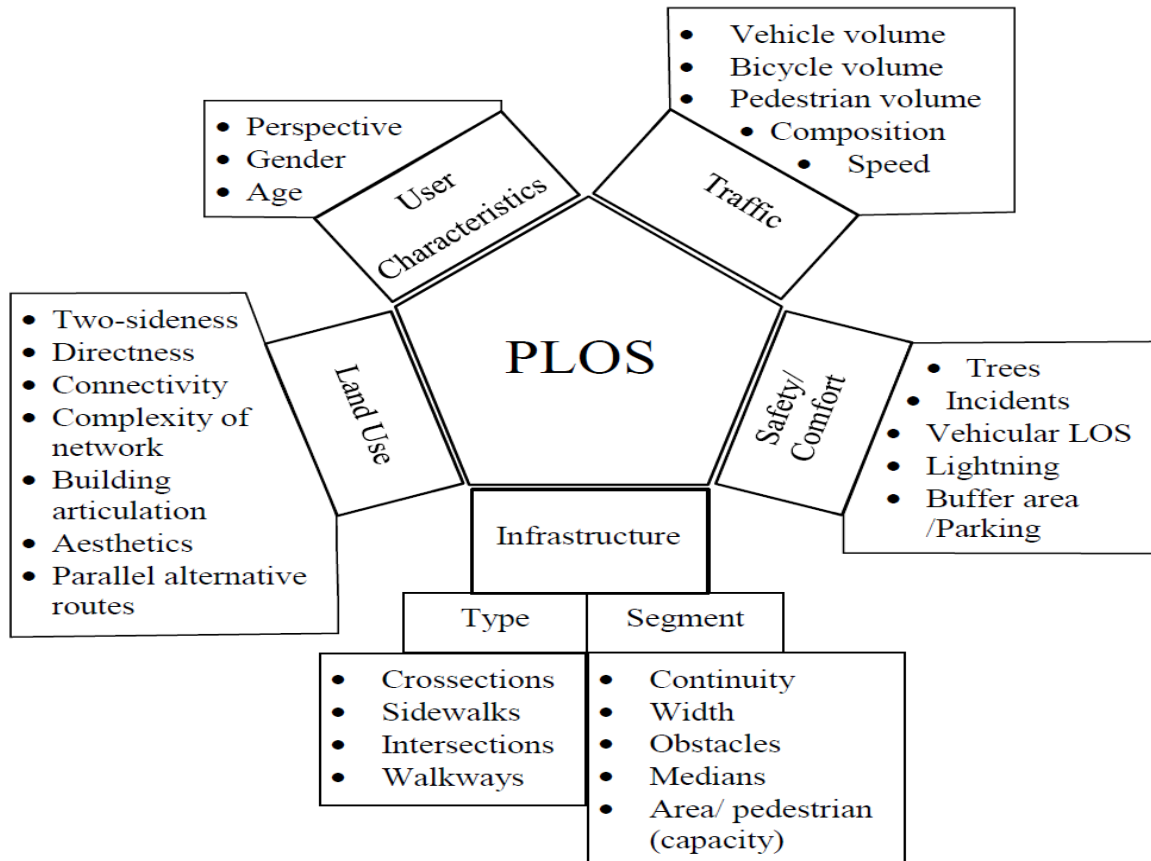
Figure 7.1 Dimensions of Pedestrian Level of Service

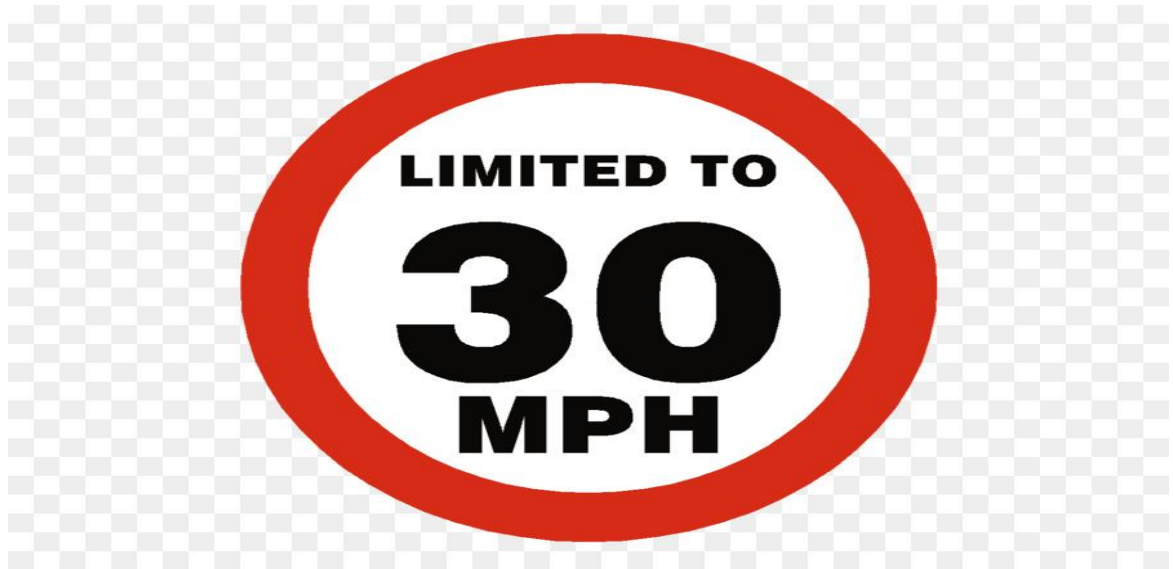
Figure 9.1 Showing Speed Limit for Vehicles

3. Vehicle Speed: The intersection which is unsignalized pedestrians find it very difficult to cross the road for that they need to find a gap in the movement of vehicles. But as the speed of vehicle normally increases at crosswalk which put pedestrians to a greater risk of

accidents. Hence the speed of vehicle at crosswalks should be organised in such a way that it would not affect the movement of pedestrians, as it would directly affect the PLOS.

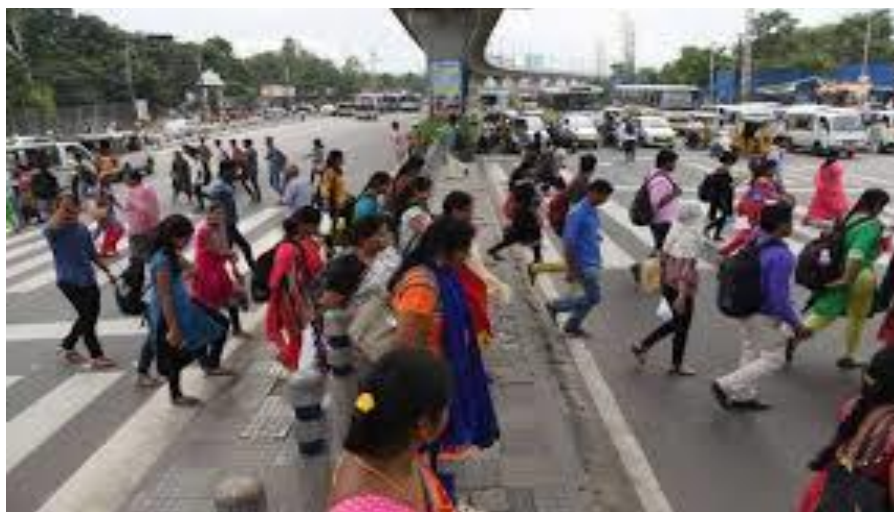
Figure 9.2 Showing Wider Carriageway Width

4. Carriageway Width: The carriageway width directly affects the LOS as increase in the carriageway width makes it a longer distance for the pedestrians to cross, which would be riskier as pedestrians will encounter with a greater number of vehicles i.e. more risks of accidents. Hence the carriageway width should be designed carefully in respect to the pedestrians crossing at the crosswalk at intersections and roundabouts.

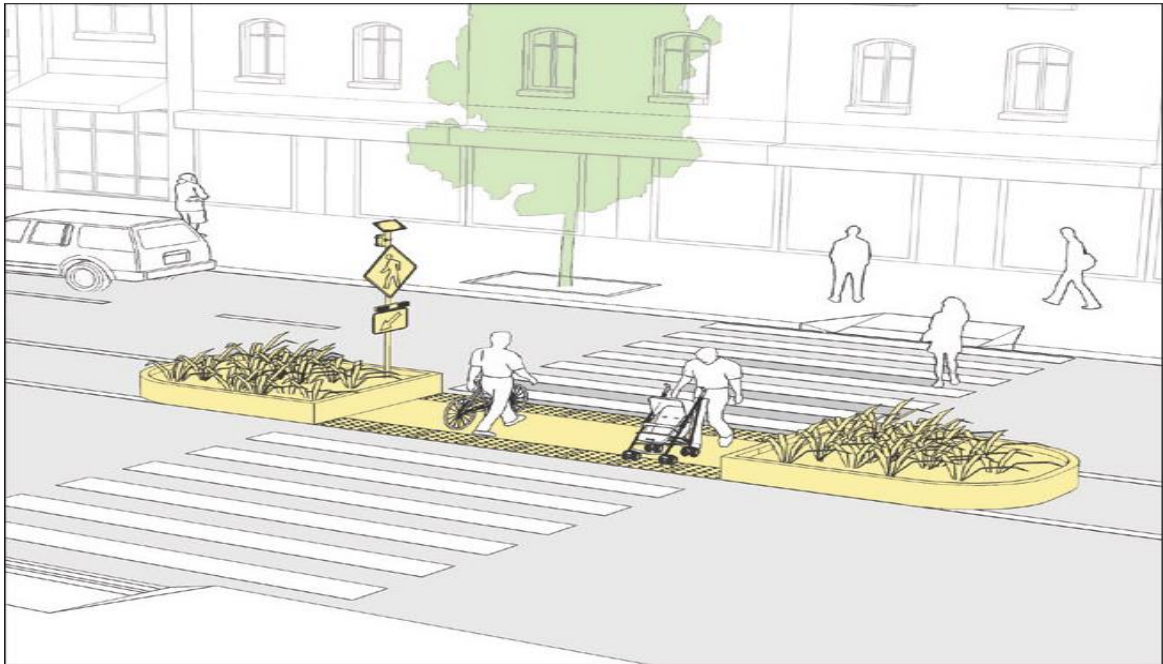
Figure 9.3 Showing Pedestrian Refuge

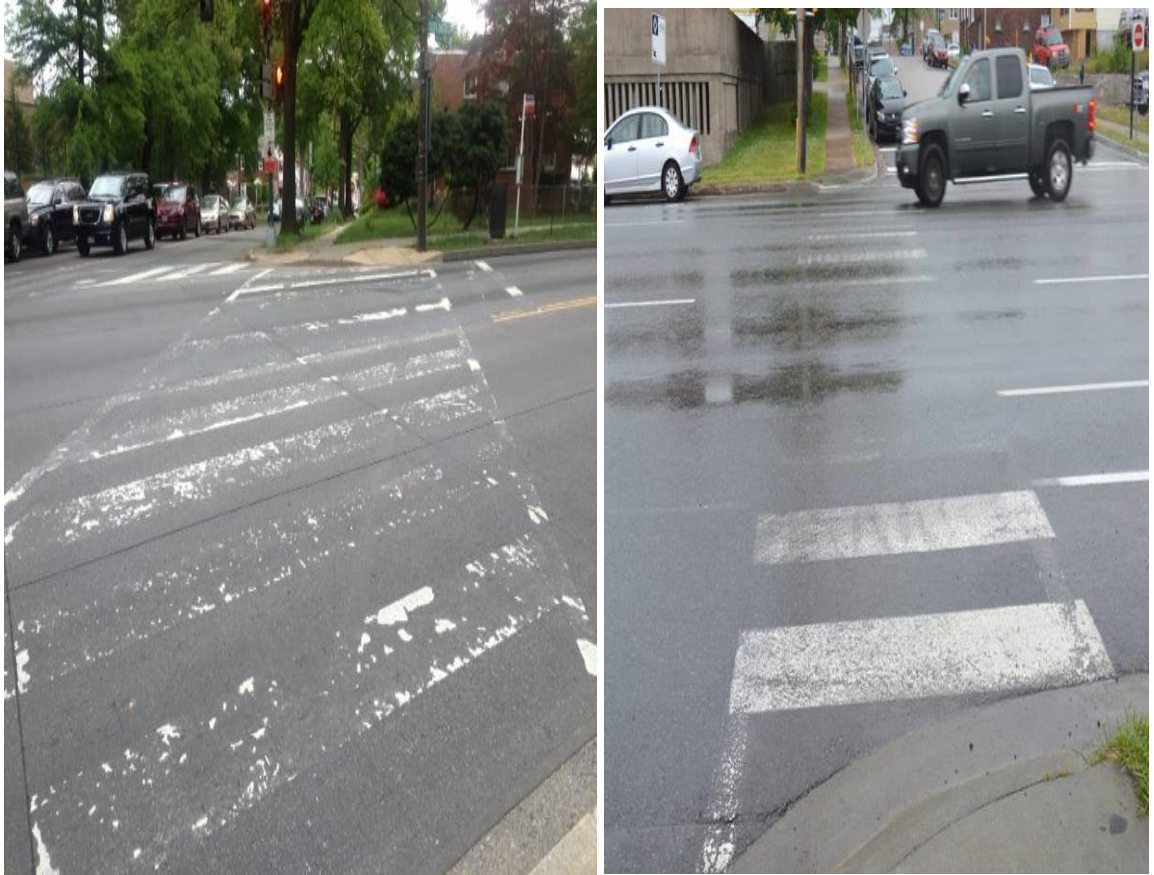
Figure 9.4 Showing Faded Marking Conditions

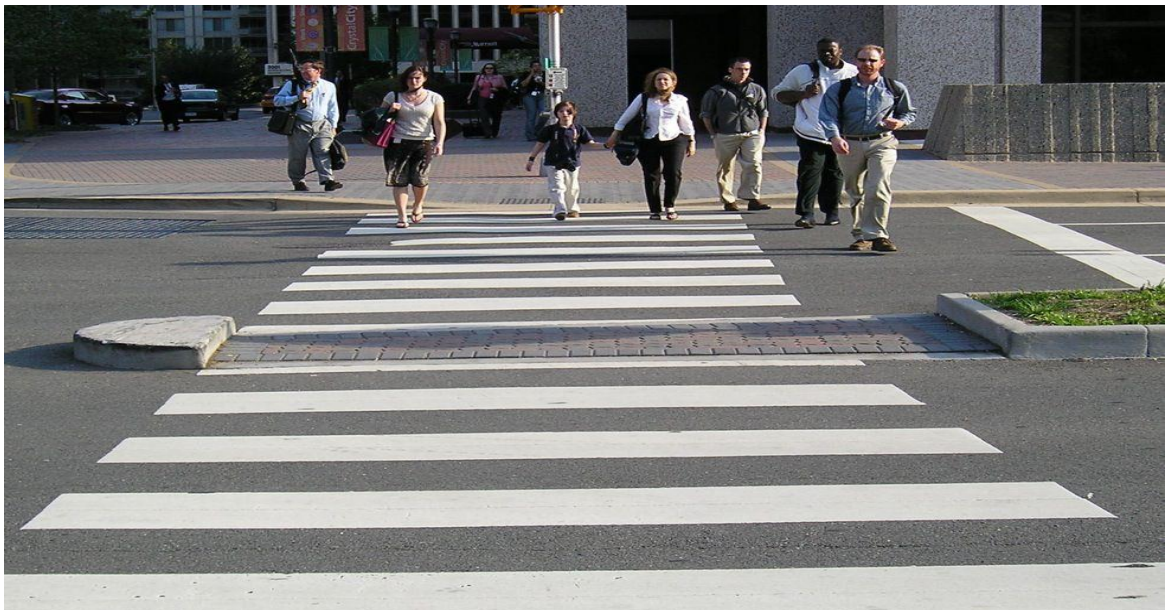
Figure 9.5 Showing Ideal Crosswalk Marking Condition

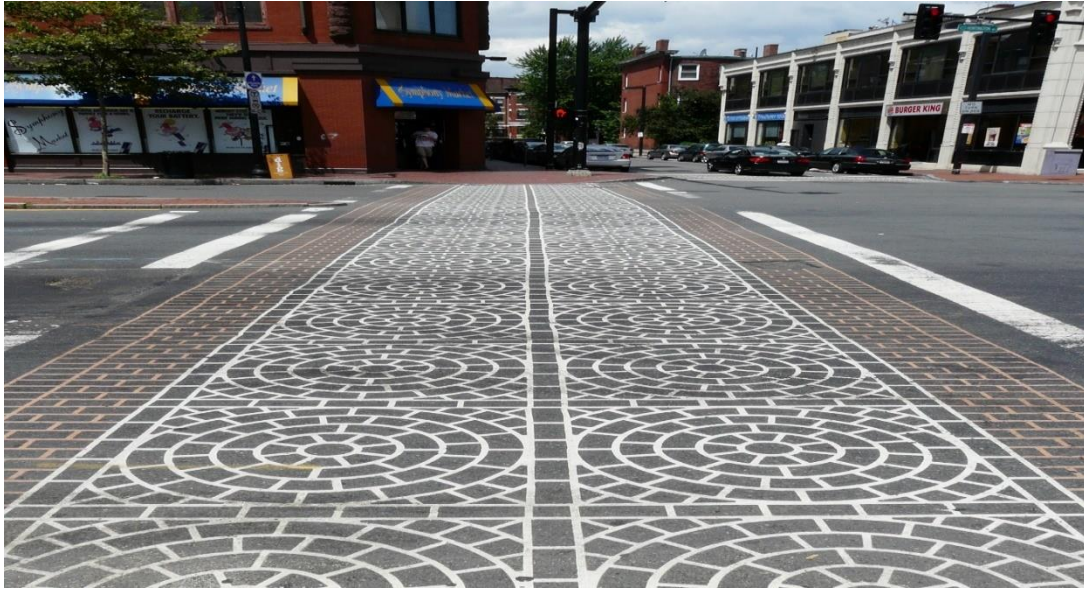
Figure 9.6 Showing Texture of Crosswalk Surface

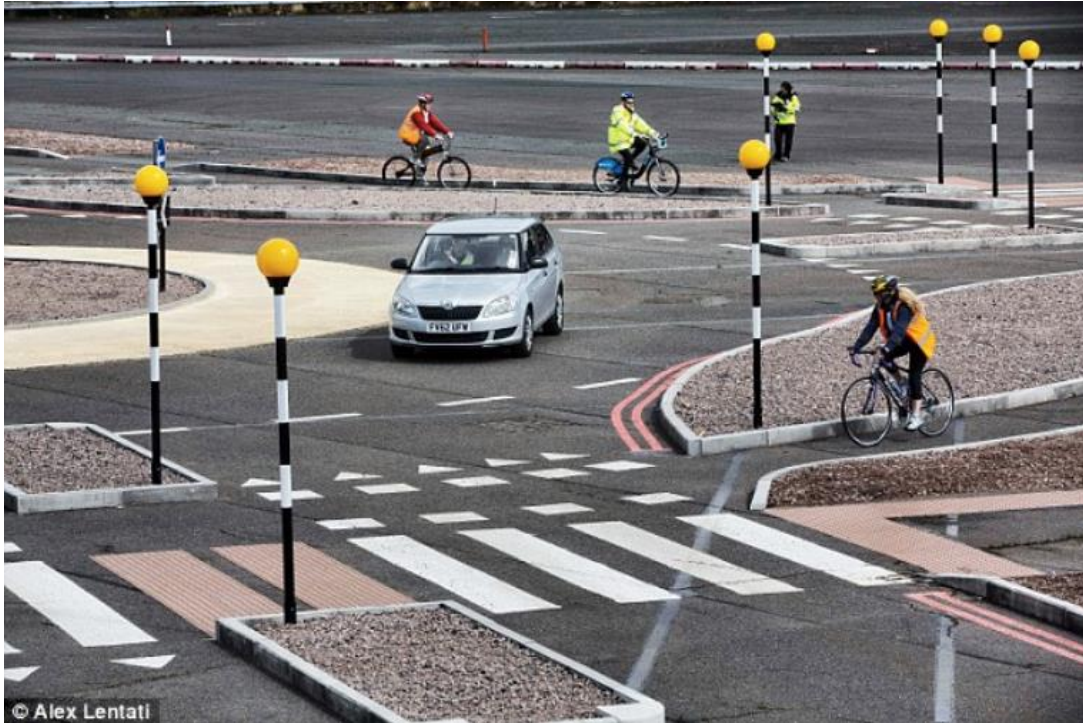
Figure 9.8 Showing ideal lightning condition at crosswalk

8. Lighting Condition at Crosswalk: Crosswalk area with a good lightening condition gives motorist a proper visibility during night time in regard to crossing pedestrians. Thus, a well-lit crosswalk area enhances safety of pedestrians and affects the PLOS.

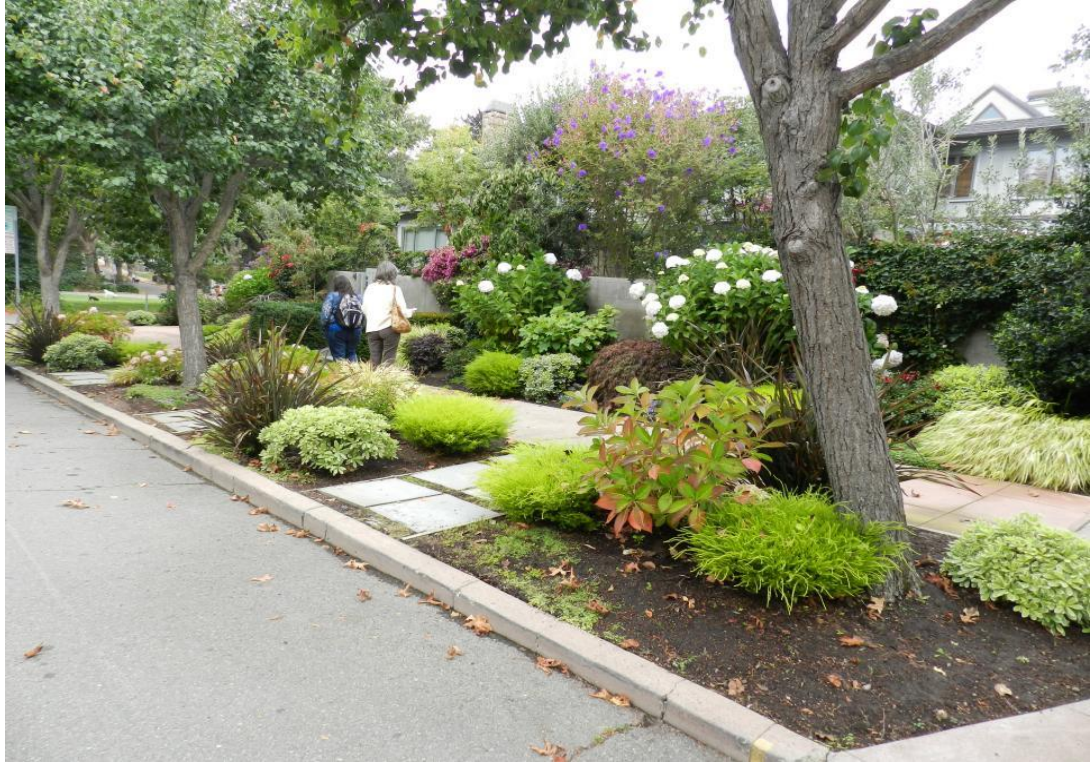
Figure 9.9 Showing walking environment adjacent to sidewalks

9. Climate Based Solution: The walking environment should have attractions which should influence the pedestrians to walk on it. Attraction like green cover, shade of tress, advertisements, etc. have a good effect on pedestrians. Shade of trees allow the pedestrians to walk in the day time also. Landscape strip can also pe provided which attracts the pedestrian towards the sidewalk.

Abundance of trees & Green cover will encourage Pedestrian to use sidewalk in a Tropicallly hot country like India

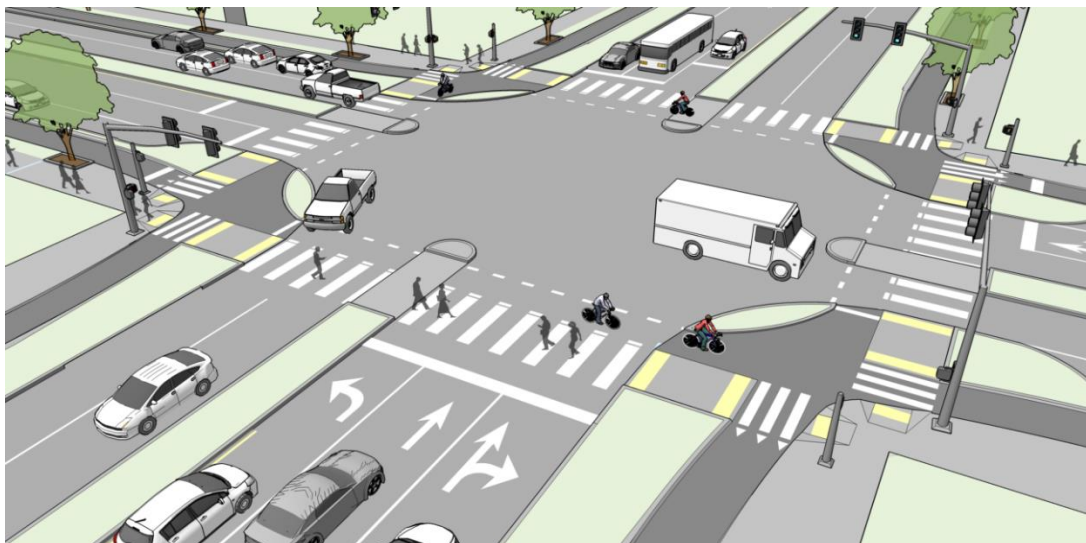
Figure 9.12 Showing the roadway Geometry and pedestrians crossing

10. Roadway Geometry: The roadway geometry directly affects the Pedestrian LOS. It should be designed in such a way that the pedestrian does not have to cross a single lane in two parts the width of the carriageway should not be too longer that pedestrians can't cross it in one go. It should also have zebra crossing and all the markings needed for the pedestrian safety that ensures pedestrians a great comfort and security from the motorized.

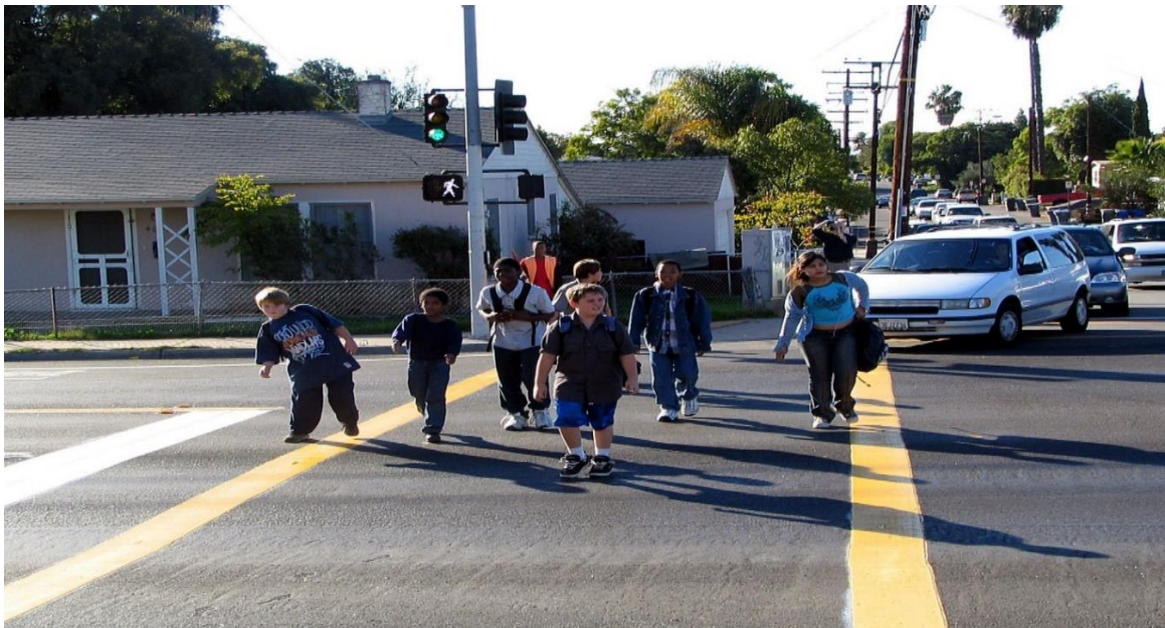
Figure 9.13 Showing Pedestrians crossing by Signal

12. Signal type: The signal type should be organized not only for the motorized but also for the non-motorized. For the safety and security of pedestrian's signal should be designed for the pedestrians which give them a priority over the motorized. Instead puffin signal facilities should also be designed for the pedestrians. This could reduce their delay at the crosswalk faced by the pedestrians and would affect the LOS in a positive way.

13. Signal phasing & Timing features: Signal Phasing can be automated to sense the Pedestrian Platoon over an area and through sensors & allow Pedestrians to Phase through.

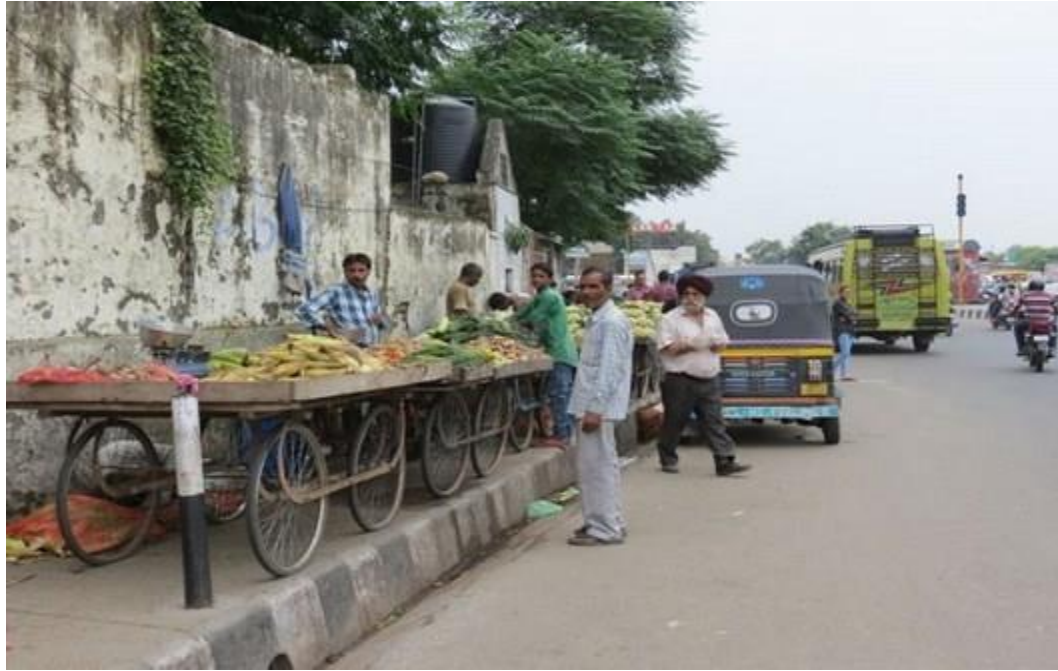
Figure 9.14 Showing Encroachments on Sidewalks

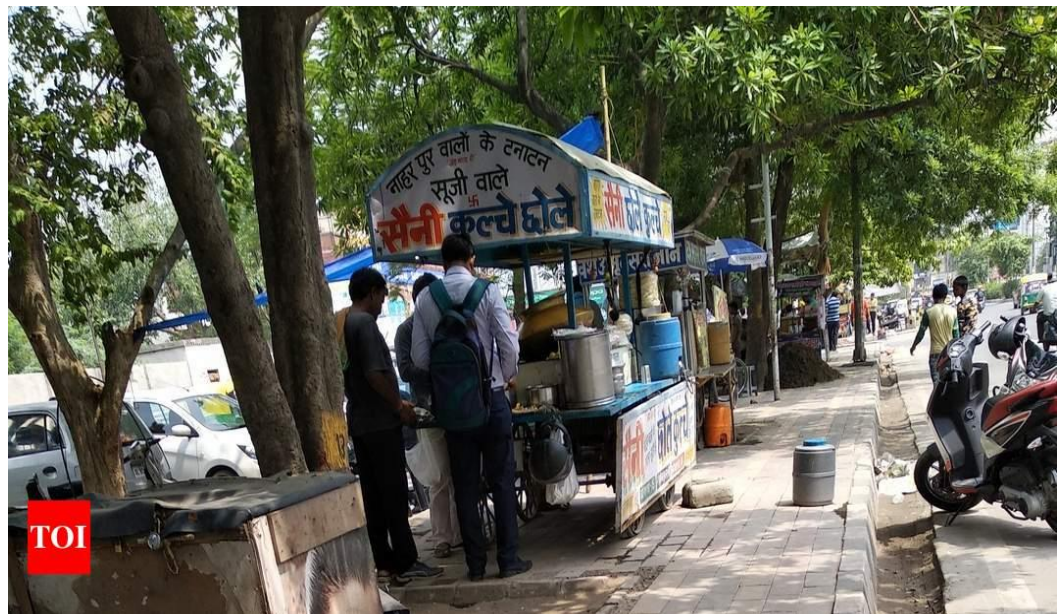
Figure 9.15 Showing Vendor Shops on Sidewalks
