A Study on Gearbox Noise with Induced Tooth Defects

*A Dissertation submitted
in partial fulfilment of the requirements
for the degree of*

Master of Engineering

Production Engineering

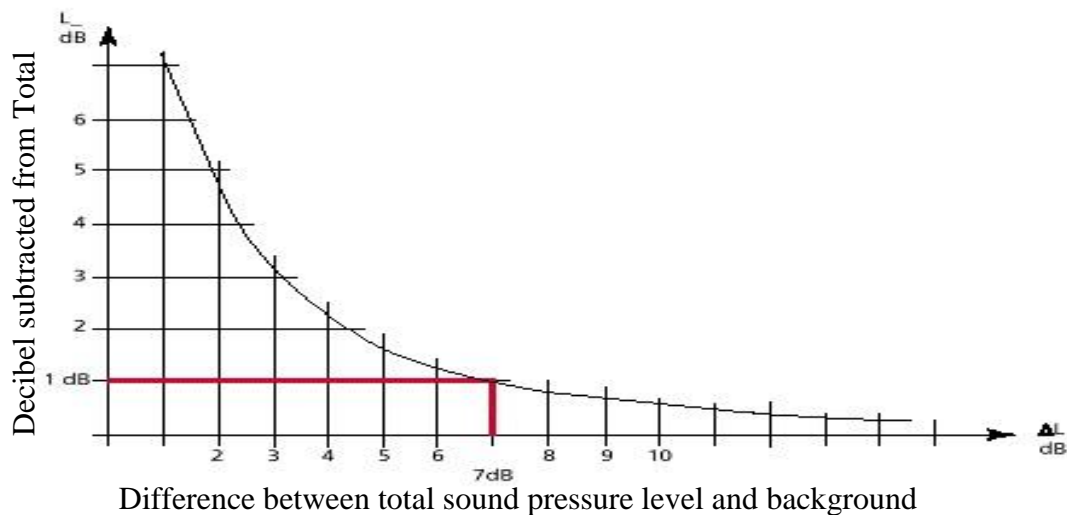
- Measure the combined sound pressure level of both source noise and background noise.
- Measure the background noise by switching off the source noise.
- Calculate the difference between these two variables.
- Read the correct value from the Fig. 1.2, if it exceeds 3 dB (A).
- Subtract the correct value from the value taken out by first step.

Figure 1.2: Background noise correction [W.2]

For example the total combined SPL of sound source and background is 60 dB (A) and background noise is measured as 53 dB (A). Subtract the background from the combined SPL, the difference is 7 dB (A). From the Fig. 1.2, 1 dB (A) is subtracted from the combined SPL. The corrected SPL is 59 dB (A).

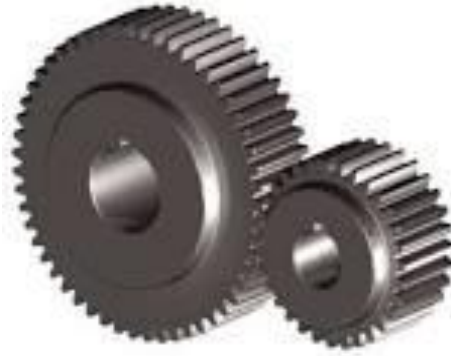
Spur gears are gears having teeth arranged in a circle with the shaft at the center of the circle and the tooth surfaces parallel to the shaft. When ordinary spur gears are rotating, the number of mating tooth pairs simultaneously in contact alternates between one and two as shown in Fig. 1.3.

Figure 1.3: Spur gears [W.3]

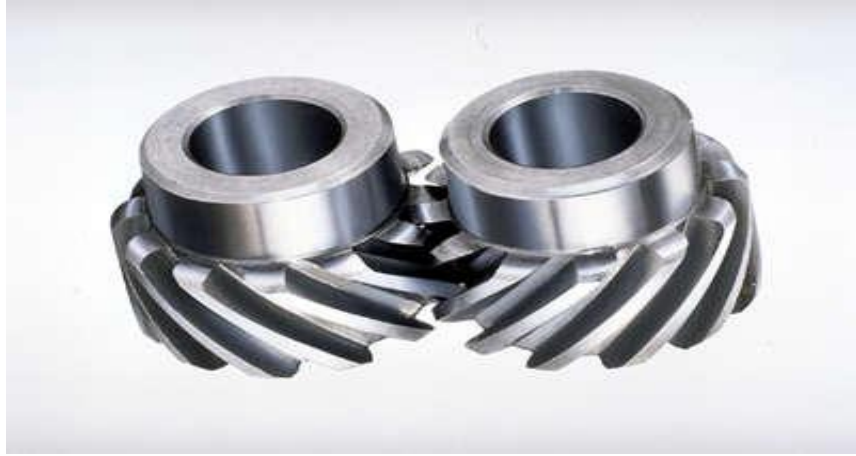
There are two contact ratio associated with a meshing pair of helical gears. The transverse contact ratio Q_t is the contact ratio defined as for spur gears, based on the geometrical tooth meshing action in the transverse plane. The axial contact ratio Q_a is the time average number of teeth simultaneously in contact along a straight line taken parallel to the gear shafts in the imaginary geometrical surface where tooth contact take place. The axial contact ratio of a meshing pair of a helical gear is positive number that can range from less than unity to about 10, or even larger. For a given application, helical gears typically generate much less noise than spur gears. Fig. 1.4 represents the single helical gear pair.

Figure 1.4: Single helical gears [W.4]

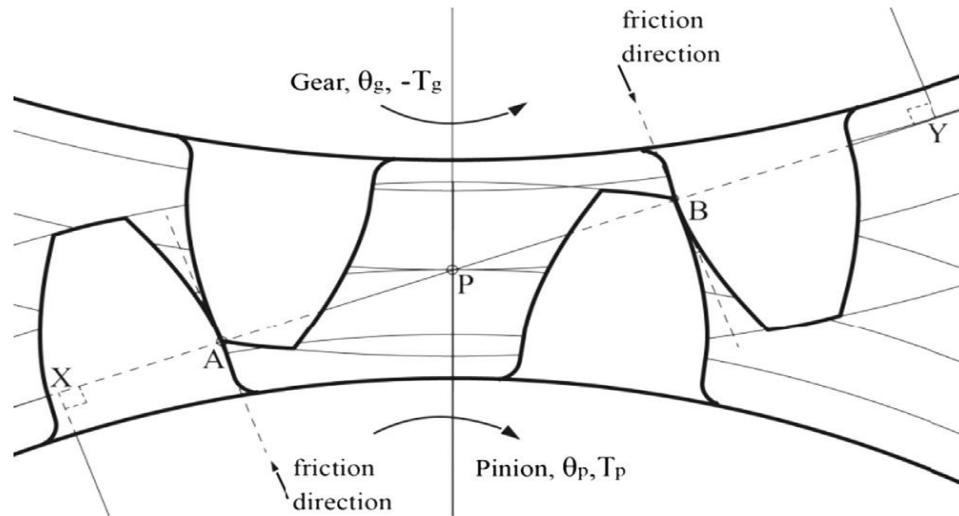
The vibratory excitation caused by sliding friction between mating teeth generally is believed to be small in comparison with that caused by the above-mentioned contribution to the static transmission error tooth meshing harmonics. Fig. 1.7 shows the friction forces.

Figure 1.7: Friction forces in meshed teeth [Kumar, 2013]

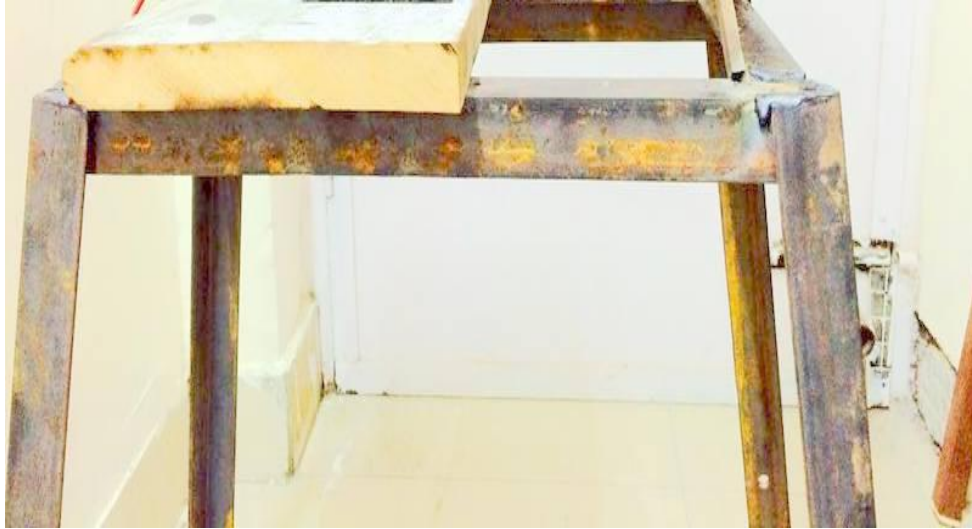
A frame was constructed to mount the coupled motor with gear box. To construct the frame 1.5 inch mild steel angles of 5mm thickness were used and the frame was welded. For the base of motor 1.25 inch thick square wood plate was bolted on the mild steel frame. The Fig. 4.1 shows mounting frame with wooden base plate after welding.

Figure 4.1: Mounting frame

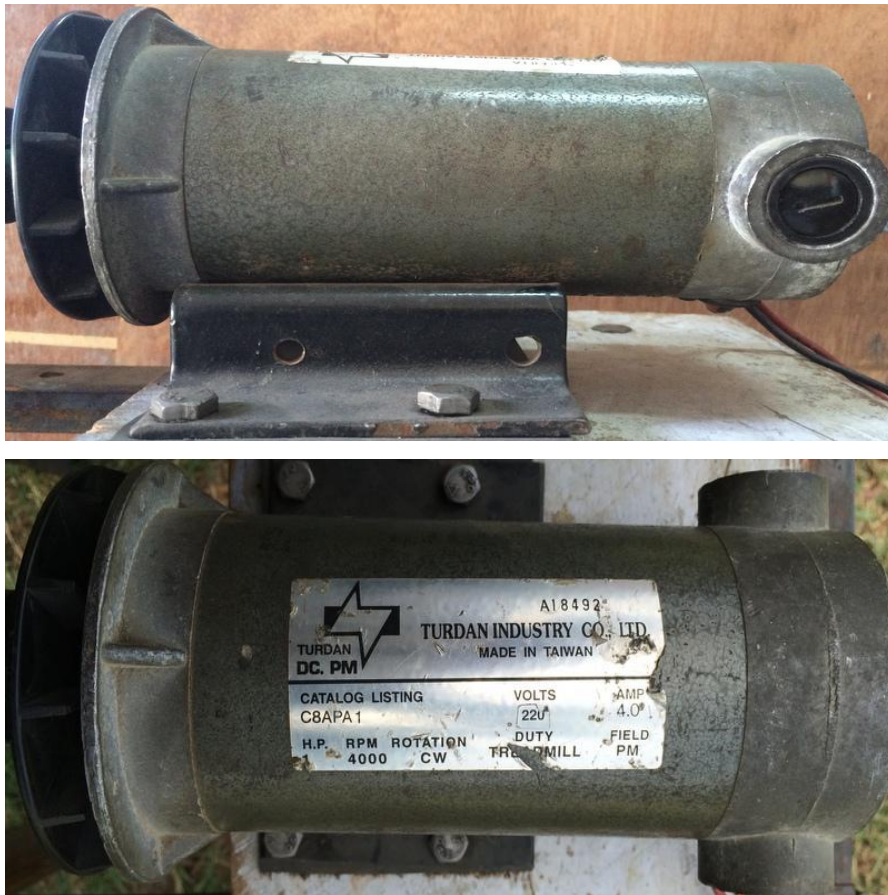
To run the gear box, DC motor of 1HP, 4000rpm has been used. The Fig. 4.2 shows the DC motor.

Figure 4.2: DC motor

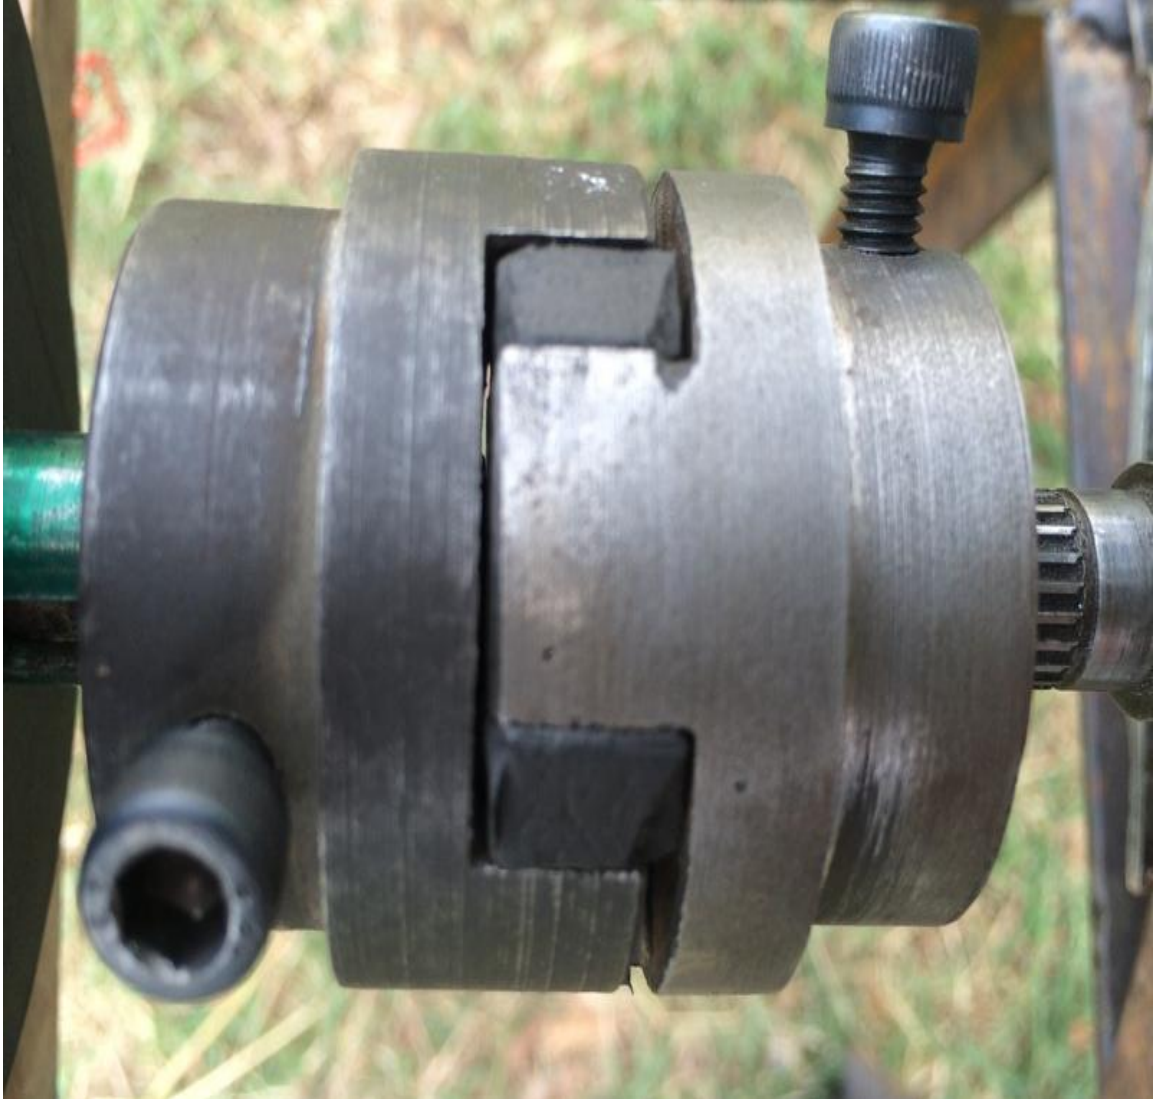
To connect the motor with gear box, flexible coupling was used. The Fig. 4.3 shows the flexible coupling.

Figure 4.3: Flexible coupling

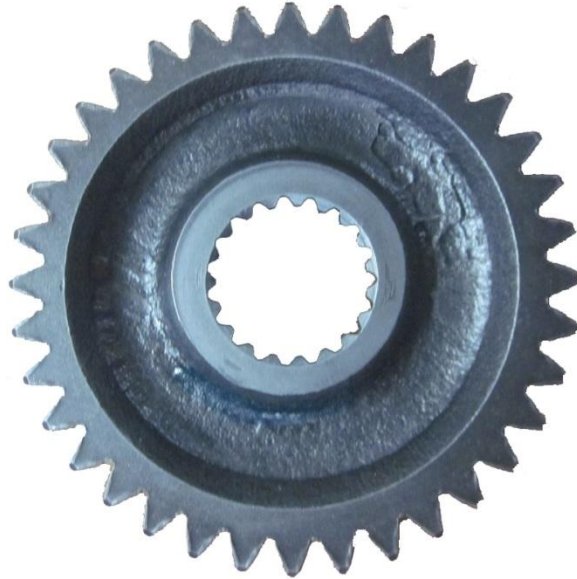
The big spur gear is taken as test gear. The Fig. 4.5 shows healthy test gear and Fig. 4.6 shows cad model of test gear.

Figure 4.5: Healthy gear

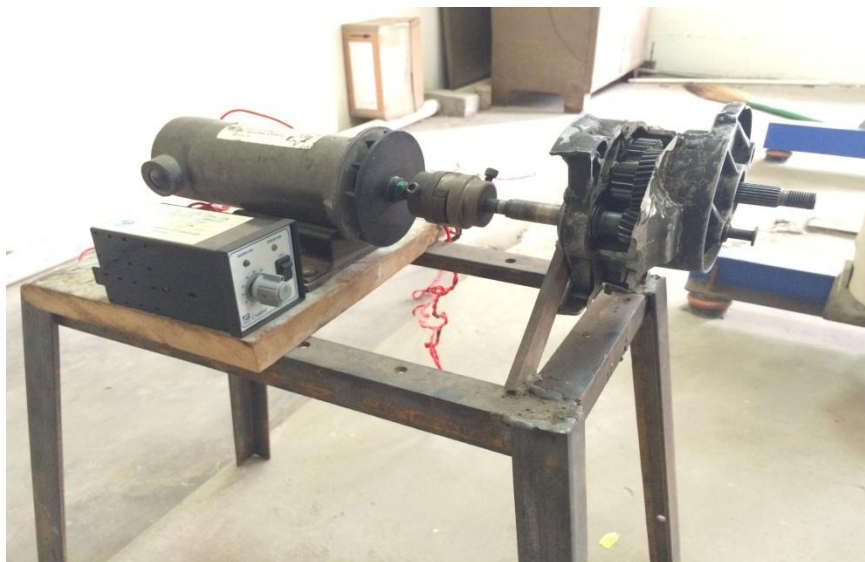
All the components of the experimental rig were purchased from the market and assembled through nuts and bolts for easy dismantle except mounting frame. The Fig. 4.8 shows the experimental rig with speed controller.

Figure 4.8: Assembly of experimental rig

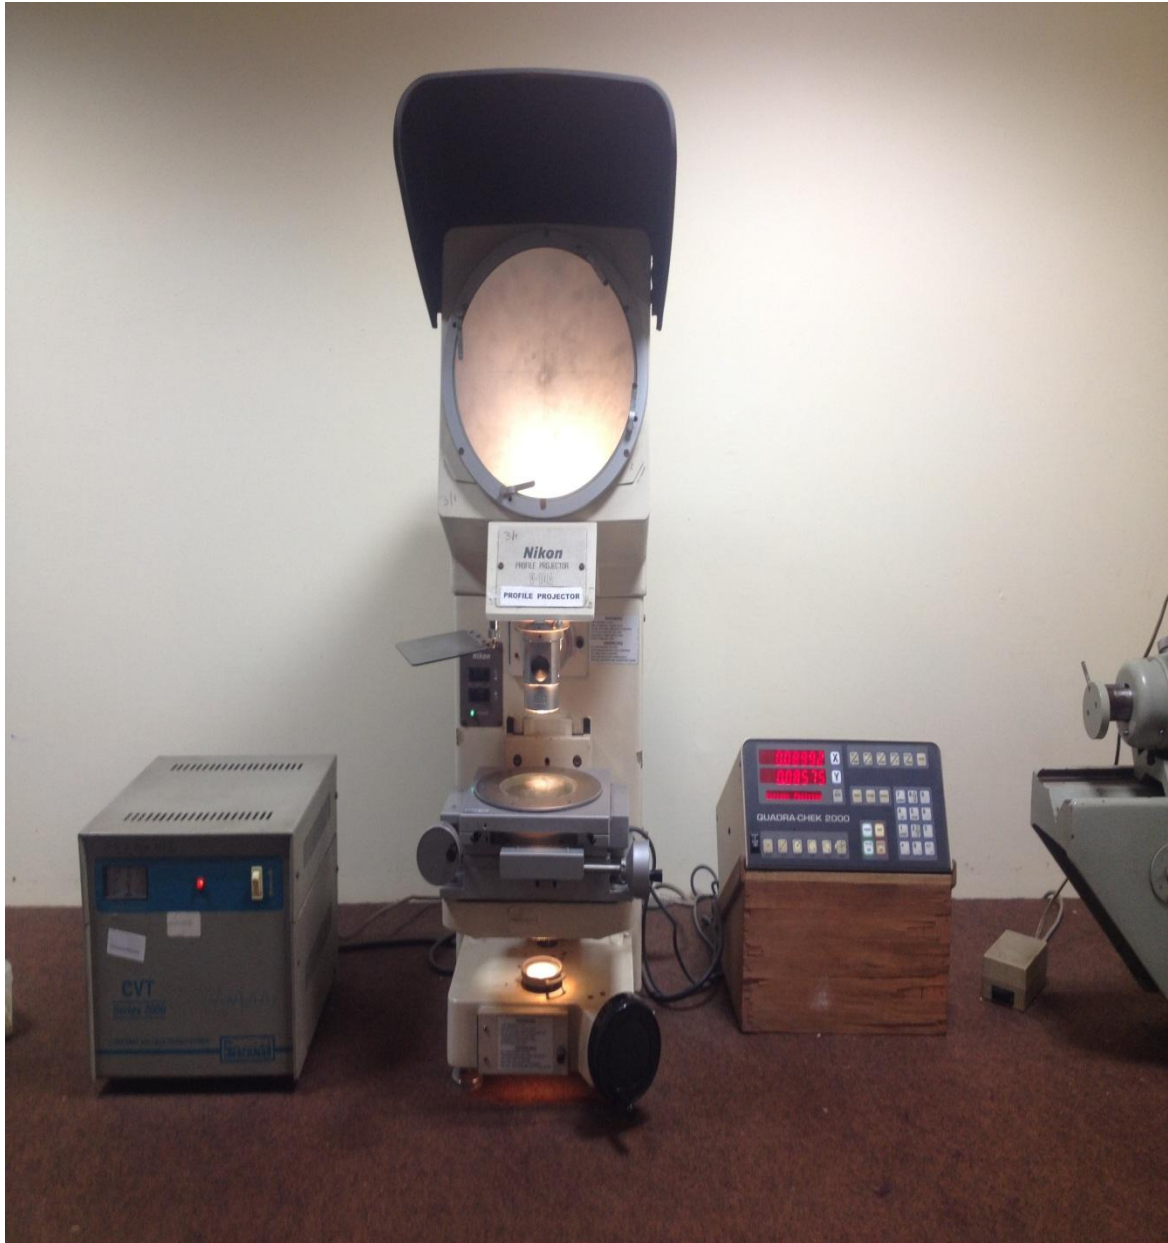
repositioned according to the X-Y scale to zero set as reference and table is moved until the X axis line or Y axis line reaches to the second measuring line, the measured distance is shown in different digital box. The profile projector is shown below in Fig. 4.21.

Figure 4.21: Nikon V10 profile projector

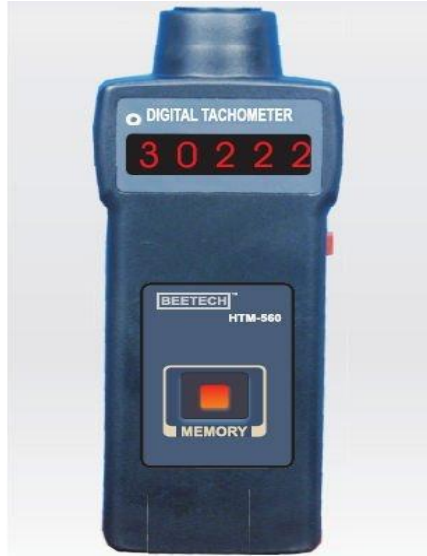
Beetech HTM-560 Contact type digital tachometer is used to measure the speed of DC motor. The digital contact type tachometer is shown below in Fig. 4.22.

Figure 4.22: Beetech HTM-560 Contact type digital tachometer [W.7]

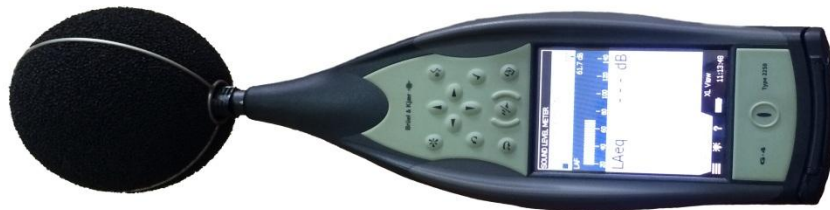
There are various types of equipment available in market to measure the sound pressure level (SPL). The sound level meter is very common among all of them to measure frequency weighted and time average sound pressure level. It is portable hand held analyzer. The Bruel and Kjaer hand-held analyzer 2250 is shown below in Fig. 4.23.

Figure 4.23: Bruel and Kjaer hand-held analyzer 2250

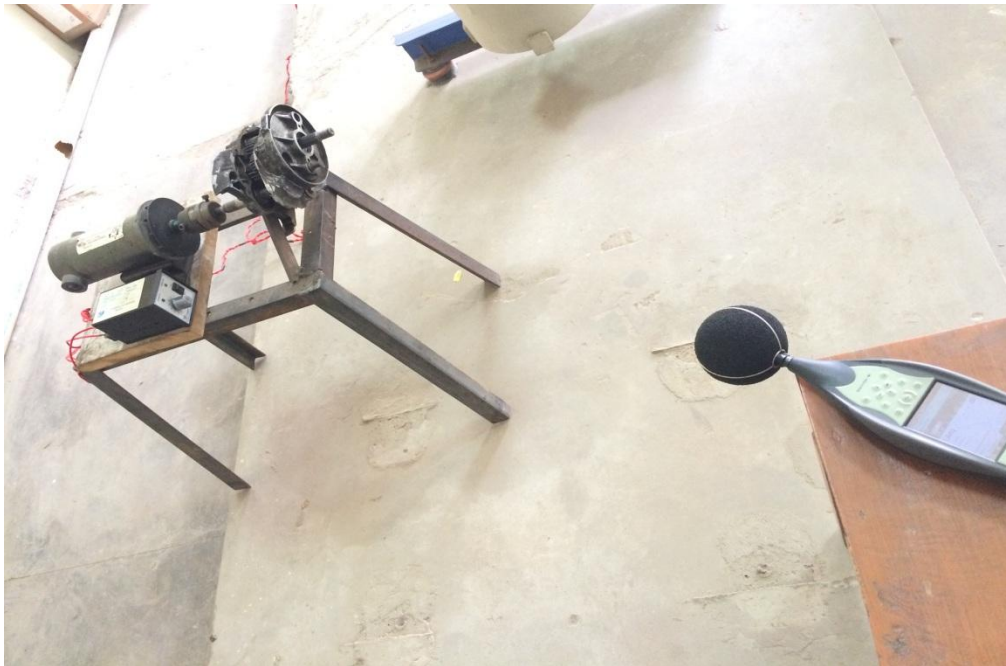
Figure 4.25 shows the experimental rig. The gear box was run by DC motor and its speed was measured by tachometer. Bruel and Kjaer (B and K) portable hand-held analyzer type 2250 with microphone and windscreen was positioned at 1.0 meter away at 45° angle. The B and K frequency analysis software BZ5503 is used to analyze the result. First the test gear of the healthy gear box is run at five different speeds and the sound pressure level was measured in 1-1 octave band at five different speeds after that two type of artificial defects, cut at the root of tooth which led to the propagation of crack in tooth and second was the decrease in height of gear, were produced at the test gear. In the first case faulty crack C1 is produced at the test gear and sound pressure level was measured at five different speeds then second faulty crack C2 is generated with the help of wire EDM and sound pressure level was measured at five different speeds. Further faulty crack C3 was generated in same way and sound pressure level was measured at five different speeds. The crack depths are ranged from 1.475 to 3.391 mm with thickness of almost 0.295 mm. Each measurement reading of sound pressure level takes 1.0 minute. Total 15 measurement of sound pressure level were measured for faulty crack case.

Figure 4.25: Measuring sound pressure level of gear box
