INFRARED IMAGING FOR DAMAGE DETECTION IN CONCRETE STRUCTURES

A Thesis Submitted in Fulfillment of the Requirement for the Award of the Degree of

MASTER OF ENGINEERING

Structure Engineering

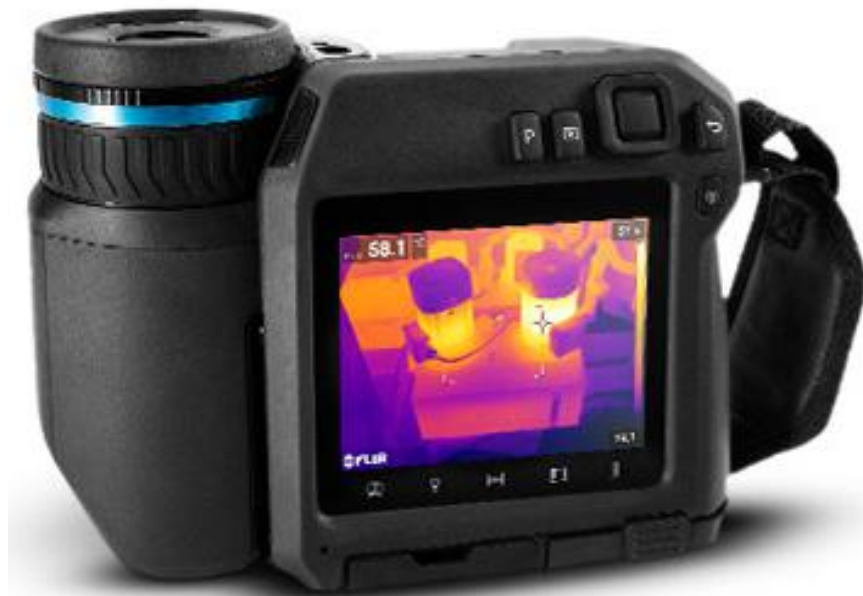
Figure 2.6: Infrared Thermographic Camera (FLIR T540) [13]

Specification	
IR Resolution	464×348 (161,472 pixels)
Object Temperature Range	-20°C to 120°C 0°C to 650°C (On calibration) 300°C to 1500°C (On calibration)
Digital Zoom	1-6x continuous
Detector Type and Pitch	Uncooled Microbolometer (Focal Plane Array), 17µm
Thermal Sensitivity	<0.03°C @ 30°C (42° lens)
Spectral Range	7.5-14 µm
Display for Image Representation	4" , 640×480 pixels touchscreen LCD with auto rotation
Accuracy	±2°C (±3.6°F) or ±2% of reading

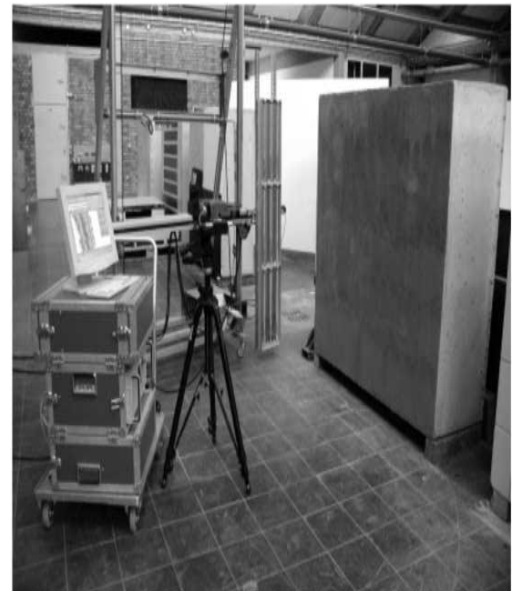
Figure 2.8: Experimental Setup [15]

Two thermal images after heating the specimens 10 minutes at 9 and 58 minutes during cooling stage were captured.

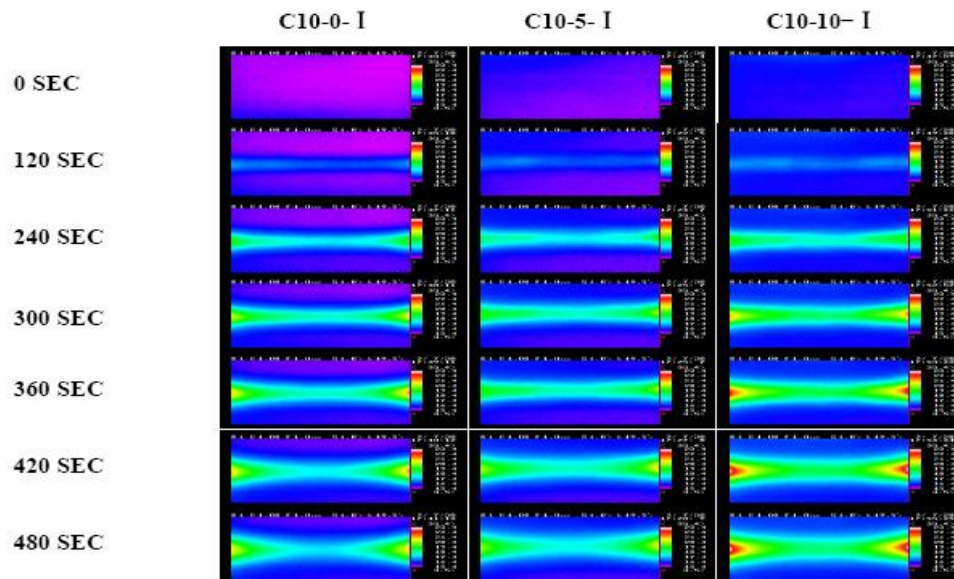
Figure2.10 shows thermographic image obtained after processing them in a visualization program.

Figure2.10: Infrared thermographic image [17]

From the results it was concluded that the higher the temperature the more is the level of corrosion.

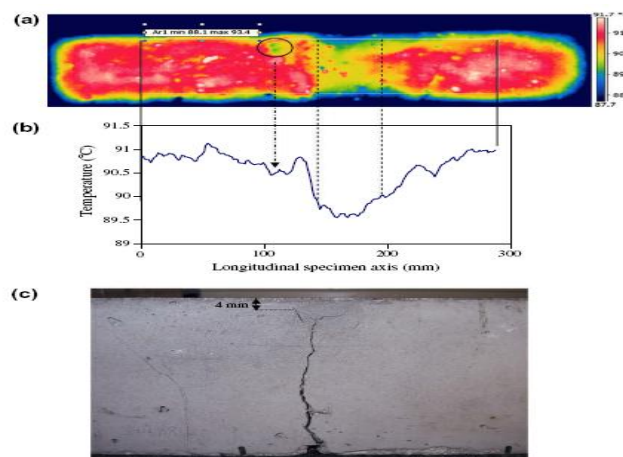
Figure 2.14: Thermograph of a specimen with 2 mm center deflection, (b) average temperature for the axis of specimen and (c) side view of the specimen [20].

From results it was concluded that for huge cracks, the thermal marks on the surface of specimen were effectively recognized on the thermogram but for smaller cracks a basic approach based on

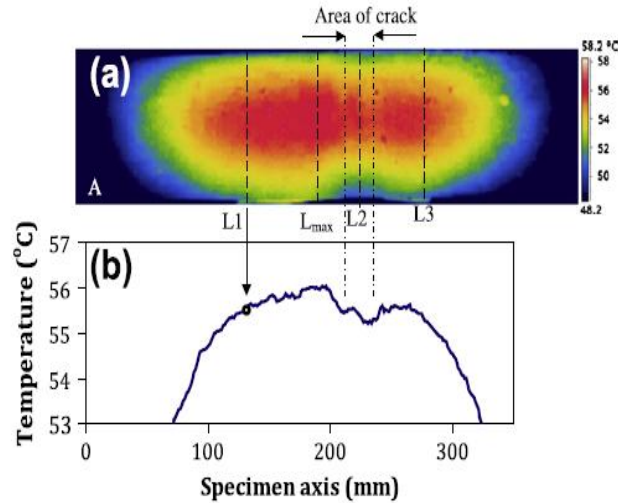
Figure 2.15: Thermograph of the specimen with mid-span deflection 3 mm and (b) average temperature along the specimen's axis [23]

From the thermographs it was revealed the presence of vertical cracks in the subsurface limited to depth of 11mm. The results from simulations and experimental wave parameter showed a very good correlation.

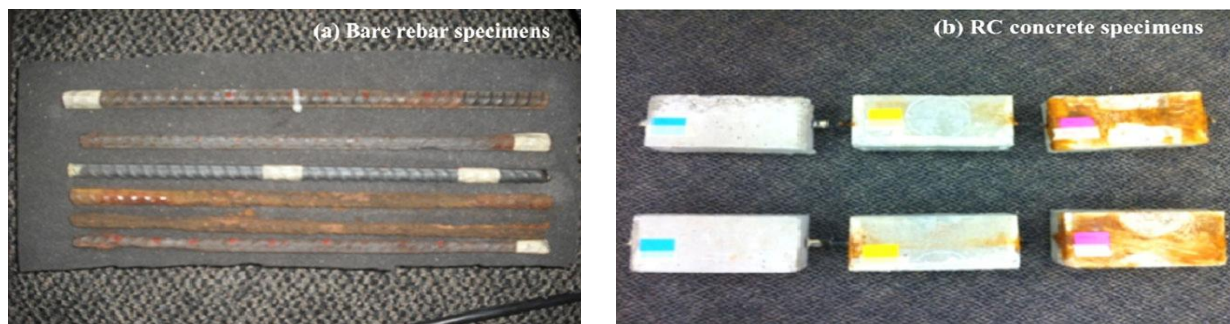
Figure 2.16: Samples of corroded specimens (a) Bare rebar specimen, (b) RC specimen [24]

Impressed current method was used to induce the corrosion in the exposed and embedded bar. The steel bar was heated using inductive heater. The heat induction unit was placed on one side and the IR setup on the other side.

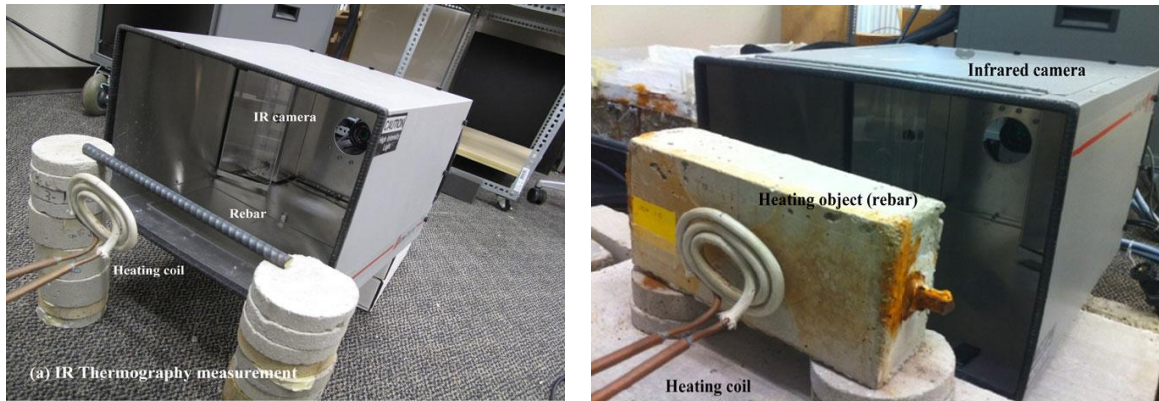
Figure 2.17: Setup for IRT for (a) Bare Bar (b) RC Specimen [24]

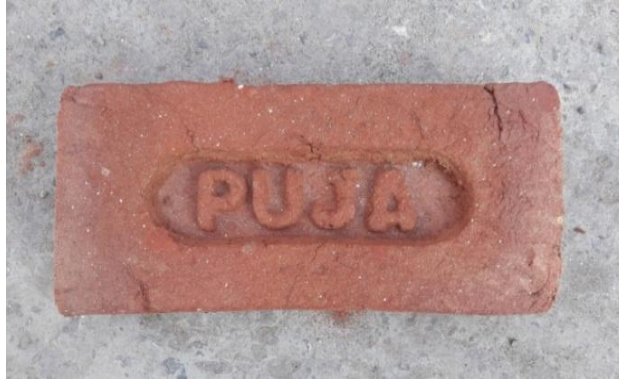
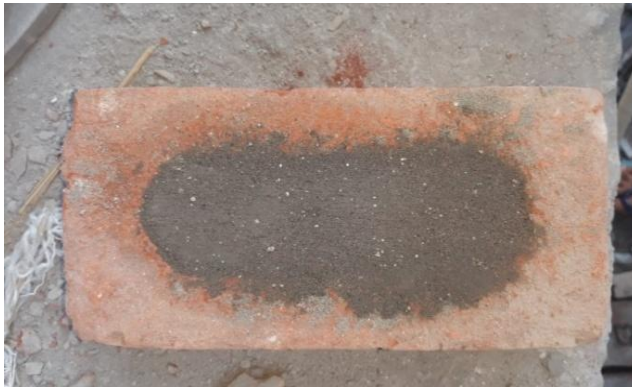
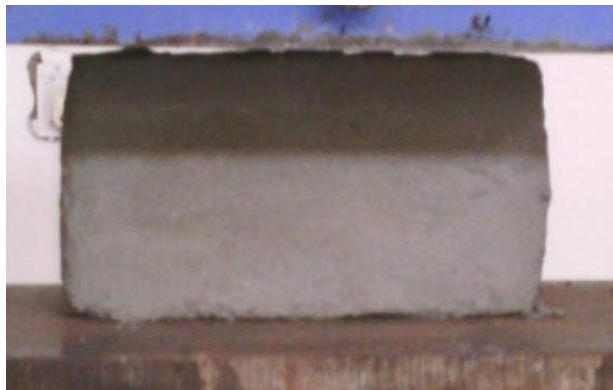
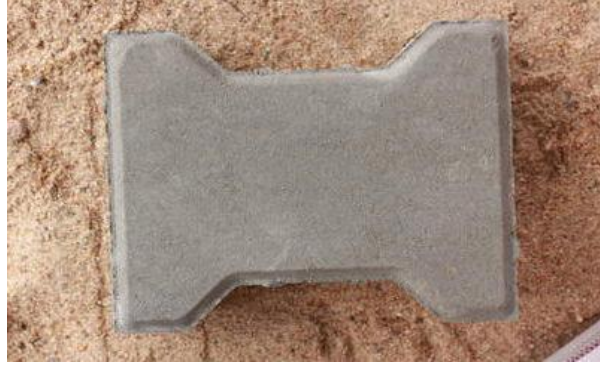
Figure 3.2: Bricks and Interlocking Tile Used in study

Three sets locally available bricks as shown in **Figure 3.1** of nominal size 230mm × 110mm × 70mm were tested.

(a): Simple Brick

(b): Frog filled Brick

(c): Plastered Brick

(d): Interlocking Tile

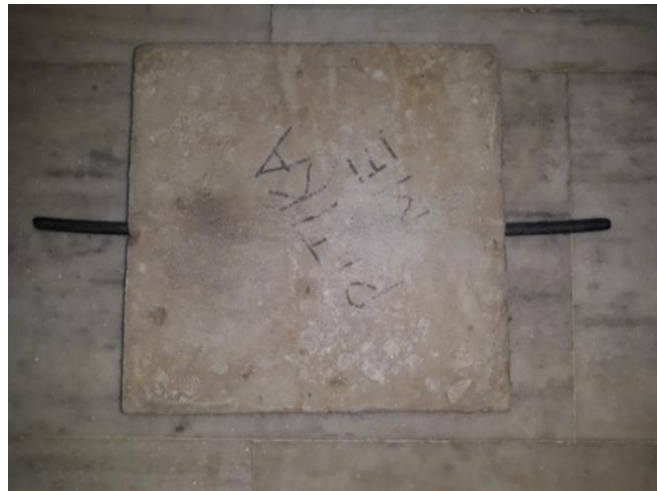
Figure 3.5: Top View of RC Slab Specimen

- ii. **Specimen for embedded bar:** In this experimental work, the RC slabs of dimensions $300\text{mm} \times 300\text{mm} \times 100\text{mm}$ thick with mild steel bar of 500m length were casted with 300mm embedded in concrete and 100mm bar was projected on both sides. Initial weight of the bars was measured and oiling of the moulds was done. When the bar had been set in position, the concrete mix was poured and the concrete mix was vibrated so that mix gets properly compacted and there are no air gaps. After demoulding, the slabs were cured using wet sack method for 28 days. The slab surface was cleaned to remove dirt and loose materials. Top view of RC Slab specimen is shown in **Figure 3.5**.

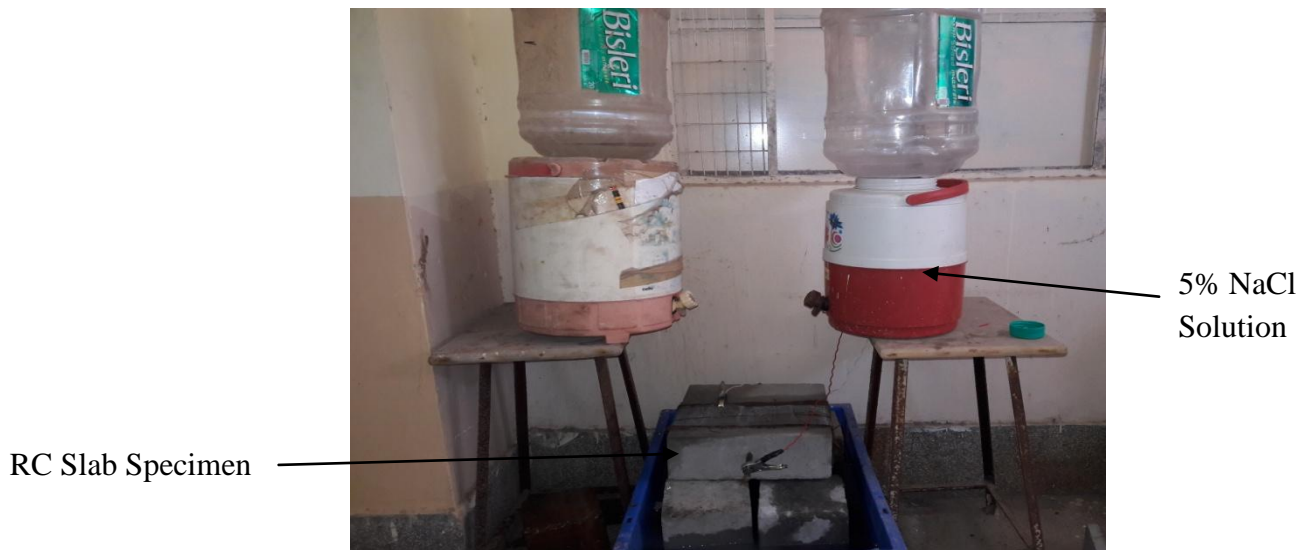
(a) Actual Setup

The methods that are generally employed for inducing the corrosion in RC specimens are salt spray method, chloride diffusion method and impressed current method [45]. However, the quickest of all methods for inducing corrosion in the inserted bar is by impressing an anodic current. It was done by subjecting the RC slabs to 5% NaCl salt solution dip on the specimen. Current was simultaneously impressed by making rebar as anode and a stainless steel (SS) mesh wrapped on the slab in the middle 100mm length as cathode. The Constant voltage of 10V was impressed in order to accelerate corrosion by the DC regulated power supply (APLAB Make, 64V, 0.5A). The setup for the accelerated corrosion is shown in **Figure 3.6**.

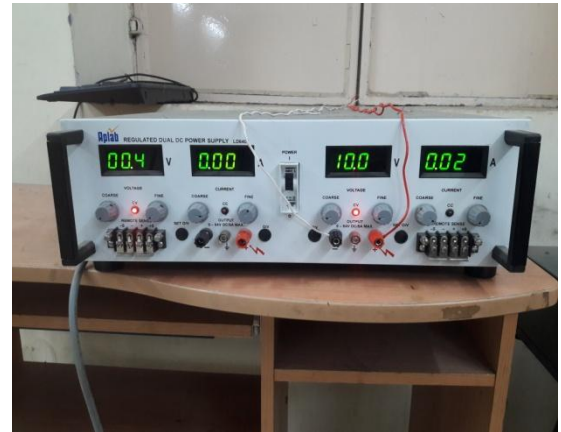
Figure 3.6: Accelerated Corrosion in RC Slab

(c) Power Supply (APLAB, 64V, 0.5A)

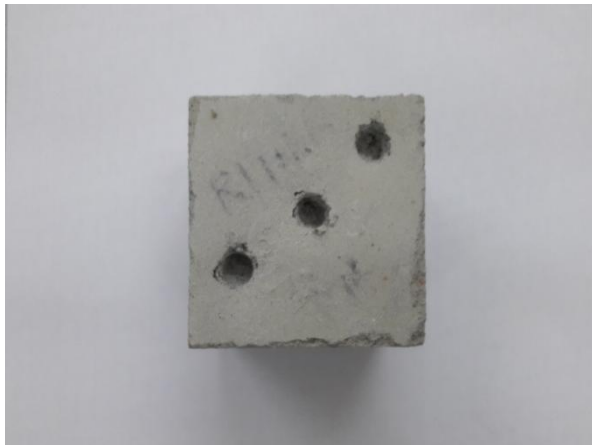
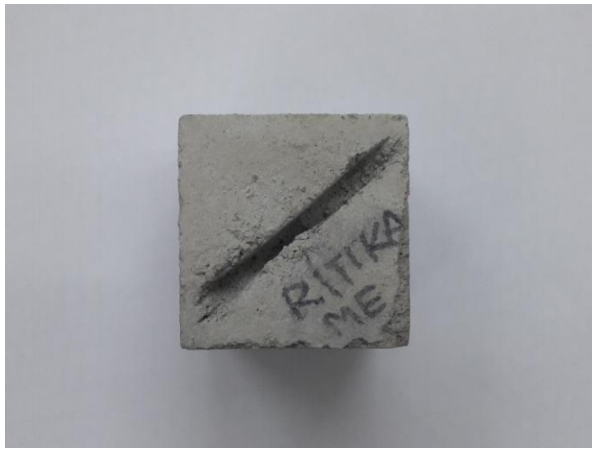
Images were taken after heating the cubes in oven for 2 hours at 90°C.

- thumb impression,
- V-groove with the help of shovel (8mm deep)
- small holes 5mm in diameter and 7mm deep

(a) Actual image of cement mortar cube with 7mm deep holes

(c) Actual image of cement mortar cube with 8mm deep V-groove

- The surface defect appears as the hot spot in the thermal image **Figure 4.10 (b), (d) and (f)**. It is because of retention of the heat energy by these shallow defects.
- These surface defects simulate the actual construction defects that can occur during the construction period of the structures.
- InfraRed Thermography helps to capture these defects easily by creating the colour contrast due to the temperature change and can easily pick up the surface damages.

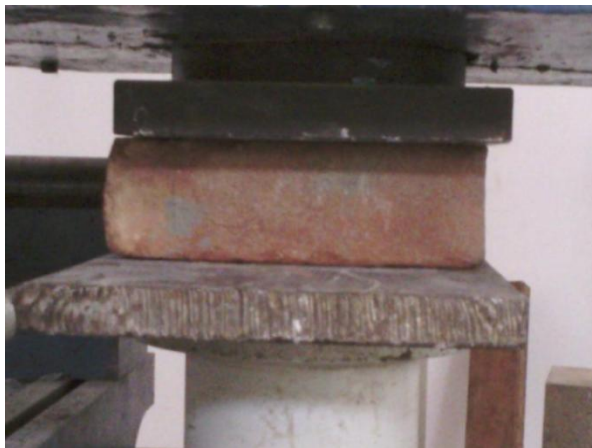
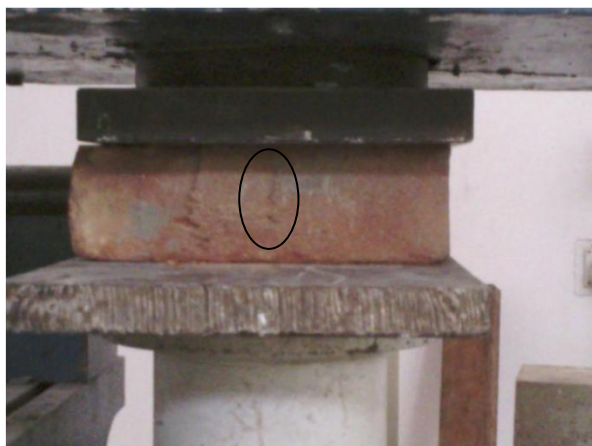
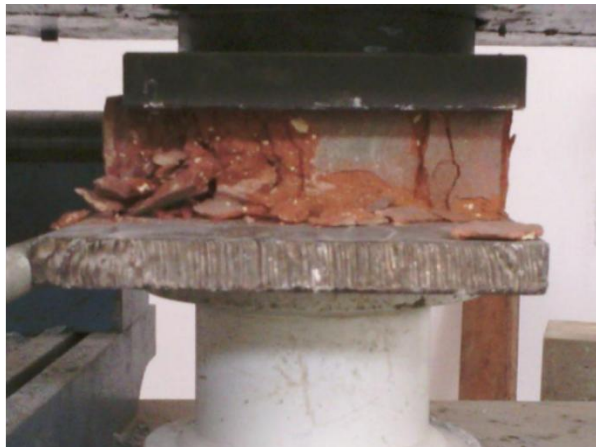
Figure 4.2: Actual and Thermal image of simple brick

a. *Bricks and Interlocking tile:* Bricks and interlocking tile under compression testing and simultaneously infrared images were taken after subjecting them to heating at regular intervals to pick up the cracking.

(a) Actual Image at initiation of test

(c) Actual Image at first major crack

(g) Actual Image at failure

- The crack pattern of the simple brick is **Figure 4.2 (d)** not well defined as compared to the frog-filled brick and plastered brick [**Figure 4.3 (d)** and **Figure 4.4 (d)**] respectively.
- Even the finest crack in each of these brick can be captured effectively as there is release of hot air from the crack which is captured by the camera very efficiently.
- Under the increasing load, spalling from the bricks can be seen easily and picked up in case of simple brick **Figure 4.2 (f)** and frog-filled brick **Figure 4.3 (f)** . Lateral expansion and spalling is observed in both simple and frog filled bricks [**Figure 4.2(h)** and **Figure**

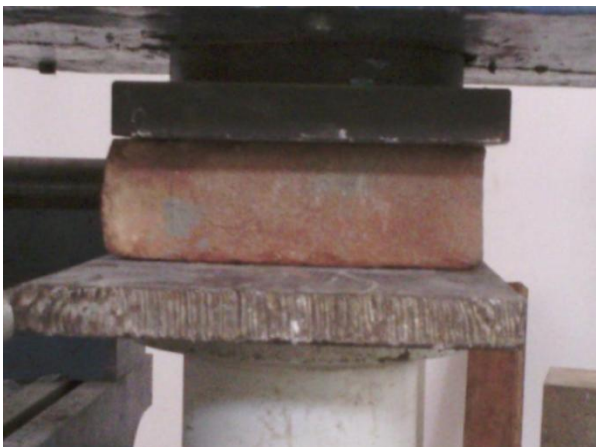
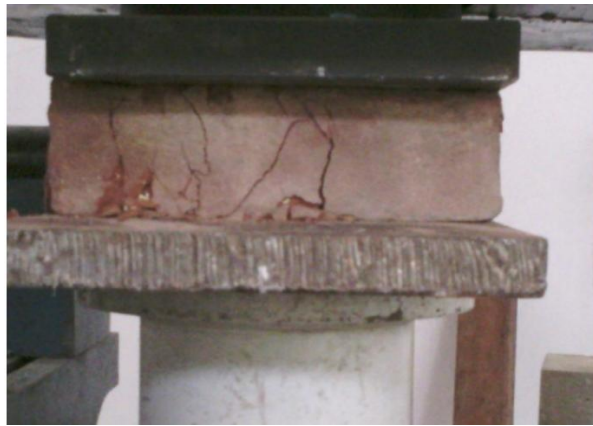
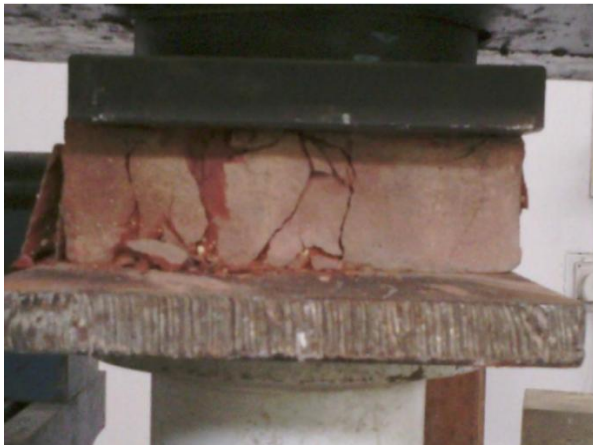
Figure 4.3: Actual and Thermal image of frog filled brick

(a) Actual image at initiation of test

(e) Actual image at ultimate load

(g) Actual

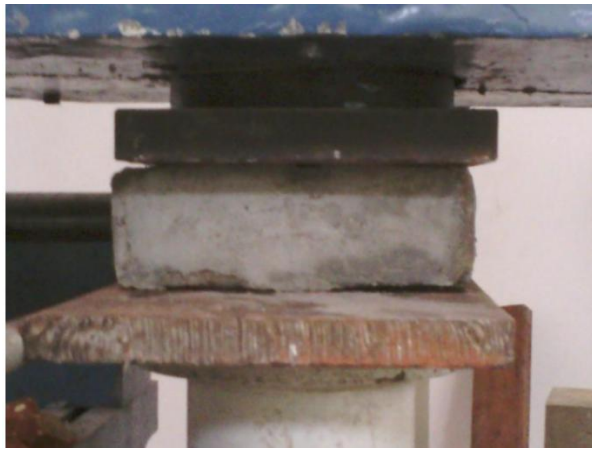
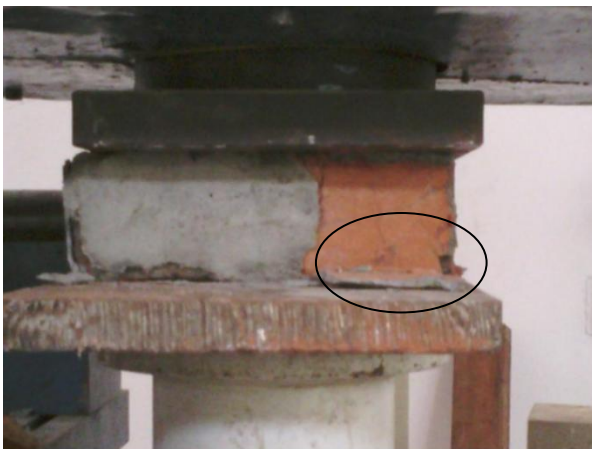
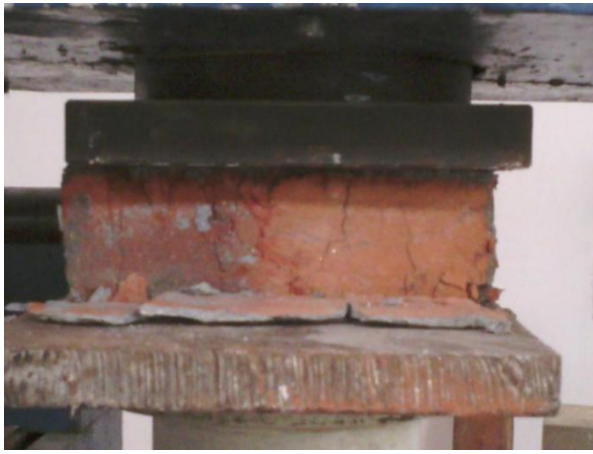
(a) Actual image at initiation of test

(e) Actual image at plaster detachment at the place of crack

(g) Actual image at failure

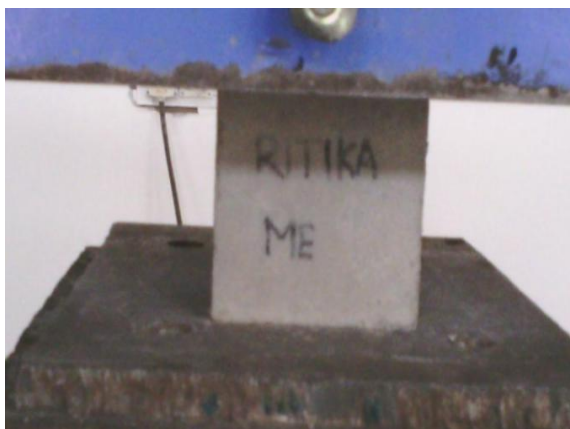
Figure 4.6: Actual Image and Thermal Image of Cement Mortar Cube at 7 days curing

- b. *Cement Mortar*: The mortar cubes were tested after 7 and 28 days under compression testing and simultaneously infrared images were taken after subjecting them to heating at regular intervals to pick up the cracking.

(a) Actual Image at the initiation of test

From the actual and IRT images of cement mortar cube at 7 and 28 days of curing in **Figure 4.6 and 4.7**, the following observations are made:

- Also, from the images of cement mortar specimens after 7 and 28 days of curing in **Figure 4.6 (c) and 4.7 (c)** it is also seen that crack pattern is clearly visible in cubes after 28 days of curing.
- The cracks in the failed cement mortar cubes under compression and the one captured by IRT as shown in **Figure 4.6 and 4.7 (c)** show a close and clear match. This shows that the IRT can clearly pick up the fracture in the cement mortar under compression and can be used as a monitoring tool for cement mortar also like bricks and interlocking tiles.

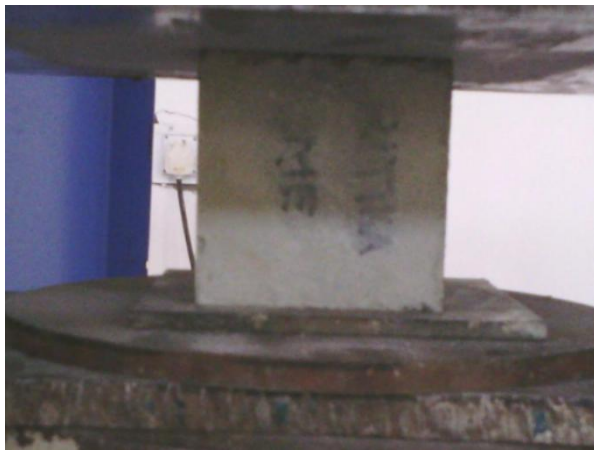
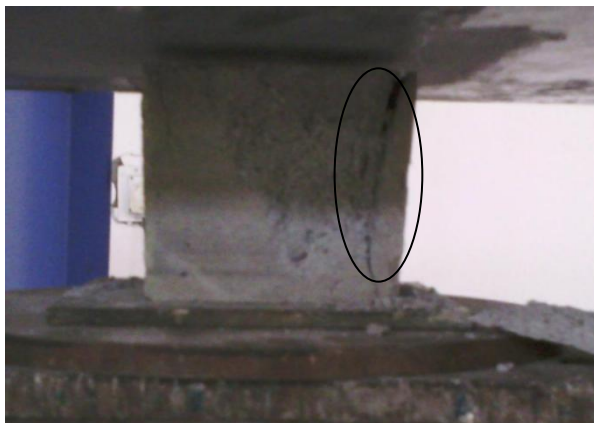
(a) Actual Image at the initiation of test

(c) Actual Image at failure

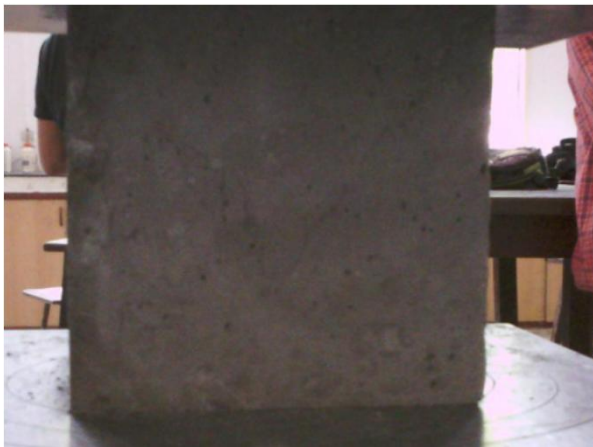
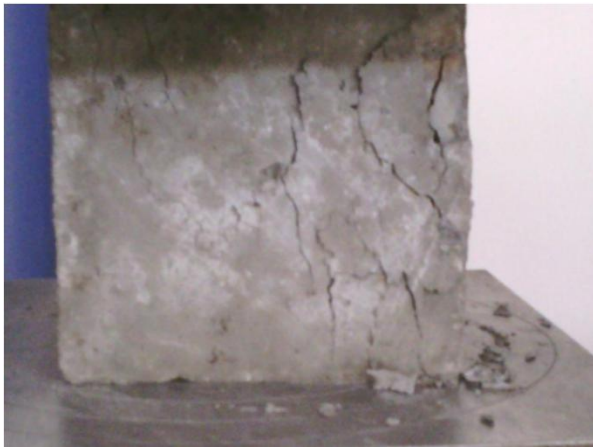
(a) Actual image at the initiation of test

(b) Thermal image at the initiation of test

(c) Actual image at first major crack

(d) Thermal image at first major crack

(e) Actual image at failure

(f) Thermal image at failure

Figure 4.8: Actual and Thermal image of cement concrete cube at 7 days curing

c. *Cement Concrete*: The study was further extended to monitoring the failure and crack pattern in cement concrete cubes. Thermal images from the beginning of the test to failure of the concrete specimen after 7 and 28 days of curing are shown in **Figure 4.8 and 4.9** respectively.

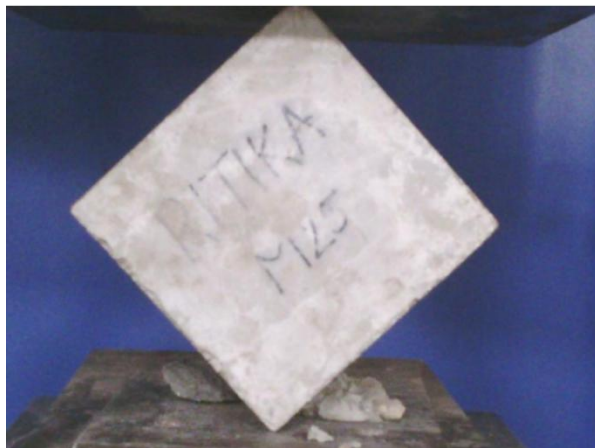
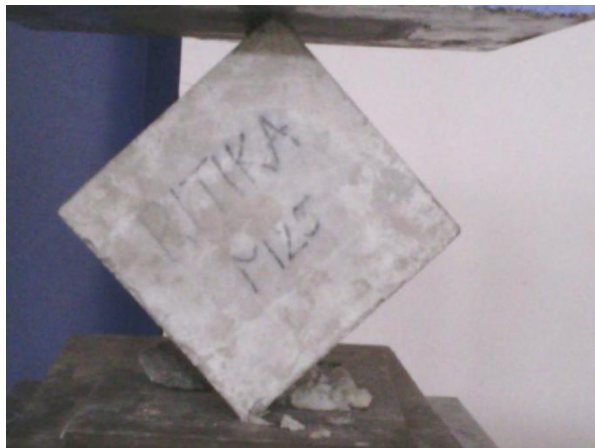
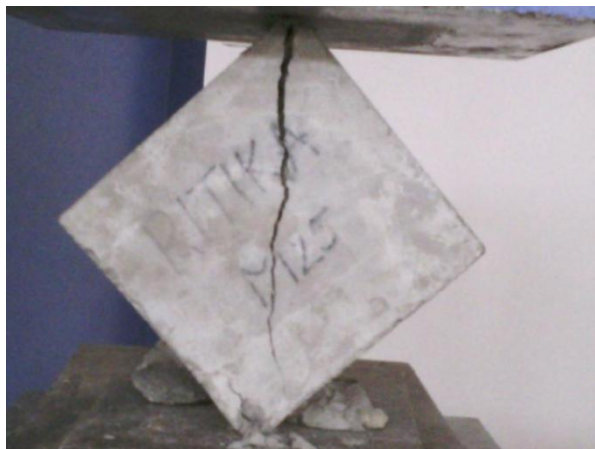
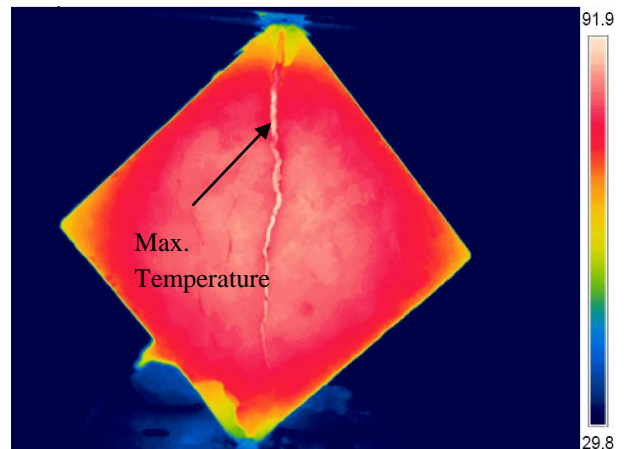
(a) Actual image at beginning of test

(c) Actual image at initiation of fracture

(d) Thermal image at initiation of fracture

(e) Actual image after 10sec of fracture initiation

(f) Thermal image after 10sec of fracture initiation

Figure 4.10: Actual and Thermal images under tensile loading at 7 days curing

- a) Cement Concrete: The study was further extended to monitoring the failure and crack pattern in cement concrete cubes in tension.

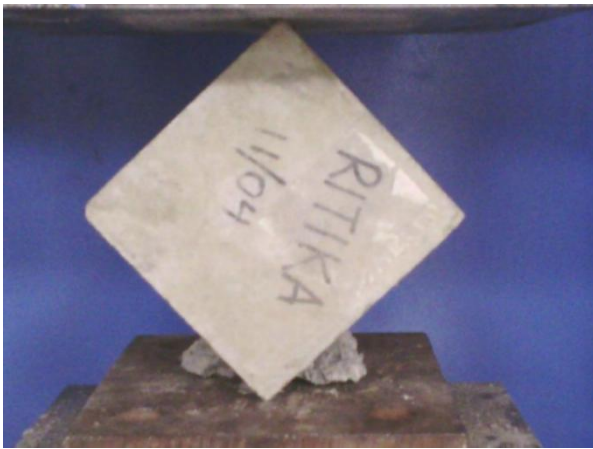
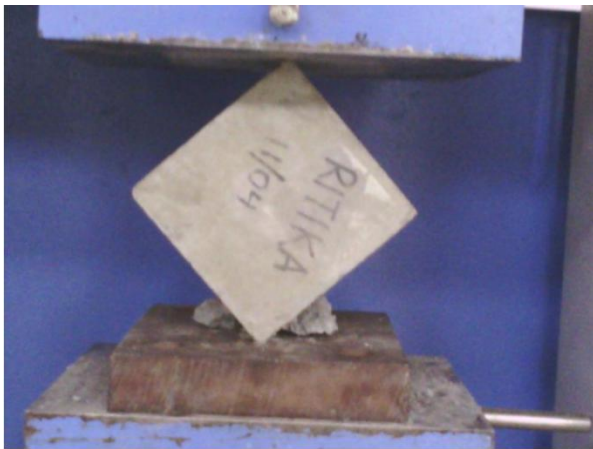
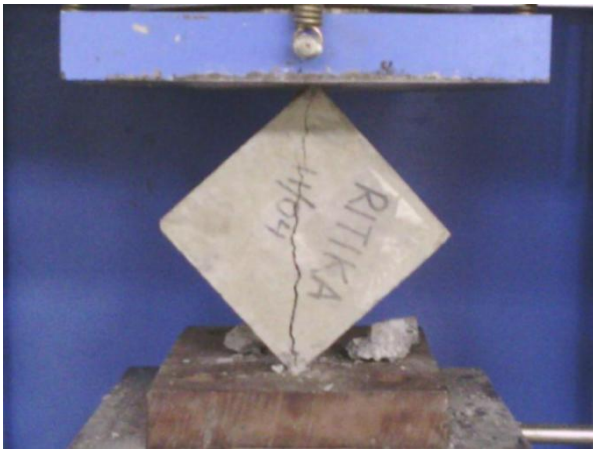
(a) Actual image at beginning of test

(c) Actual image at initiation of fracture

(e) Actual image after 20sec of fracture initiation

- The propagation of the crack is distinctly visible in the image of **Figure 4.10 and 4.11 (d)** of the specimens after 7 and 28 days of curing. The small area at the centre of the specimens is at high temperature than the surrounding concrete. It is specified that the propagating crack started near the contact before moving to the centre of the specimen and thermographic images were taken simultaneously.
- When flanks of the crack move away, much higher temperature was noticed developing in the location of the crack surface. The thermographic images suggest that the tensile stresses causing the initiation fracture are not concentrated near the centre but at the contacts (**Figure 4.10 and 4.11 (c) & (d)**).

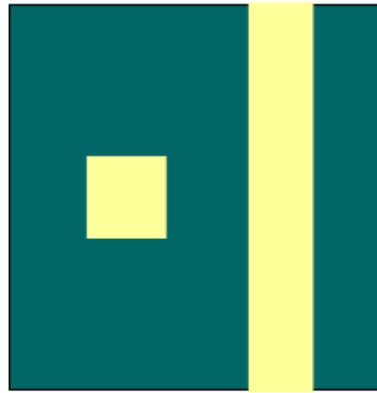
Figure 4.20: Schematic and thermal images of Specimen 1 from top

The GFRP wrapped RC cube with seeded artificial delaminations to be investigated was heated in oven for 10-30 minutes at 50°C . Thermal images after the heating period of 10min, 15min and 30min to the cooling of the specimens are shown in **Figure 4.20 and 4.21**.

(a) Top View of Specimen 1

- From the thermal images in **Figure 4.20 and 4.21 (b) & (c)** it was seen that simulated debonding and delamination of GFRP from the surrounding concrete can be easily picked up by IRT after 10 minutes of heating and the long strip is visible after the heating of 15 minutes.

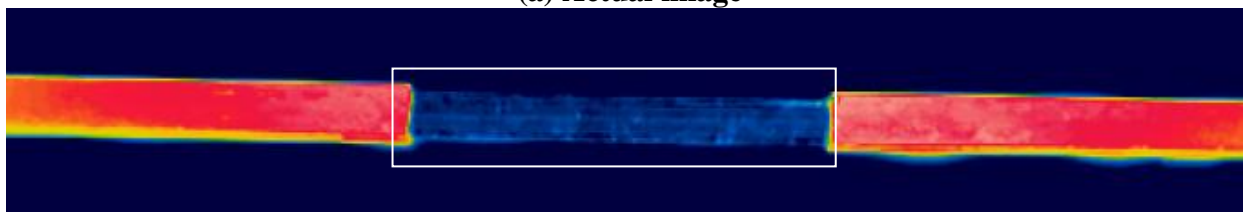
Figure 4.25: Actual and Thermal image of a bar with square section reduced to circular.

(b) Thermal image

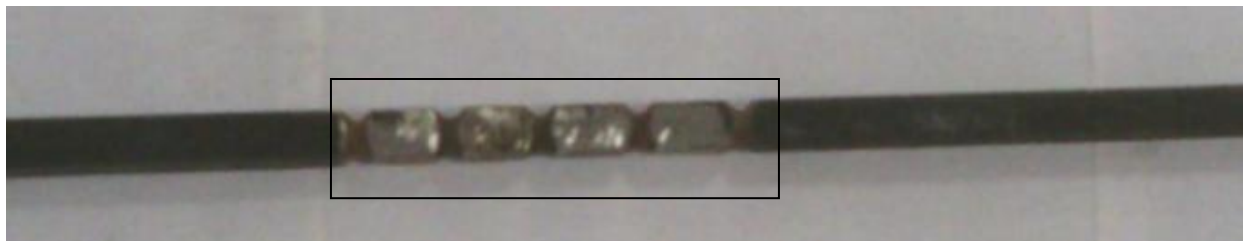
e) Corrugations

(a) Actual image

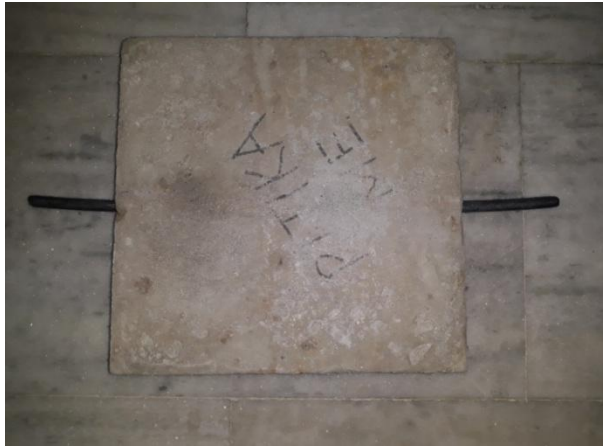
Two RC slab specimens embedded with steel rebar with no corrosion and accelerated corrosion were investigated for corrosion damage using IRT. Gas welding torch was used to heat the embedded bar in slab. The flames directly used at the node from where bar was exposed to the environment.

a) Healthy specimen

(a) Actual image
