**ASSESSMENT OF DAMAGE IN CORRODED AND FRP REPAIRED
CORRODED BEAMS USING ADVANCED NDT
TECHNIQUES**

A Thesis

CIVIL ENGINEERING

August 2021

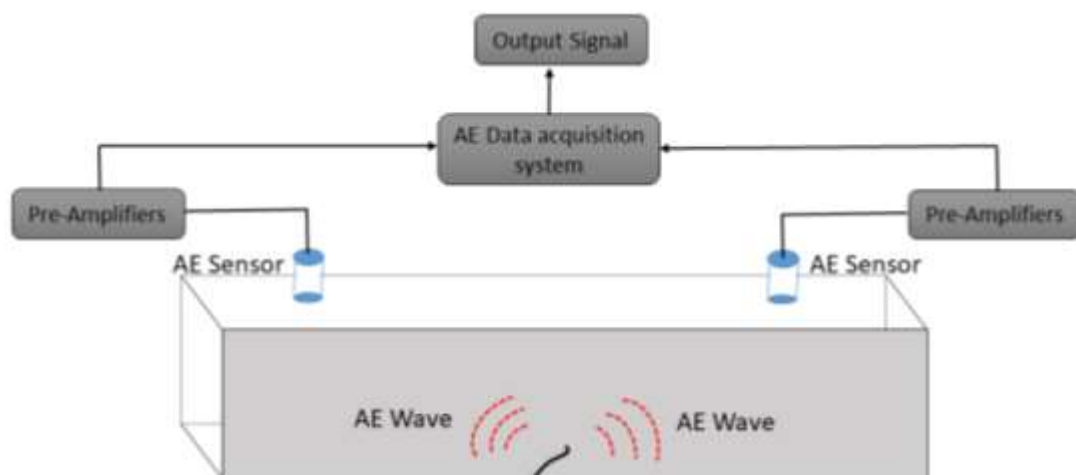
Figure 2.4: Schematic illustration of AE Monitoring Process [114]

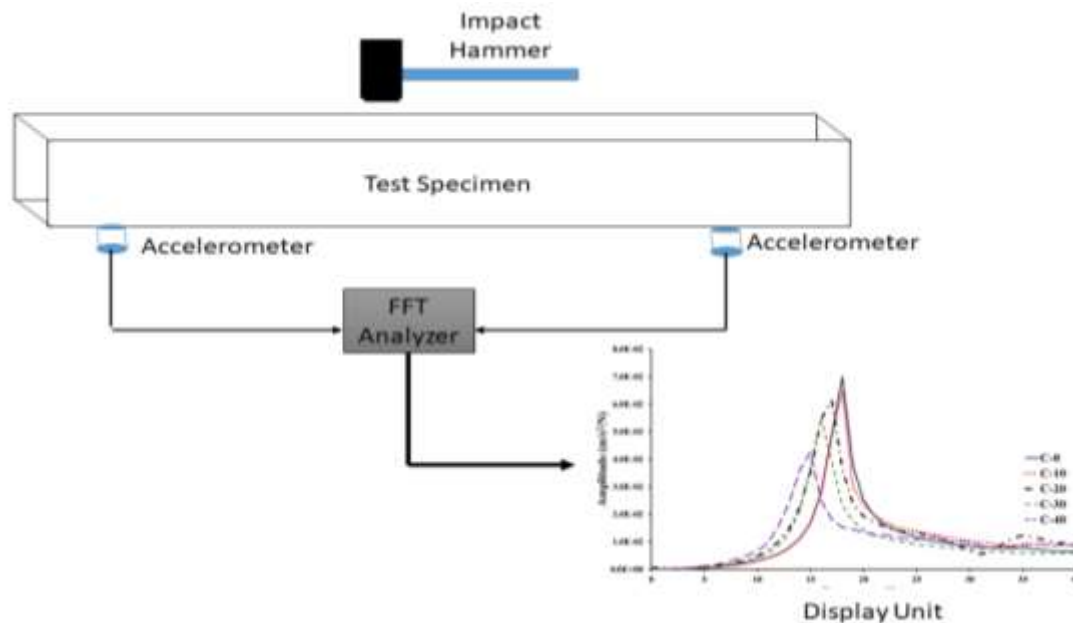
Figure 2.9 Schematic illustration of Vibration monitoring

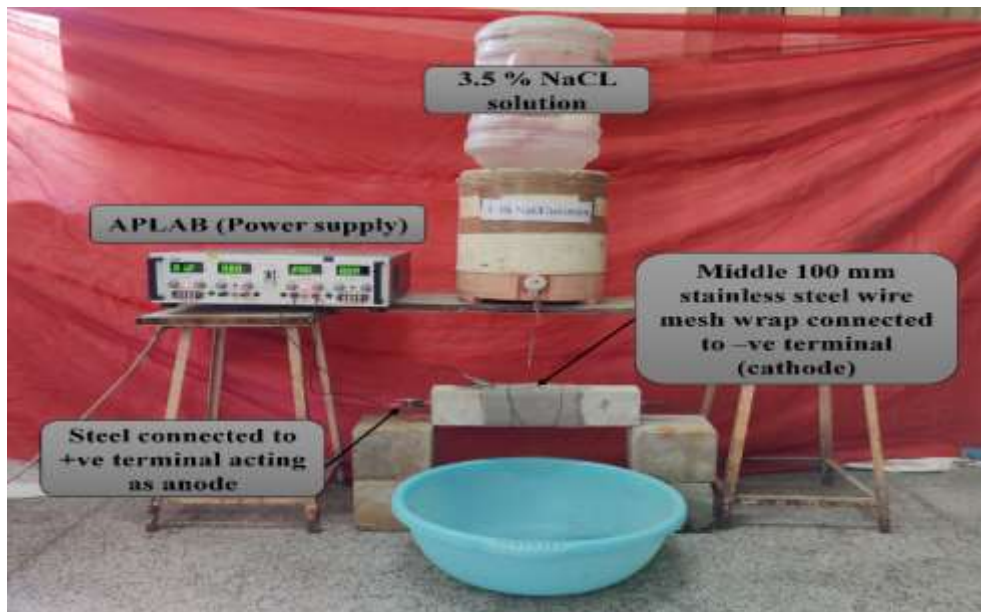
(a) Schematic of corrosion set up

(b) Actual corrosion set up

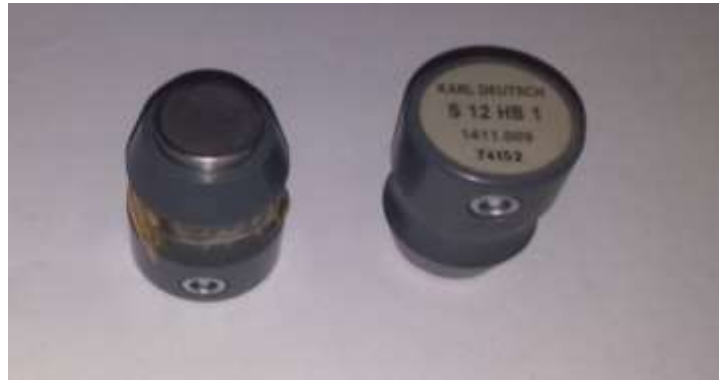
(a) Transducer (S12 HB 1) (12 mm diameter) of 1 MHz frequency

(b) Ultrasonic Guided Wave Set-up

Figure. 3.3 Experimental Set up

reduces as the bars undergo deterioration due to corrosion. Fall in signal strength is quantitative indicator of extent of the corrosion.

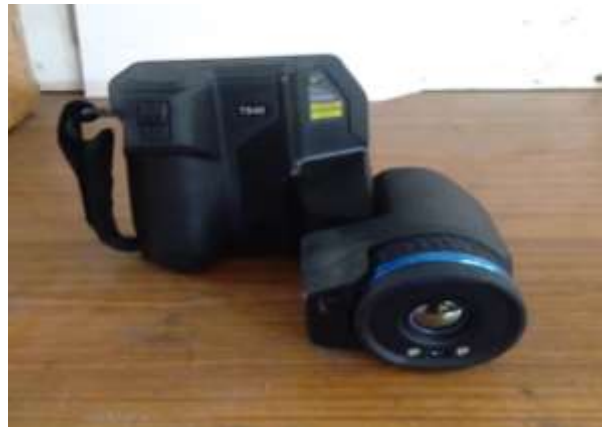
(a) FLIR T-540 used in study

(b) IRT set up

with temperature range of -20°C to $+120^{\circ}\text{C}$ (**Figure 3.4 a**). In this work it IS proposed to use infrared thermography for monitoring real time corrosion as well as simulated corrosion damage in concrete along with combination of AE and UGW. First the samples were heated using a source of heat (Welding machine used) within temperature range of $20-200^{\circ}\text{C}$. The IR camera was placed at the constant distance of 1.6m from the samples to take IRT images at regular intervals as the beams were subjected to increasing damage (**Figure 3.4 b**). First the IRT images of bars with simulated damage in air were taken, then they were cast in concrete and IRT images were again taken. For beams subjected to corrosion IRT images were taken for thermal wave inspection and analysed after corrosion for 8, 19, 26 and 33 days (S8, S19, S26 & S33).

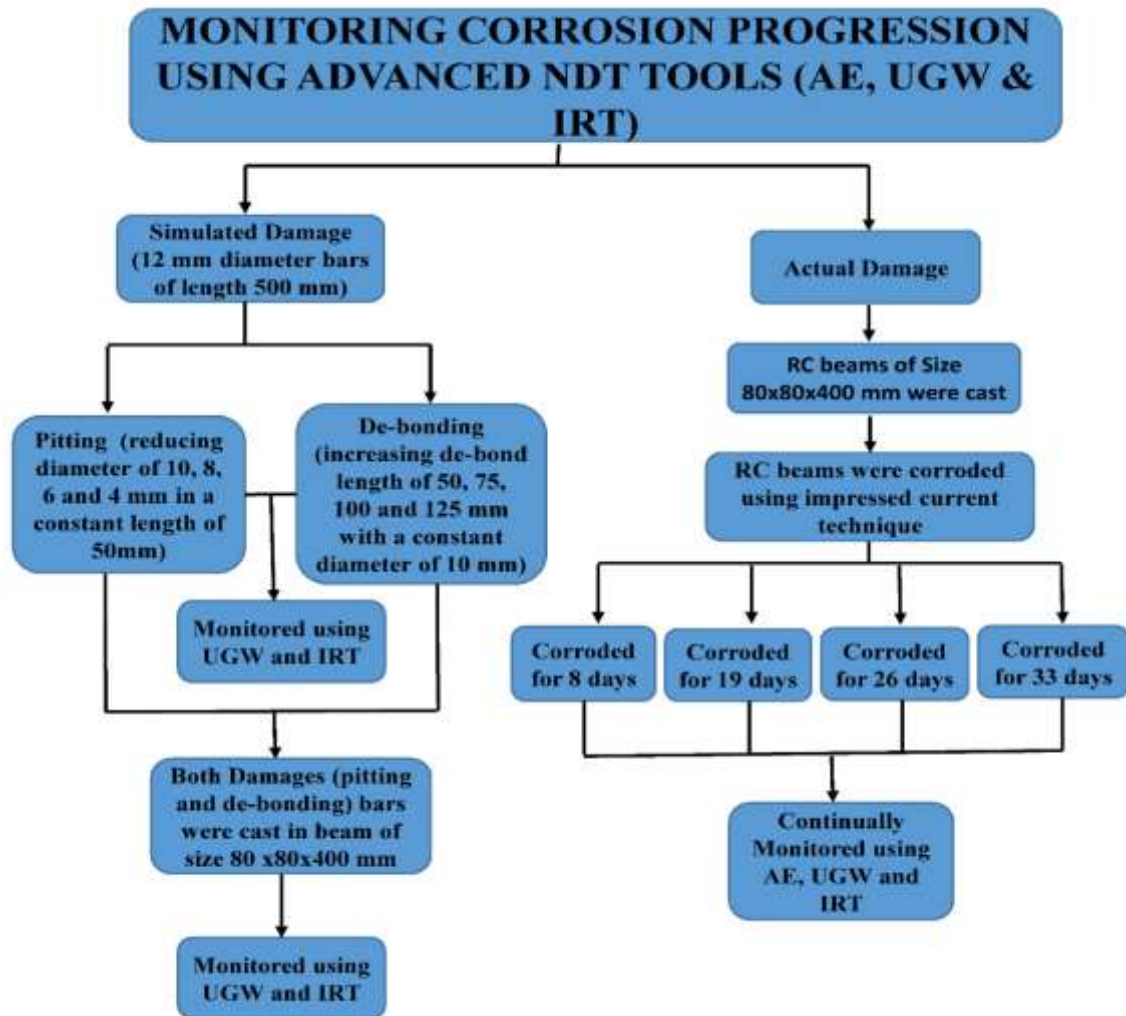
Figure: 3.8 Flow chart for monitoring real time corrosion

In this study, cumulative AE hits and their amplitude along with pictorial AE X-Y event plots for damage localization have been used to relate the corrosion damage. AE X-Y plots will provide pictorial representation of cracking beneath the concrete surface, which help us to understand the progression of damage inside concrete. Hence, it is expected that change in AE parameters with corrosion damage will lead to quantitative assessment of corrosion. The flow chart for the methodology followed for objective 1 real time corrosion monitoring is detailed in **Figure 3.8**.

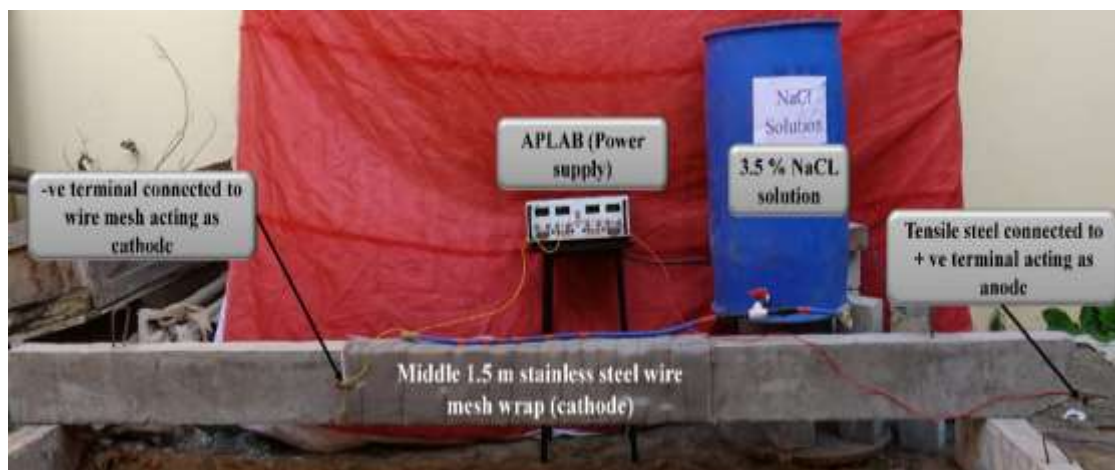
All eight RC beams were subjected to accelerated corrosion using impressed current technique, where a constant electric potential of 10V is supplied using a constant voltage source (APLAB Make, 64V, 5 A). The tensile reinforcement acting as anode is connected to the positive terminal of power source.

Figure 3.12. Accelerated impressed current corrosion set up

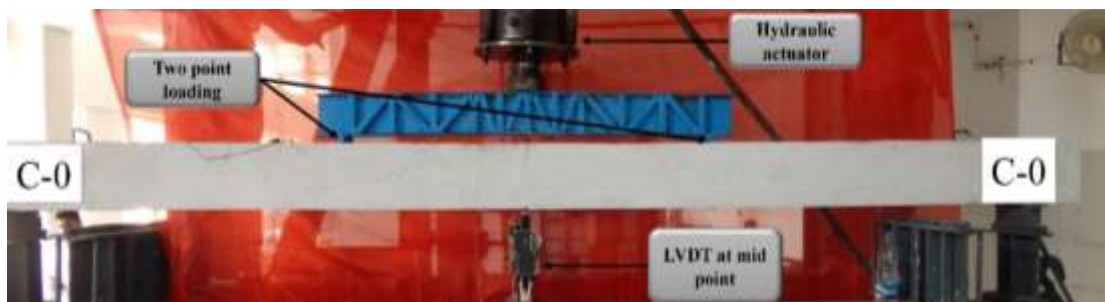
Figure. 3.15. Flexure testing set up

RC beams corroded to different levels (C-10, C-20, C-30 and C-40) and subsequent GFRP repaired beams (R-10, R-20, R-30 and R-40) were inspected for assessing the extent of damage due to corrosion by vibration monitoring technique. Further these beams were then subjected to flexural testing until failure for determining their load carrying behaviour after corrosion and further when repaired against corrosion by GFRP wrapping (**Figure 3.15**).

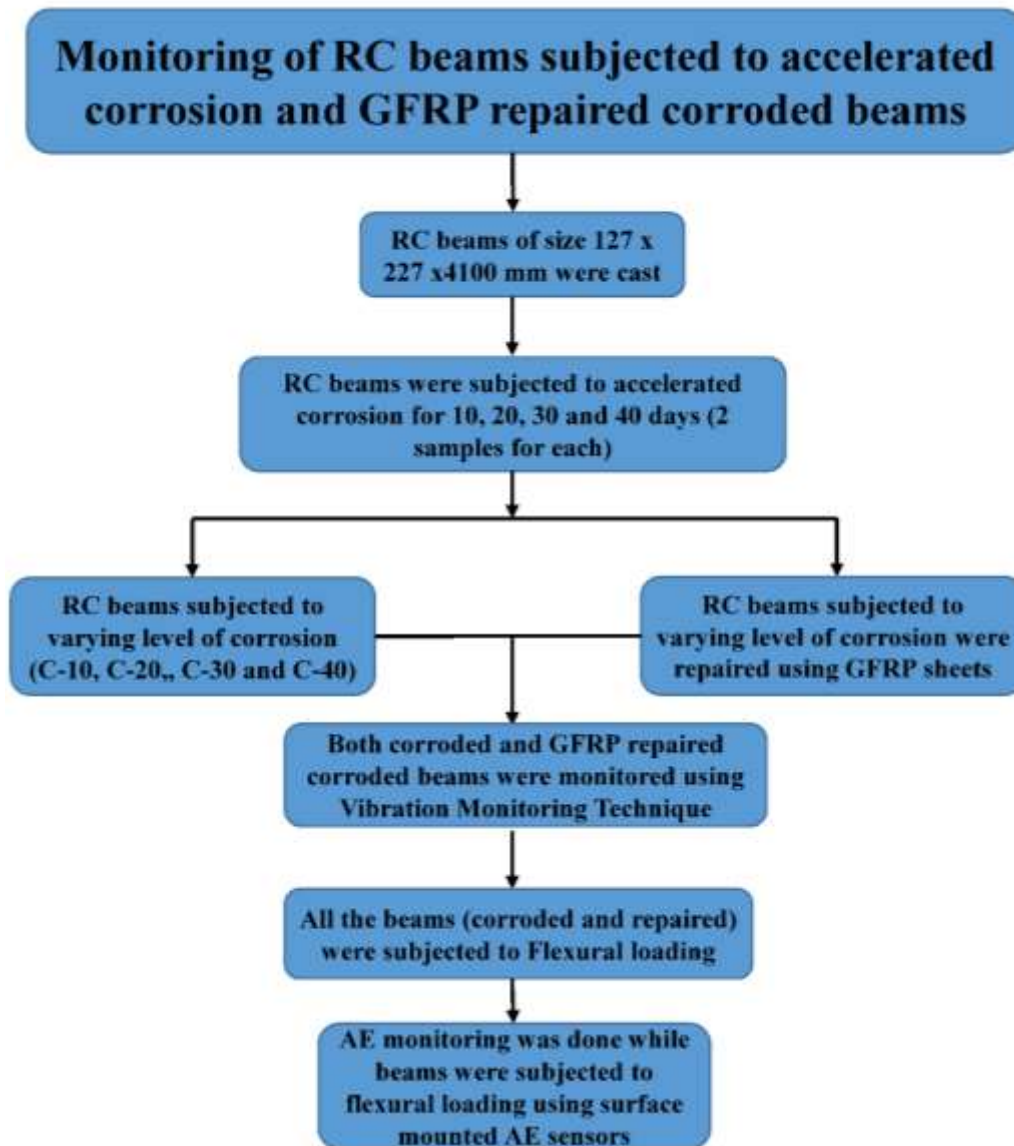
Figure: 3.17 Flow chart for monitoring corroded and GFRP repaired corroded beams using NDT tools
