**“EFFECT OF INITIAL STRESS LEVELS ON STRENGTH OF BEAMS
RETROFITTED USING PRE-STRESSED FIBRE COMPOSITES”**

A thesis report submitted in the partial fulfillment
of the requirement for the award of the degree

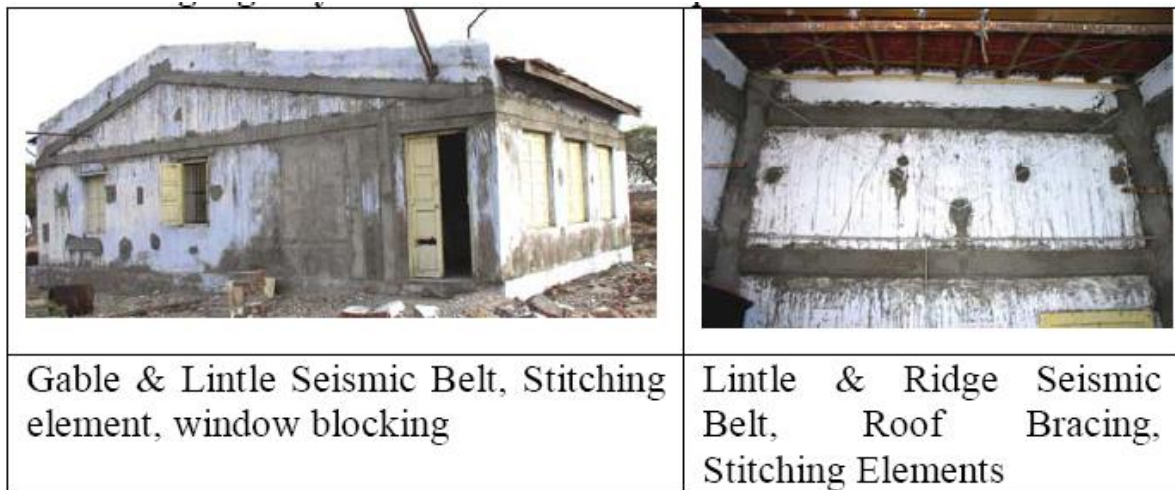
Fig 2.2: Repair work at R & B Office cum Storage at Patadi town in Gujrat, Year 2002.

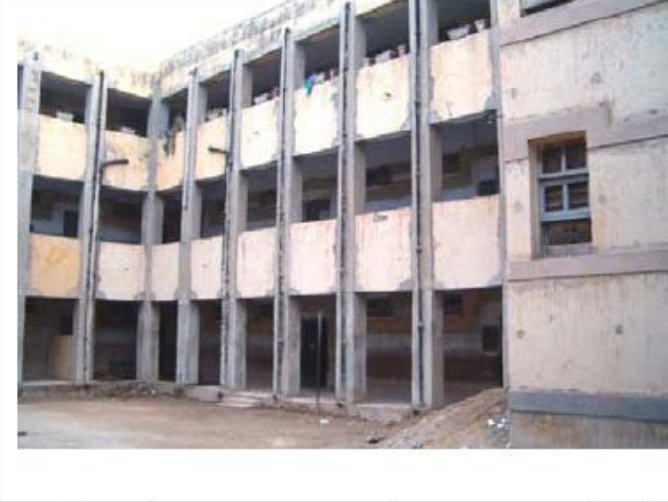
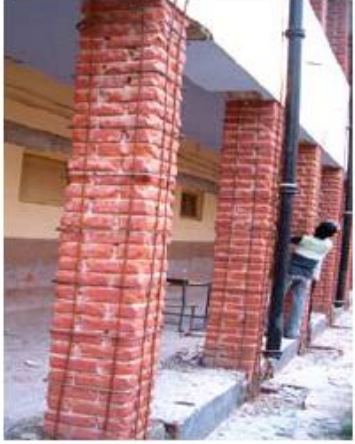
<p>Jacketed Masonry Columns & Seismic Belts</p>	<p>Jacketing reinforcement</p>

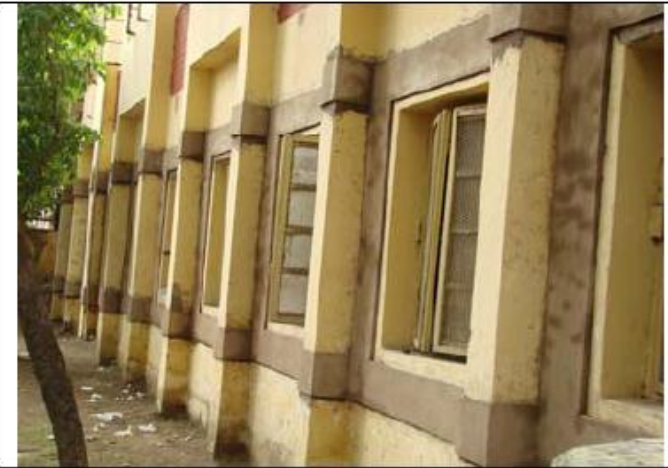
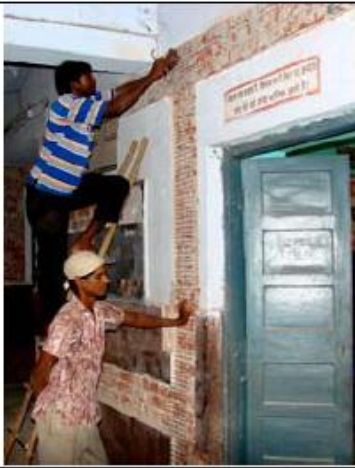
<p>Lintle & Sill Belts & Window Encasement</p>	<p>Encasement of door way</p>

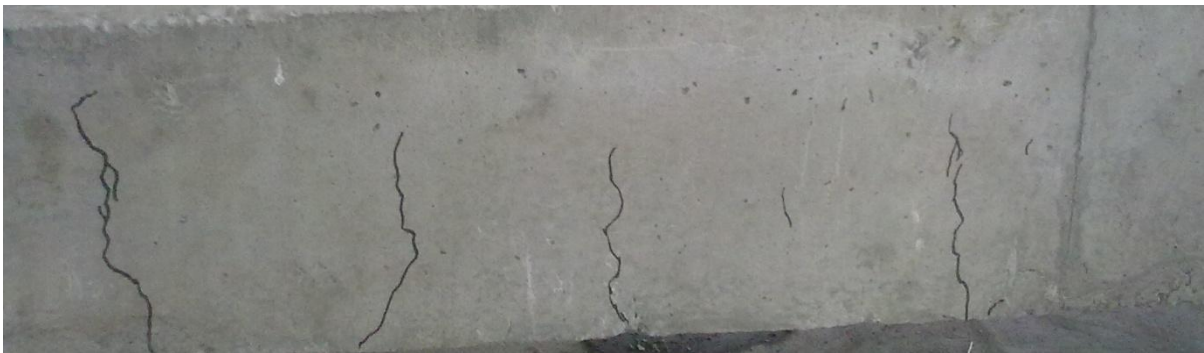
Fig 4.2: Crack pattern observed after CB01 is failed

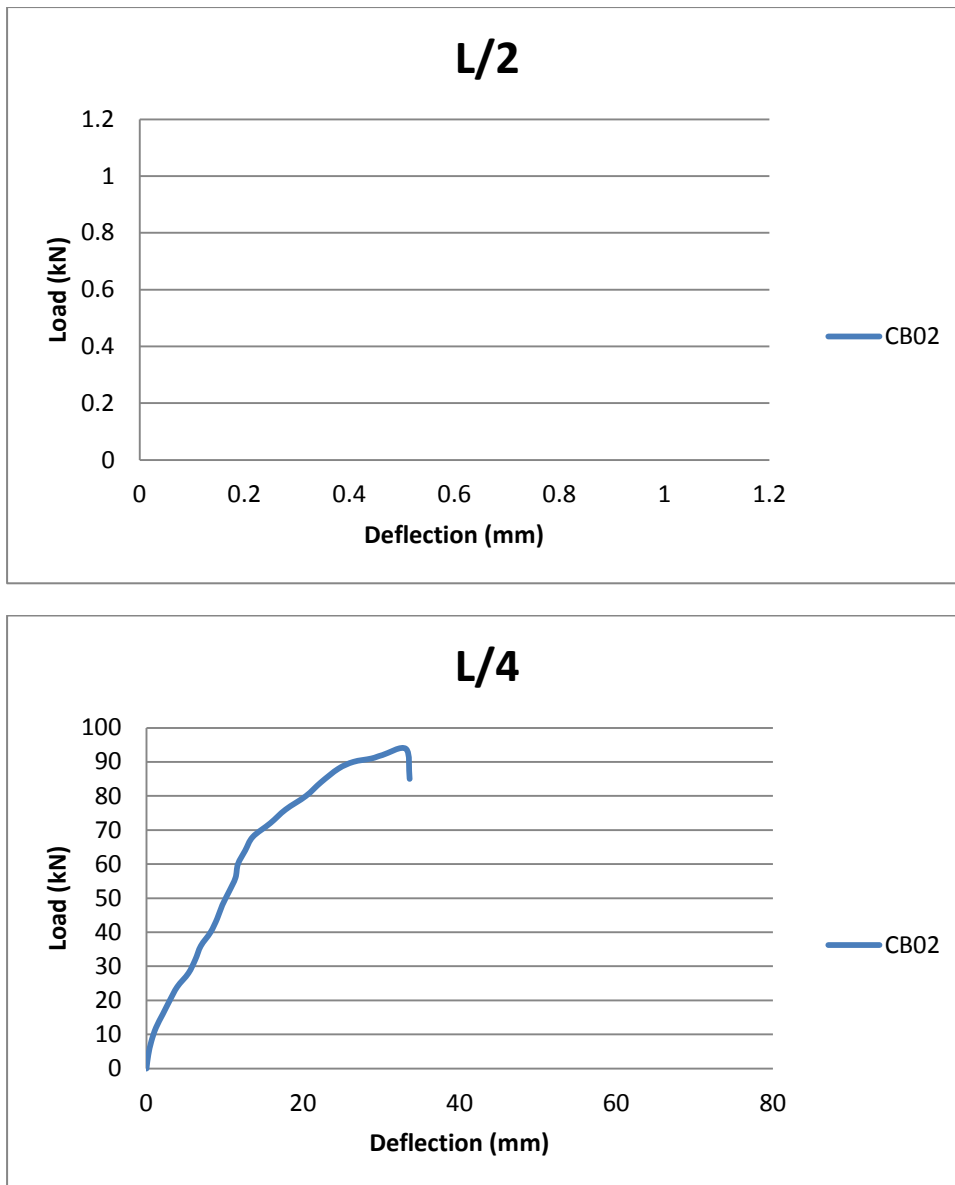
Fig 4.3: Load-deflection curves of CB02 a) at centre and b) at quarter of the span.

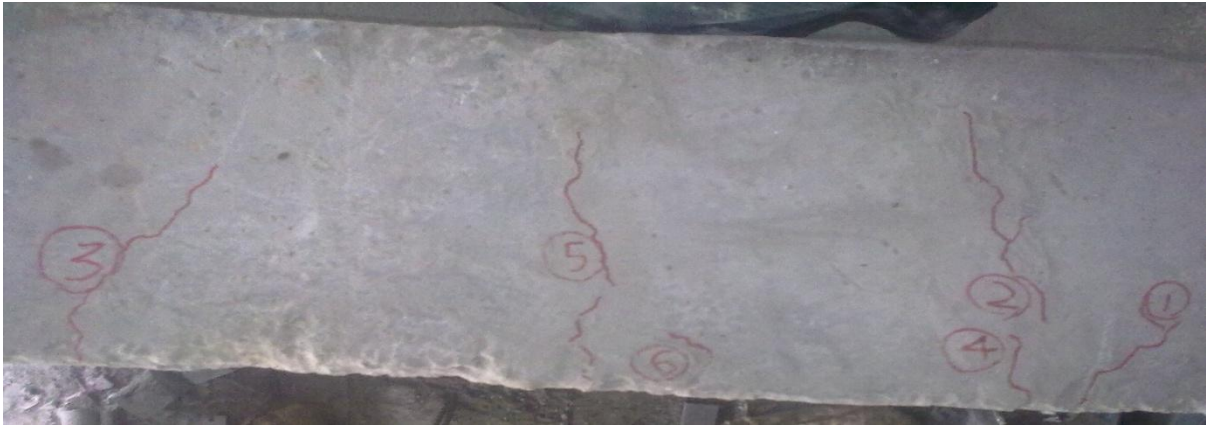
Fig 4.4: Crack pattern observed after CB02 is failed

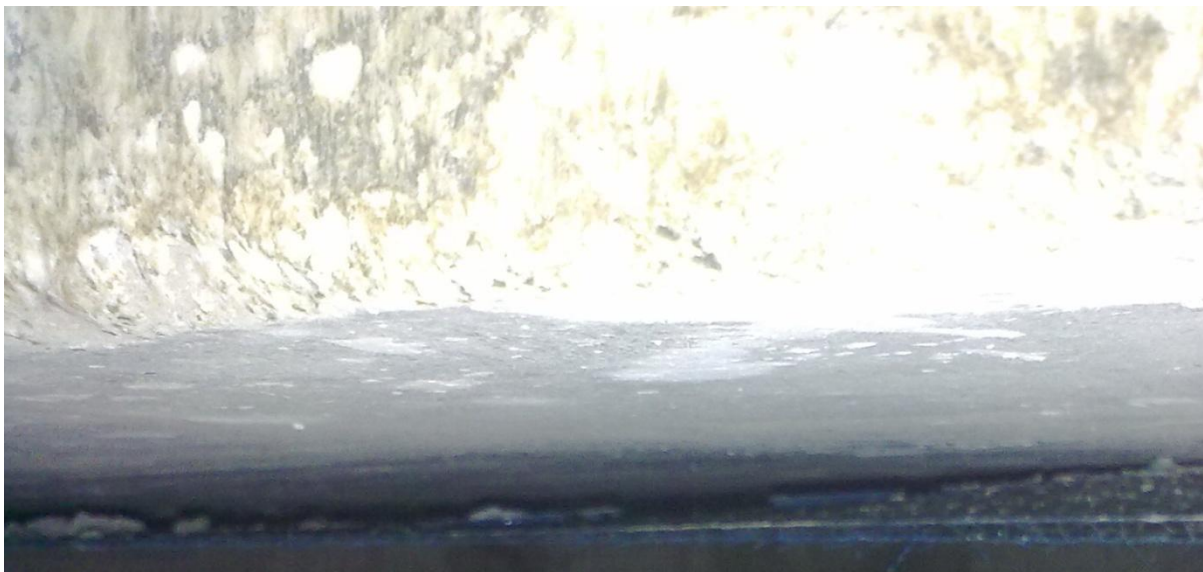
Fig 4.10: Failure of DB12 by debonding of sheets

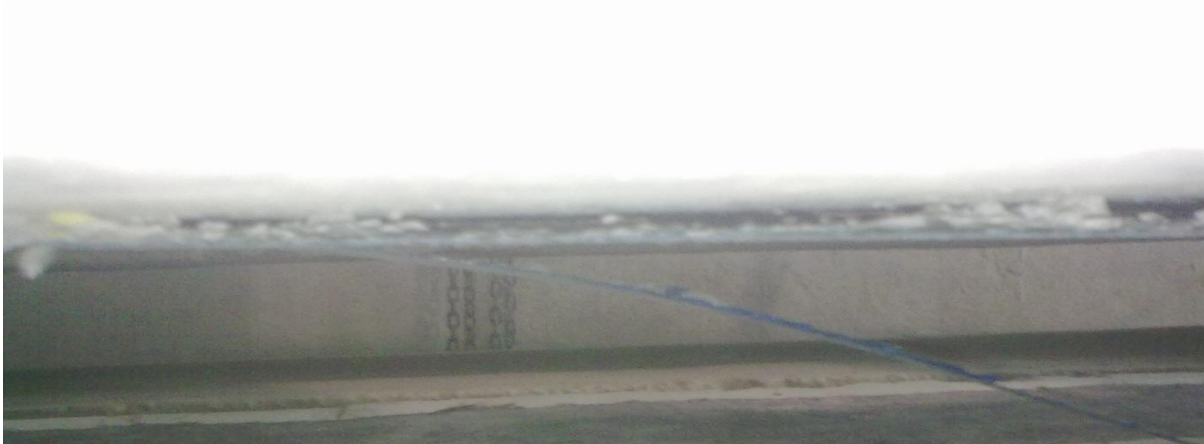
Fig 4.13: Failure of DB12 by debonding of sheets

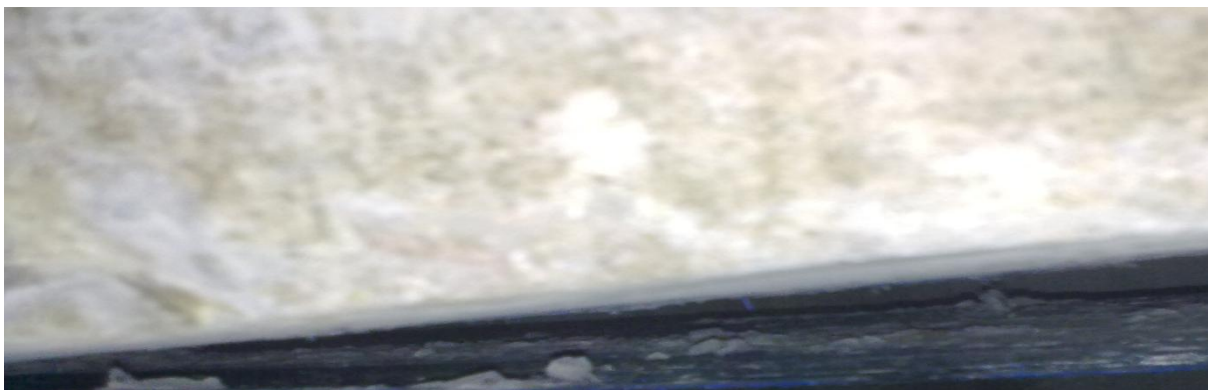
Fig 4.16: Failure of DB12 by debonding of sheets

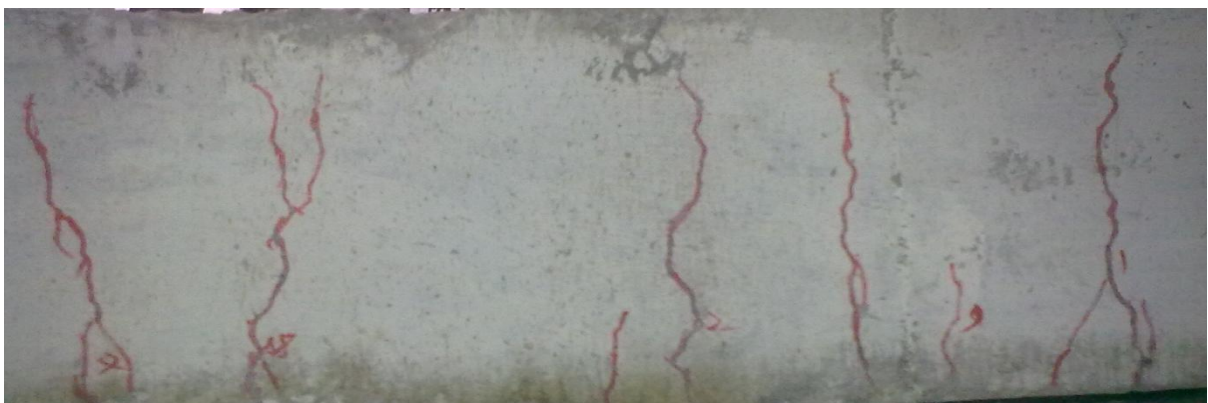
Fig 4.17: Cracking pattern of DB12

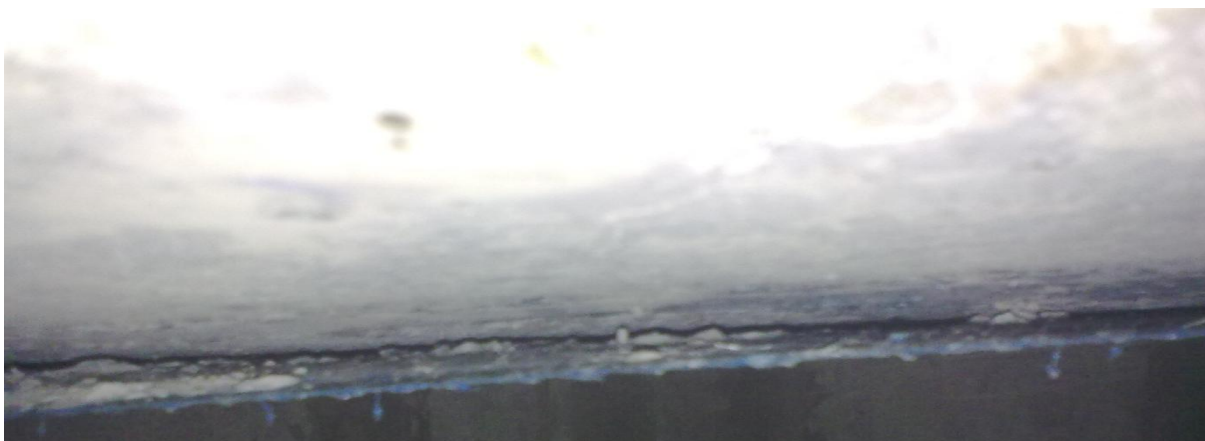
Fig 4.20: Failure of DB31 by debonding of sheets

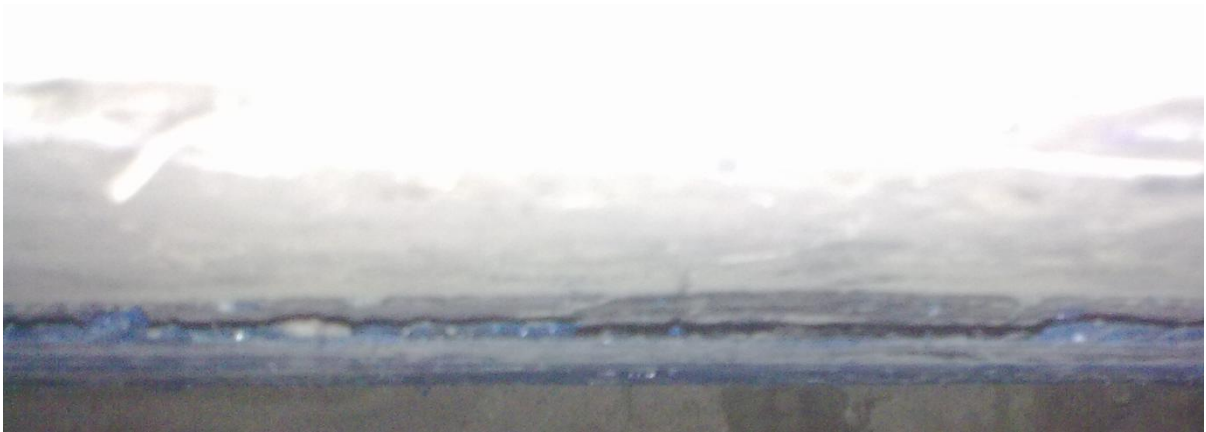
Fig 4.23: Failure of DB32 by debonding of sheets
