# Performance of externally bonded GFRP sheets on concrete in tropical environments. Part I: Structural scale tests

A. Mukherjee<sup>a,\*</sup>, S.J. Arwika<sup>b,1</sup>

## Abstract

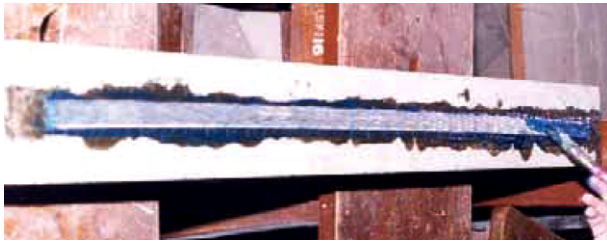
Fig. 1. 20 mm wide E-glass sheet bonded to plain concrete beam.

The specimen consists of 100 mm wide, 100 mm deep and 1000 mm long plain concrete beams without any internal reinforcements. All the beams after casting were cured at normal temperature in a water bath for 28 days. The effective span of the beam was 940 mm. The beams were reinforced with a 20 mm wide strip of E-glass fibre sheet (Fig. 1). The strip length was adjusted to keep a gap of 25 mm between the support and the end of the strip.

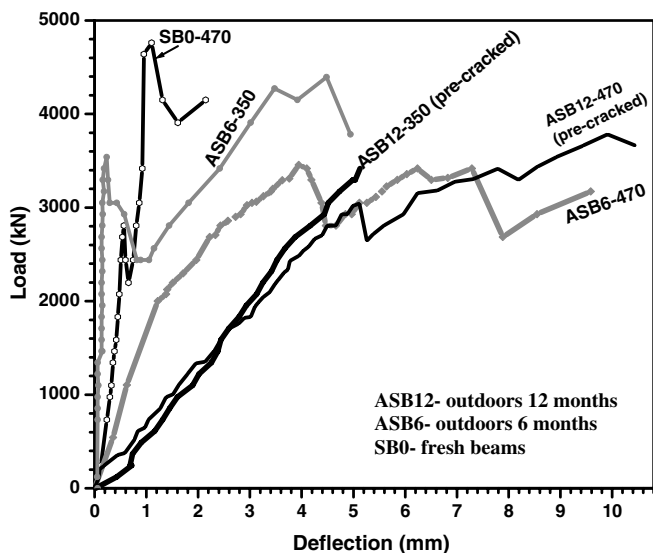
Fig. 6. Load–deflection characteristics of beams conditioned outdoors.

The beams ASB6-470 and ASB6-350, which were conditioned outdoors for six months, deflected by large amount 9.8 mm and 5 mm in comparison to 2 mm of fresh beams SB0-470 and SB0-350 (Fig. 6). The peak loads were less i.e. 37% for a moment arm of 470 mm and 20% for a

moment arm of 350 mm. The reason for this reduction could be due to the development of fine thermal cracks in the plain concrete beams due to outdoor conditioning. In Fig. 6, it is seen that initial load–deflection behaviour of the beam is linear. The load in the beam drops significantly at the onset of the tension crack in the concrete. This shows that the GFRP sheet bridges the crack in concrete. Due to cracking the stiffness of the beam declines significantly. Thereafter the crack width increases steadily and there is progressive slip at the GFRP-concrete interface due to delamination. Ultimately the beams failed due to rupture of the sheets. The debonding resulted in large deflection of the beams.

Load–deflection characteristics of pre-cracked specimens subjected to natural weathering for a year is plotted in Fig. 6. In this case, the beams were pre-cracked. The behaviour of the pre-cracked beams depends on the crack height induced and the debonding of the sheets at the time of pre-cracking. For ASB12-470, load–deflection relation was almost a straight line and the initial stiffness was much lower than the uncracked beams. The beam deflection was large due to large debond length and finally failed due to rupture of the sheets. The peak load was 41% less for a moment arm of 450 mm. For ASB12-350, the load–deflection relation was similar to beam ASB12-450 initially. The debond length was less than the earlier beam. The peak load was also 41% less for a moment arm of 350 mm. Comparison of the pre-cracked and the uncracked beams show that the difference is mainly in the initial stiffness. The ultimate load and the deflection of the beams are similar. The pre-crack did not have a pronounced effect on the environmental degradation of the specimens. The crack pattern is investigated next to understand the debonding and failure mechanism of the sheet bonded beams.

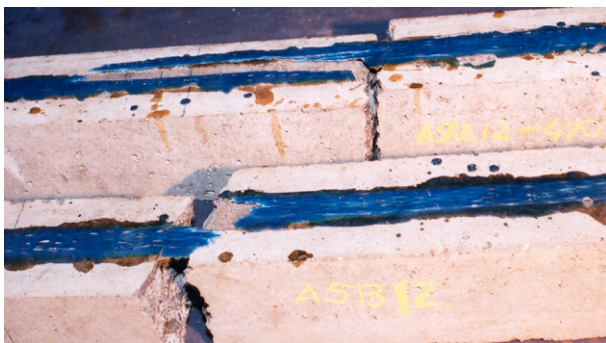
Fig. 10. Debonding and rupture of sheet for pre-cracked beams conditioned outdoors (ASB12-350 and ASB12-470).

In all the conditioned beams the sheets failed by rupture and no debonding was observed. The failed specimens are shown in Figs. 9 and 10. The failure of beams conditioned outdoors for 6 and 12 months took place due to partial

debonding leading to the rupture of sheet (Fig. 10). The rupture of sheet suggests loss of strength of sheet due to conditioning.

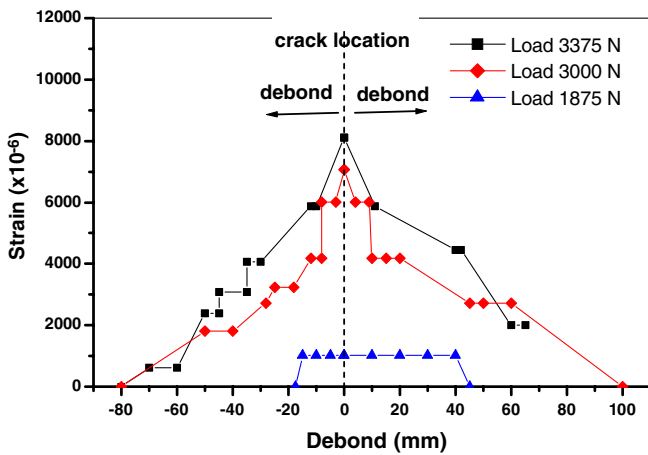
Fig. 12. Debonding characteristics of the E-glass sheet in beam, conditioned outdoors for six months.

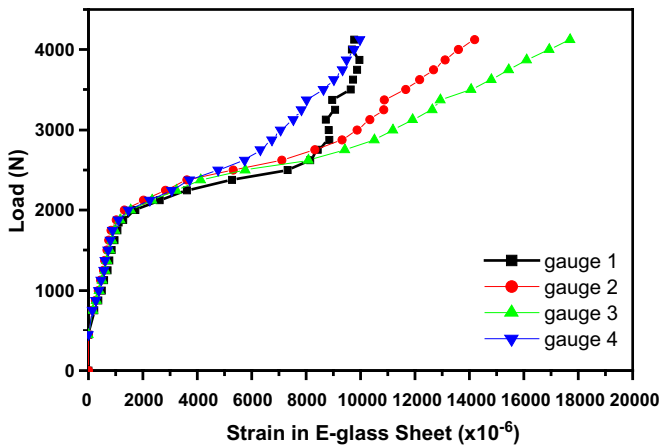
Fig. 13. Strain in E-glass sheet near the crack in the beam, conditioned outdoor for six months.

the edge of the beam leading to failure. The maximum strain in sheet at failure was about 1.77% (Fig. 13). The corresponding stress in fibre was 1275 MPa which is below the failure value of 1500 MPa. The beams fail due to debond before the stress in fibre can reach its failure value.

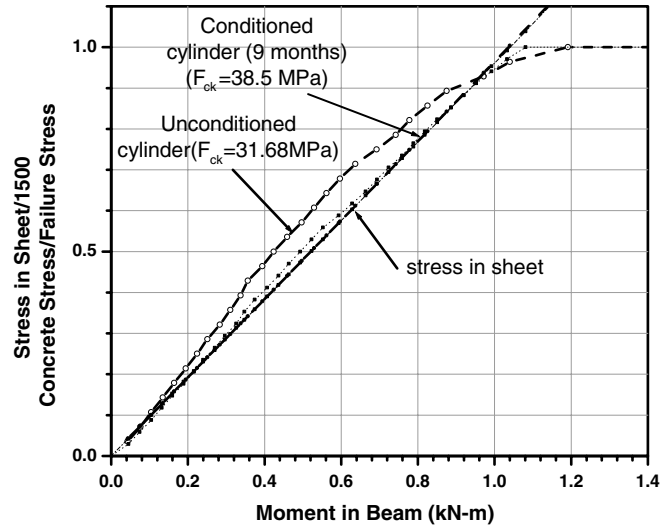
Fig. 15. Stresses in concrete and sheet corresponding to the moment in the beam.

The unconditioned beam SB0-470 failed at 1.06 kN m due to debond. Both the compressive stress in concrete and the stress in the sheet reached about 95% of its ultimate failure value (Fig. 15). The conditioned beam SB9-470 failed at 1.2 kN m. The stress in the sheet exceeds its design ultimate strength. The rupture of the sheet is justified here. However, SB3-470 and SB6-470 failed in rupture of sheet when the stress in sheet was only 95% of its design ultimate strength. The sheets did not debond and they ruptured instead. At this point it was decided to investigate the sheets by removing them from the conditioned beams.

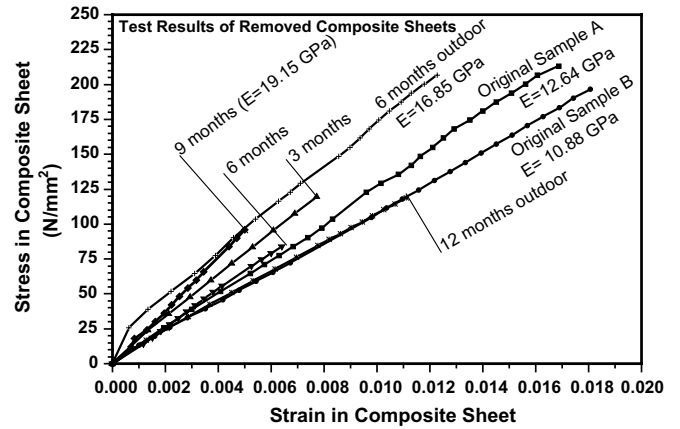
Fig. 17. Stress–strain diagram of conditioned composite sheets.

composite sheet works out to be 15.6 GPa based on fibre volume fraction. From stress–strain diagram of tested sheets (Fig. 17) it can be seen that the modulus of elasticity of the sheets varied from 10.88 to 19.15 GPa. Here, the stresses are calculated on the basis of net composite sectional area. These variations can be attributed to the variations in the epoxy thickness, error in cutting exact 20 mm wide woven sheet, changes in properties of the constituent materials due to conditioning and mode of failure of sheet composite.

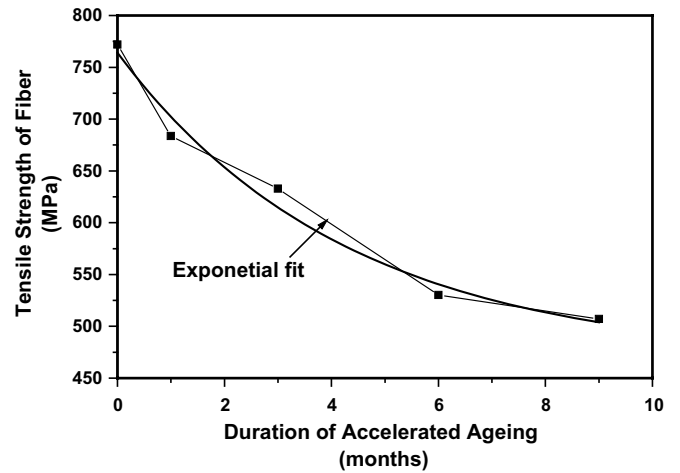
Fig. 18. Decrease in strength of GFRP sheet fibre due to accelerated ageing.
