**BEHAVIOUR OF THREE DIMENSIONAL EXPANDED
POLYSTYRENE (EPS) SANDWICHED CONCRETE PANELS
UNDER AGGRESSIVE ENVIRONMENT**

A thesis

DOCTOR OF PHILOSOPHY

CIVIL ENGINEERING

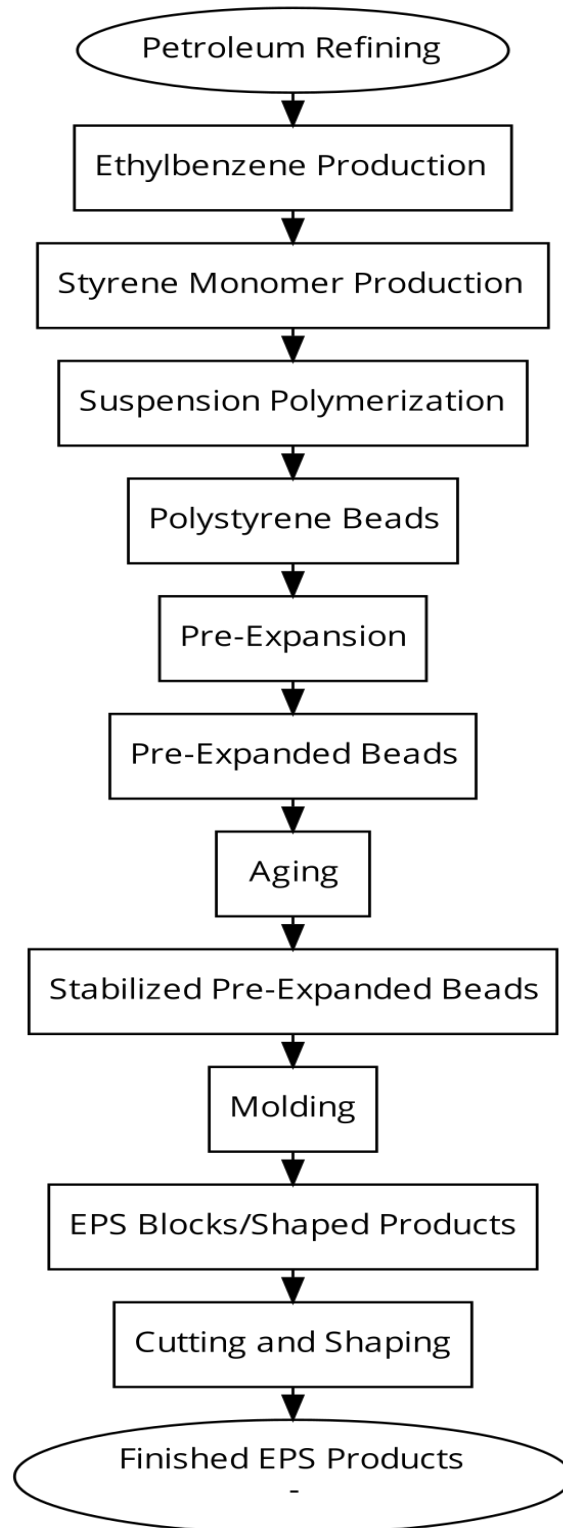
Figure 1.2 Flow chart outline - Stages in the production of EPS

- ii. *Expansion:* The formed polystyrene beads exposed to steam heat or warm air causes the vaporization of the entrapped pentane gas. The steam heat softens the boundary walls of the polystyrene beads, and the vaporised pentane gas exerts the pressure on the boundary walls resulting in the 20 to 50 times expansion of the polystyrene beads making pre-expanded beads.

- iii. *Aging:* This process allows the pre-expanded beads to rest or age for a period after expansion and before moulding into a final product. This aging period is crucial for optimizing the properties and performance of the beads in the final product. The beads stabilize and condition to reach equilibrium.

- iv. *Moulding*: The stabilized pre-expanded beads placed in moulds and subjected to steam, causing them to expand further. The further expansion of the pre-expanded beads in a confined mould results in fused packing of the EPS beads filling up the voids between cells. Thereafter, vacuum is created inside the mould resulting in cooling of the mould and removal of the moisture from the mould. The vacuum also eliminates the pentane gas from the polystyrene leaving no residual gasses inside the EPS foam. The outcome obtained in the form of EPS blocks or shaped products.

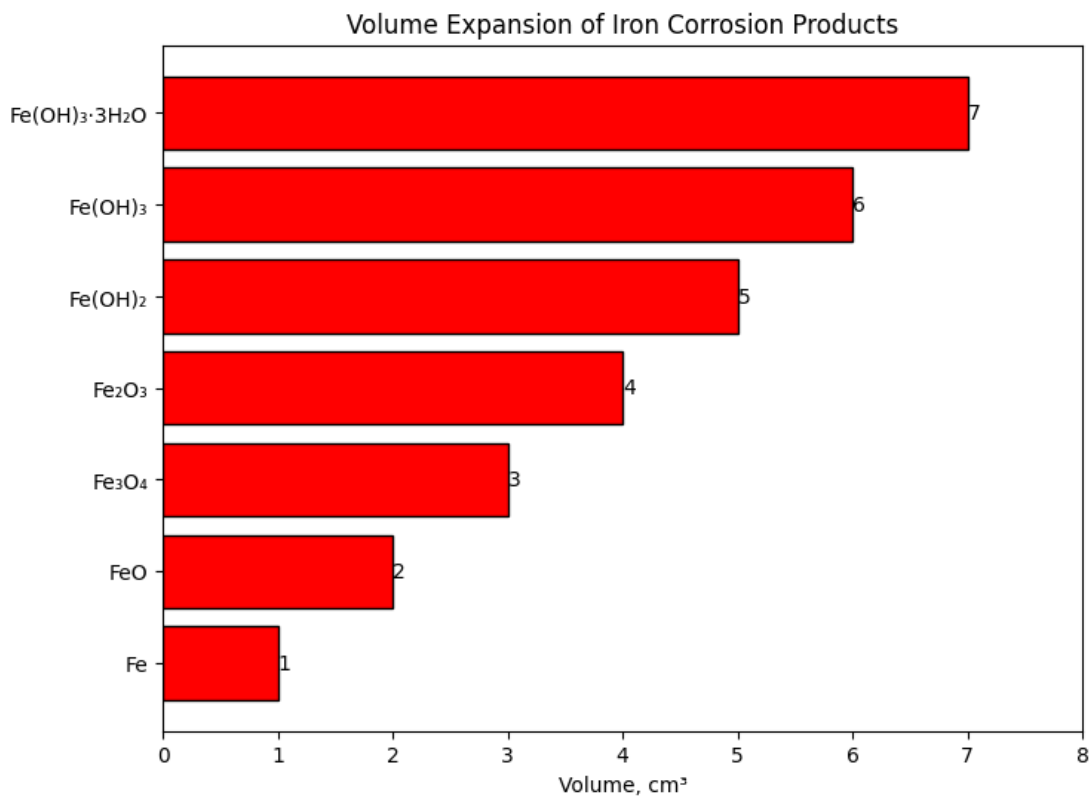
Figure 1.6 Volume expansion of the corrosion rust produced

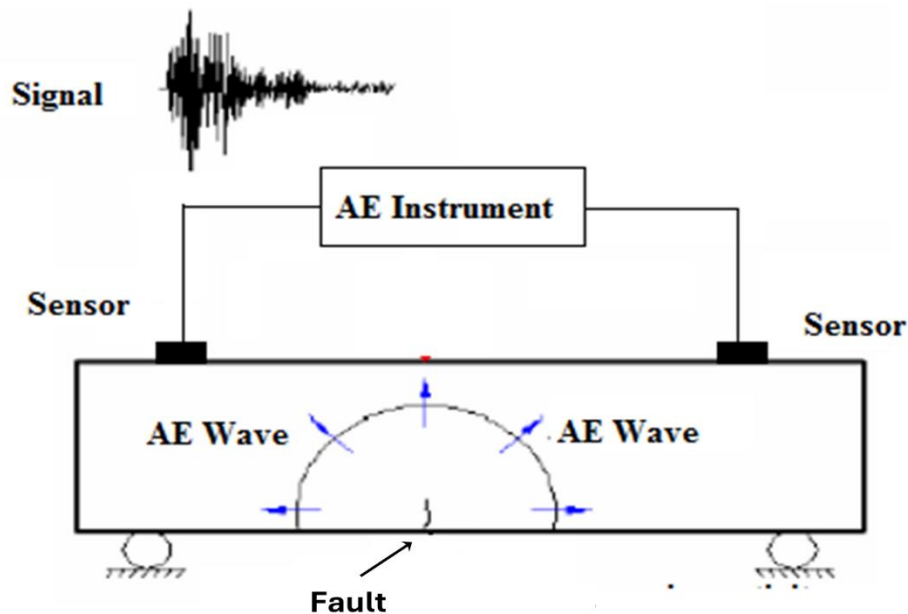
Figure 1.9 Schematic illustration of AE Monitoring Process (Ohtsu and Ono 1986)

damage or deformation (Figure 1.9). Detected acoustic signals are amplified, filtered, and analyzed to distinguish between background noise and relevant AE events. By analyzing the waveform parameters, such as wave rise time, duration, and energy release, it is possible to identify the type and location of structural defects or damage. Figure 1.9 shows a schematic diagram in which crack occurrence due to tension forces of corrosion is created due to which the transient waves are generated and travels in all directions. The surfaces mounted with the AE sensors receive them and transfer the electrical converted signal to the AE instrument set-up.

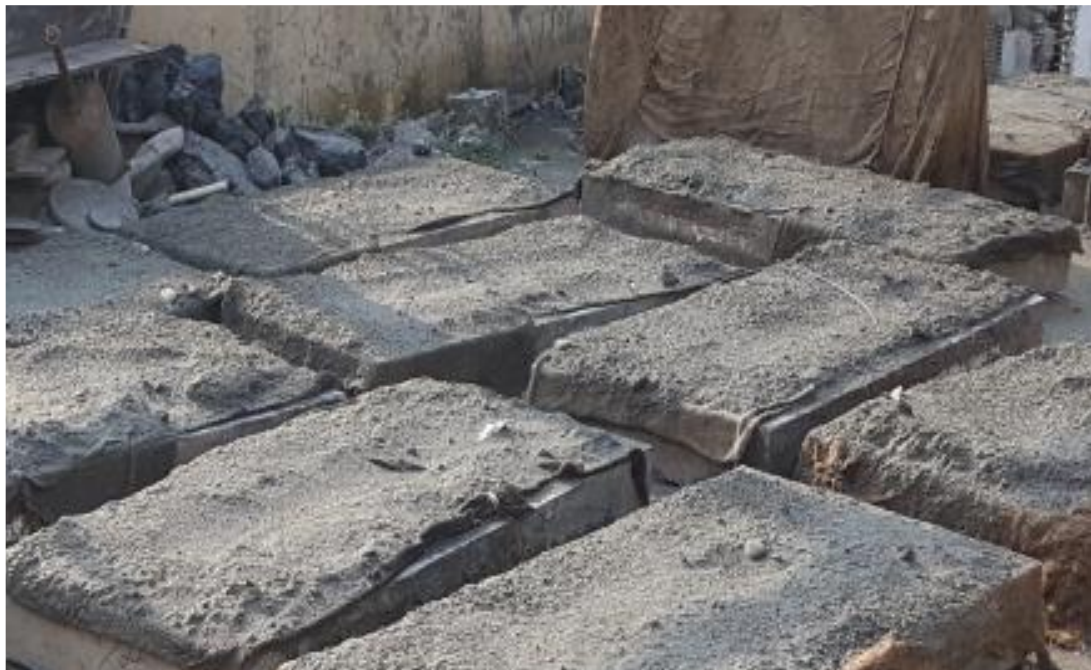
Figure 3.4 Curing of EPS sandwiched concrete panels

The casting process is illustrated in Figure 3.3. The panel skeleton (EPS, mesh grid, and shear connectors) was cut to size and placed in the mold. The panels casted for corrosion were provided with electric wires connecting the wire mesh before plastering (Figure 3.3a). The mortar mix was then applied to the upper side of the EPS panel. A mold cap was used to flip the panel and plaster the lower wythe. After plastering the wythes, the end beams were cast with the concrete mix. After 24 hours, the panels were removed from the molds, laid horizontally on the ground, and covered with jute bags for curing (Figure 3.4). To ensure proper curing, water was sprinkled periodically (every 2 hours during the day and every 6 hours at night) to maintain moisture. The panels were cured for a total of 28 days.

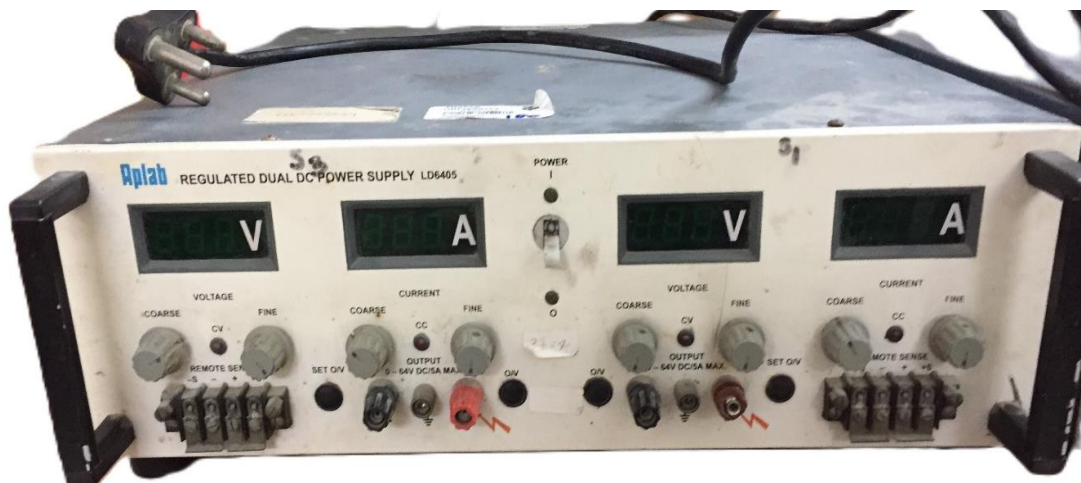
Figure 3.5 APLAB regulated DC power supply

EPS structures are susceptible to degradation in regions with high annual rainfall or extensive coastlines and humid climates. An accelerated corrosion technique was employed to simulate different deterioration stages in the EPS panels rapidly (Bahekar and Gadve 2017, Ahmad et al. 2022). A constant voltage DC power supply (details provided in Figure 3.5) was used for this process. The EPS panels were subjected to a constant voltage of 10 V for varying durations to induce accelerated chloride corrosion in the central 600 mm length. A stainless-steel mesh served as the cathode, and the wire mesh reinforcement acted as the anode. The central portion was continuously dripped with a 3.5% NaCl solution to maintain conductivity (Figure 3.6). The corrosion current was recorded daily at 6-hour intervals.

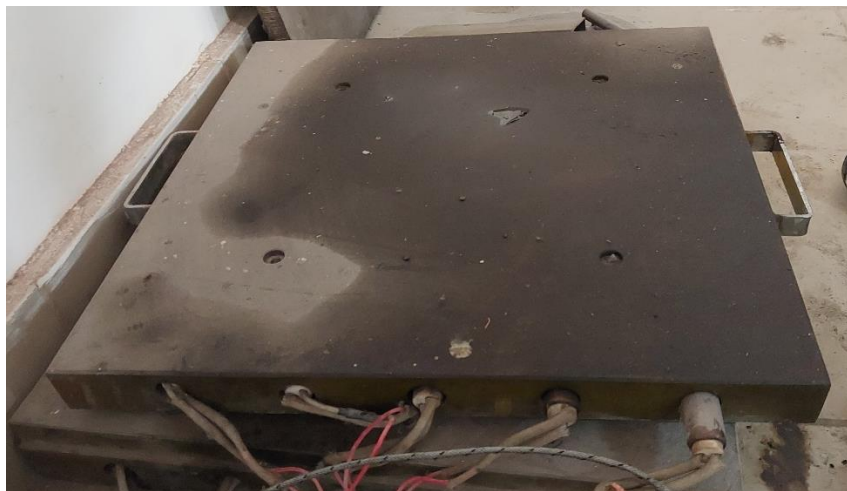
Figure 3.8 Square 400 mm heating plate used for the elevated temperature set-up

After casting and curing for 28 days, the EPS panels were exposed to elevated temperatures using two hot plates, each sized 400 mm × 400 mm and encapsulating five cartridge heaters (Figure 3.8). The test setup was configured in a mold with dimensions of 190 mm in depth, 700 mm in width, and 1400 mm in length. The panels were placed horizontally within the mold, with hot plates positioned beneath the bottom wythe (Figure 3.9). The hot plates were aligned with the centroid of the EPS panel. To prevent heat loss, the cavity area around the EPS panel was filled with glass wool. Thermocouples were attached to the hot plates, and the heating rate was set at 10°C/min. The EPS panel was subjected to heat of varying intensities from the bottom wythe at a constant rate for 3 hours after reaching the target temperature (Figure 3.10). The opposite side of the panel (top wythe) was exposed to the environment, which was at room temperature (~26°C). Details of the exposure for different panels are provided in Table 3.6.

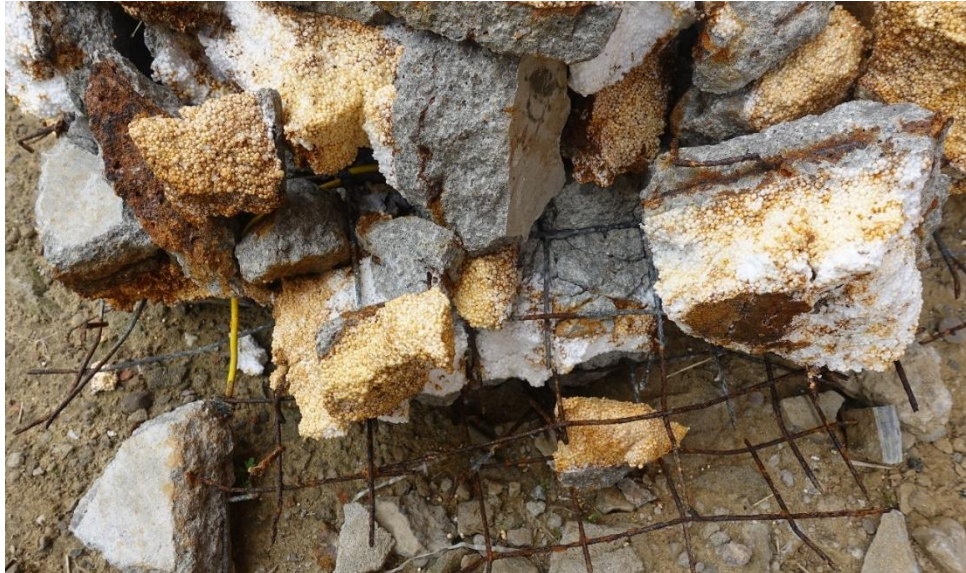
Figure 4.3 Extricated EPS and wire mesh after panel testing

To assess the extent of corrosion, the concrete cover of the wire mesh was chipped away, revealing that corrosion initiated around the joints of the wire mesh and spread in all directions. The corrosion found to be concealed around the EPS beads of the insulation. This explains why initial corrosion is not visible on the surface of the EPS panels, as the corrosion remain hidden around the EPS beads (Figure 4.2 & Figure 4.3).

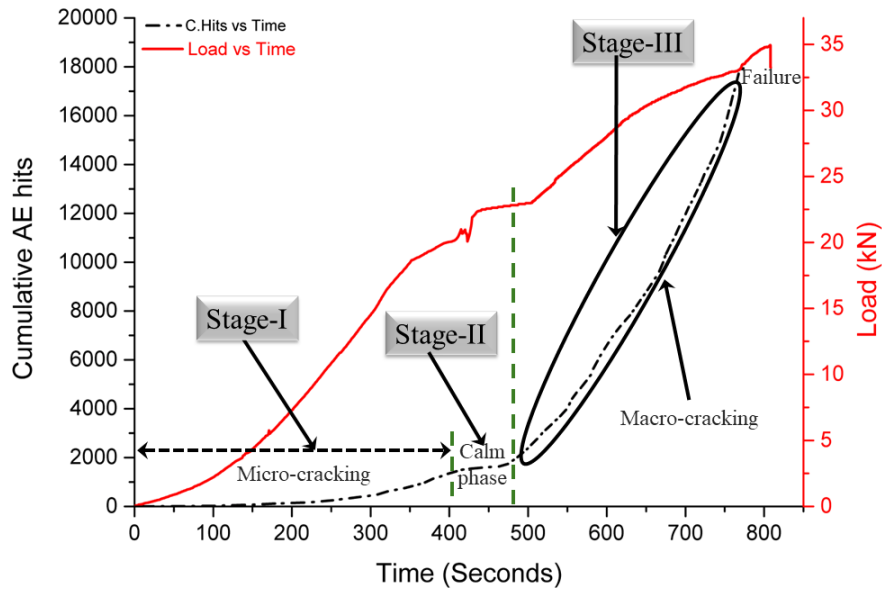
Figure 4.9 Variation in AE Hits Vs Time in control panel (EPS-00)

An AE hit is an acoustic signal surpassing a predetermined threshold limit. The cumulative AE hits signify the aggregation of damage caused by advancing cracks and escalating flexural loading in EPS panels. The hits observed in the samples immediately indicate the existence of cracks as loads are applied and damage occurs. The cumulative AE hits and load vs. time graph for the control panel EPS-00 is presented in Figure 4.9. Efforts are made to relate the cumulative AE hits with the three zones defined in load-deflection curves. The plot shows that the EPS panels show micro-cracking during the initial loading stage, and the number of hits keeps increasing with the load. The gradual increase of slope demonstrates the occurrence of micro-cracking in the early stage, termed Stage-I (Figure 4.9). Stage-I of the cumulative AE hits corresponds to the yielding load of the load-deflection curve, showing that micro-cracking occurs until the yielding of the EPS panels, visible through the gradual increase of cumulative AE hits. Just after Stage I, there is a calm phase termed Stage II, characterized by the absence of any notable increase in AE impacts (Figure 4.9). After Stage II, the number of AE hits consistently and quickly increases with the load until the material fails completely at 34.95 kN, indicating the occurrence of macro-cracking, termed Stage-III (Figure 4.9). The degradation advances as visible fissures develop in the panel.

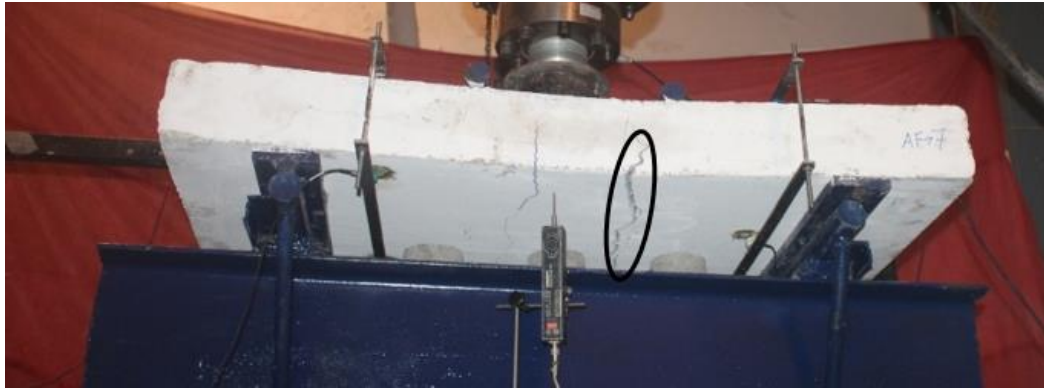
(a) EPS-A7

Figure 5.5 Failures in acid exposed EPS panels

The visual inspection of EPS panels post-failure in flexural testing is shown in Figure 5.5. For sulphate-exposed panels, the failure pattern was similar to the control specimen, with breaks occurring between the loading points. Acid-exposed panels showed varied failure patterns based on exposure duration. EPS-A7 and EPS-A14 behaved similarly to the control panel. However, EPS-A21 exhibited horizontal cracking along the interface of insulation and concrete wythe, and the highly acid-exposed EPS-A28 showed both horizontal and shear cracking near the supports, as well as middle cracks between the loading points.

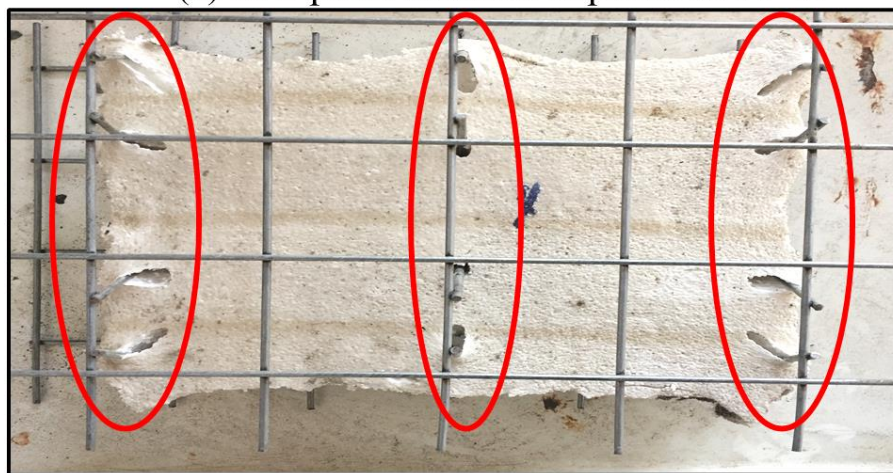
(b) EPS panel skeleton exposed to 100⁰ C

Figure 6.1 Exposure of EPS skeleton to elevated temperature

Prior to subjecting the cast EPS panels to combined thermal and mechanical loading, a preliminary investigation was conducted to understand the standalone behavior of the EPS skeleton under elevated temperatures. This involved visually inspecting the EPS skeleton (without the concrete wythes) within a hot-air oven. The EPS skeleton was initially exposed to a temperature of 50°C for 15 minutes. This initial exposure did not produce any noticeable changes to the EPS or the shear connectors, as illustrated in Figure 6.1a. Subsequently, the temperature was increased to 100°C using the same procedure. This significant temperature rise resulted in substantial shrinkage of the EPS, as evident in Figure 6.1b. The individual EPS beads were observed to shrink and stretch around the shear connectors. Manufacturer specifications for the EPS material indicated a glass transition temperature of approximately 120°C. Based on this information, the EPS skeleton was further exposed to this specific temperature for 15 minutes. This exposure caused a more pronounced shrinkage effect, causing the EPS to consolidate towards the center of the sample (Figure 6.1c). This visual observation suggests a transition in the material's physical state, potentially accompanied by the bursting of EPS beads and the thermoplastic stretching of the polystyrene material. Notably, the EPS volume decreased with increasing temperature, leading to a corresponding increase in density. Additionally, a color change from light to dark was observed, further indicating a transformation within the material. It is important to note that further exposure to even higher temperatures was not conducted within the scope of this study.

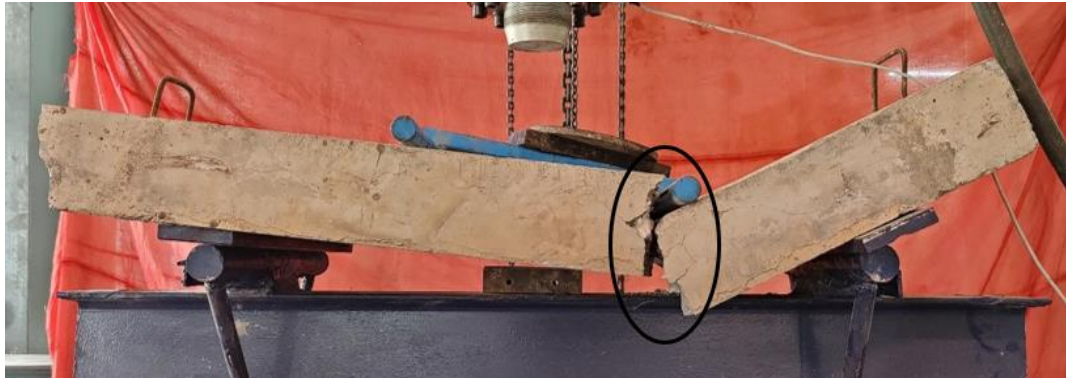
(a) EPS-H50

Figure 6.2 Visuals of flexural tested EPS panels exposed to elevated temperatures

The EPS panels were tested under flexure after exposure to designed temperatures. The visuals of failures are shown in Figure 6.2. It is observed that the EPS panels exposed to temperatures up to 100⁰ C show similar failure as of control panel. These panels developed cracks in the lower wythe of the EPS panel. A crack developed between the points of loading, and it was observed that the increased loading caused minor cracks near the edges of the lower wythe (Figure 6.2a & b). These panels ultimately failed with the expansion of middle crack in the lower wythe. The top wythe didn't show any signs of crack till failure.

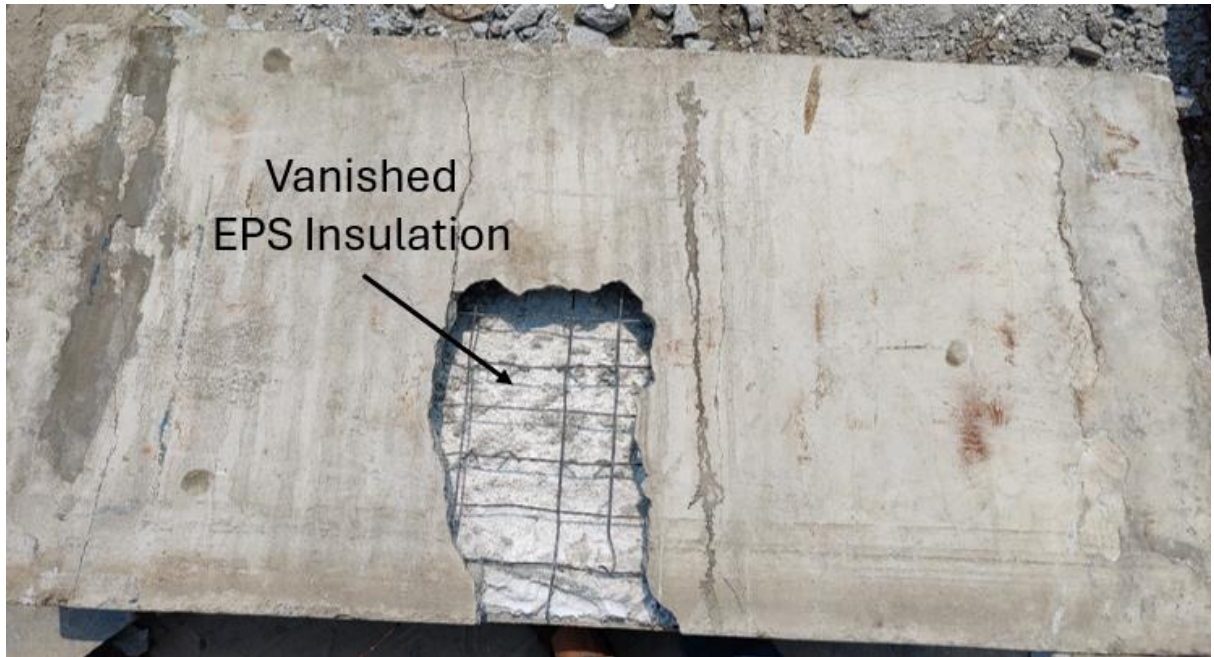
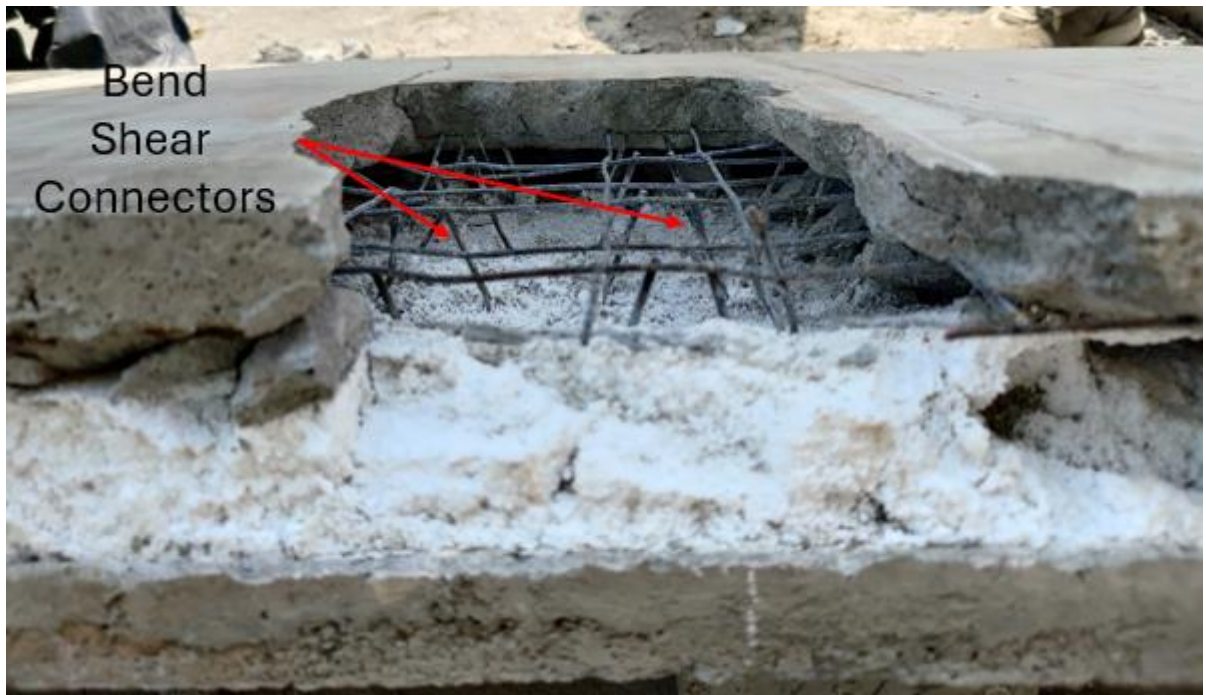
Figure 6.3 Internal views of EPS-H150

The behavior of EPS-H150 and EPS-H200 was observed to be different during four-point flexural loading tests. The EPS-H150 panel was broken to examine the internal structure (Figure 6.3). It was found that the EPS insulation inside the panel was completely vandalized. The EPS beads were burst and the shrunken material adhered to the outer concrete surfaces. The shear connectors were bent in many locations inside the EPS panels. The horizontal cracks observed in EPS-H150 and EPS-H200 may result from the absence of sandwiched insulation in the panel, leading to less load sharing between the wythes.

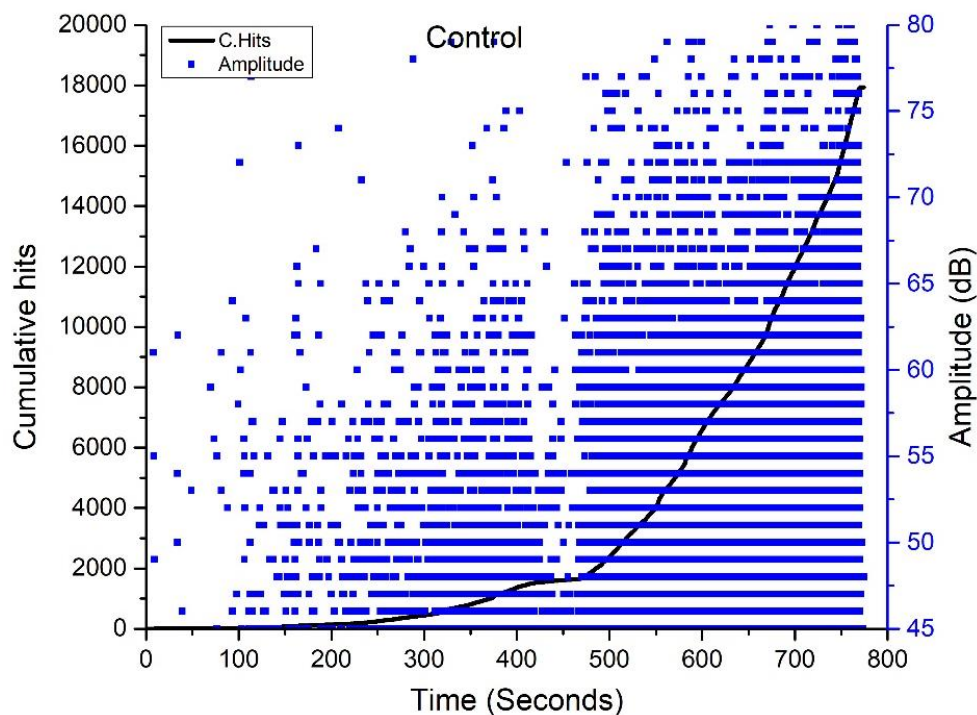
Figure 6.6 Cumulative hits-amplitude vs time plots of control panel
