# **Behaviour of Beam-Column Joints Retrofitted with High Strength Fiber Reinforced Concrete at Varying Levels of Corrosion Damage**

*Thesis*

**Department of Civil Engineering  
Thapar Institute of Engineering and Technology  
Patiala-147004 (Punjab), India  
February 2024**

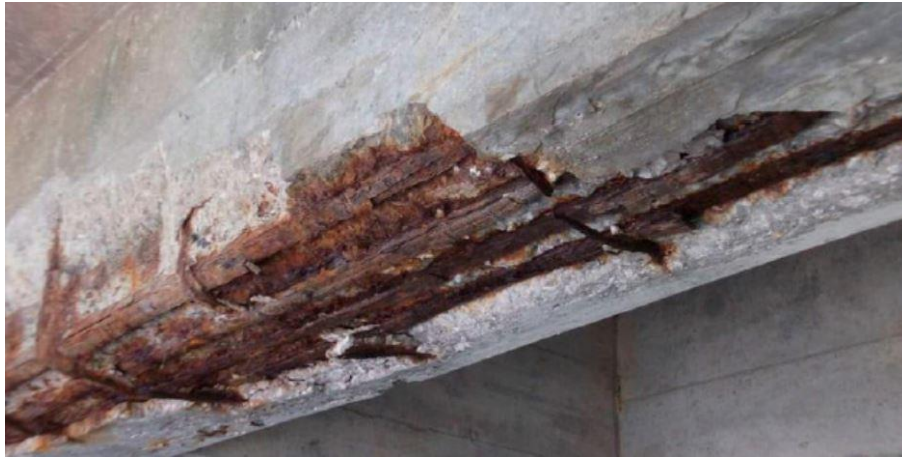
Figure 1. 1 Severely corroded reinforcement bars degrading the performance of RC structure (Duvnjak et al. 2021)

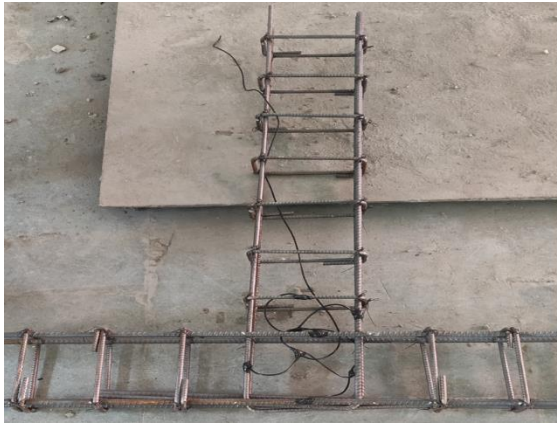
(a) Reinforcement cage

Figure 3. 4 Construction details of beam-column joint specimens

The BCJ specimens were cast in mild steel moulds of the designated dimensions. The reinforcement cages prepared for the non-seismically detailed and seismically detailed specimens are shown in Figure 3.4 (a). The parallel connections of the copper wires were installed on the reinforcement cages for the accelerated corrosion process (see Figure 3.4 (b)). Before casting, oiling of the mould is done to facilitate easy de-moulding. The cover blocks of 25 mm were provided between the shuttering and the reinforcement cage to provide the nominal cover all around the BCJ specimen (see Figure 3.4 (b)). The pouring of concrete into the mould was done in two layers; each layer was vibrated uniformly using a 60 mm diameter needle vibrator for voids removal from the fresh concrete (see Figure 3.4 (c)). Post-casting, wet gunny bags were used to cover the specimens to provide curing for 28 days, as shown in Figure 3.4 (d).

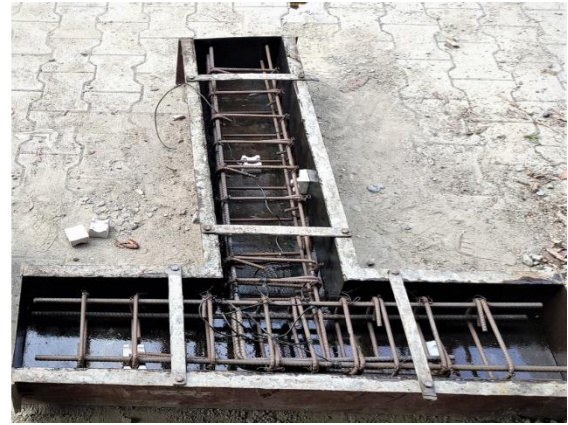
(b) Reinforcement cage inside the mould

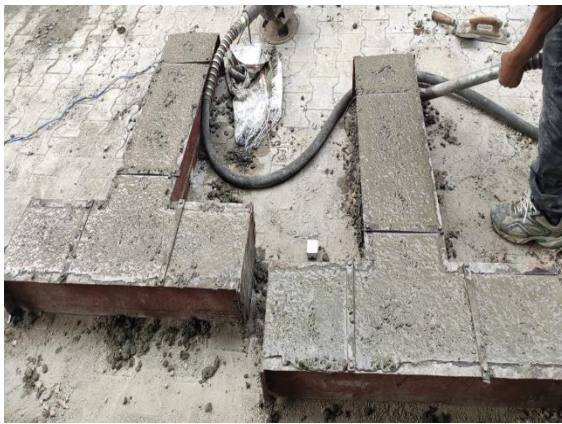
(c) Needle vibrator used for uniform vibration

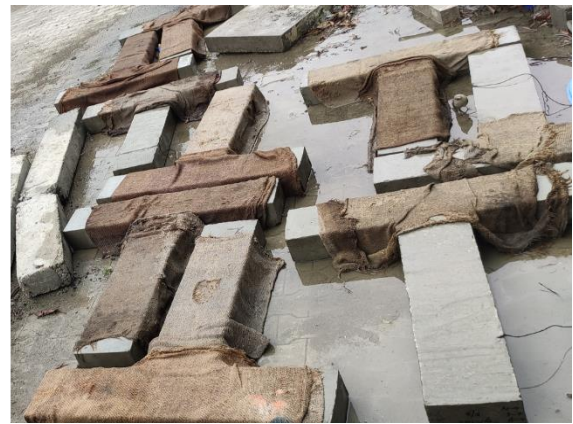
(d) Curing of the specimens

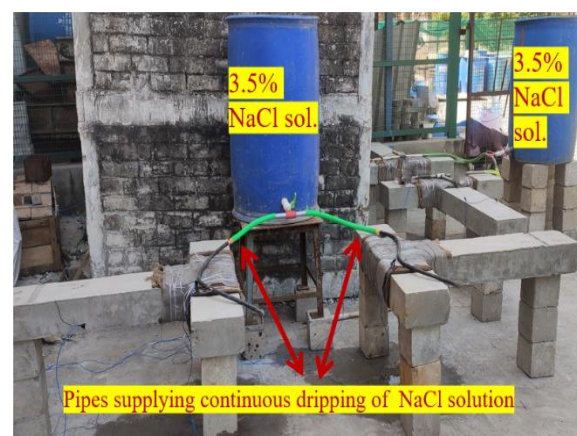
(d) Setup for accelerated corrosion

Figure 3. 5 Accelerated corrosion test set-up

The specimen was wrapped with gunny bags all around the target corrosion area. Above the gunny bag wrapping, a stainless-steel wire mesh covering is provided. The stainless-steel mesh is connected via an alligator clip to the DC power supply (at the negative terminal) acting as a cathode. The reinforcement bars (with the help of a parallel wire connection provided on the reinforcement cage, as shown in Figure 3.5 (a)), are connected to the DC power supply (at the positive terminal) acting as an anode, as shown in Figure 3.5 (c). A continuous dripping of 3.5% NaCl solution is maintained over the mesh-covered region of the BCJ specimens (Figure 3.5 (d)).

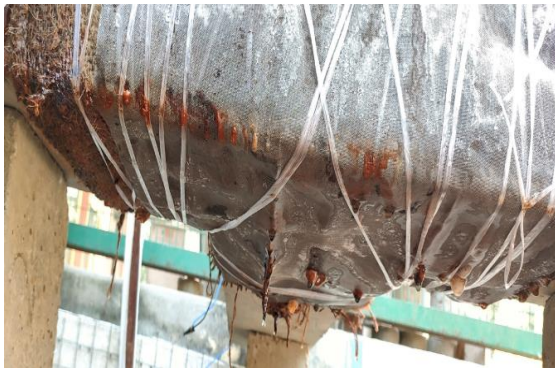
(a) Initial stage of corrosion

Figure 3. 7 A visual description of specimens under different levels of corrosion

**Phase 1:** A linear increasing trend of the impressed current was experienced as the corrosion duration proceeded. After a few days of initiation of the corrosion process, some brown patches representing the rust products were visible on the gunny bags as well as on the steel mesh surface, as shown in Figure 3.7 (a). When the specimens were unwrapped for checking, fine hairline cracks were visible on the longitudinal surface of the column and beam (see Figure 3.7 (b)).

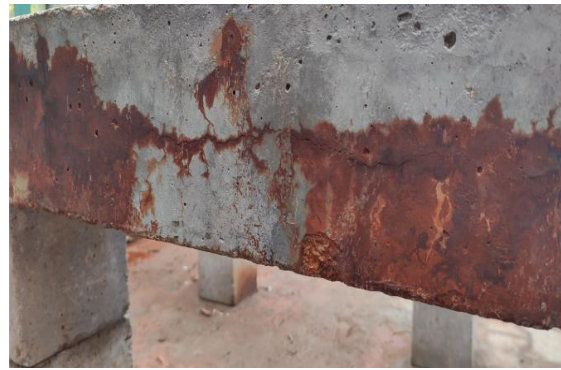
(b) Hairline cracks due to corrosion

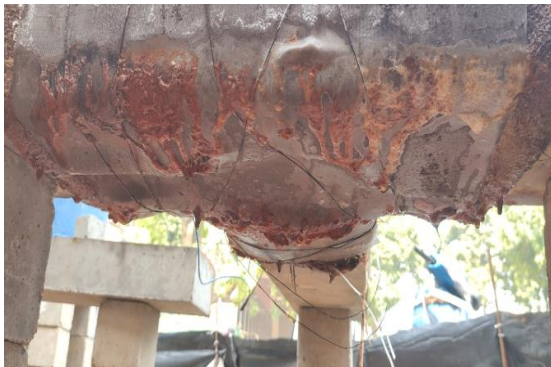
(c) More rust deposition

**Phase 2:** In this phase, a drop in the current intensity was experienced which lasted for some instance of time. More rust deposition was seen on the mesh surface along with several new red and brown patches (see Figure 3.7 (c)). The reddish-brown liquid oozes out from the specimen, as shown in Figure 3.7 (d).

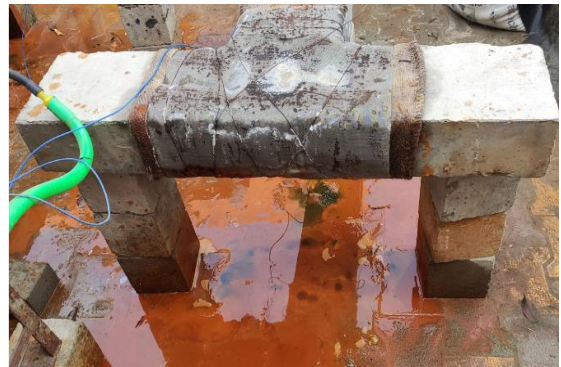
(d) Reddish-brown liquid oozing out

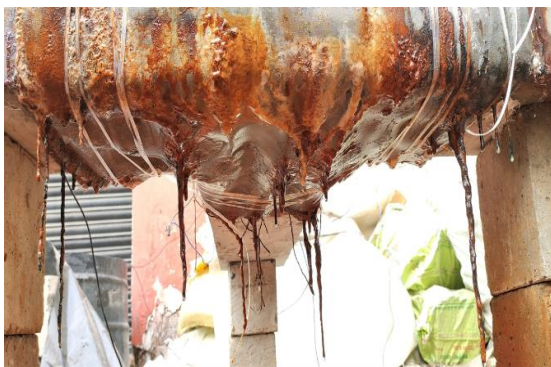
(e) Long suspended peaks of deposited rust

**Phase 3:** This phase shows a sudden upward trend in the current intensity after a particular duration. The rust deposits are denser at this phase and have taken the shape of long suspended peaks at the surface of the mesh, as can be seen in Figure 3.7 (e). A dark brown liquid carrying washed-off rust products was observed coming out of the specimens. When the specimen was unwrapped, it was experienced that some new hairline cracks had appeared and the existing cracks from 1st phase had widened (see Figure 3.7 (f)).

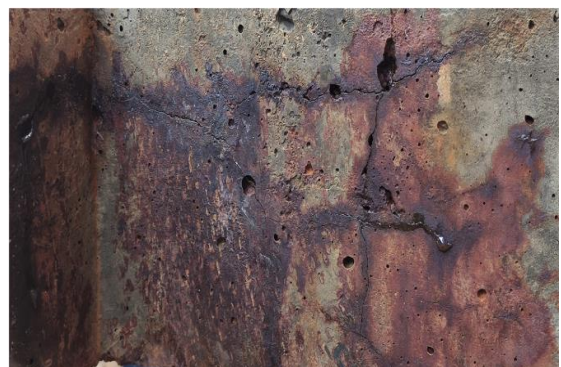
(f) Wide cracks at higher levels of corrosion

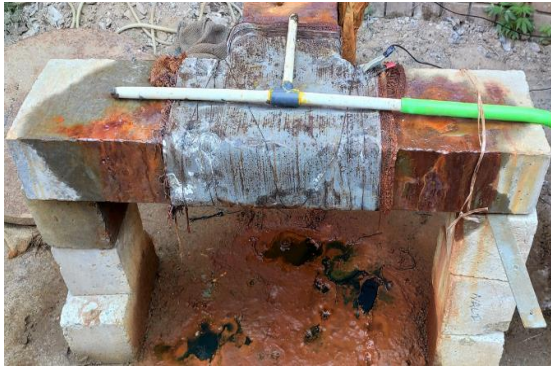
(g) Black liquid oozes out of cracks

**Phase 4:** A drop in current intensity was observed in this phase and after that, a constant rate was experienced throughout the entire corrosion duration. The black liquid oozes out of cracks along with some black rust particles, as shown in Figure 3.7 (g). During the unwrapping of the specimen, deposited rust on the surface of the mesh surface is shown in Figure 3.7 (h). The wider cracks along the longitudinal surface of beam and column were experienced, as shown in Figure 3.7 (i). A noticeable reduction in the concrete cover around the mesh and gunny bags-wrapped surface of BCJs was also experienced.

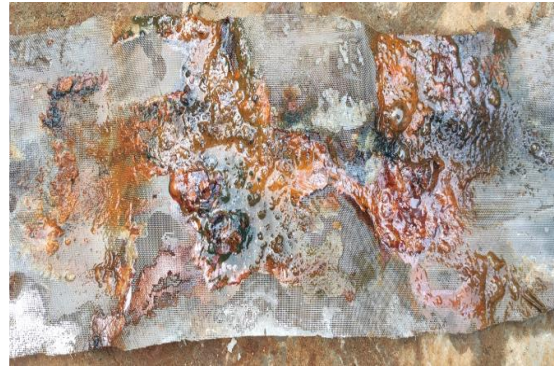
(h) Deposited rust on the mesh surface

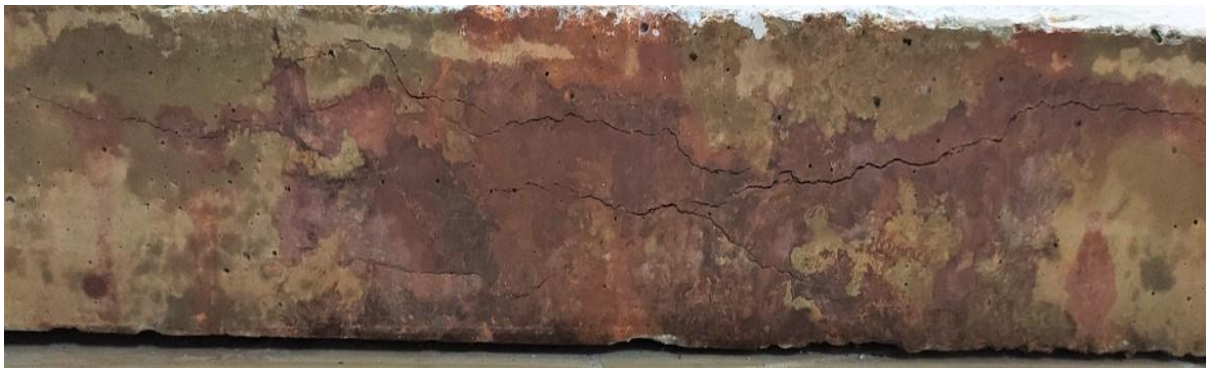
(i) Wider cracks along the longitudinal surface of the column

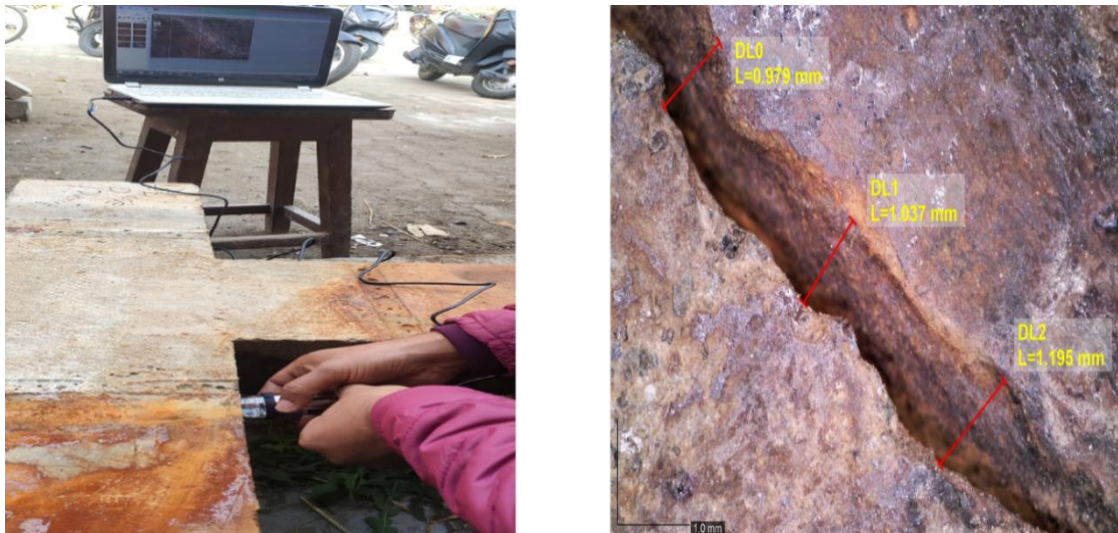
After every level of corrosion, the pilot specimens were unwrapped and checked for the cracks generated due to the induced corrosion. The width of these cracks on the beam and column surface was measured with the help of a Dino-Lite edge digital microscope (series AM7915). This instrument has a resolution of 5 M pixels (2592x1944) and a magnification range of 10x ~ 220x which allows for capturing a crystal-clear image of the crack. Thereafter, the captured images were processed in the associated software (DinoCapture 2.0 version 1.5.44) for the exact dimensioning of the crack width, as shown in Figure 3.8.

Figure 3. 8 Crack monitoring and measuring via Dino-Lite edge digital microscope

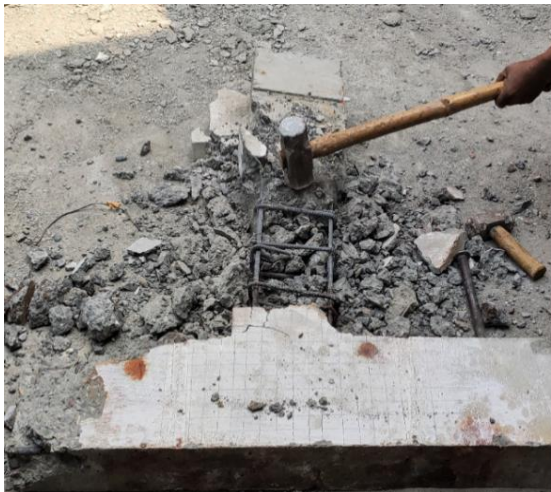
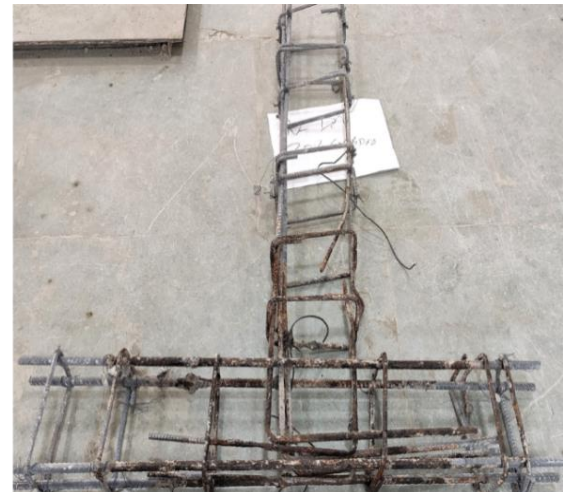
Figure 3. 9 Specimens were distorted after the cyclic loading test for calculating mass loss

corrosion-damaged reinforcement cage was extracted, as shown in Figure 3.9. The corroded bars of the desired length (550 mm, based on the visual inspection, also shown in Figure 3.9) were cut from the corroded reinforcement cage, as shown in Figure 3.10 (a). The rust deposits along with loose concrete were knocked by a wire brush and were further cleaned with the help of a 10% HCL solution, as shown in Figure 3.10 (b). Due to severe corrosion damage, the localized pitting on the stirrups and longitudinal reinforcement bars can be visible, resulting in the fracture of stirrups, cross-sectional area reduction, and de-scaling of longitudinal reinforcing bars, as shown in Figure 3.11. The weight of bars of decided length before corrosion and after the cleaning process of corroded reinforcement was noted, as shown in Figure 3.12. The actual mass loss is determined by using the following formula shown in Equation 3.2. After cutting and cleaning of corrosion-damaged reinforcing bars of 8mm, 10mm and 12mm diameters, tensile testing was done and the corresponding load-displacement graphs are shown in Figure 3.13.

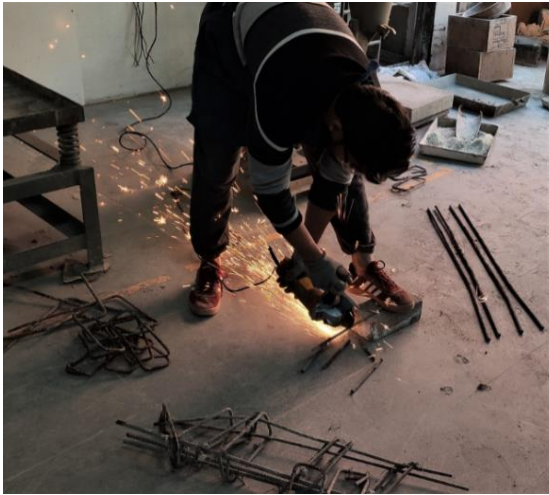
(a) Corroded bars of desired length were cut

Figure 3. 10 Cutting and cleaning of corrosion-damaged reinforcement bars for the mass loss

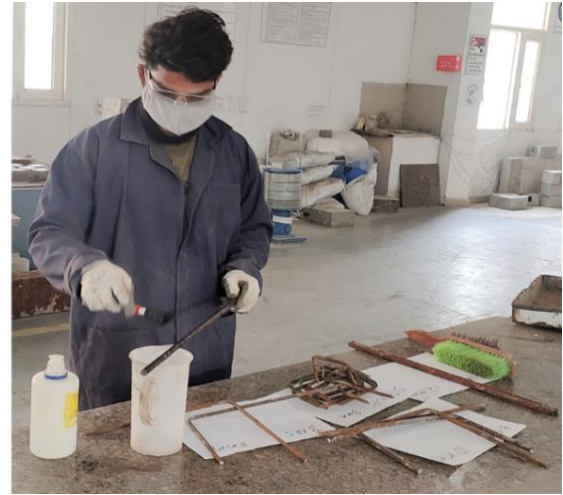
(b) Cleaning and removal of deposited rust

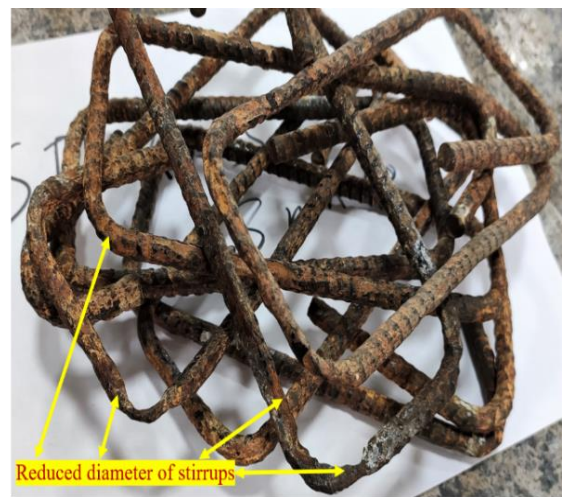
Figure 3. 11 (a) & (b) Fractured stirrups, (c) & (d) cross-sectional area reduction and de-scaling of longitudinal reinforcement bars

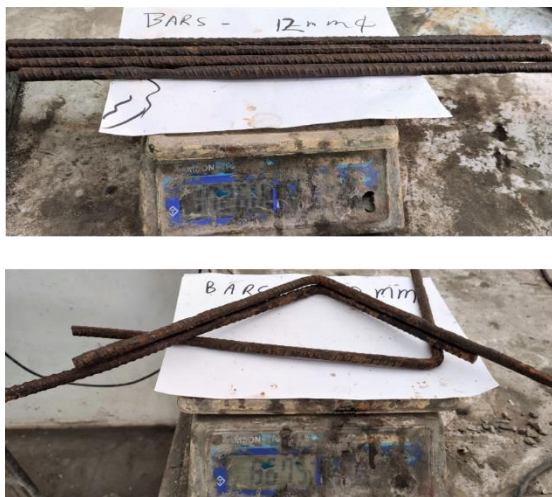
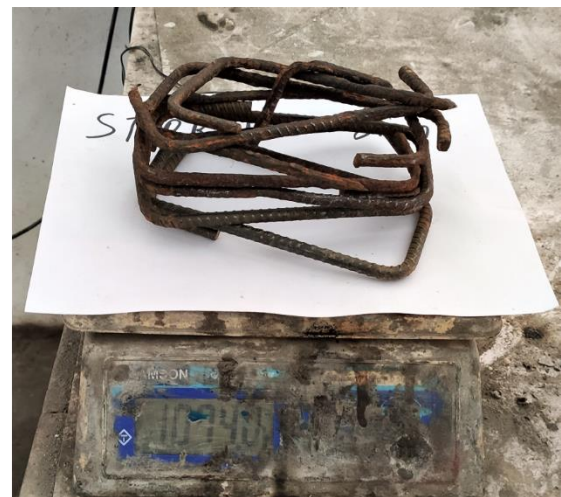
Figure 3. 12 Determining the mass loss for different levels of corroded specimens

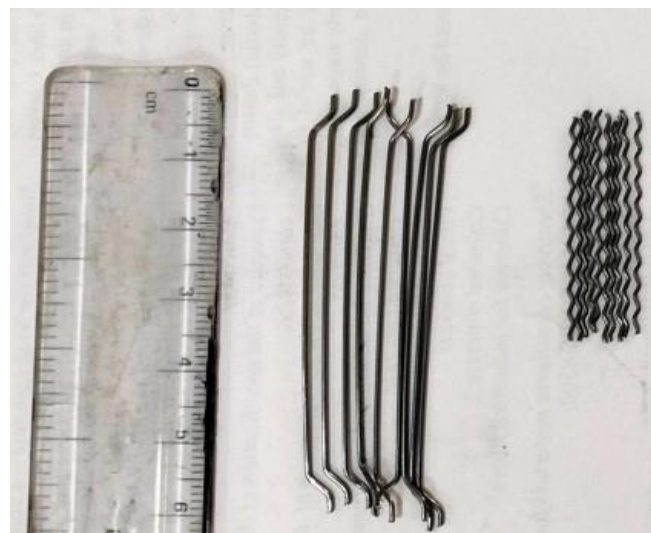
Steel fibers of two types i.e., hooked-end steel fibers and crimped steel fibers were used in the present study, as shown in Figure 3.16. The hooked-end steel fibers had mechanically deformed hooks at both ends of the fibers while the crimped steel fibers had an undulated surface along the length of the fibers. The aspect ratio and tensile strength of both steel fiber types are presented in Table 3.6.

Figure 3. 16 Crimped and hooked-end steel fibers

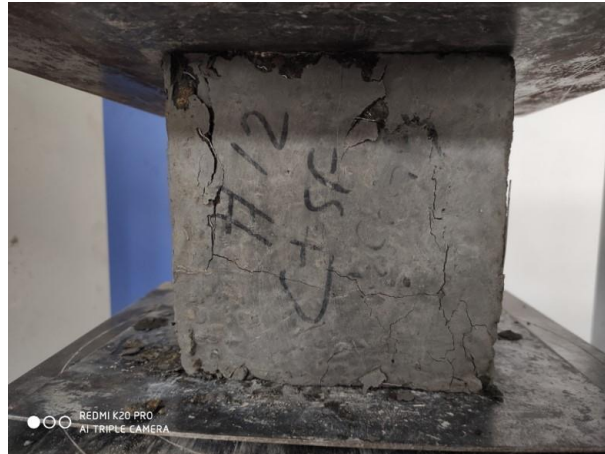
The compressive strength of the mix was determined with the help of a Compression Testing Machine (500-ton loading carrying capacity). The loading rate was 140 Kg/square cm/minute. The average of three 150×150×150 mm size cubes was used to evaluate and report the compressive strength, as shown in Figure 3.17. The average 28-day compressive strength was experienced to be 85 MPa.

Figure 3. 17 Test setup for determining compressive strength of HSFRC

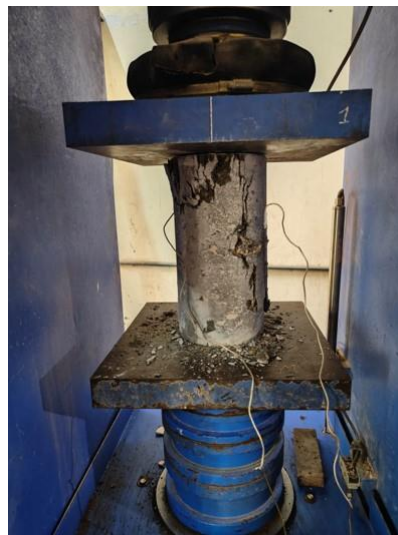
The cylinders of size 150 mm × 300 mm were cast to determine the axial stress-strain behaviour of the developed HSFRC. At the surface of the test cylindrical specimen, two strain gauges (60 mm gauge length) were installed in the axial direction, one each on the opposing vertical faces, as shown in Figure 3.18. Figure 3.19 shows the experimental stress-strain curve of the tested HSFRC cylindrical specimen.

Figure 3. 18 Test setup to evaluate the stress-strain behaviour of HSFRC

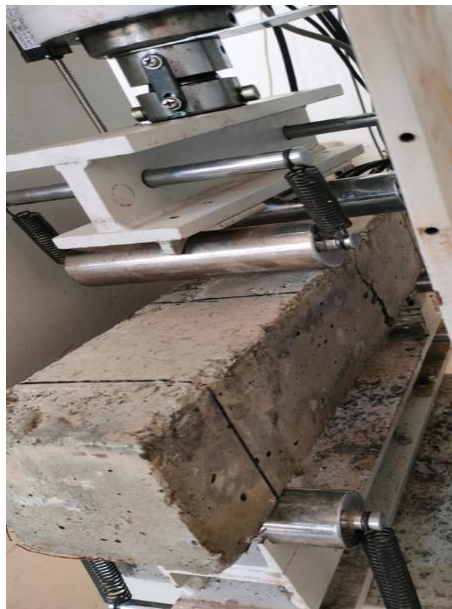
Figure 3. 20 Two-point bending test Set-up arrangement

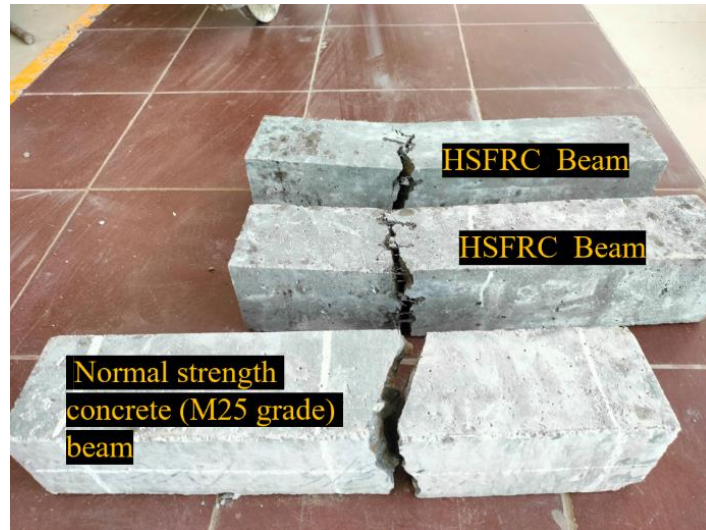
Figure 3. 21 Flexural failure of beam specimens

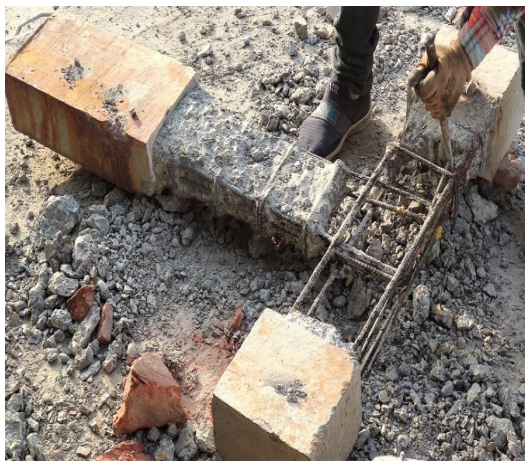
(a) Removal of corrosion damage concrete

The damaged concrete of the specimens due to severe corrosion is entirely removed up to a particular length and is replaced by HSFRC. To identify the target region for repair, the reference test specimen used for the pilot study of corrosion (refer to section 3.5.2) was cut open by removal of the entire concrete to expose the corrosion-damaged reinforcement cage (see Figure 3.22). From Figure 3.22, it can be observed that severe damage to the reinforcement bars was experienced in the corrosion target area (i.e., around the junction of the beam-column). It was visually observed that the corrosion-affected length for the beam main reinforcement was up to 350 mm, initiating from the junction of BCJ. Similarly, the column reinforcing bars were damaged up to a length of 150 mm from either side of the junction. Therefore, a length of 400 mm for the beam and 200 mm length for either side of the column from the interface of BCJ was finalized for the repairing scheme for this study. Figure 3.23 (a) shows the removal of damaged concrete from the corroded BCJ specimens up to the decided length. The removed concrete dimensions up to the selected length in the beam and column side are illustrated in Figure 3.23 (b). After removing the damaged concrete from test specimens, the fracture, localized pitting of stirrups, descaling, and cross-sectional reduction of longitudinal bars due to severe corrosion were observed, as shown in Figure 3.24. To restore the ductility and strength of corrosion-damaged specimens, the HSFRC rehabilitation scheme was performed in certain steps:

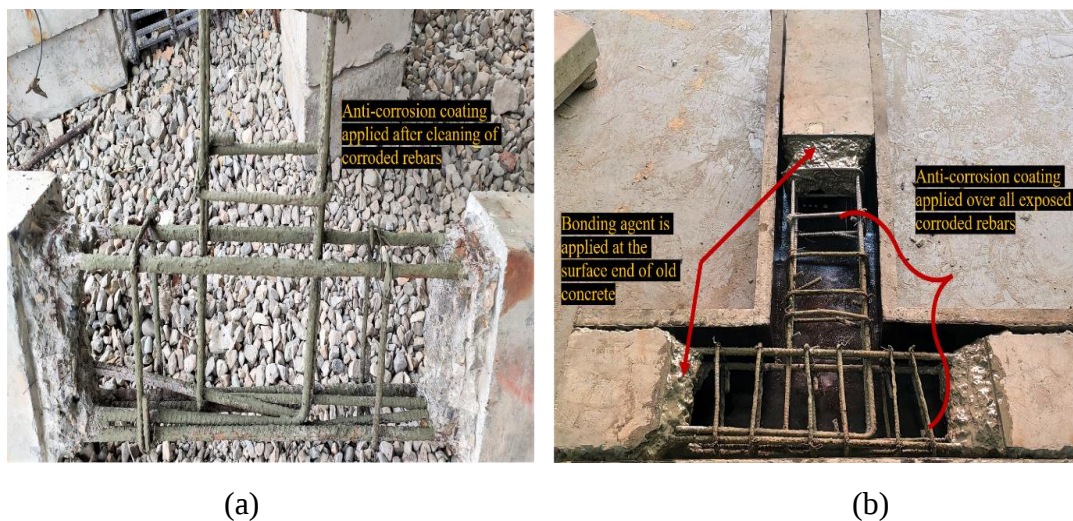
Figure 3. 25 (a) Application of anti-corrosive coating on the surface of corroded reinforcing bar, (b) Specimen placed in formwork for retrofitting

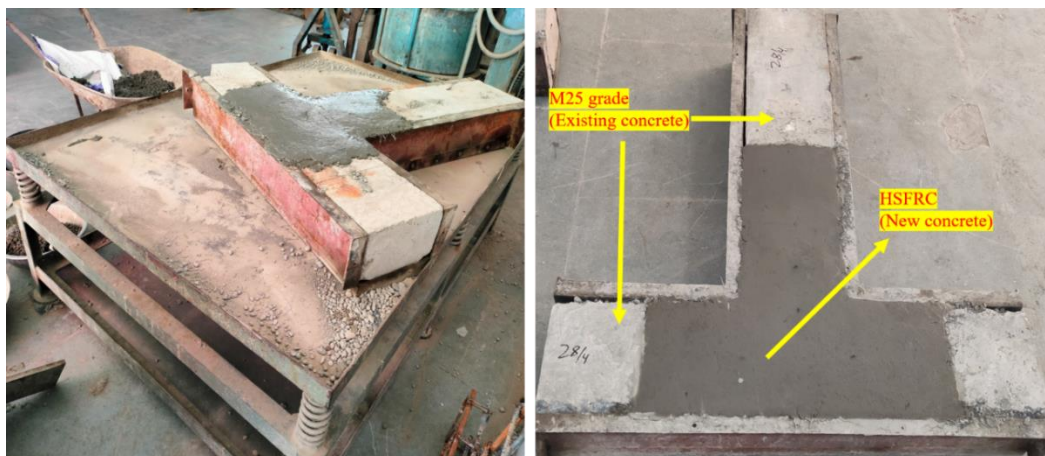
Figure 3. 26 Table vibration provided to the retrofitted specimen

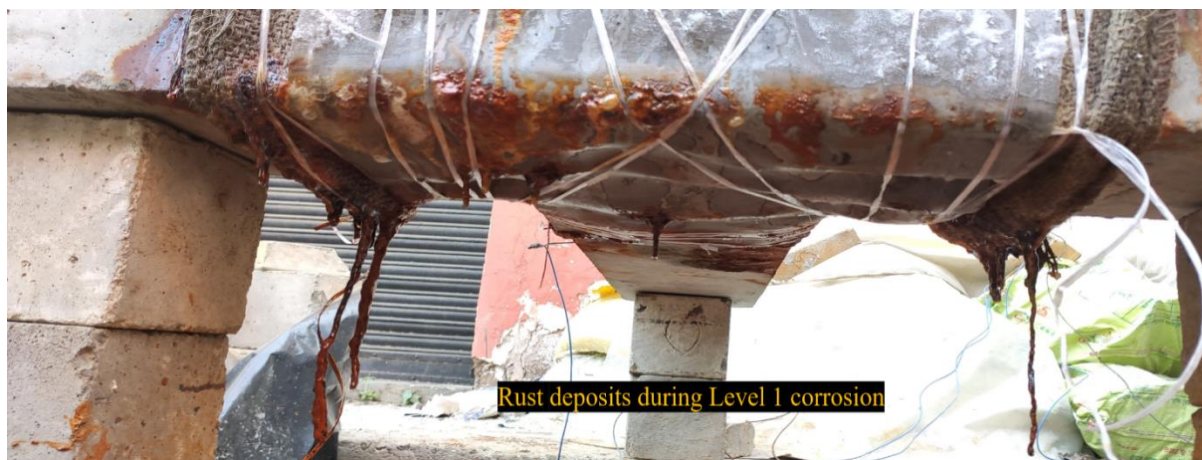
Figure 4. 2 (a) Rust deposition on the surface of stainless-steel mesh and (b) maximum crack width for Level-1 corroded specimen

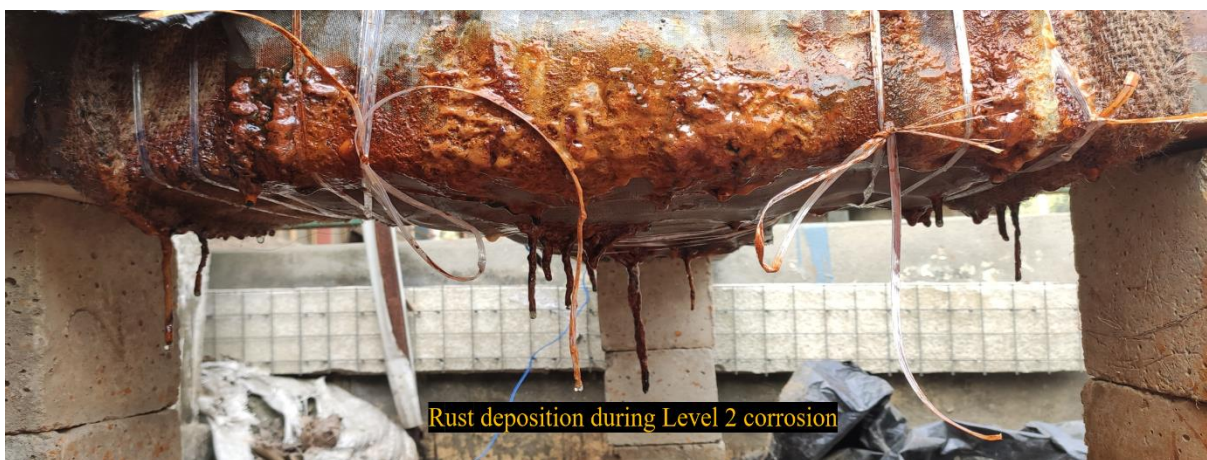
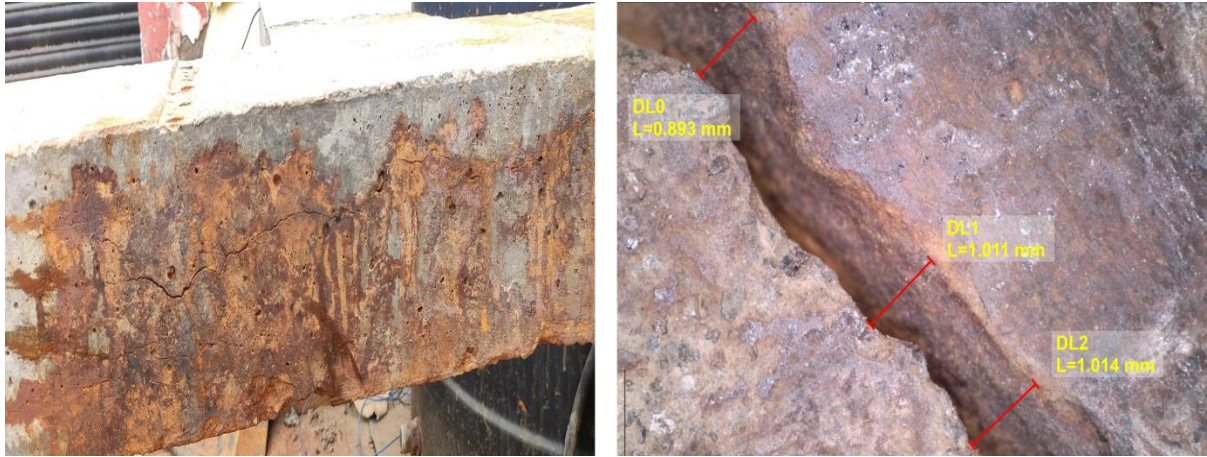
As the corrosion-exposure duration increases, severe rust deposition on the surface of steel mesh can be experienced in the shape of long suspended peaks, as shown in Figure 4.3 (a). The water dripping down the specimen now appeared to be dark brown, carrying the washed-out rust products from inside the specimens. The specimens when unwrapped and cleaned showed wider cracks on the longitudinal reinforcement direction of the column and beam surface when compared to Level-1 specimens. The cracks were measured with the help of a Dino-Lite edge digital microscope (series AM7915) having a magnification range of 10x ~ 220x. These images were then processed in the associated software for accurate dimensioning of crack width, as shown in Figure 4.3 (b).

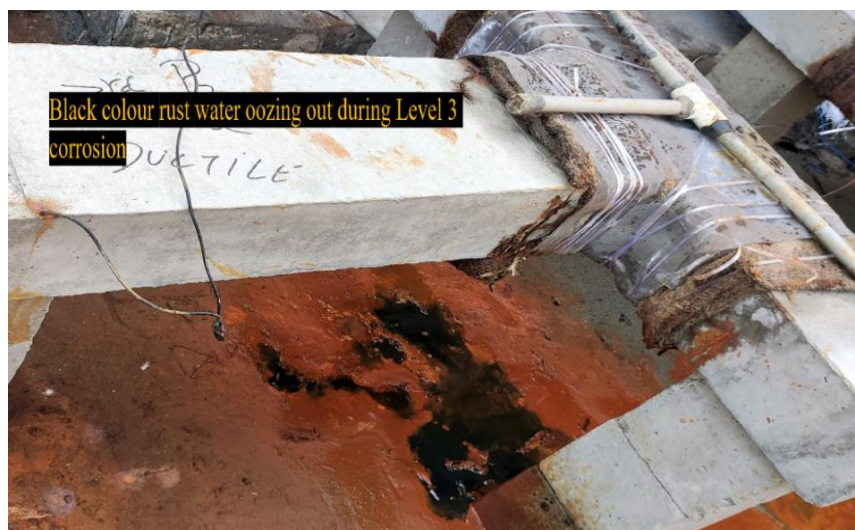
(a)

At Level-3 corrosion, the specimen showed immense deposition of rust on the mesh surface. The black colour water along with rust products oozes out of the specimens, as shown in Figure 4.4 (a). The cracks extended on the longitudinal surface of the beam and column and were visible without even unwrapping the specimen. The crack width (up to 1.5 mm) as shown in Figure 4.4 (b) was experienced on the surface of the specimen, which is alarmingly dangerous for any structure.

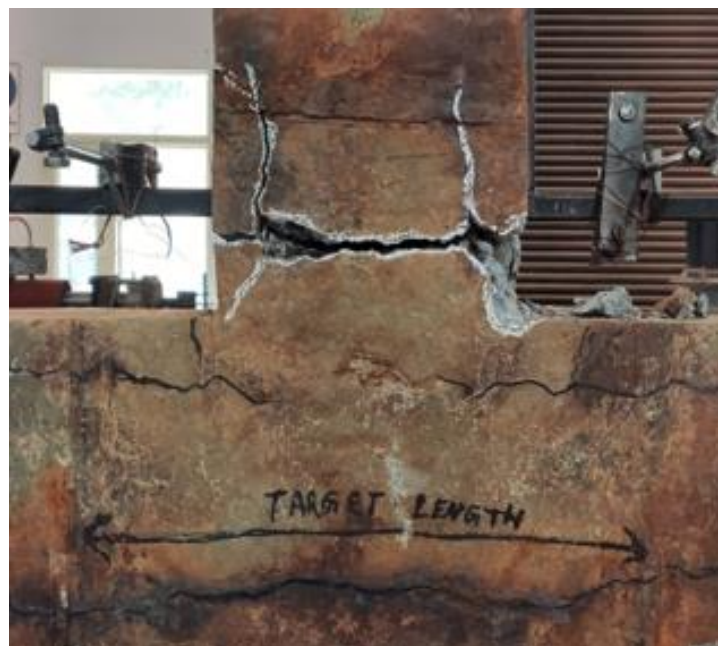
Figure 4. 10 Ultimate failure of NDC-3

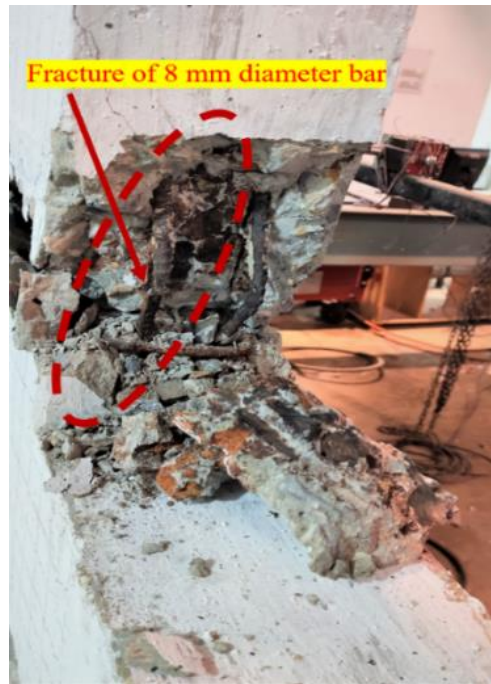
The fracture of the 8mm diameter bar was visually confirmed when the loading test was completed, as shown in Figure 4.11. The bar fracture was also noted when the corroded specimens were cut open after the cyclic loading test for determining mass loss. The spalling and shredding of a large amount of damaged concrete from the core region can be experienced at higher displacement. The damage progression corresponding to the drift ratios of control and corroded non-seismic specimens is shown in Table 4.2.

Figure 4. 11 Fracture of corroded reinforcement bar

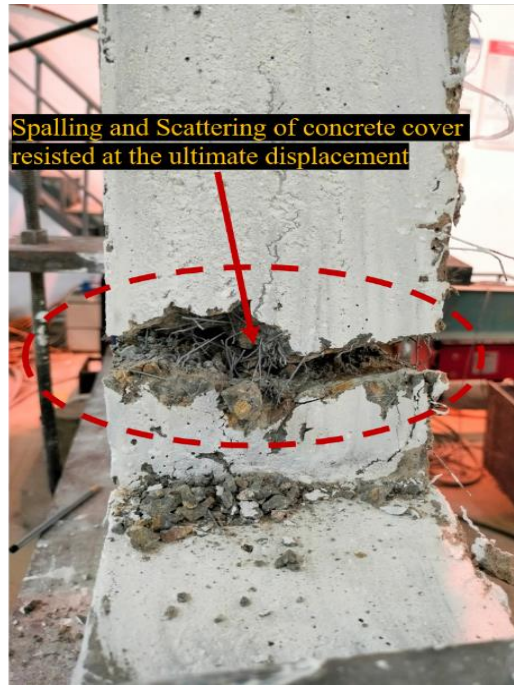
Figure 5. 11 Side view of the RD-3 specimen showing steel fiber-concrete bond

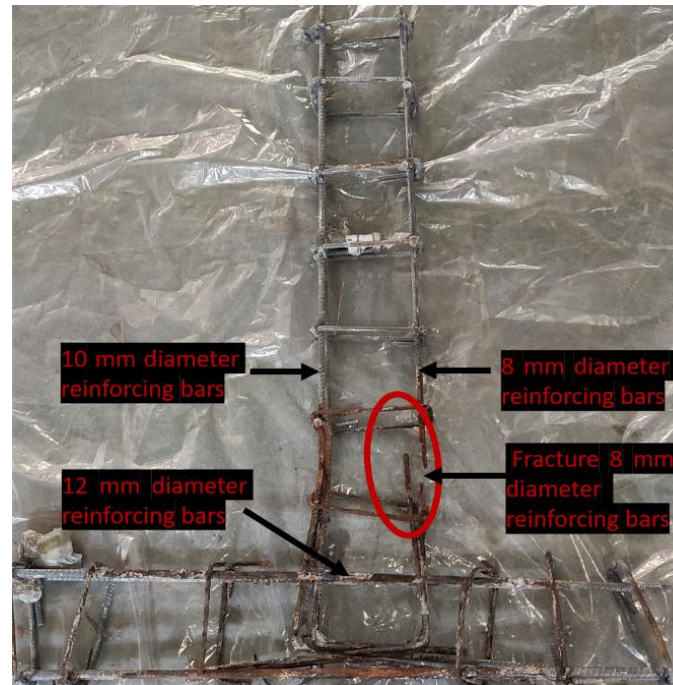
Figure 6. 4 Target corrosion affected length at the reinforcing bars surface (Dangwal and Singh 2023)

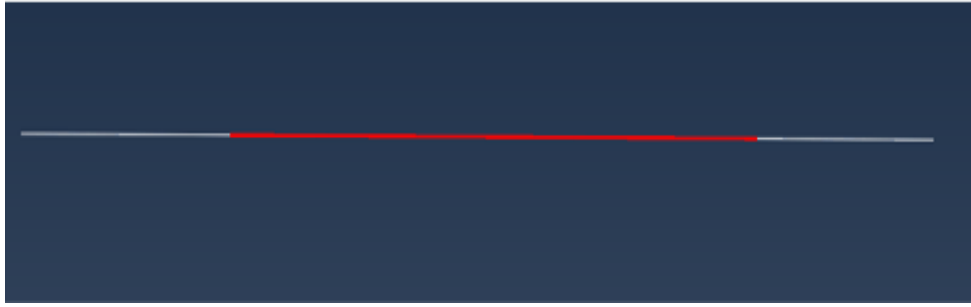
Figure 6. 5 Schematic configuration of corrosion site (part in red) on the surface of reinforcing bars of (a) 8 mm (b) 10mm and (c) 12 mm diameter

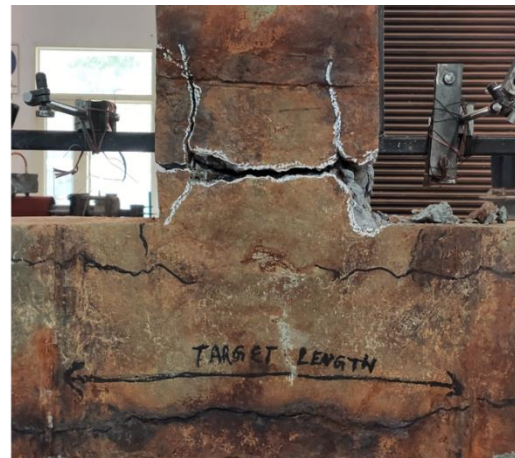
(h) NDC-3

Figure 6. 26 Crack patterns of non-seismically detailed specimens corresponding to  $\pm 4.36\%$  drift ratio
