Durability enhancement and prevention of damage in reinforced concrete structures using bacteria

A Thesis

DOCTOR OF PHILOSOPHY

BIOTECHNOLOGY

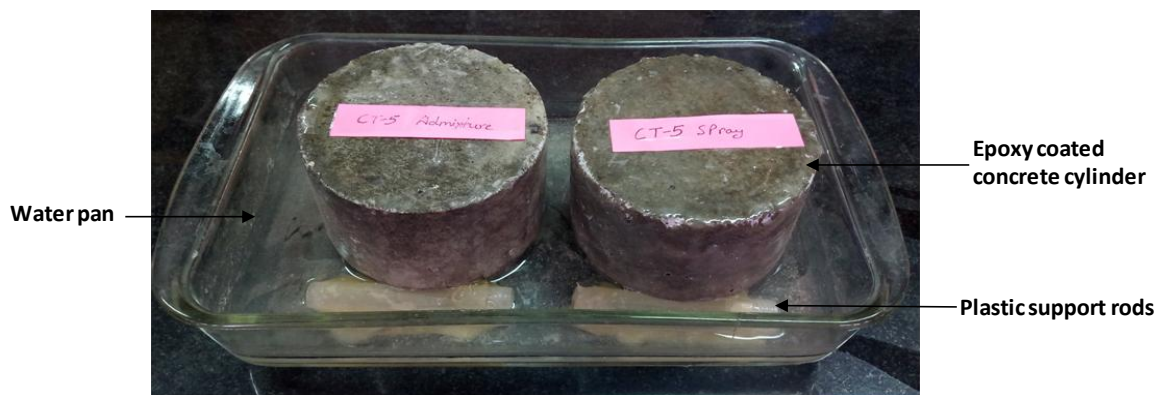
Figure 3.4 Arrangement of the sorptivity test

The rate of uni-directional absorption of water by concrete sample due to capillary rise is defined as sorptivity test. It correlates the transport of water with the pore system of specimen. Sorptivity of concrete specimens was determined according to ASTM standard (ASTM C1585). This test method is used to determine the rate of absorption of water by hydraulic cement concrete by measuring the increase in the mass of a specimen resulting from absorption of water as a function of time when only one surface of the specimen is exposed to water. Seven concrete mixes as specified in section 3.3.1 were used for the casting of concrete cylinders and curing in a similar manner as mentioned in Table 3.4. The standard test sample, concrete discs with diameter 100 mm and 50 mm thickness were obtained from the cured concrete cylinders (Table 3.6). The test setup is illustrated in Figure 3.4. The concrete disc sample was then saturated by placing in vacuum dedicator and vacuum is maintained for 3 hours. After saturating, samples are placed in the environmental chamber at a temperature of 50 ± 2 °C and RH of 80 ± 3 % for 3 days. After the 3 days, samples were placed inside a sealable container and stored at 23 ± 2 °C for at least 15 days before the start of the absorption procedure.

Test Procedure

- Immediately the specimen was replaced on the support device of water filled pan.
- The mass change was recorded at the intervals of 60 s, 5 min, 10 min, 20 min, 30 min, 60 min and every hour up to 6 hours.

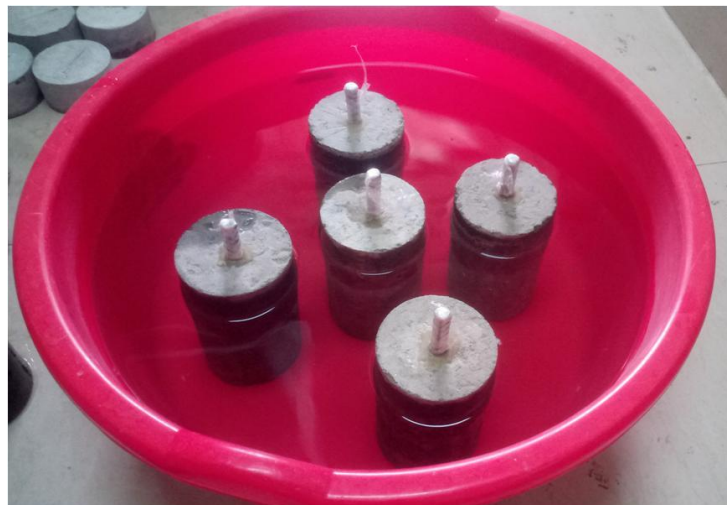
Figure 3.6 Reinforced cylinders exposed to 5% NaCl solution

After 28 days of curing, concrete cylinders were air-dried for 2 days and kept at ambient temperature. After that, epoxy resin was applied on the lower horizontal surface of all the concrete cylinders. After coating with epoxy, samples were allowed to cure until the sealant was no longer sticky to the touch. Then the specimens were kept immersed in 5% sodium chloride (NaCl) solution so that the vertical surface of cylinders up to the height of 190 mm is exposed to the solution. The purpose of keeping the NaCl solution below the upper surface of cylinder specimen is to protect the protruded rebar from atmospheric corrosion. Specimens exposed to chloride solutions are shown in Figure 3.6.

To accelerate the chloride ion ingress in reinforced concrete specimens, wet-dry cycle of 7 days immersion in NaCl solution and 3 days air drying was adopted. This wetting and drying cycle of chloride exposure was adopted so that the specimens remain partially saturated as well as sufficient oxygen is also available in abundance. With the availability of oxygen, corrosion can proceed unhindered in steel reinforcement when initiated. The corrosive solution of 5% NaCl was renewed after every 10 days.

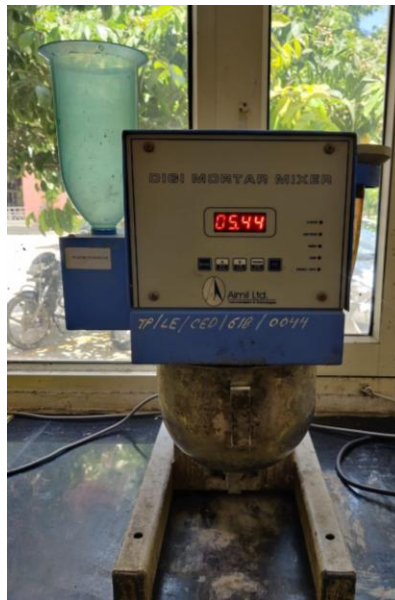
Figure 3.8 Hobart-type laboratory mixer to prepare fly ash amended cementitious grout

For the preparation of grout, hobart-type laboratory mixer (AIMIL India Ltd, New Delhi) was used to mix cement and fly ash as shown in Figure 3.8.

A standard procedure was followed in which cement and fly ash was dry mixed for 1 minute in the mixer operating at slow speed (140 ± 5 rpm). Then the water was added into the mixer with dry composite of cement and fly ash material and the mixer was operated for next 1 minute at slow speed and thereafter the speed of mixer was increased immediately for next 30 seconds. In case of bacterial based cementitious grout, bacterial culture was added into the mixer instead of water. The mixer was stopped for 90 seconds and the cementitious grout was hand mixed properly in the mean time. Further, the mixer was operated for the last 1 minute at high speed

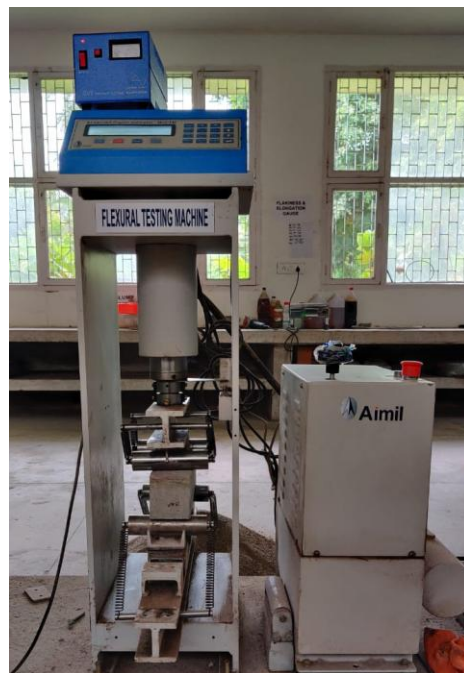
Figure 3.12 Flexural testing machine with arrangement of concrete prism in between supporting and loading rollers

To study the efficiency of bacterial treatment in flexural strength recovery, untreated and bacterial grout repaired concrete prisms were used. Flexural strength test of all concrete prisms was carried out using the flexural testing machine (AIMIL India Ltd, New Delhi) according to Indian standard (IS: 516-1959) as shown in Figure 3.12. In order to perform flexural strength test, concrete prism were placed on the supporting rollers of testing machine and uniform loading was applied to uppermost surface of specimen until the failure.

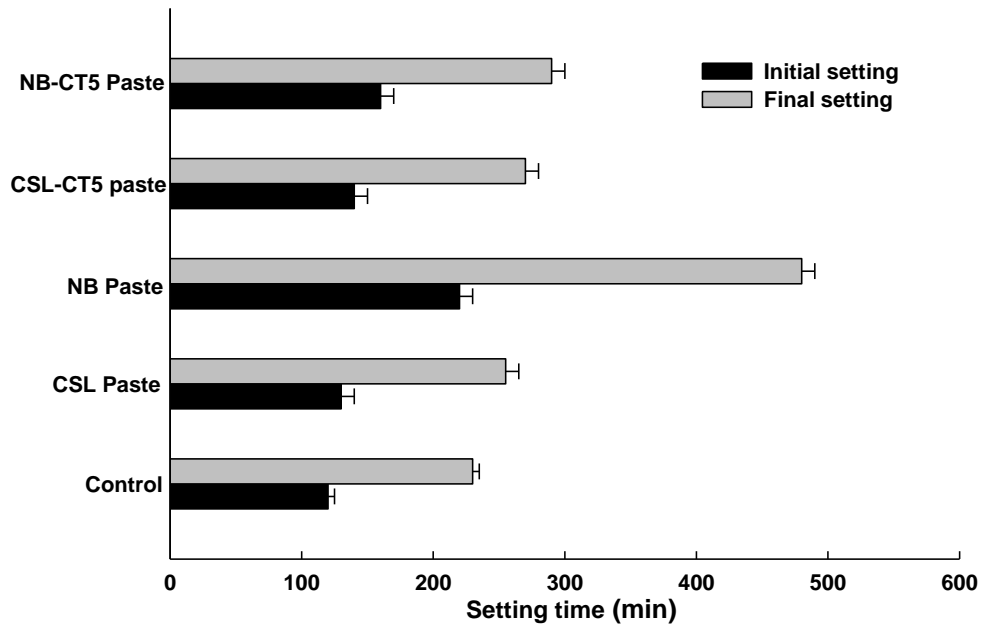
Figure 4.1 Initial and final setting times of different cement paste mixes. Error bars represent standard deviation (n = 3)

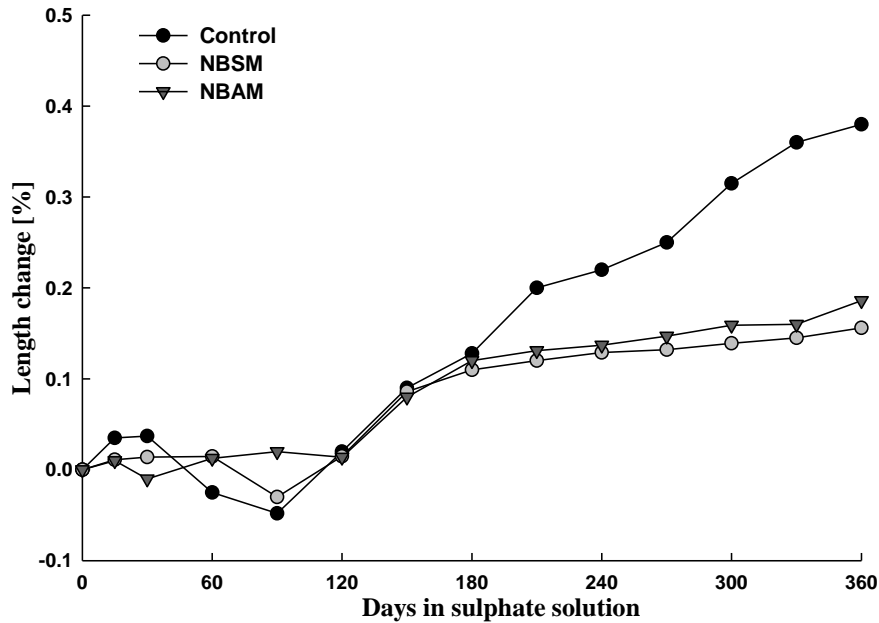
Figure 4.20 Influence of chemical sulfate exposure on length expansion of control, NB-bacterial admixed mortar (NBAM) and NB-bacterial spray treated mortar (NBSM) specimens till the age of 365 days

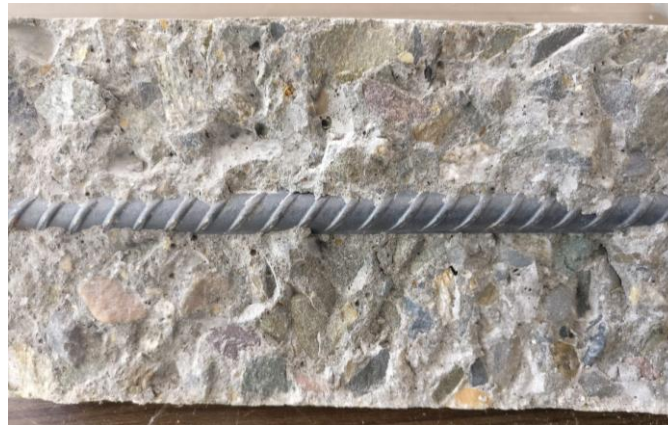
Figure 4.35 Rebar-concrete interface of NBAT specimen after 130 days of chloride exposure depicts no sign of corrosion initiation

Unaffected rebar surface from corrosion in NBAT specimen shows the significant reduction in diffusion of chloride ions inside concrete matrix. This study on the basis of corrosion monitoring obtained throughout chloride exposure, highlight the potential of MICP applications in resisting the ingress of chloride ions. On the basis of I_{corr} and E_{corr} trends obtained, NBAT and NBST specimen performed effectively under the aggressive chloride environment. From the observed results in the present study, it is concluded that the utilization of biomineralization activity of calcifying bacteria provides an innovative approach in the prevention of rebar corrosion.

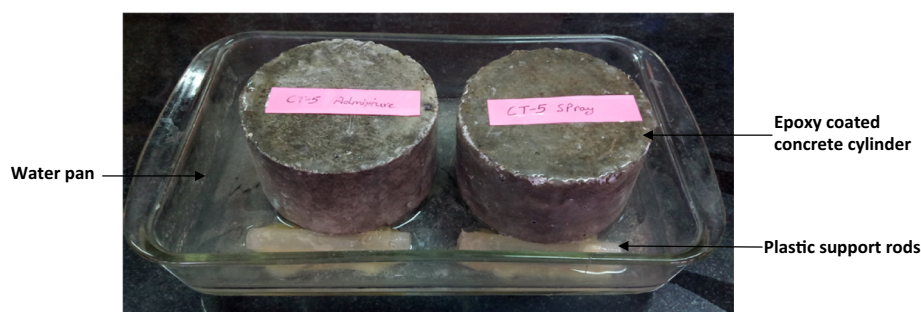
Fig. 1. Arrangement of the sorptivity test.

Permeation properties of various mixes were measured at 28 days of casting, taking the average of three specimens as the representative value. Sorptivity was determined according to ASTM C1585 [24]. The test is based on the rate of uni-directional absorption of water by concrete sample due to capillary rise. It correlates the transport of water with the pore system of specimen [25]. To conduct sorptivity test, the concrete cylinders with diameter 100 mm and 50 mm thickness were prepared. Before conducting the test, side surface of specimen was sealed with epoxy sealing material and initial mass was noted. One surface of specimen was exposed to water and mass increase of specimen by absorption was monitored by weighing it at different time intervals. The test setup is illustrated in Fig. 1. The mass change was recorded at the intervals of 60 s, 5, 10, 20, 30, 60 min and every hour up to 6 h. From the value of mass change, volume of water absorbed per unit cross sectional area was evaluated for each time interval. A plot between the square root of time and volume of water
