Dry Abrasion Wear of Windshield Glass and its Effect on Night Driving

A thesis project report submitted in requirements for the

Master of Engineering

CAD/CAM Engineering

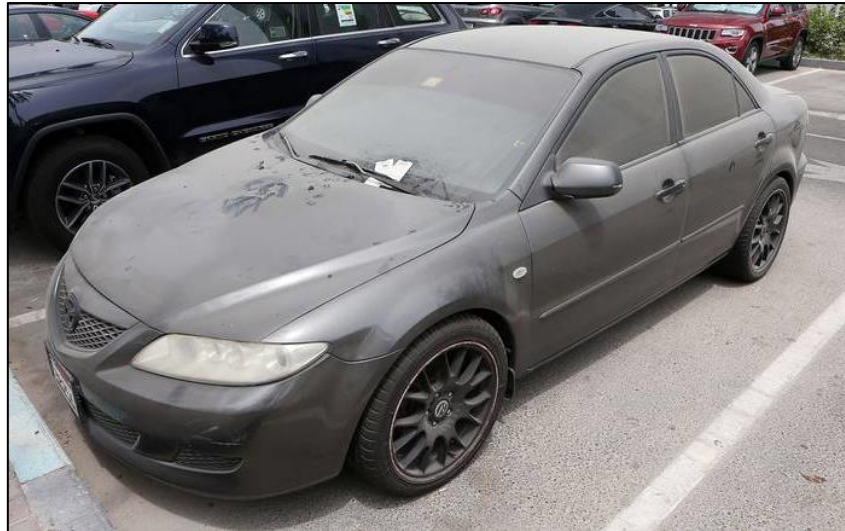
Fig. 1.1 Dust deposition on a car [4]

This pollution is our major concern here as with the increase in particle pollution, the dust and dirt in the atmosphere increases and ultimately, as this dust settles down, it makes a significant layer on the vehicles as shown in Fig. 1.1. These particles may include dust, dirt, soot, etc. This dust is deposited not only in the open but also on vehicles parked in covered places/parking. However, the continuous use of windshield wipers can cause wear and tear on the windshield, leading to scratches, pitting, and other forms of damage. This wear and tear, if not addressed, can impair the driver's vision, leading to unsafe driving conditions.

Fig. 1.1 and Fig. 1.2 clearly show the dust deposition on the windshield and the wiper blades. This dust acts as an abrasive material between the wiper blade and the windshield which causes obstruction in clear vision.

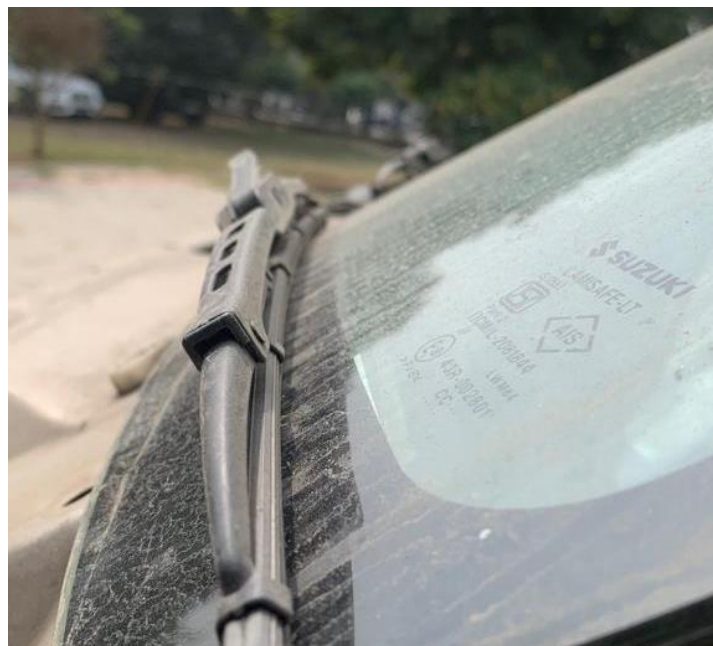
Fig. 1.2 Dust deposition on the windshield

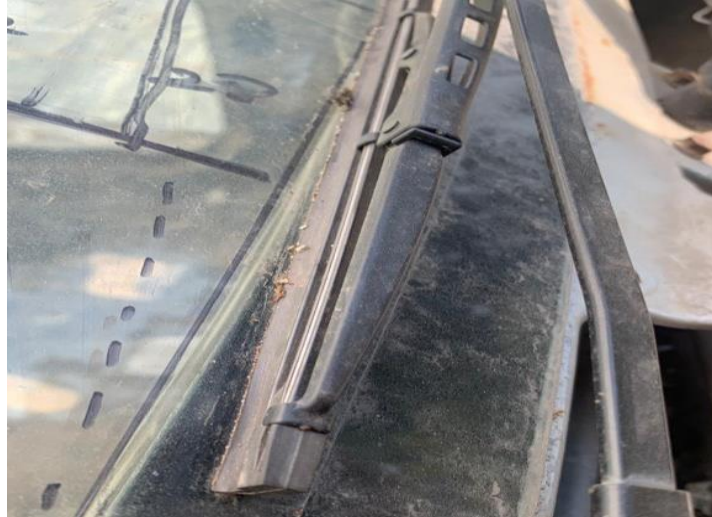
Fig. 1.3 Dust deposition on the wiper blades

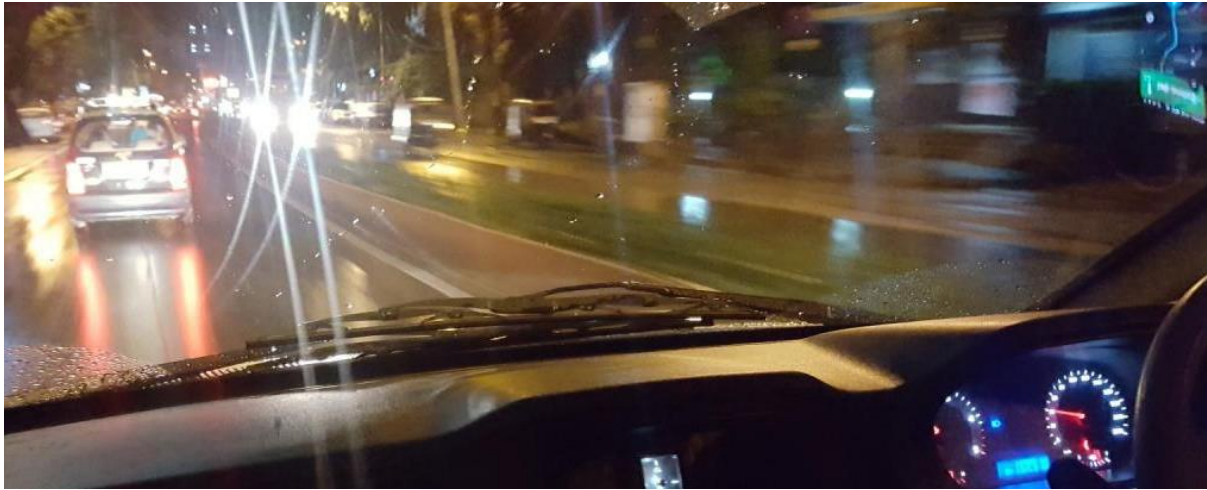
During the day time driving, these scratches seem to be insignificant and looks very minor, however, during night driving, as the headlight from different vehicles fall on the windshield, the light rays get reflected into multiple directions, thus causes glare as shown in Fig. 3.1. The secondary reflection restricts the driver's visibility resulting into unsafe driving conditions.

Fig. 3.1 Glare during night-time driving

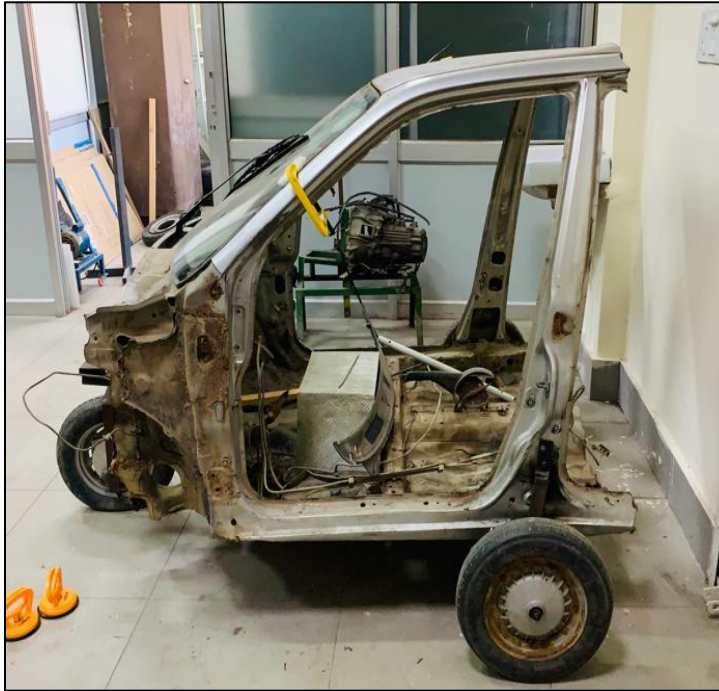
Fig. 4.2 Test Vehicle (Side View)

The side view of the test vehicle is shown in Fig. 4.2. The ground clearance of the test vehicle was kept at 190 mm, the average of most low and mid-segment cars today.

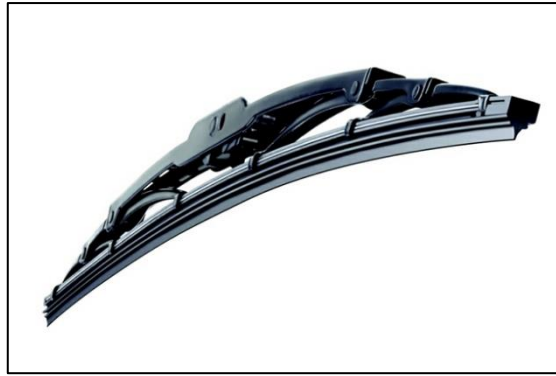
There are three main types of wiper blades: conventional, flat and hybrid. A conventional type wiper blades were used in this experiment. Two set of wiper blades were used to obtain a relationship between the wiper blade's age and the windshield wear: a Wiper Blade 18" (New) and a Wiper Blade 18" (Old) were used which were compatible with the model and type of the car chassis. The old wiper was taken from an old car (mileage of 25,000 Kms and 4 years old).

Fig. 4.3 Conventional type wiper blade [12]

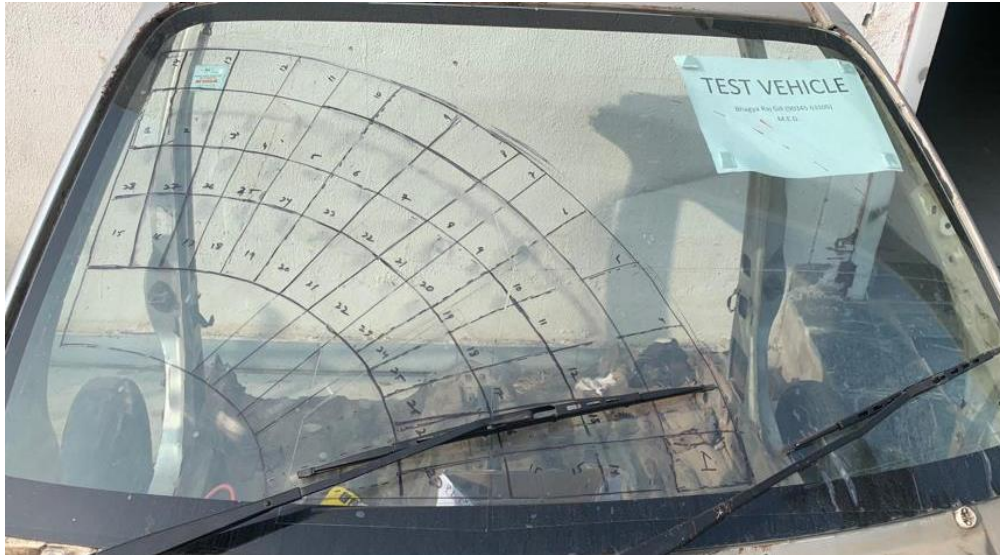
In order to perform systematic wear on two windshields, the windshields were protected with a thin transparent film from outside to protect it from abrasion to control the number of abrasion cycles over different regions. The swept area of wipers and segments to be studied were marked on inside of the windshield. This swept area was further divided into small segments numbered accordingly, as shown in Fig. 4.4. The idea was to study the wear of windshields with respect to the number of wiper cycles. These marked sections of the laminations were removed after defined number of strokes to perform the experiments.

Fig. 4.4 Segmentation of Windshield

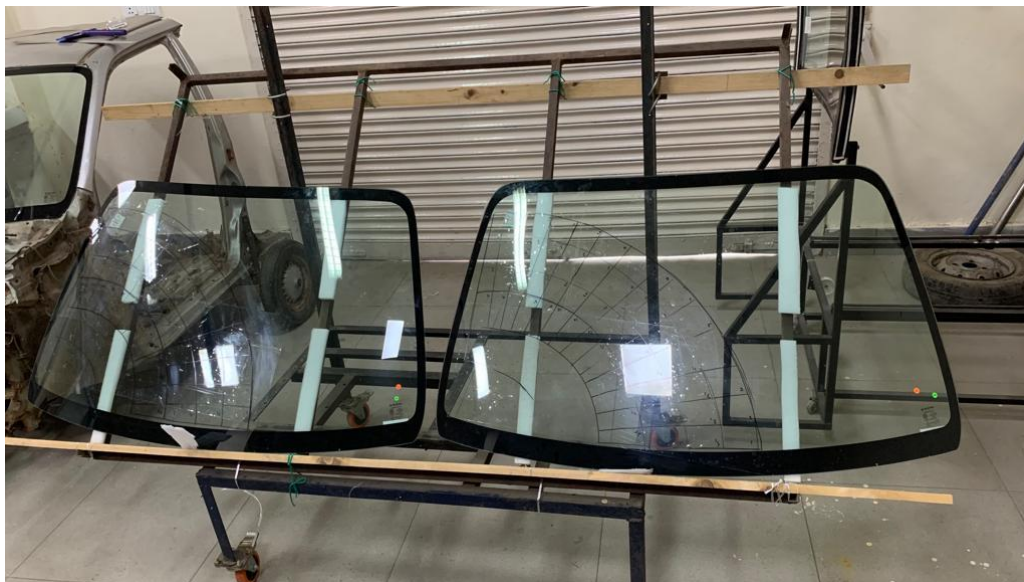
A frame was also made to keep the windshield outside safely, as shown below in Fig. 4.5. The setup was made such that it could easily be moved from one place to another. The wheels had stoppers to keep the windshields safe and the frame stationary during different weather conditions. Inclination of the windshield on frame was kept similar to that of car chassis so that dust accumulation would be same.

Fig. 4.5 Windshield Frame

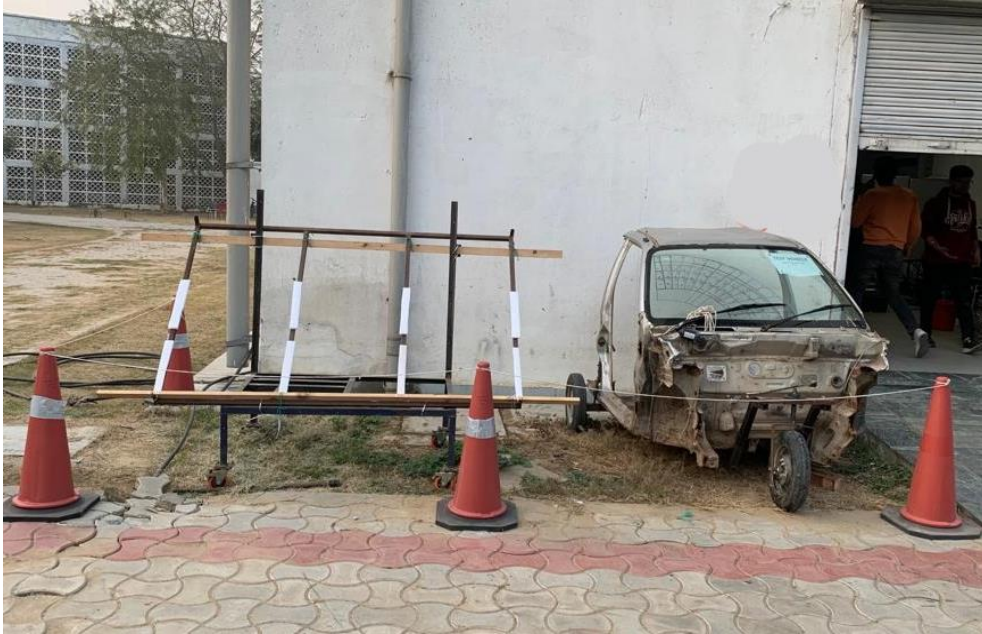
The experimental setup i.e. the test vehicle and the windshield frame were kept in an open environment as shown in Fig. 4.6.

Fig. 4.6 Experimental Setup

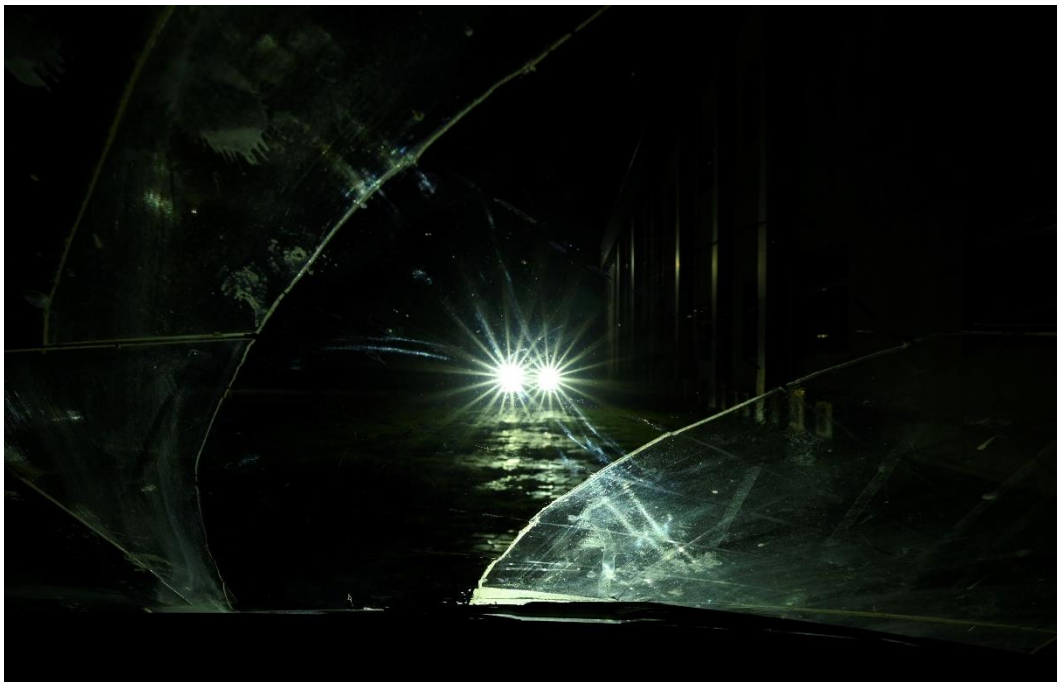
The light source was an actual Maruti Suzuki Baleno, with white (6500K) LED headlights. The lights were kept on high beam as shown in Fig. 4.9.

Fig. 4.9 Image taken from the test vehicle

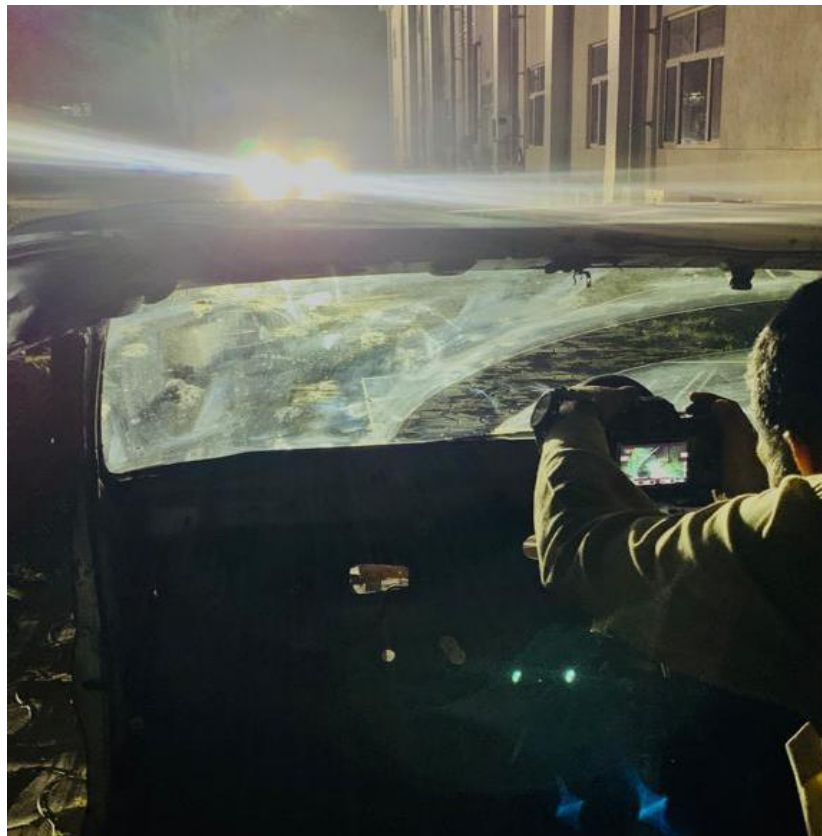
The night photography was performed from inside the test vehicle, as shown in Fig. 4.10. Photographs of each section were taken separately to study the effect of wear during night driving. The photography was done in two phases in May 2023 and June 2023 and the weather was all clear when the photography was done. Fig. 4.11 shows an image taken from section 7D of one of the windshields. Brightness of the light source i.e car headlamp was assumed to be unchanged over the time of different experiments. Settings for the camera and the lens were also fixed (ISO speed: ISO 400, F-stop: f/4.5, Exposure time $\frac{1}{2}$ seconds) for all the experiments so as to capture images using same imaging conditions.

Fig. 4.10 Photography in the night-time

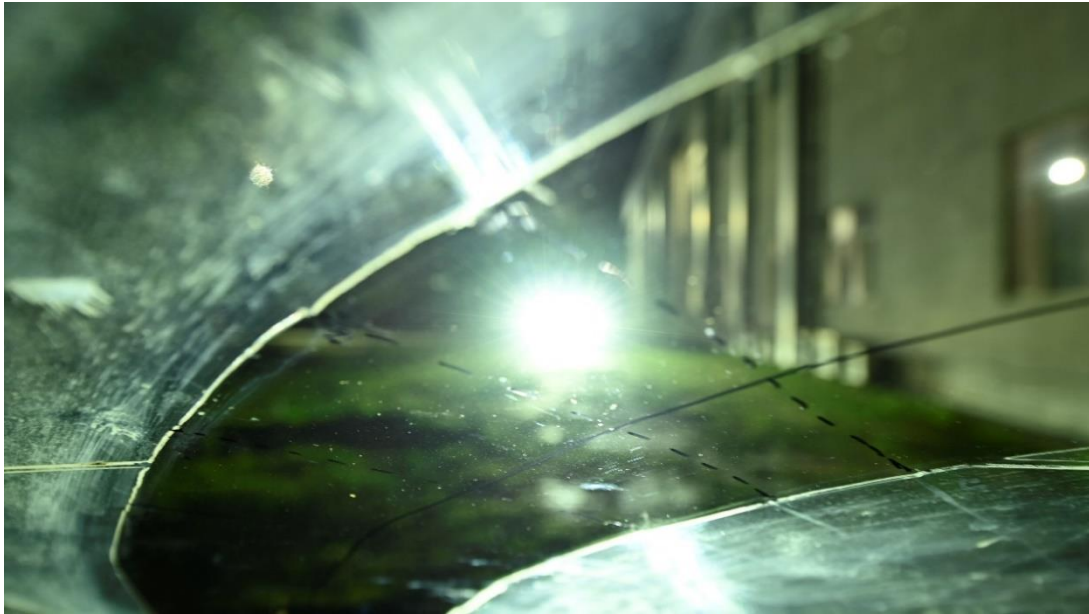
Fig. 4.11 Image taken at section 7D

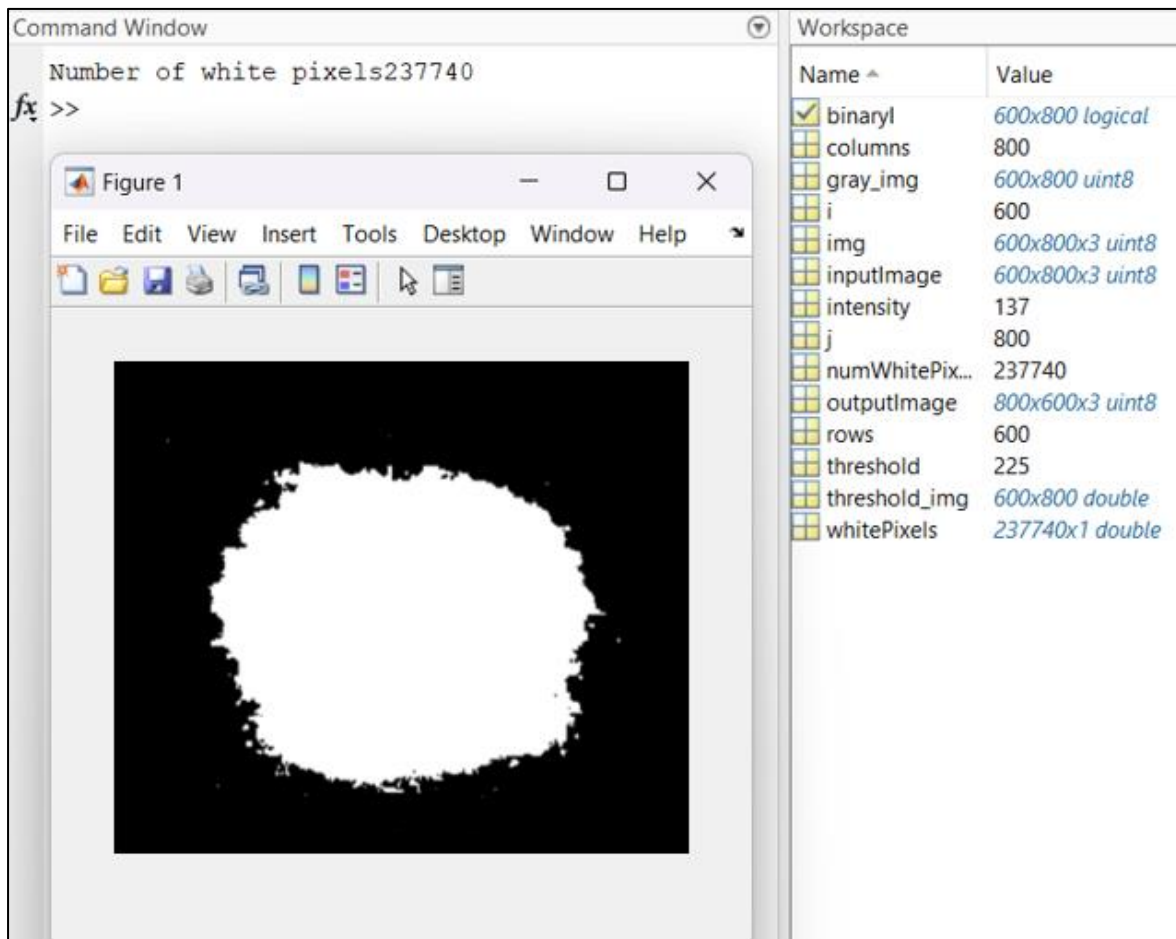
1. The cropped images were imported into MATLAB software
2. The imported images were converted into grayscale
3. Intensity of each pixel was calculated
4. A threshold value of 225 was finalized for the intensity
5. An if/else loop was created to filter out the image
6. Threshold image was converted into a binary image (Black and White)
7. The number of white pixels was calculated
8. The filtered image was saved.

Fig. 4.14 MATLAB Code results

A binary image was obtained as shown in Fig. 4.14 and the number of white pixels was calculated for the section 1D of the windshield abraded through old wiper blade.

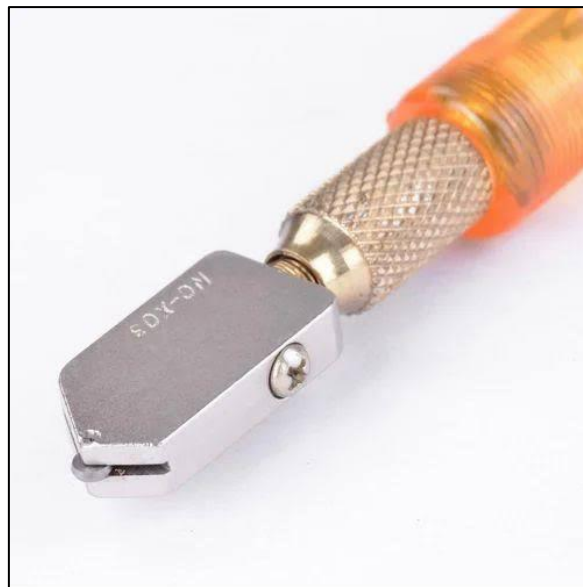
It was not possible to do the roughness testing of the whole windshield as it was curved and also, there are certain limitations of the roughness testing machine related to sample size. Mitutoyo surface roughness tester cannot accommodate large size samples. The windshield was cut into different pieces suitable for roughness testing. Using a diamond cutter as shown in Fig. 4.16, the windshield was cut from above and beneath along the marked sections. A gas flame was used to melt the thin transparent UPVC film between the windshield.

Fig. 4.15 Diamond Glass Cutter

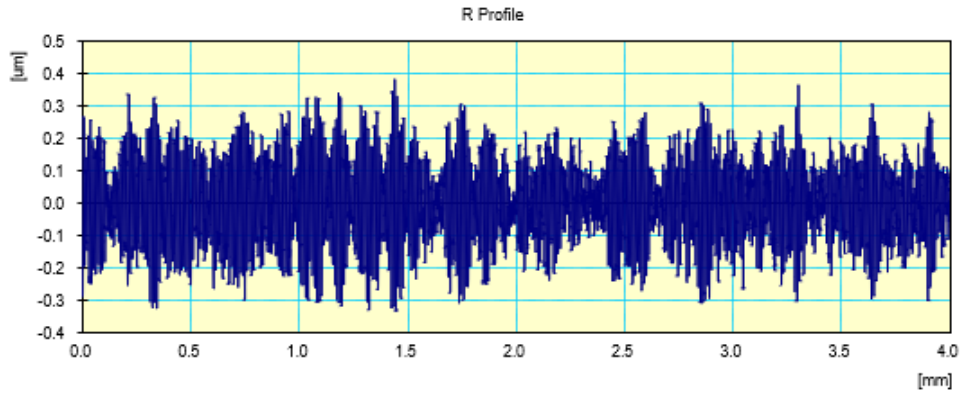
Work Name	Sample	Operator	Mitutoyo
Measuring Tool	SurfTest SJ-400	Comment	Ver4.00
Standard	JIS 2001	N	5
Profile	R	Cut-Off	0.8mm
Range	800µm	Filter	GAUSS
Ra	0.10µm		
Rz	0.7µm		
Rq	0.12µm

Fig. 5.3 Certificate of inspection of 9A section

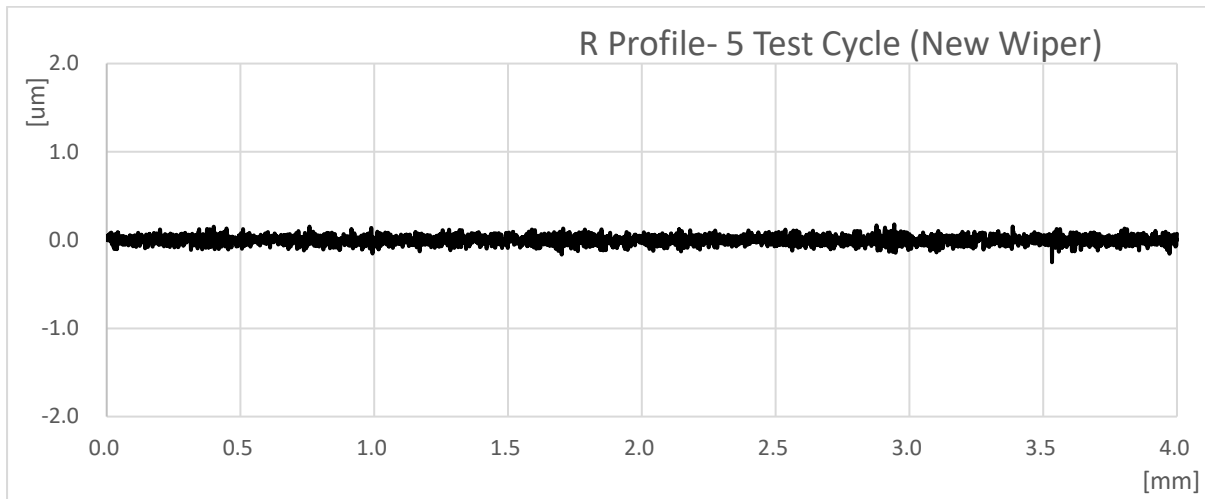
Parameter	After 5 test cycle	After 110 test cycles
	Value μm	
<i>Ra</i>	0.04	0.26
<i>Rz</i>	0.3	2.4

Fig. 5.6 Roughness profile of windshield after 5 test cycles using new wiper

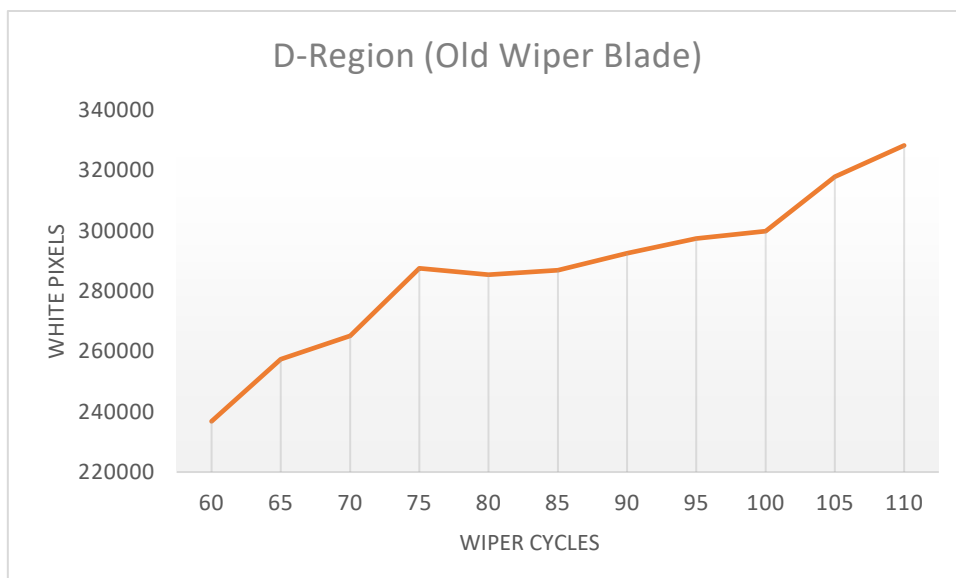
Fig. 5.14 Effect of number of wiper cycles at D- Region

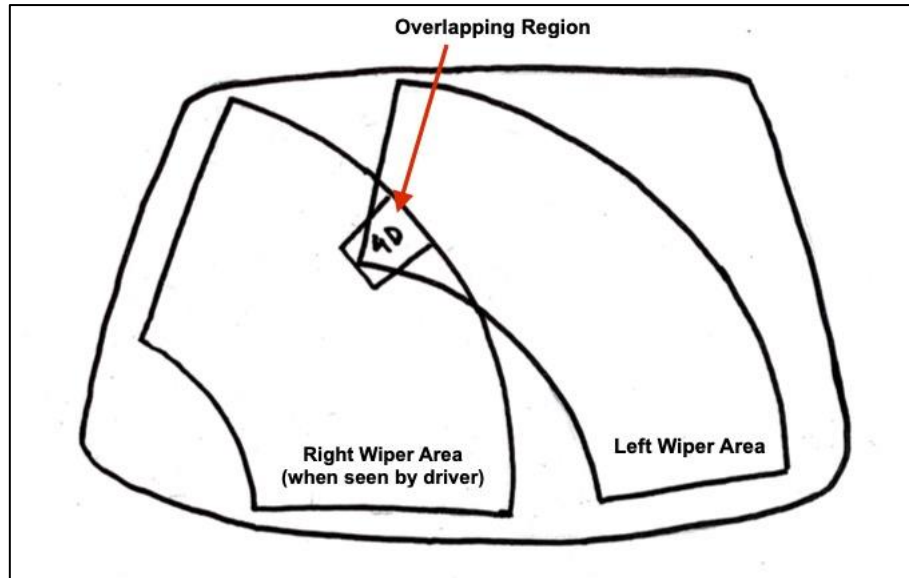
wiper as shown in the Fig. 5.15. Over lapping region is the common region which gets cleaned/wiped by both the wipers. It is in the middle of the windshield. The spike in the graph shows high wear in the over lapped region.

Fig 5.15 Overlapping Region
