**CORROSION MONITORING IN RC BEAMS USING
ACOUSTIC EMISSION AND ULTRASONIC GUIDED WAVES**

**MASTERS OF ENGINEERING
IN
CIVIL (STRUCTURES) ENGINEERING**

In the present study, a RC beam, of dimensions 150mm×150mm×700mm with an embedded steel bar of dia. 25 mm and 1000mm in length, is subjected to accelerated induced corrosion. Ultrasonic guided wave monitoring is done periodically after every 24 hours for 30 days. A mode with minimum attenuation and mode shape that is sensitive to particular type of damage due to corrosion is chosen from dispersion curves. For this purpose, Pulse-transmission investigation is used using peizo-electric transducers. Also, AE sensors detecting acoustic emission signals are mounted on the RC beam specimen before it is subjected to accelerated corrosion. AE set up simultaneously records the events and hits continuously for 30 days relating to crack initiation and progression due to corrosion in RC beams as the exposure to corrosion increases. It is observed that corrosion of reinforcing bars in concrete is discernible using ultrasonic guided wave and acoustic emission technique.

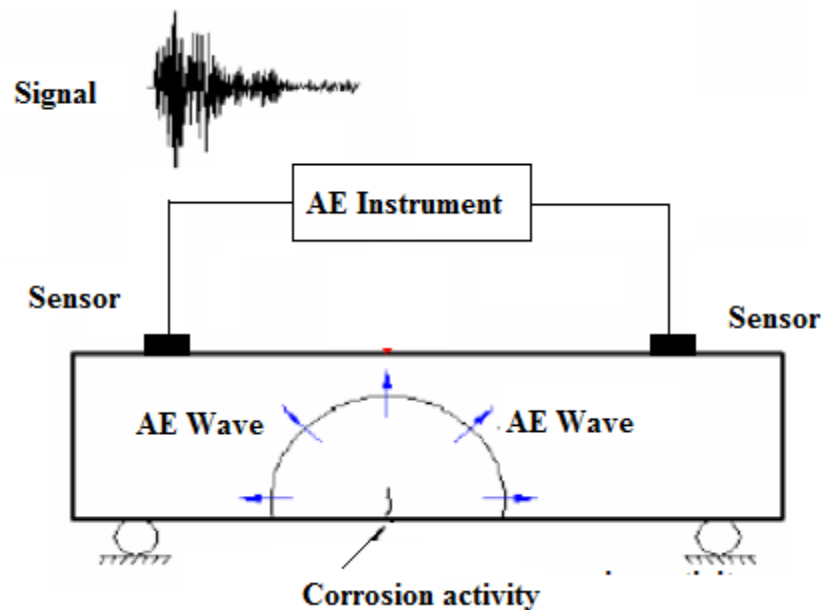
Fig.1.9: Schematic representation of AE Monitoring Process

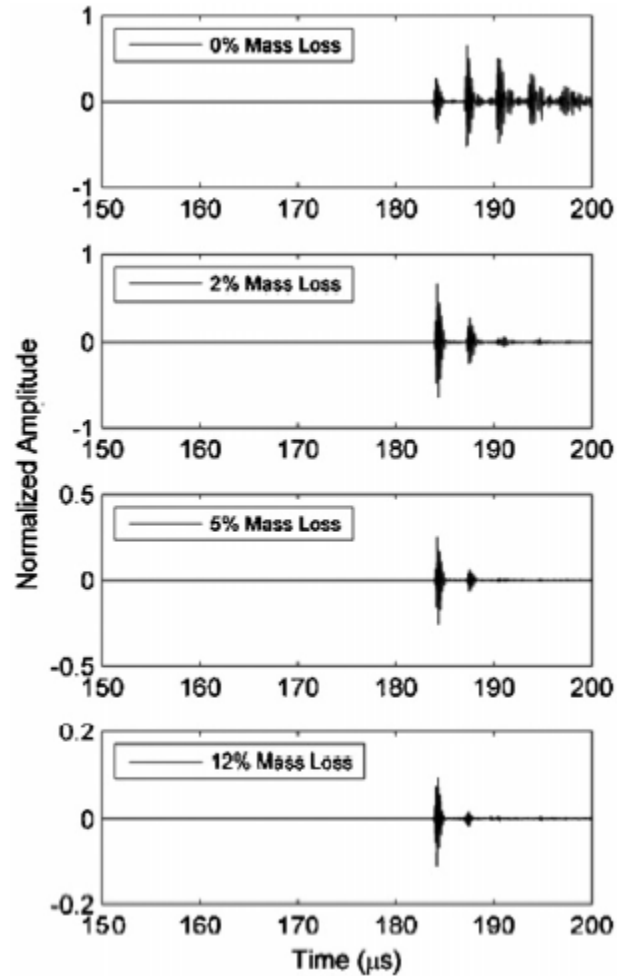
L(0,9) mode was relatively insensitive to the surrounding interface conditions at high frequencies. This allowed the monitoring of steel cross sectional area and bar topography, from the onset of corrosion to severe pitting (**Fig.2.8**).

Fig.2.8: Time domain response at different levels of mass loss for high-frequency monitoring of accelerated corrosion. The input signal was a 5.08 MHz single cycle pulse, with a bandpass of 2 MHz and 10 MHz.(Ervin et al., 2008)

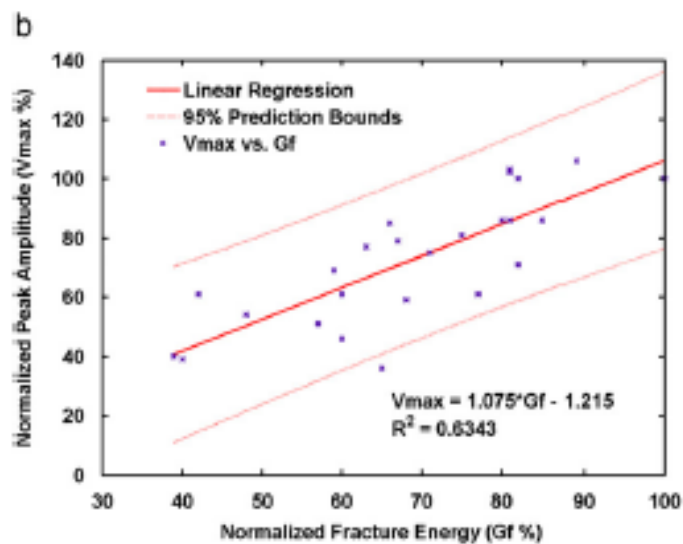
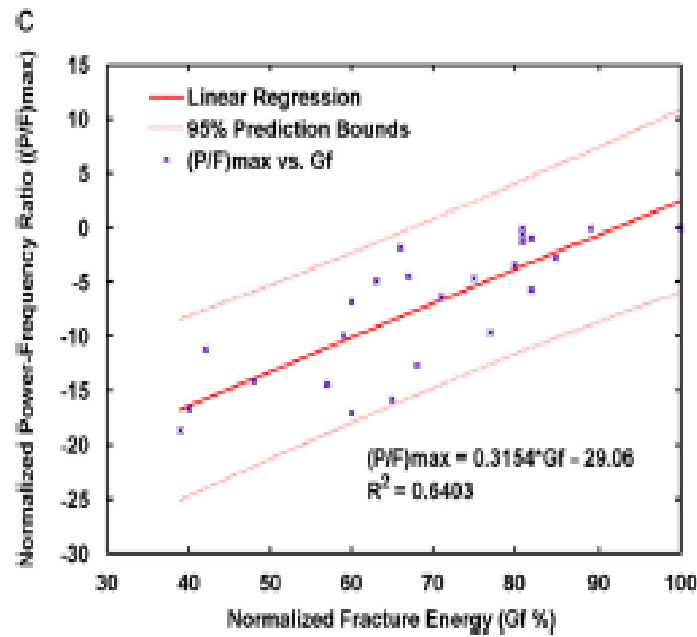
destructive study was carried out on mode-11 fracture loading of CFRP concrete samples subjected to some ageing conditions and temperature and a parameter, fracture energy was obtained. A correlation analysis was performed at each ageing temperature, between the non-destructive parameters (P_{avg} , P_{max}) and destructive parameter, as shown in **Fig.2.9**.

Fig 2.9 (a): Linear regression of non-destructive ultrasonic parameters vs. fracture energy results of CFRP–concrete samples subjected to accelerated aging temperatures: (a) average power (P_{avg}) vs. Fracture energy(Gf).(Mahmoud et al., 2010)

Fig 2.9(b): peak amplitude (V_{max}) vs. Fracture energy(Gf) (Mahmoud et al., 2010)

Fig 2.9 (c): Maximum power–frequency ratio of PSD ((P/F) max) vs fracture energy (). Linear equations and 95% prediction bounds are shown. (Mahmoud et al., 2010)

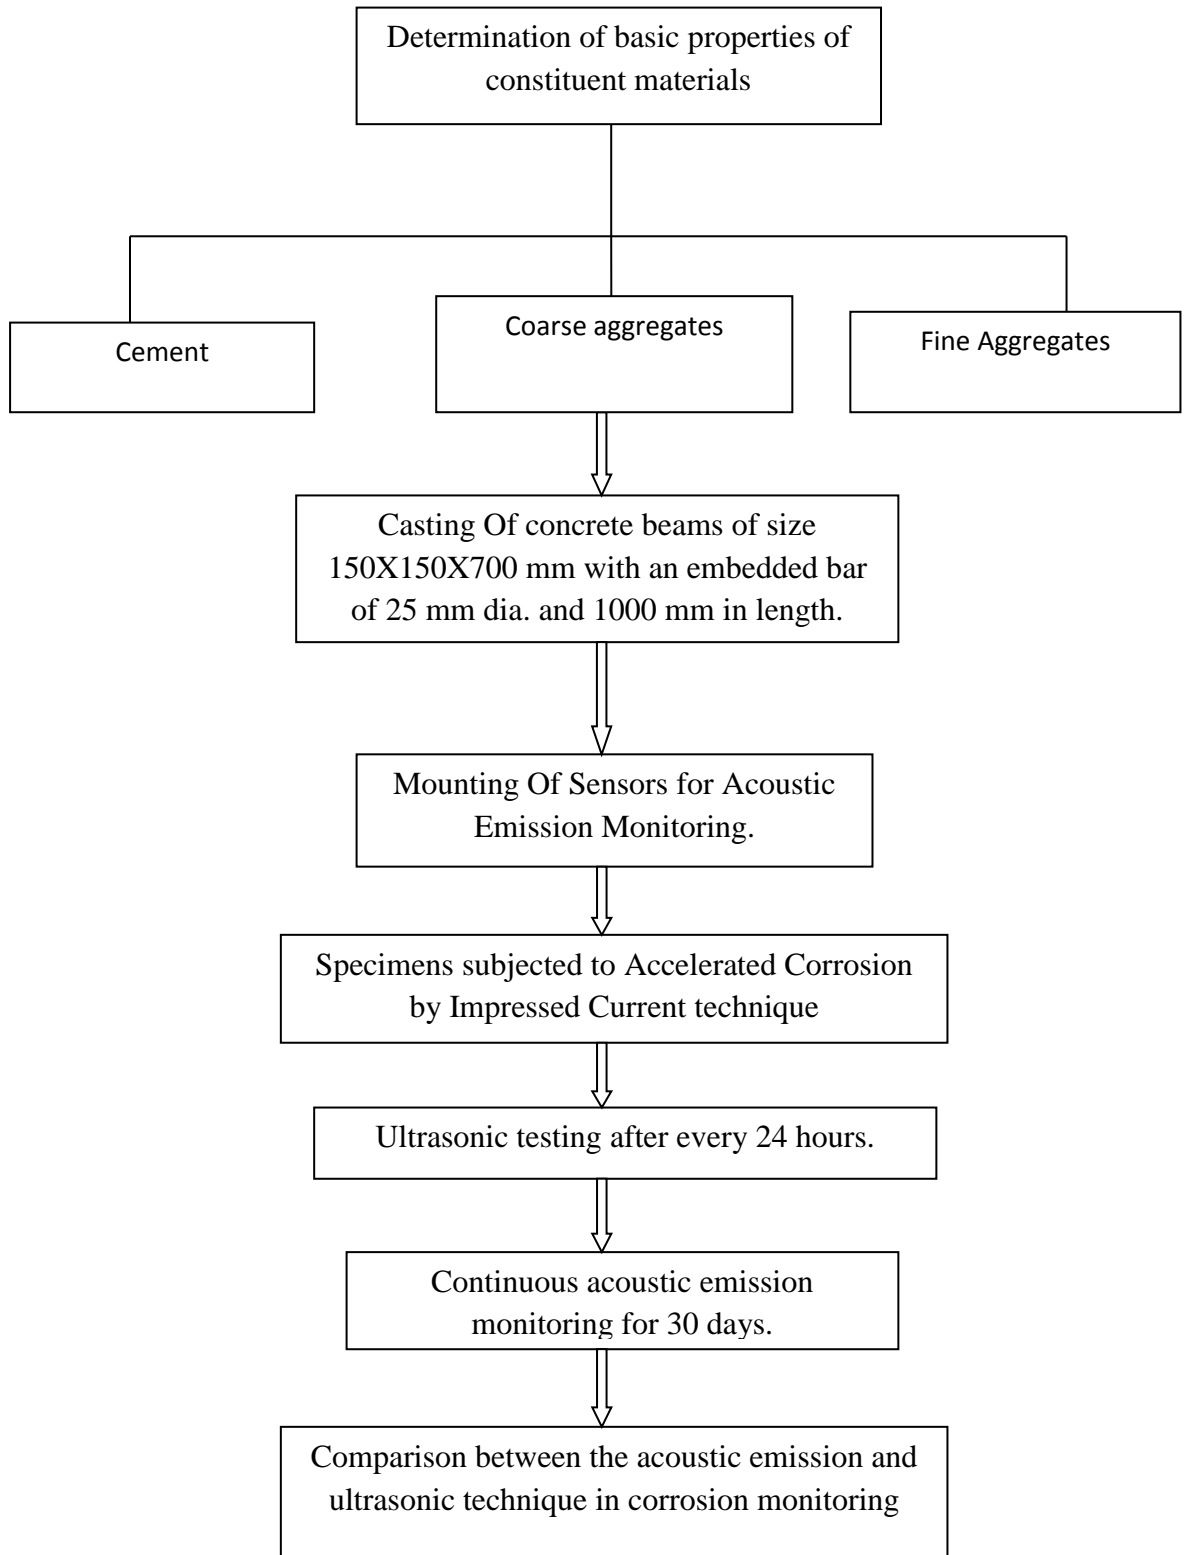
Fig.3.1: Test program in the form of flow chart

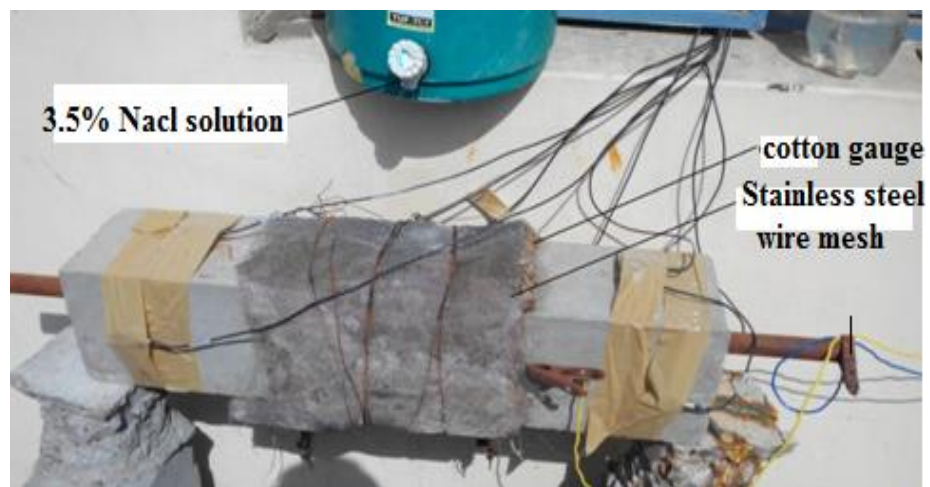
Fig.3.3: Test specimen with arrangement for induced corrosion

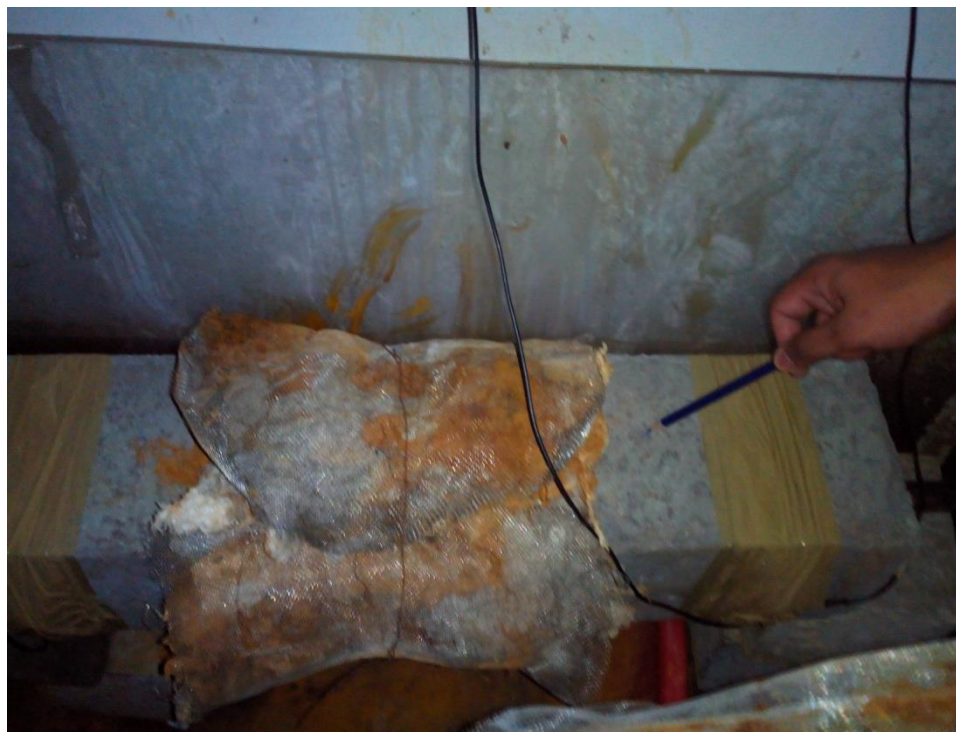
Fig.3.21: pencil break test done in the study.

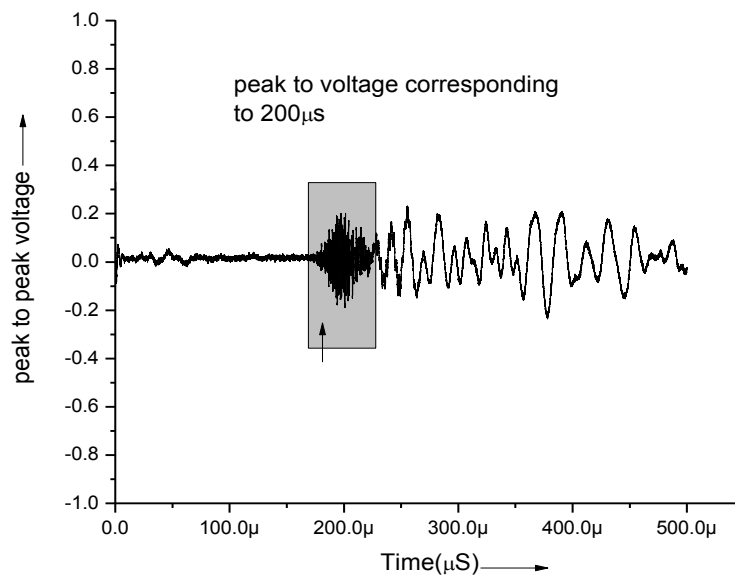
Fig.4.4: 15th day Peak to peak voltage

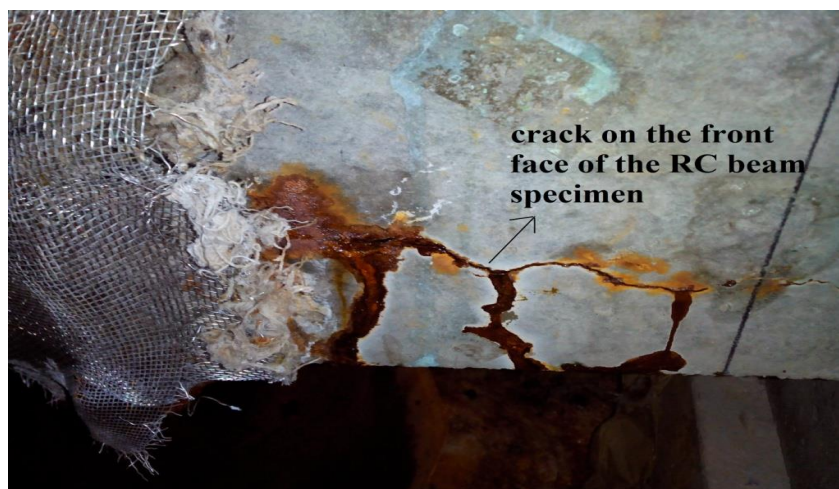
Fig.4.30: Condition of specimen after exposure to 20 days of accelerated corrosion

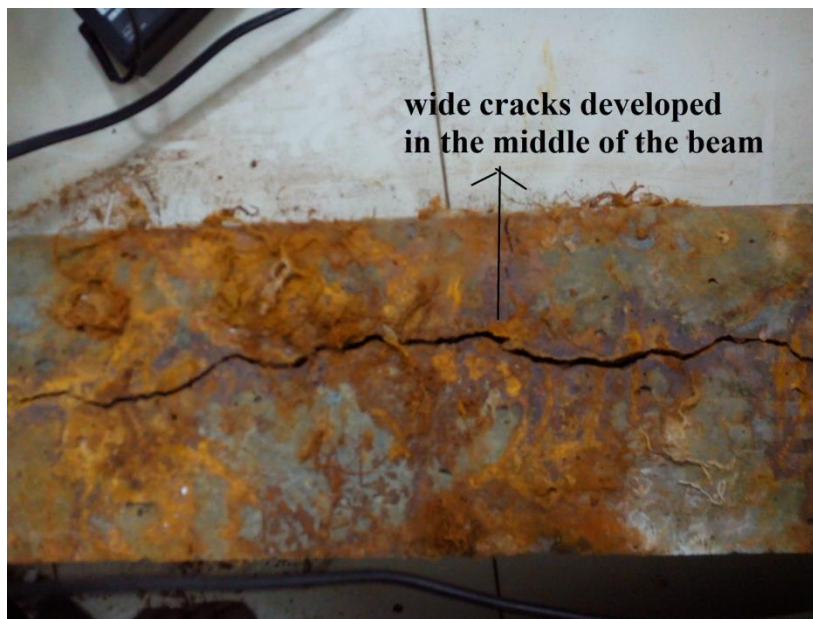
Fig.4.36: Cracks developed in specimen after 30 days of accelerated corrosion.
