DETERIORATION OF RC BEAMS DUE TO REINFORCEMENT CORROSION

A thesis report submitted in the partial fulfillment of the
requirements for the award of degree of

STRUCTURAL ENGINEERING

**DEPARTMENT OF CIVIL ENGINEERING, THAPAR
UNIVERSITY, PATIALA-147004, INDIA JANUARY –
JULY (2013)**

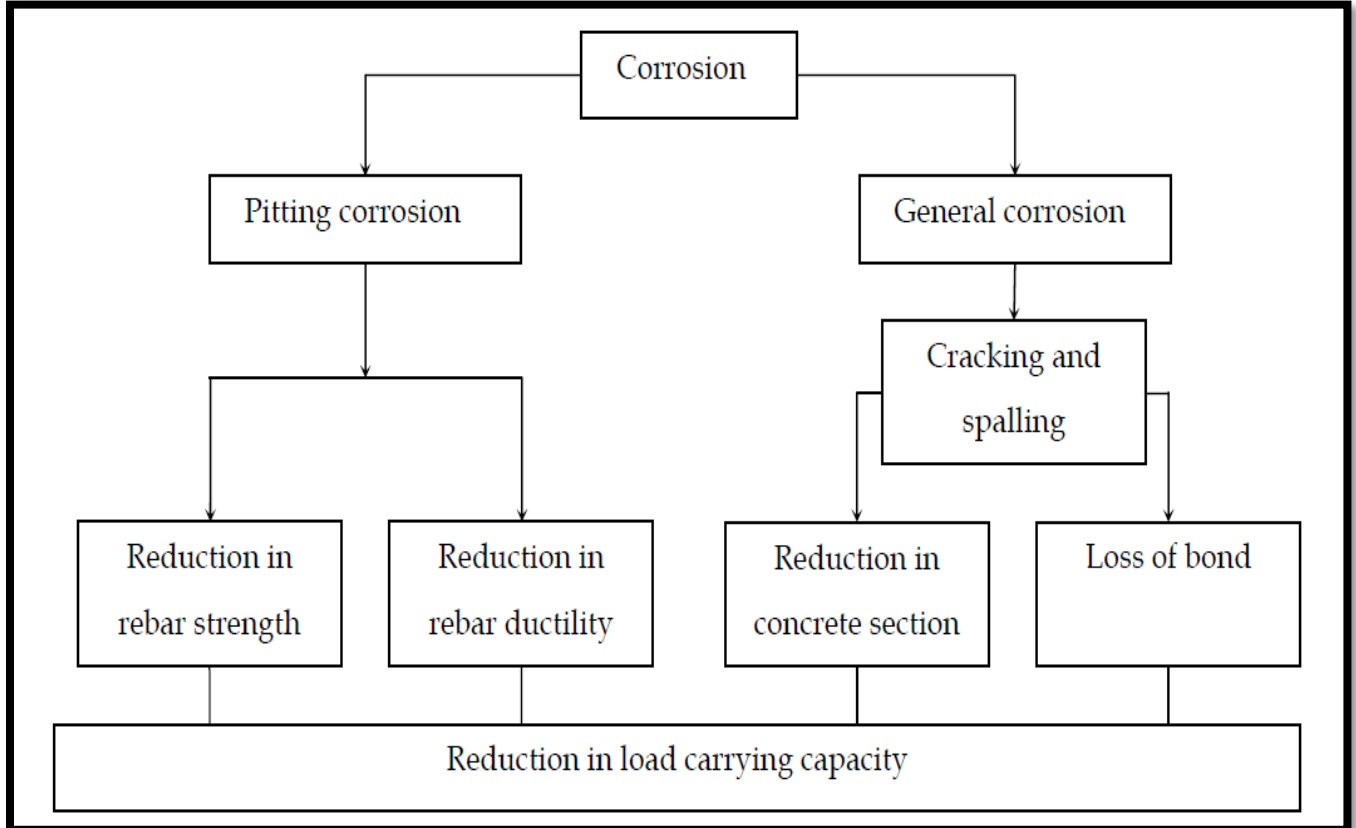
Fig: 1.2 Effects of corrosion on reinforced concrete members ([www.google](http://www.google.com) images.com)

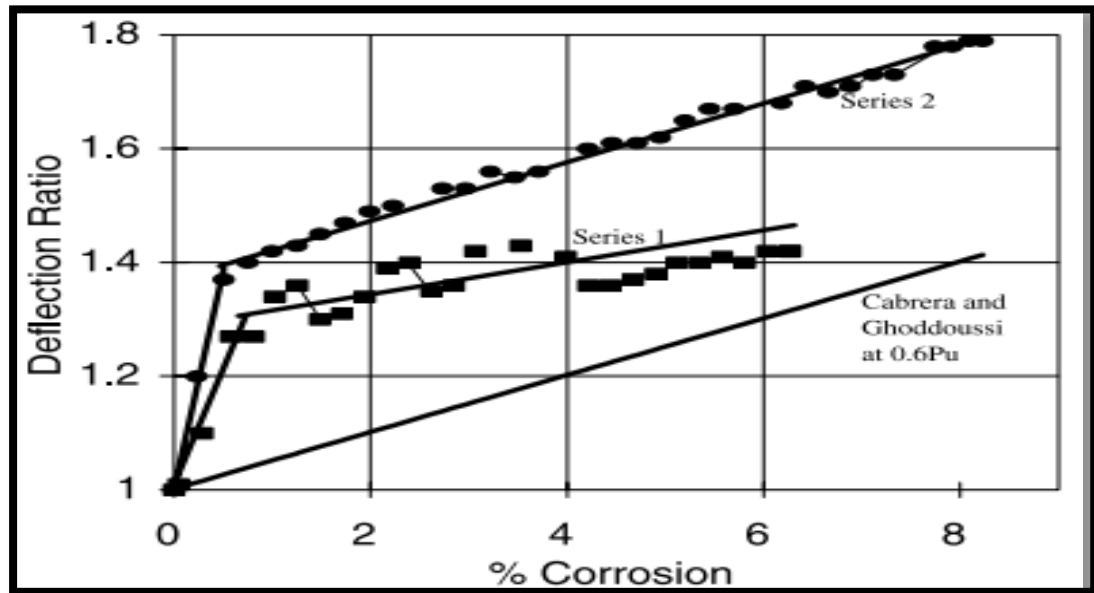
overtime, was found to be highest for beams corroded under a high load. It is therefore evident that deflections were more sensitive to the level of corrosion on beams corroded under a high load. In addition, this ratio was found to constantly increase with the level of corrosion which indicates that at higher levels of corrosion (especially for beams corroded under high loads), the majority of measured deflections would be from the corrosion and not the creep.

Fig: 3.4 Effect of corrosion on the deflection ratio of RC beams. Series I – loaded to 0.23Pu (Ballim and Reid, 2003)

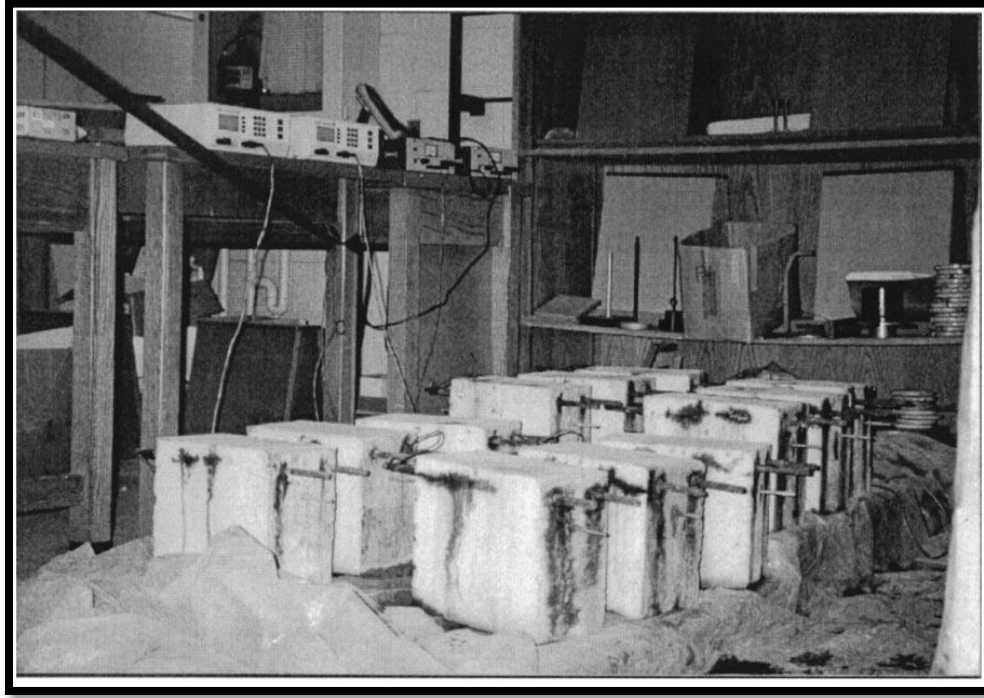
mix. The strain response due to the expansion of corrosion products was measured at each face of the prisms.

Fig: 3.5 General view for accelerated corrosion (El-Maaddawy et al., 2003)

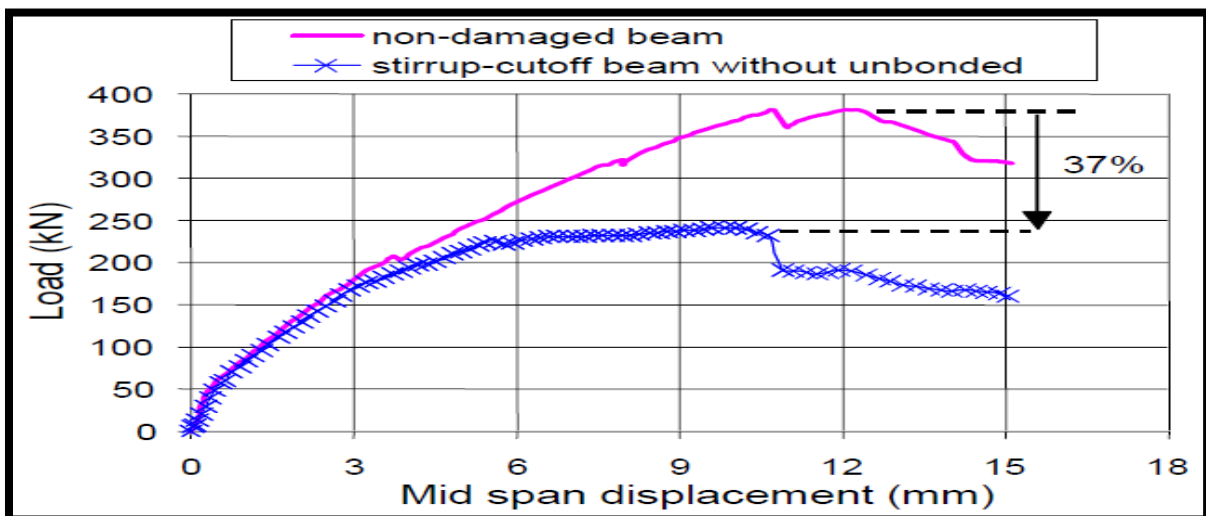
Fig: 3.7 below shows the load deflection curves of the damaged beam with the fractured stirrups and the undamaged reference beam. The results showed that the damaged beam experienced 37% reduction in shear capacity compared to the undamaged beam. It was also observed that beams having stirrups without proper anchorage experienced longitudinal cracking along the main reinforcement before inclined cracking, which leads to the ineffectiveness of stirrups. The load carrying mechanism was changed from a truss mechanism to a tied-arch action leading to anchorage failure of the main reinforcement.

Fig: 3.7 Load ~ Deflection Curve (Toongoenthong and Maekawa, 2005)

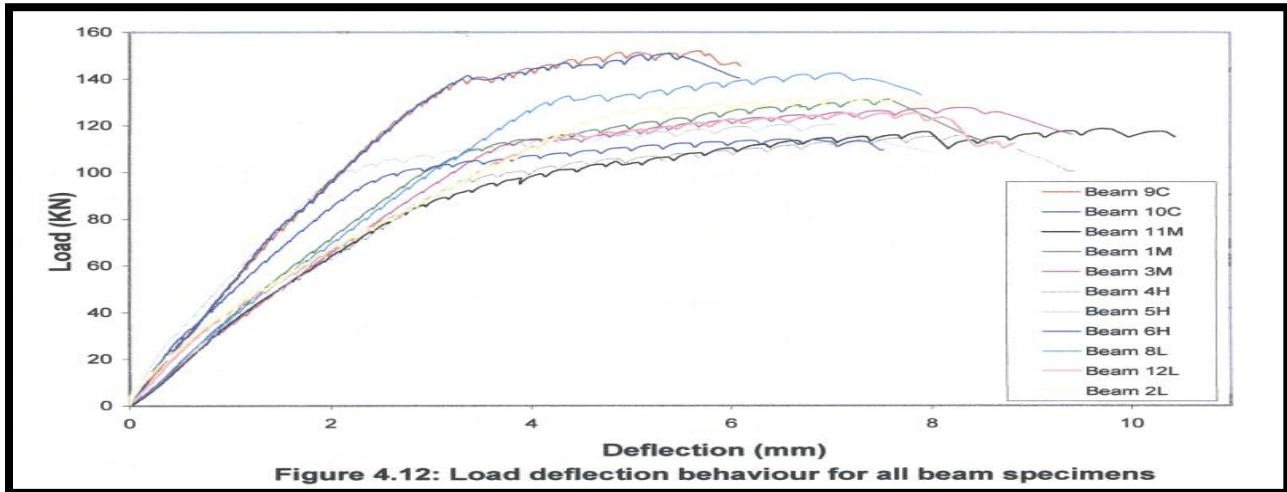
Joyce, (2008) carried out experiments to study the effect of corrosion on the flexural behavior of reinforced concrete (RC) beams. The corrosion of the steel was isolated in the flexural region in order to eliminate contributions from stirrup corrosion and loss of bond within the development length. It was determined that the flexural capacity of reinforced concrete beams decreased as the rate of corrosion increased.

Fig: 3.8 Load Deflection Behavior for all beam specimens Joyce, 2008

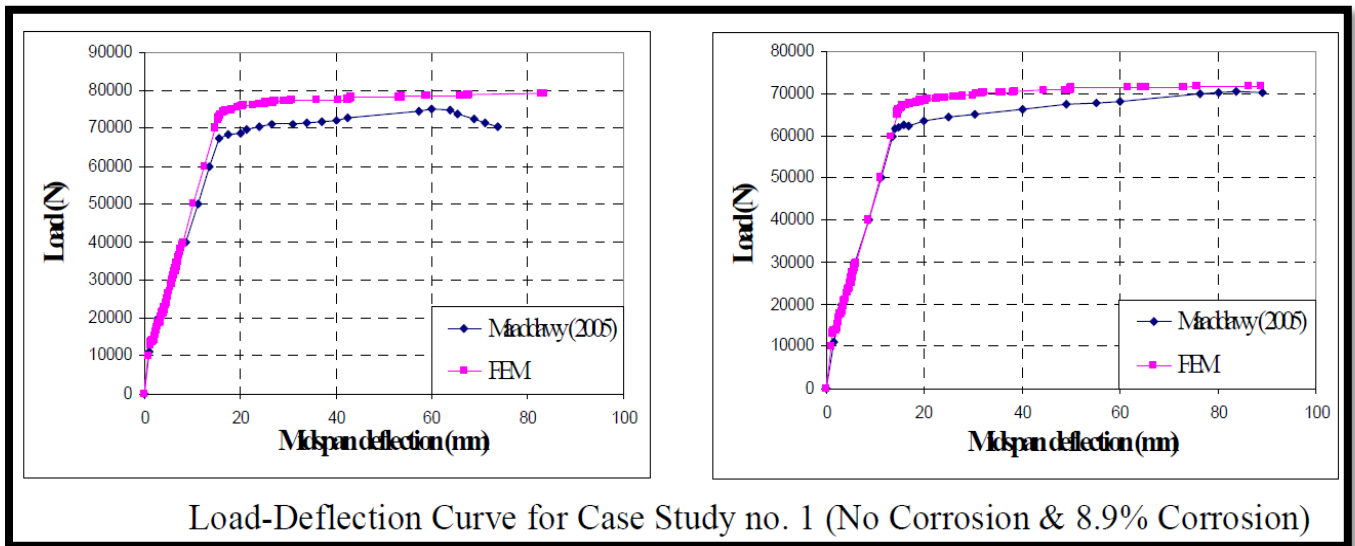
For case study no.1 where corrosion of reinforcement in the middle portion of RC beam, the study showed that bond-slip contributed relatively smaller effect than did the reduction of the cross-sectional steel area. When the degree of corrosion increased, the ultimate load and the yield load decreased accordingly. Immediately after first crack at the middle portion of the beam, additional flexural cracks occur at interval within constant moment region. At the ultimate load capacity, diagonal tensile crack occurs at the shear region near support, and the compressive crushing occurs at the top fiber of the beam.

**Fig: 3.11 Load-Deflection Curve for Case Study no. 1 (No Corrosion & 8.9% Corrosion)
(Phuvoravan)**

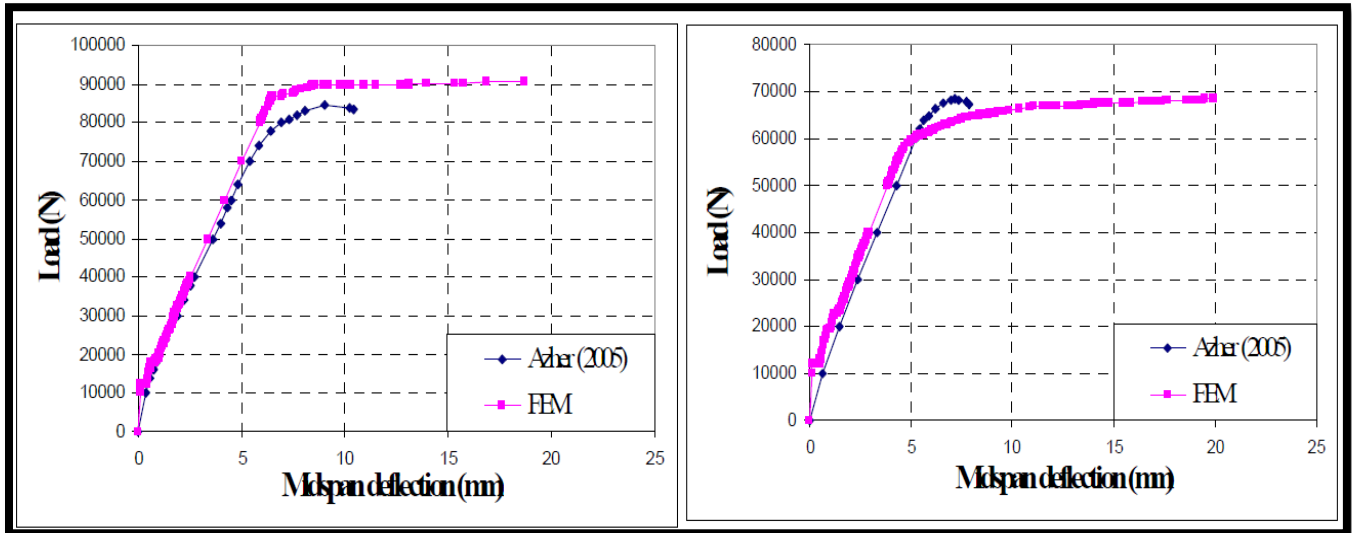
For case study no. 2 where corrosion of reinforcement for the whole length of RC beam, bond-slip behavior plays a important role in the flexural behavior of the beam. When the degree of corrosion increased, the ultimate load and the yield load decreased rapidly. At first cracking state, flexural cracking is concentrated at the middle bottom portion of the beam. At the ultimate load capacity, diagonal tensile crack occurs at the shear region near support, the compressive crushing occurs at the top fiber of the beam, and cracking spreads throughout the beam.

Fig: 3.12 Load-Deflection Curve for Case Study no. 2 (No Corrosion & 8.8% Corrosion) (Phuvoravan)

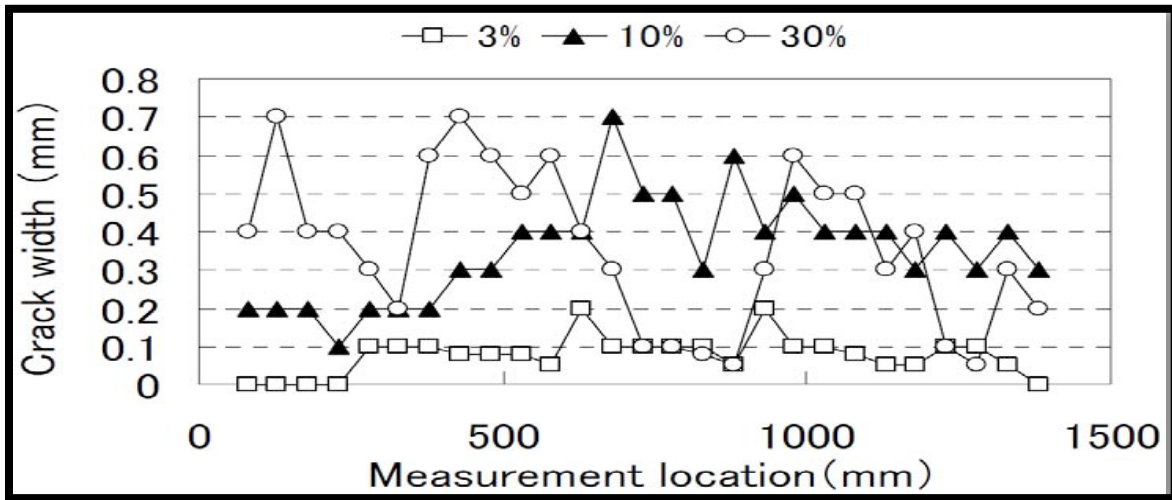
weight loss. In severe corrosion case (10 % and 30 % cases), crack width along a specimen axis was not so constant that it indicates that corrosion was occurred locally.

Fig: 3.13 Crack width Okude et. al., (2009)

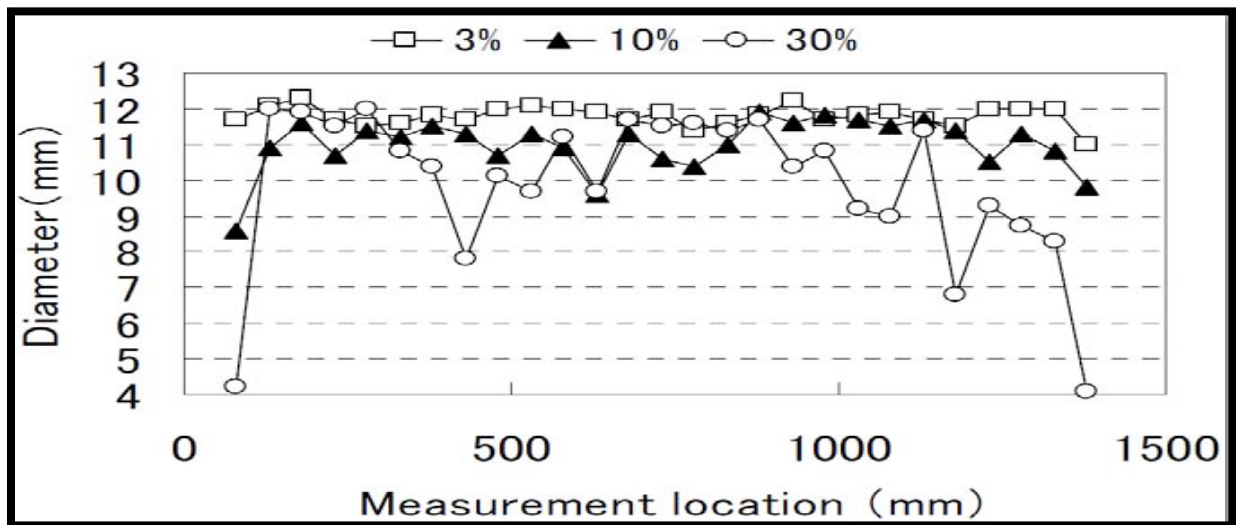
Fig: 3.14 shown below indicates the diameter of rebar measured in longitudinal direction at an interval of 50 mm. Nominal diameter of the rebar used in this test was 13 mm. Significant decrease of rebar diameter was observed locally, especially in the case of severe corrosion (30%).

Fig: 3.14 Diameter rebar measured in longitudinal direction Okude et al., (2009)

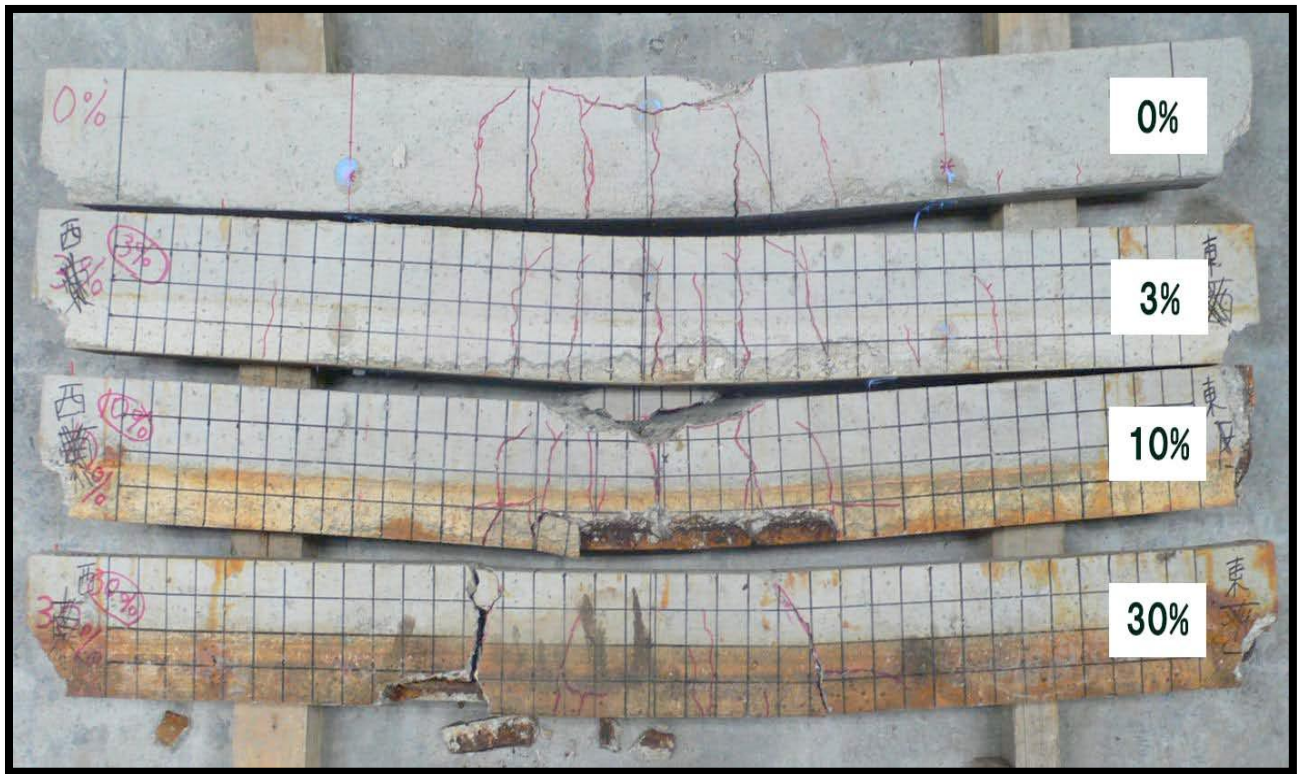
Four-point bending tests were conducted with a constant moment length of 280 mm and total span length of 1260 mm. In this test, load and displacement at loading points were measured by a load cell with a capacity of 100 kN (sensitivity: 33 N) and LVDT with a capacity of 50 mm (sensitivity: 0.01 mm), respectively. Fig: 3.15 shown below represent the crack patterns after the loading tests. In the case of no corrosion, more than five cracks were observed. Decrease in the number of cracks, which normally represents lower bond property, was observed in only 30% case.

Fig: 3.15 Crack patterns after loading tests Okude et. al., (2009)

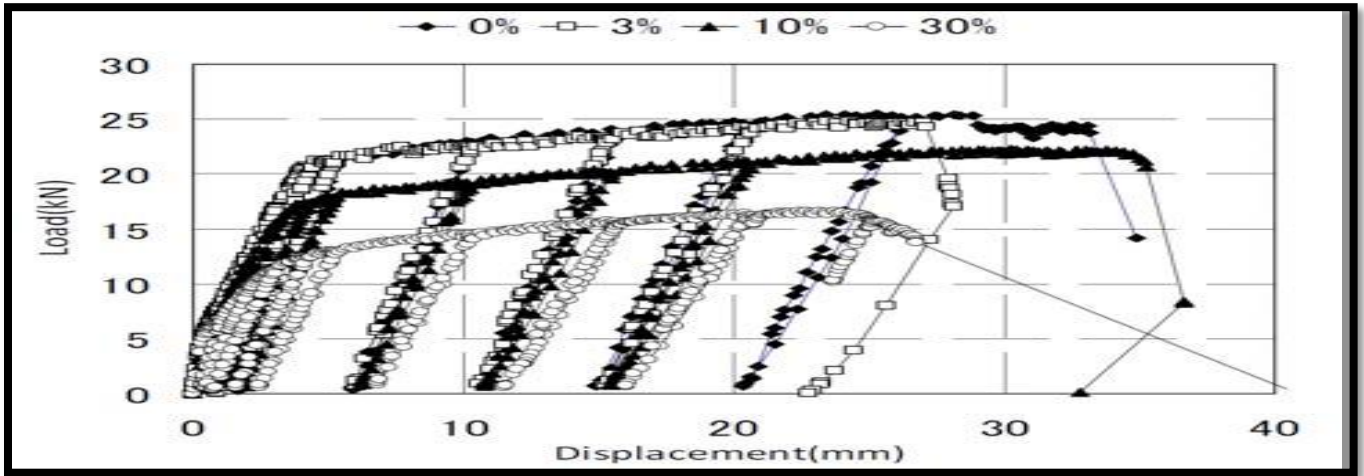
Fig: 3.16 below shows the measured load-displacement curves in all series. There was no significant difference in 0% and 3% cases. In other cases, however, the yielding and maximum loads became lower with increasing corrosion levels (weight loss). Especially in the case of 30%, rebar was finally broken.

Fig: 3.16 Load Vs Displacement curve Okude et al., (2009)

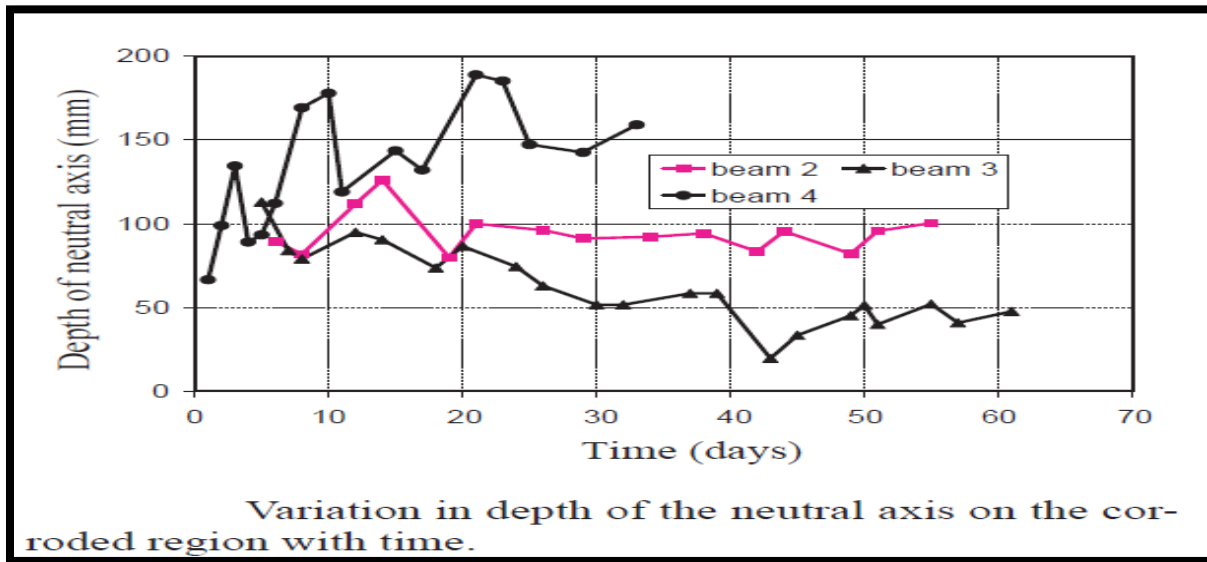
Fig: 3.19 below shows that depth of the neutral axis is independent of the level of corrosion for beams free from flexural cracks and beams free from corrosion but significantly reduces with an increase in degree of corrosion for corroded beams with flexural cracks as shown below.

Fig: 3.19 Variation in depth of the neutral axis on the corroded region with time.
 Malumbela et al., 2009

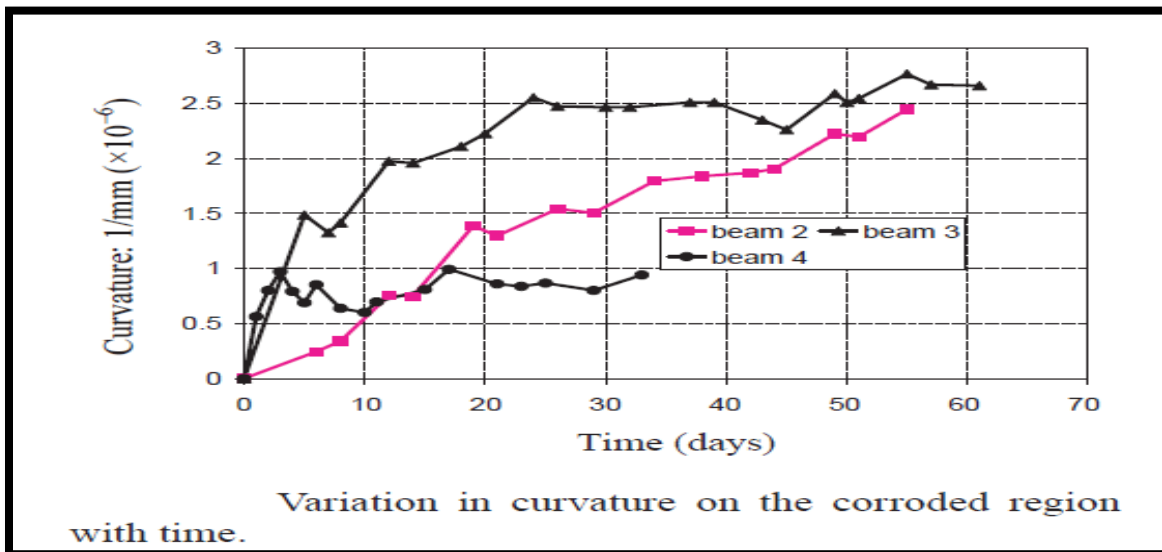
Fig: 3.20 below shows that curvatures of corroded beams increase monotonically with degree of corrosion but at a decreasing rate.

Fig: 3.20 Variation in curvature on the corroded region with time.
 Malumbela et al., 2009

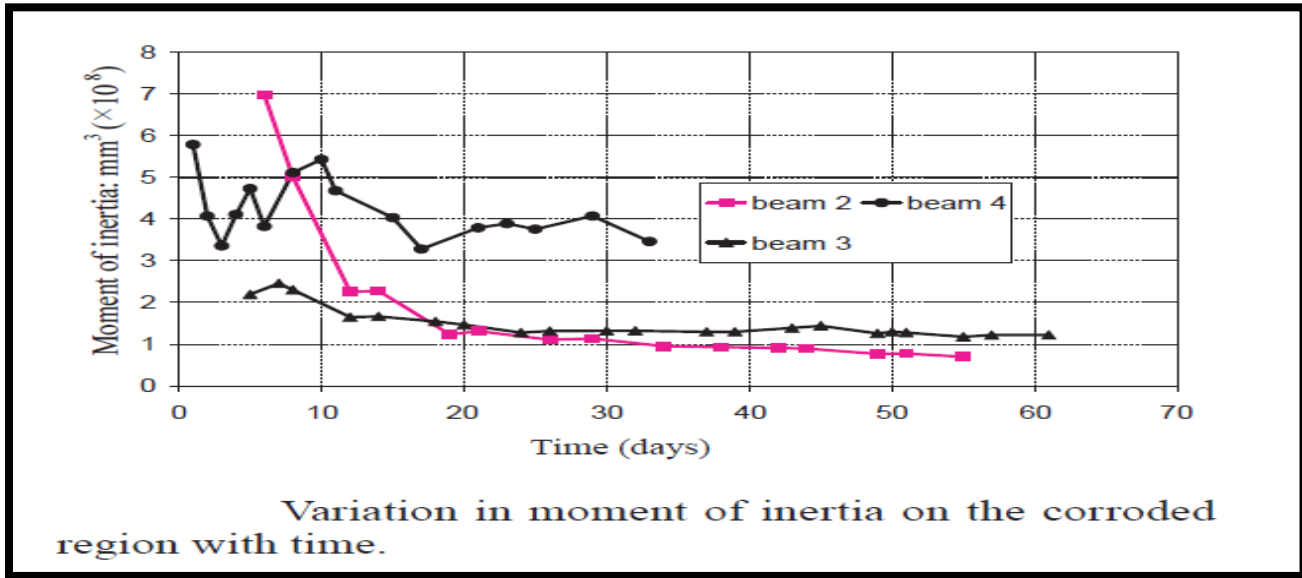
1. The effective moment of inertia of corroded beams decreases monotonically with time of electrolysis but at a decreasing rate.
2. For corroded beams, the effective moment of inertia of beams with flexural cracks is almost the same as the effective moment of inertia of beams free from flexural cracks

Fig: 3.21 Variation in moment of inertia on the corroded region with time.
Malumbela et al., 2009

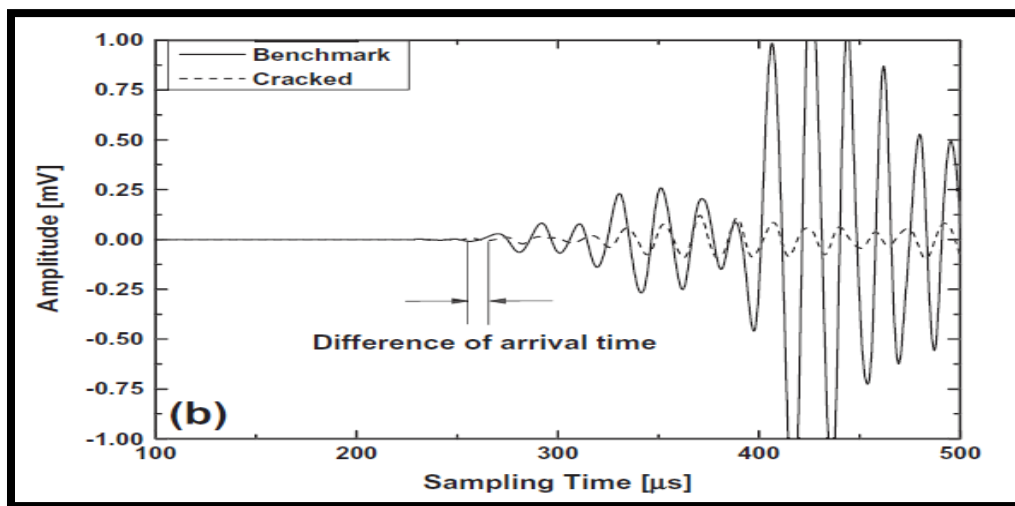
Experimental testing demonstrated that the surface-attached PZT disks were capable of detecting the change in material properties due to the existence of cracking. It was concluded that slim piezoelectric elements can activate and sense bulk and surface waves propagating in concrete with a good signal-to-noise ratio at frequencies below 100 kHz. A decrease in the dynamic Young’s modulus of concrete beams due to concrete cracking can be evaluated by the change in the velocity of bulk waves propagating in the concrete. The presence of surrounding concrete significantly dissipates the propagation of guided waves through the embedded rebar, indicated by decreases in wave magnitude and velocity.

Fig: 3.23 Comparison of wave signals with and without cracking damage (Ye Lu et al., 2013)

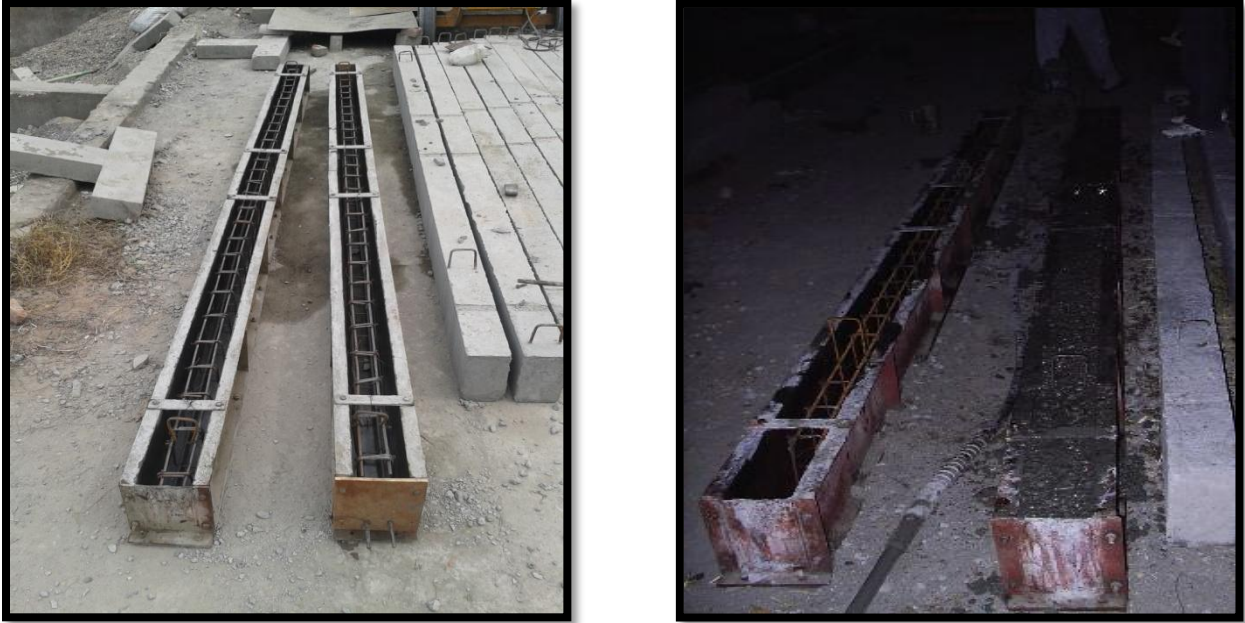
The casting of beams was done in single stage. The beams were cast in mould of size 127 x 227 x 4100 mm. Entire beam mould is first oiled so that the beam can be easily removed from the mould after 24 hours. Spacers of size 25mm are used to provide uniform cover to the reinforcement. When the bars have been placed in position as per design, concrete mix is poured in the mould and the beam is vibrated using a needle vibrator, to ensure the proper compaction. The vibration is done until the mould is completely filled and there is no gap left. The beams are then removed from the mould after 48 hours. After demoulding the beams are cured for 28 days using jute bags. Fig. 4.2 shows the beams before and after casting.

Fig. 4.2 Beams Before and After Casting

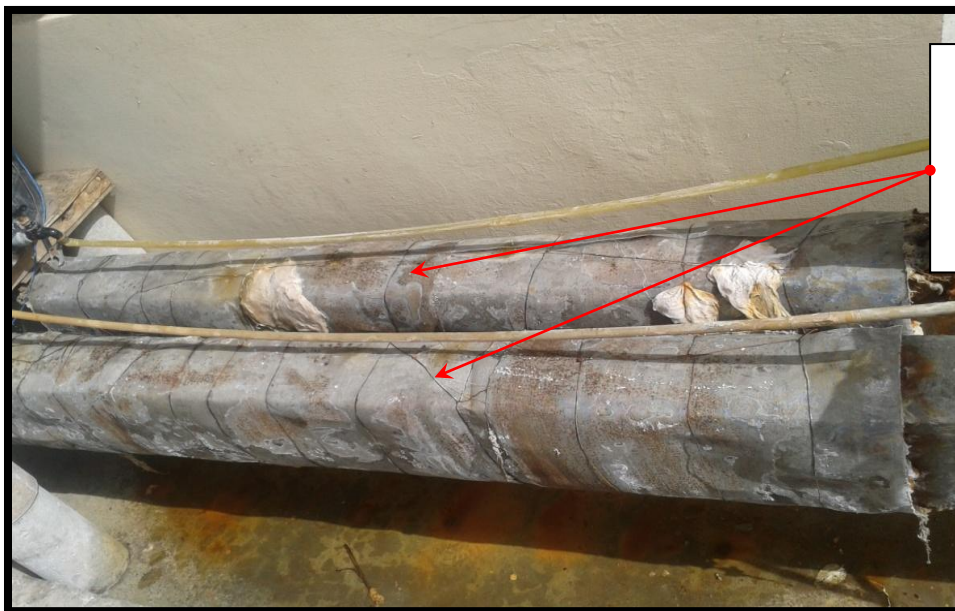
Stainless steel wire mesh wrapped all around concrete beams at centre 1.5m portion served as a cathode

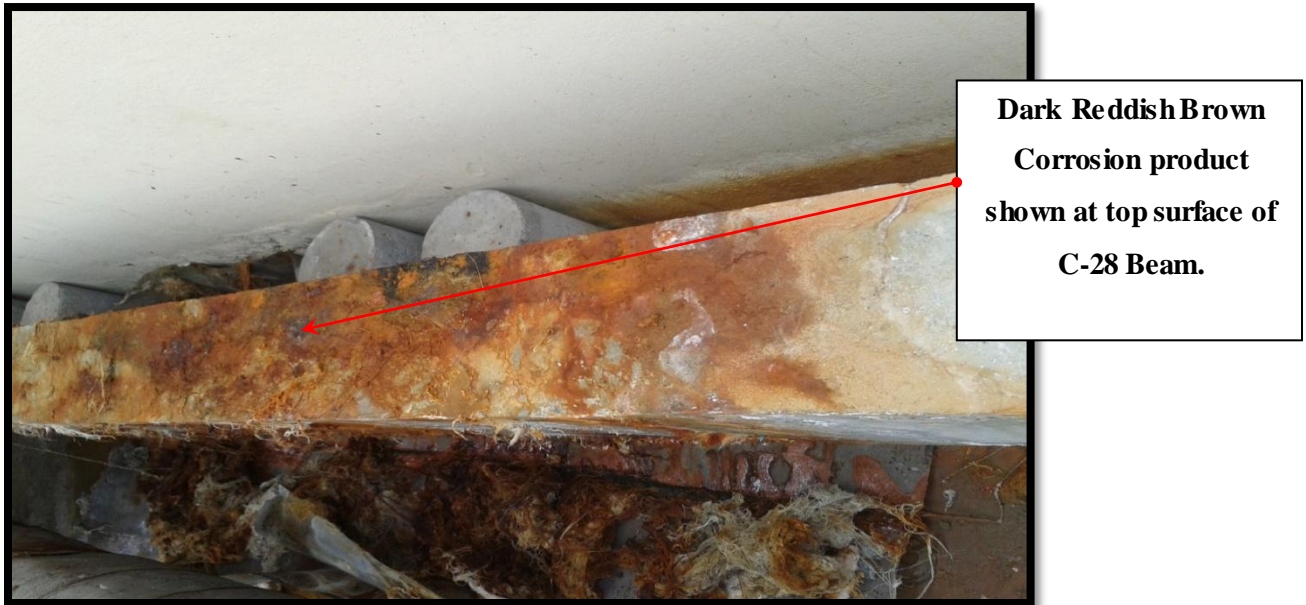
Beams undergoing corrosion for 28 days shows dark reddish brown corrosion products with reddish brown liquid oozes out from the cracks on all faces of the beam at centre 1.5m portion. Corrosion products formed in C-28 beam was in large volume than in other cases. At the top surface of C-28 beam continuous longitudinal crack was observed throughout the centre 1.5m portion of the beam as shown in Fig: 5.1. At the front side face also longitudinal crack was observed throughout the centre 1.5m portion along the tension bar as shown in Fig: 5.2. At the back side face small vertical and horizontal cracks were observed as shown in Fig: 5.3. At the bottom face of beam large corrosion products were noticed but no crack generated. It was noted that deterioration of C-28 beam due to corrosion was more than the other beams.

Fig: 5.1 (a) Top surface of C-28 beam

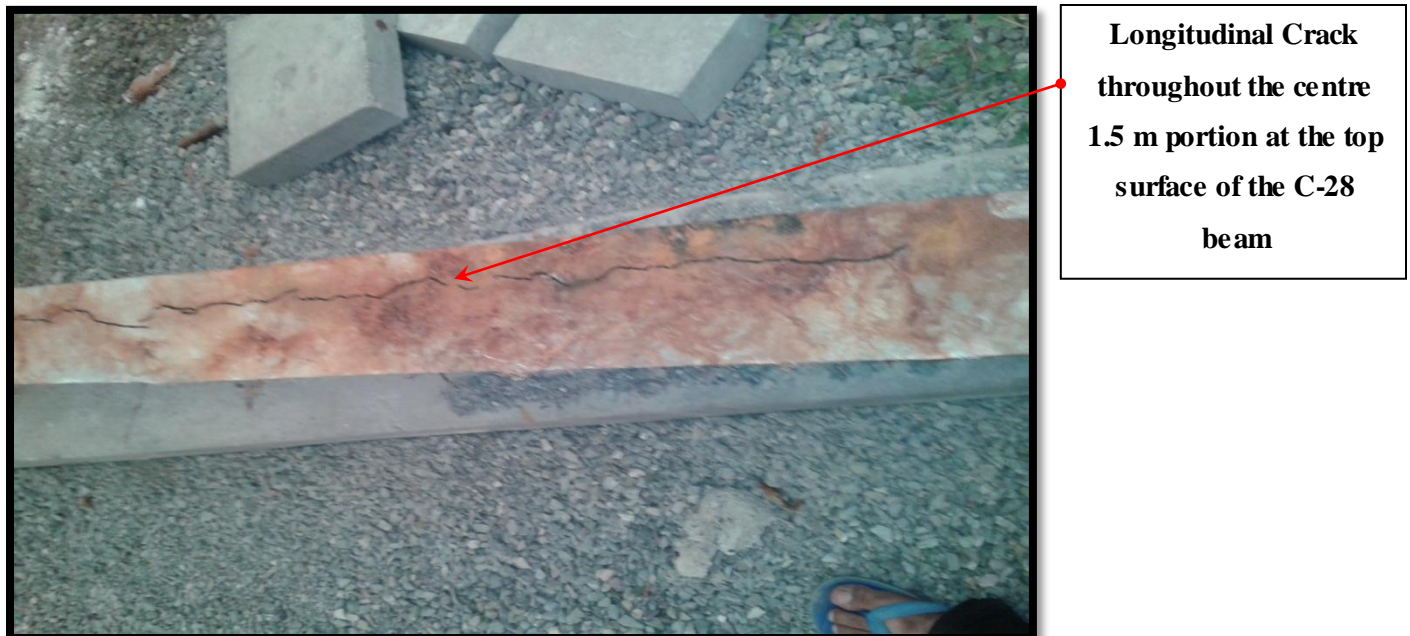
Fig: 5.1 (b) Longitudinal Crack on top surface of C-28 beam

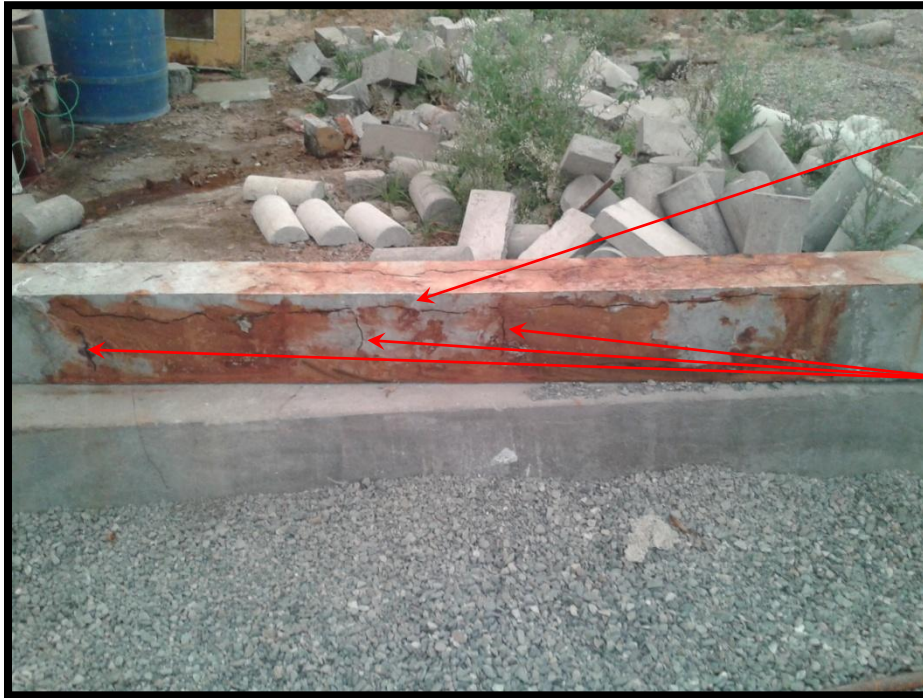
Longitudinal Crack along the compression bar throughout the corroded portion near the tension bar

Fig: 5.2 Front Side Face of C-28 Beam

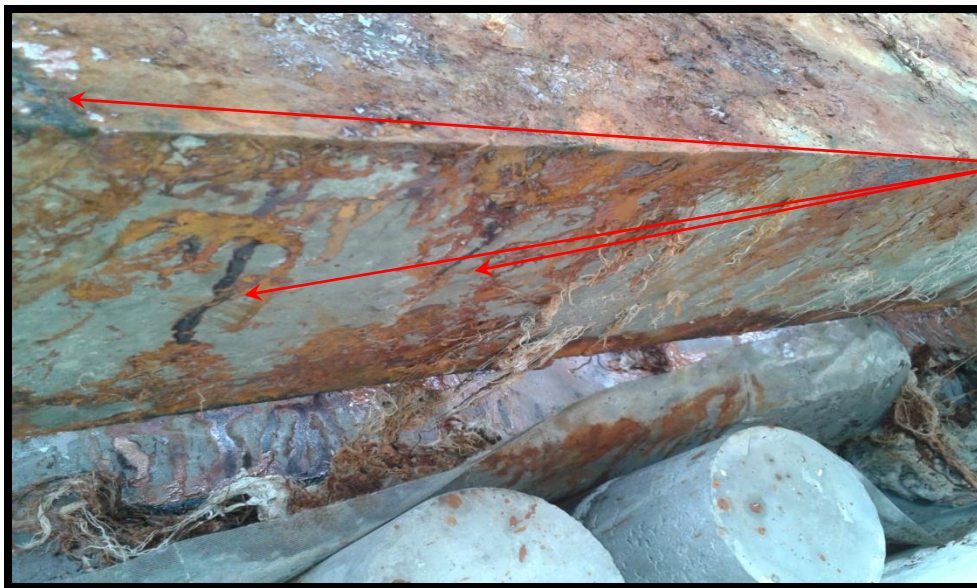
Dark Reddish brown liquid oozes out from the vertical cracks

Fig: 5.3 (a) Back Side Face of C-28 beam.

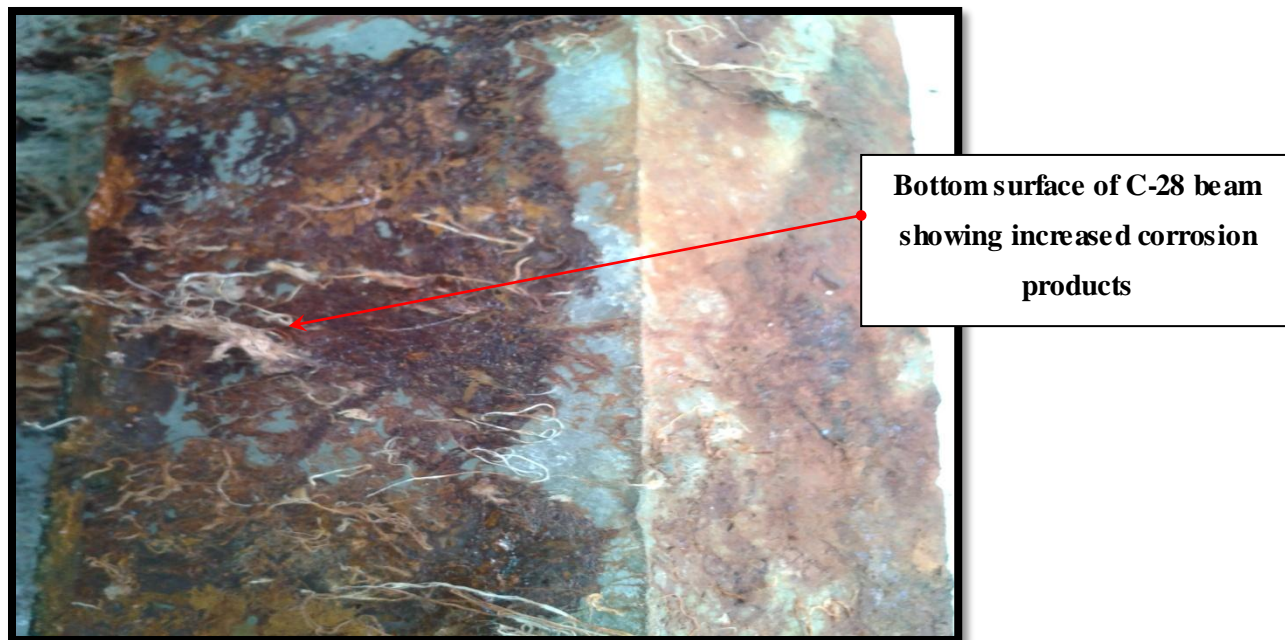
Fig: 5.4 Bottom Face of C-28 beam

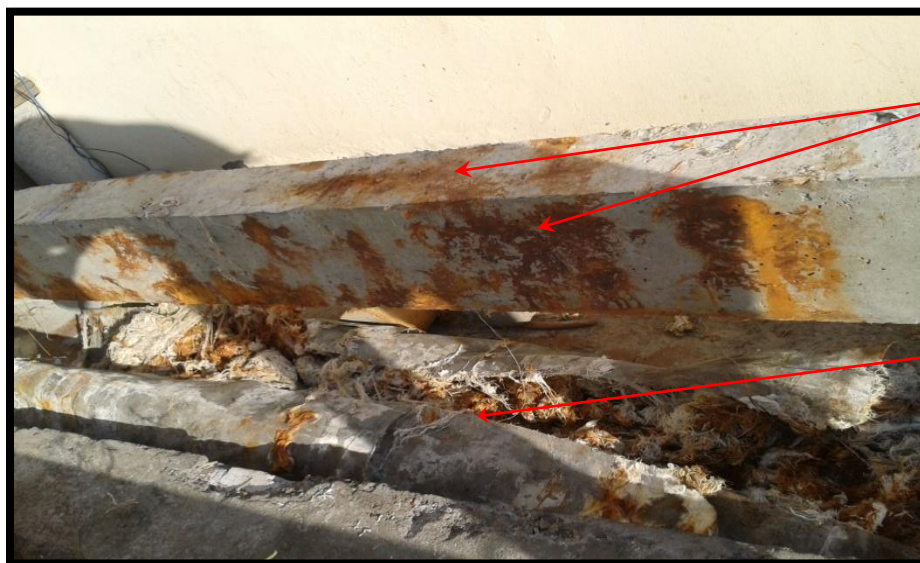
Top and Front Side Face of beam with corrosion patches

Fig: 5.6 Front Side face of C-6 beam

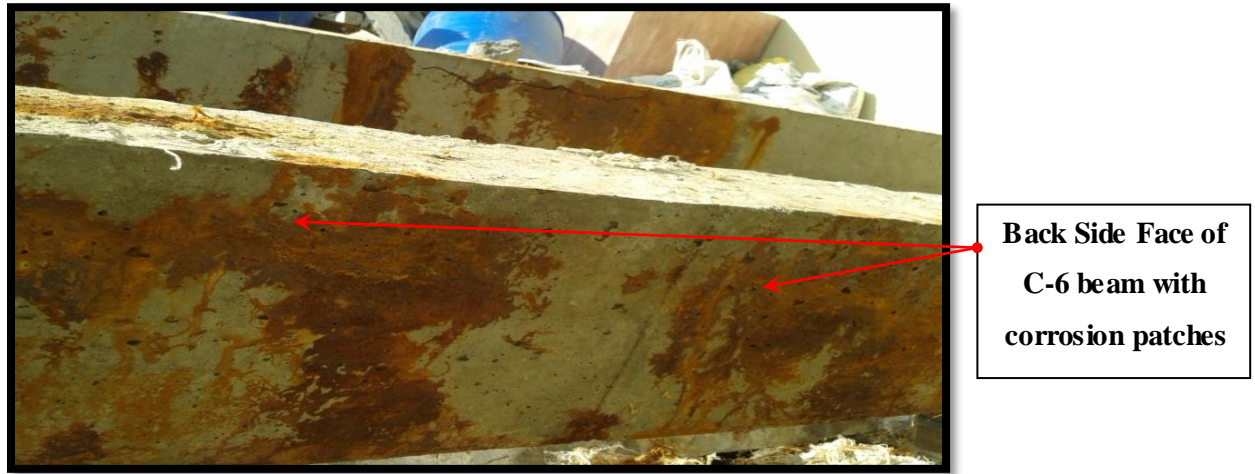
Fig: 5.7 back Side face C-6 beam

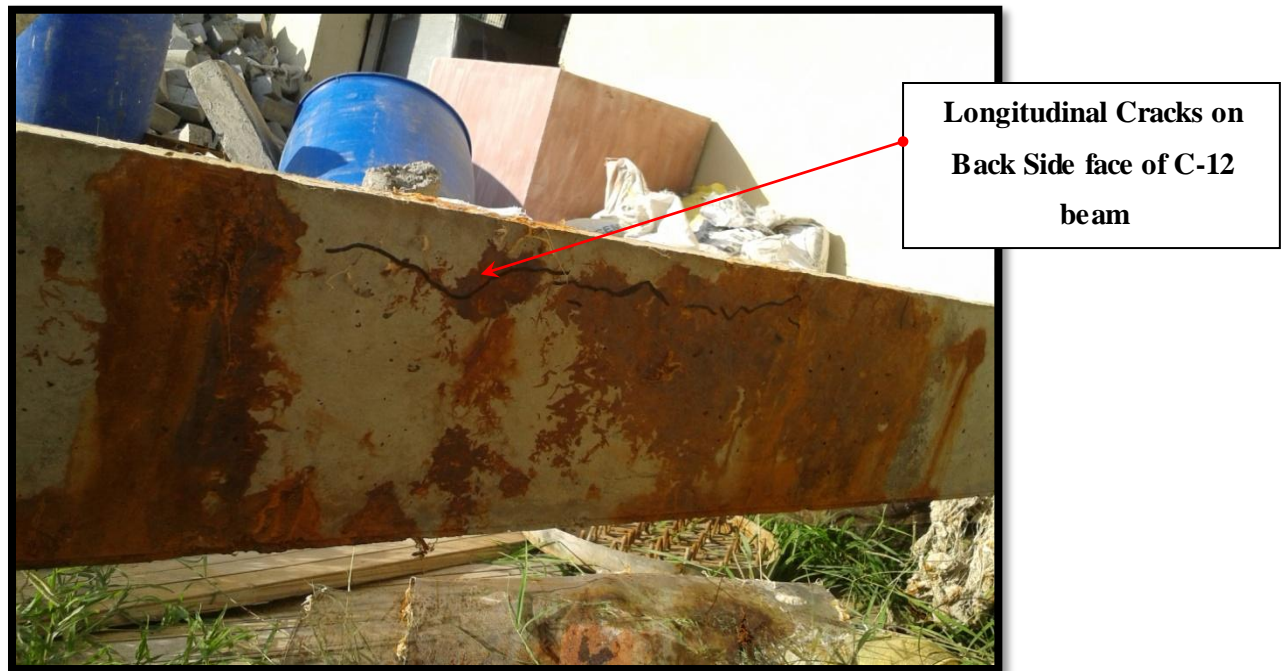
Fig: 5.10 Back Side Face of C-12 beam

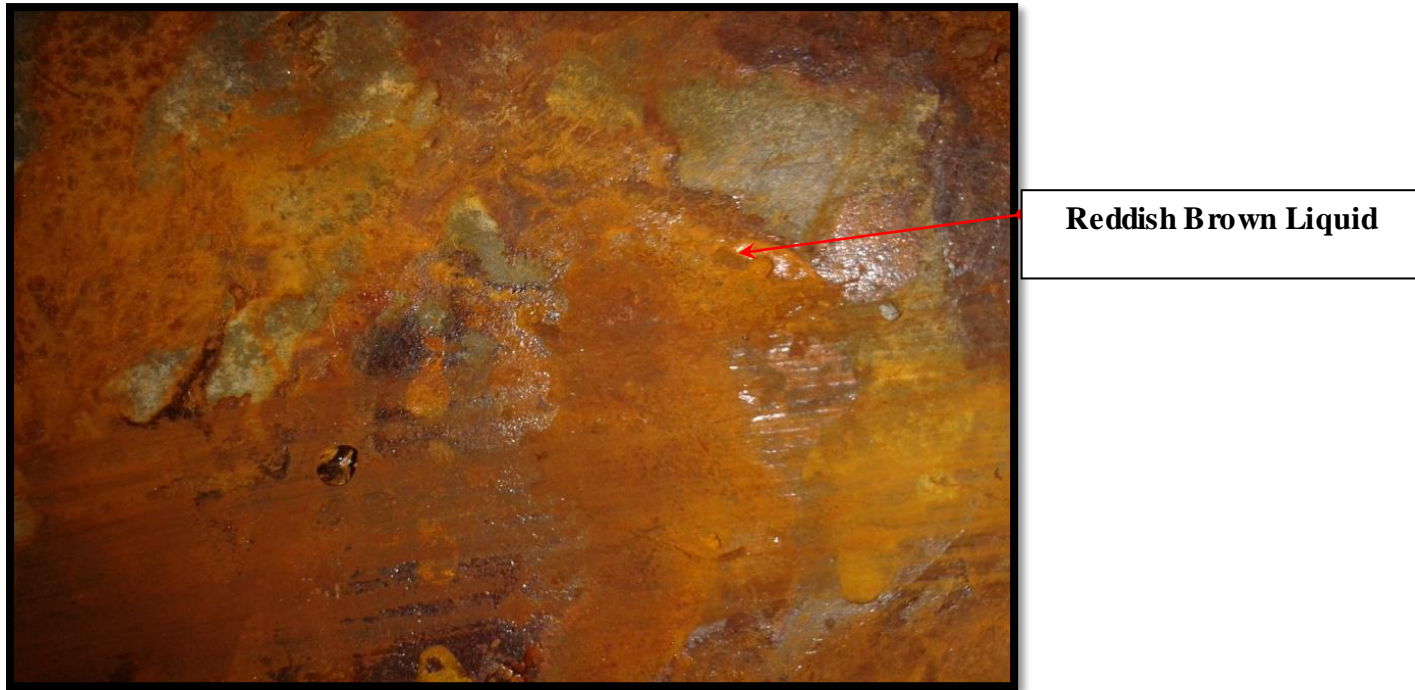
Fig: 5.14 back Side face of C-18 Beam

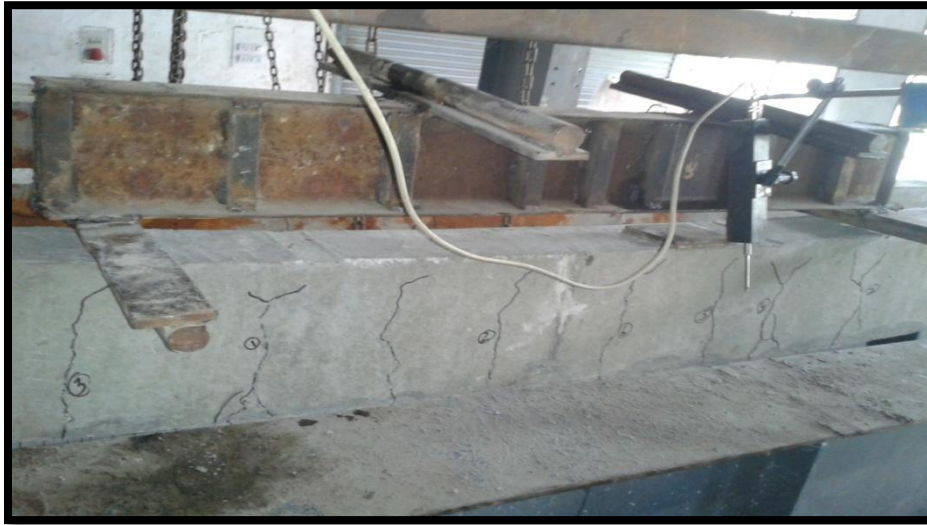
Fig: 5.15 Flexure Cracks on side face of C-0 beam

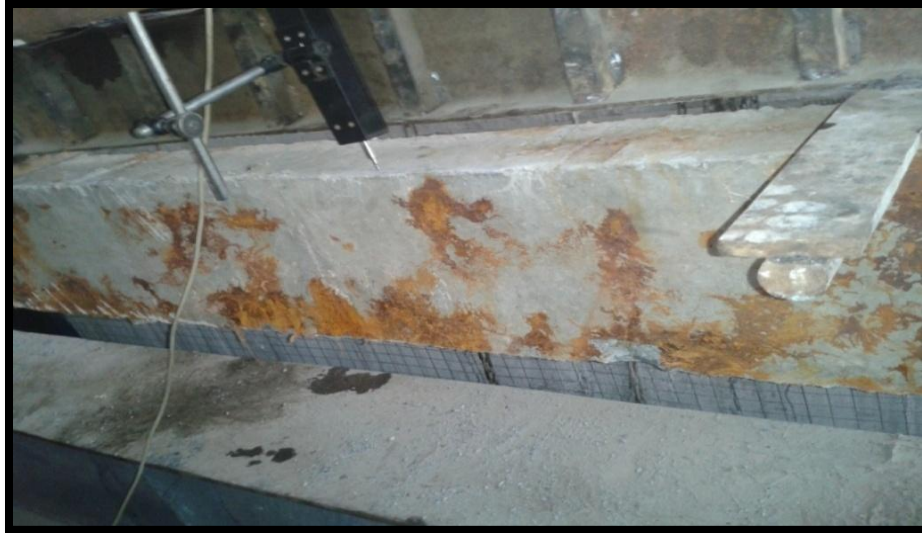
Fig: 5.17 Side face of C-6 Beam before loading

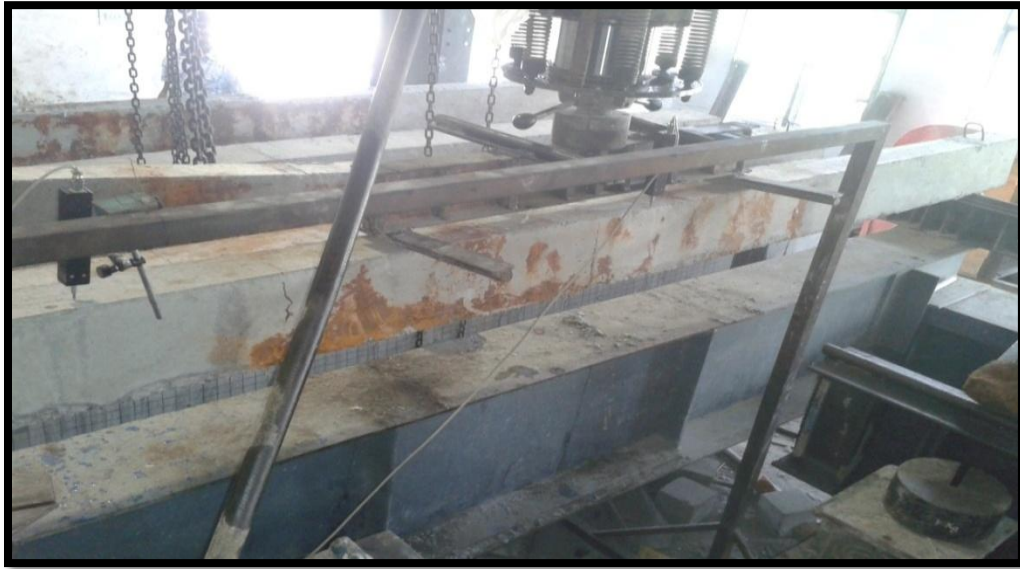
Fig: 5.20 Side face of C-12 Beam before loading
