DETERIORATION OF RC BEAMS DUE TO REINFORCEMENT CORROSION

A thesis report submitted in the partial fulfillment of the
requirements for the award of degree of

STRUCTURAL ENGINEERING

**DEPARTMENT OF CIVIL ENGINEERING, THAPAR
UNIVERSITY, PATIALA-147004, INDIA JANUARY –
JULY (2013)**

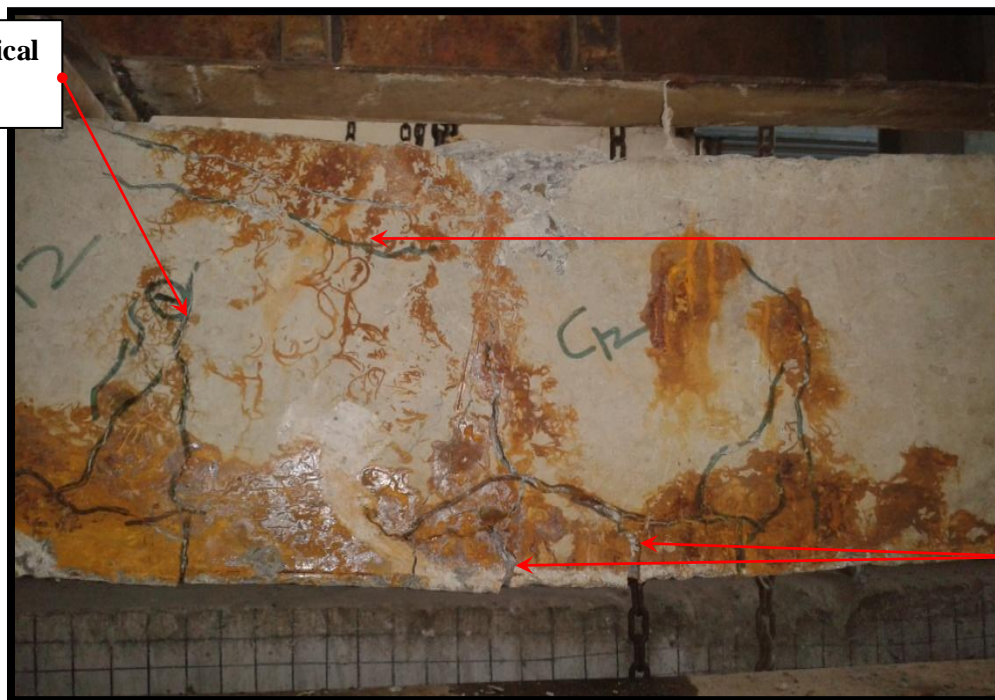
First Vertical
Crack

Fig: 5.21 Side face of C-12 Beam showing cracks after failure

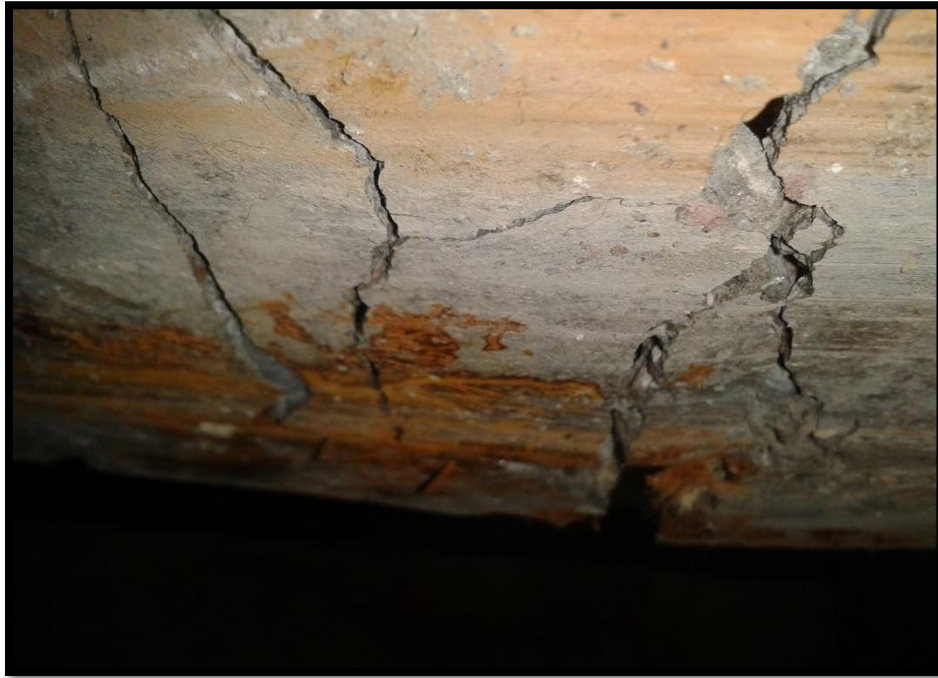
Fig: 5.22 C-12 Beam showing Cracks generated at the soffit after failure

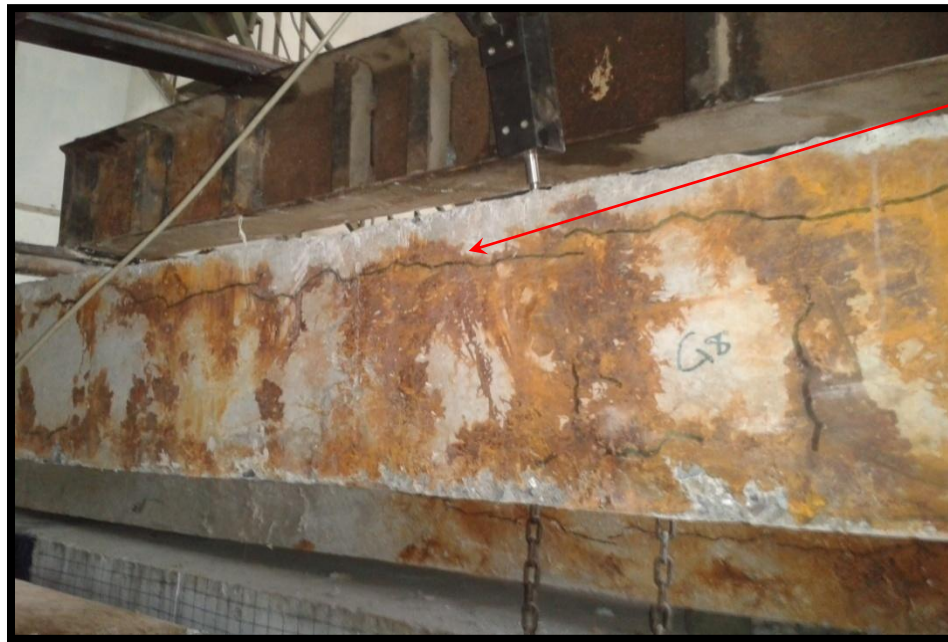
**Longitudinal
corrosion crack
before loading**

Fig: 5.24 Side face of C-18 Beam before loading

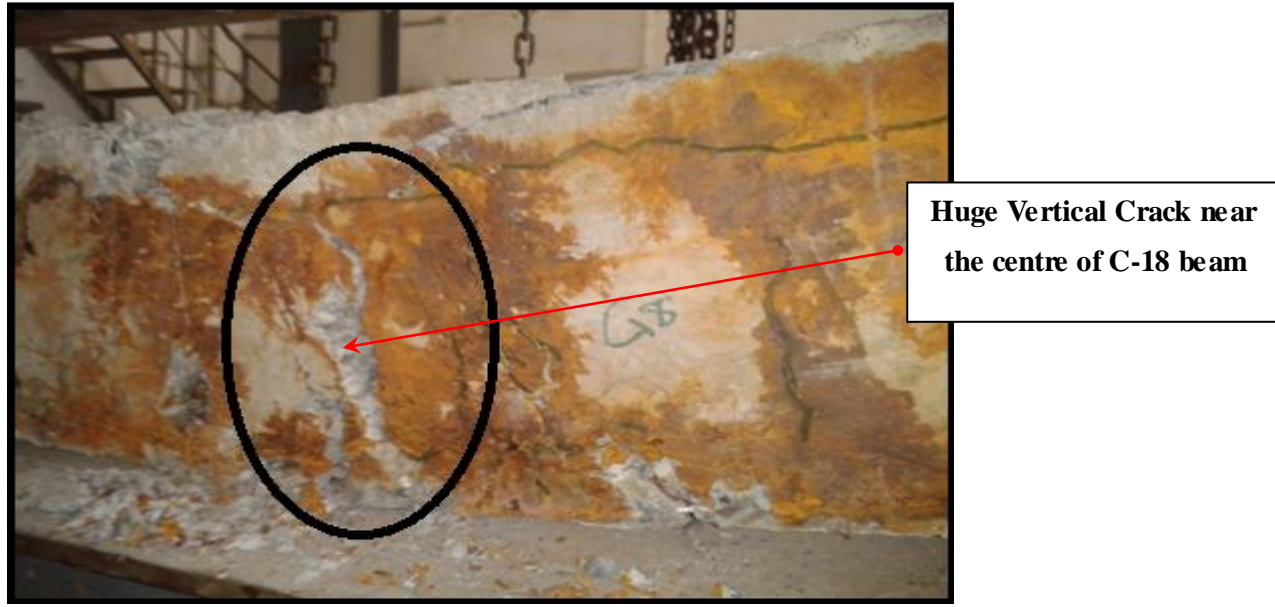
Fig: 5.25 C-18 beam showing large vertical crack near the centre of beam

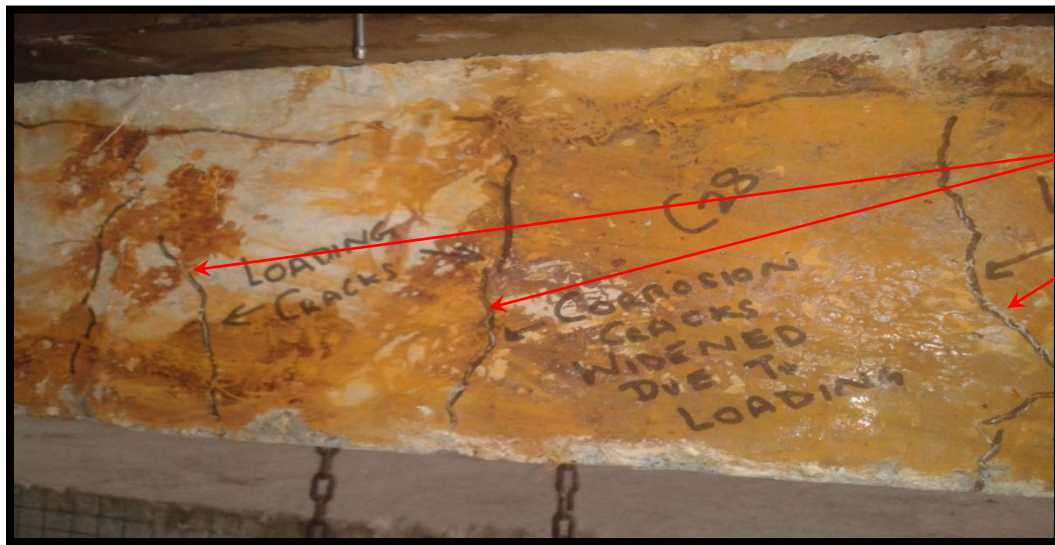
C-28 Beam showing cracks on left side from centre of side face of beam after failure

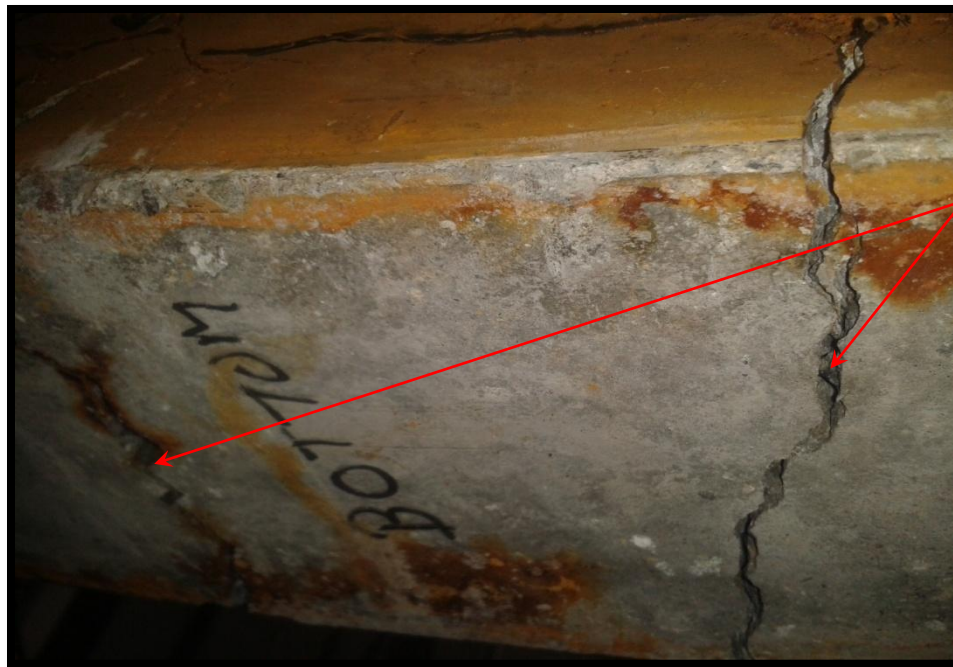
Cracks generated at extreme tension face after failure

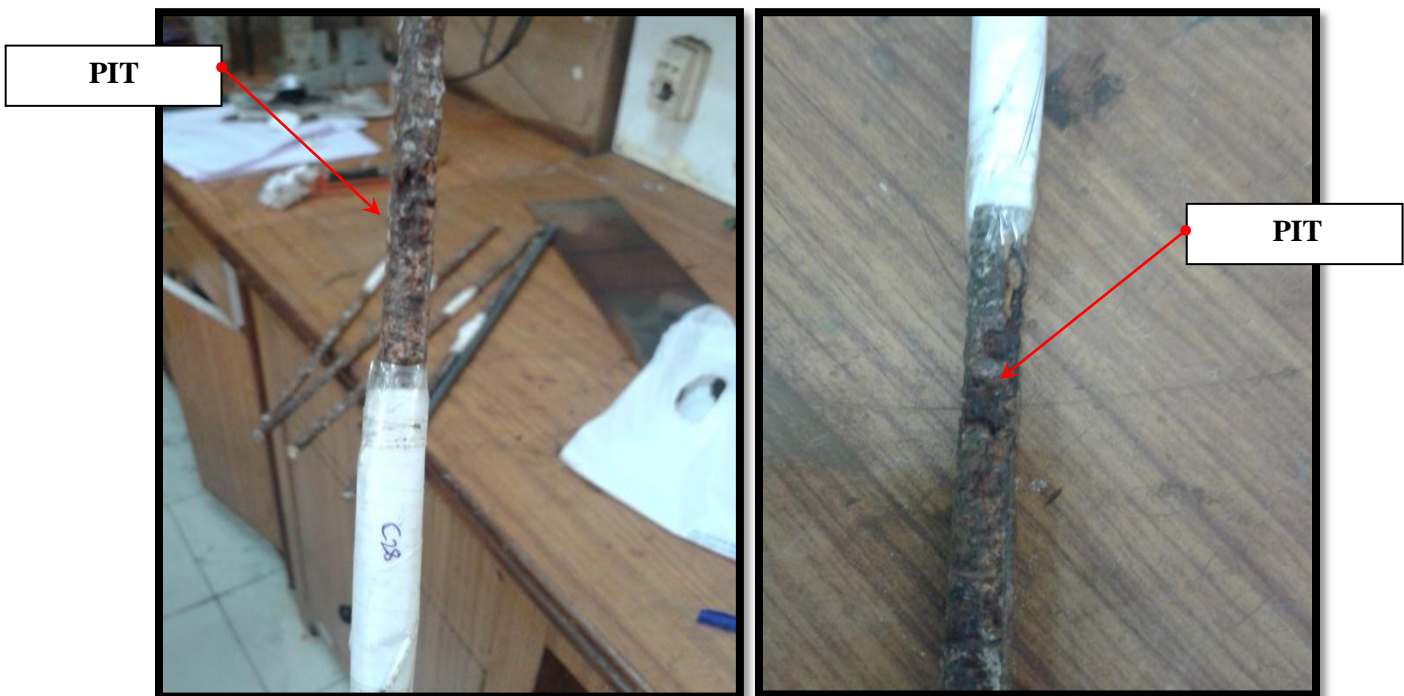
Fig: 5.40 Closure View of Pit formation
