**Ultrasonic Guided Wave and Acoustic Emission
Techniques for monitoring corrosion in Reinforced
Concrete Structures**

A Thesis

DOCTOR OF PHILOSOPHY

THAPAR INSTITUTE
OF ENGINEERING & TECHNOLOGY
(Deemed to be University)

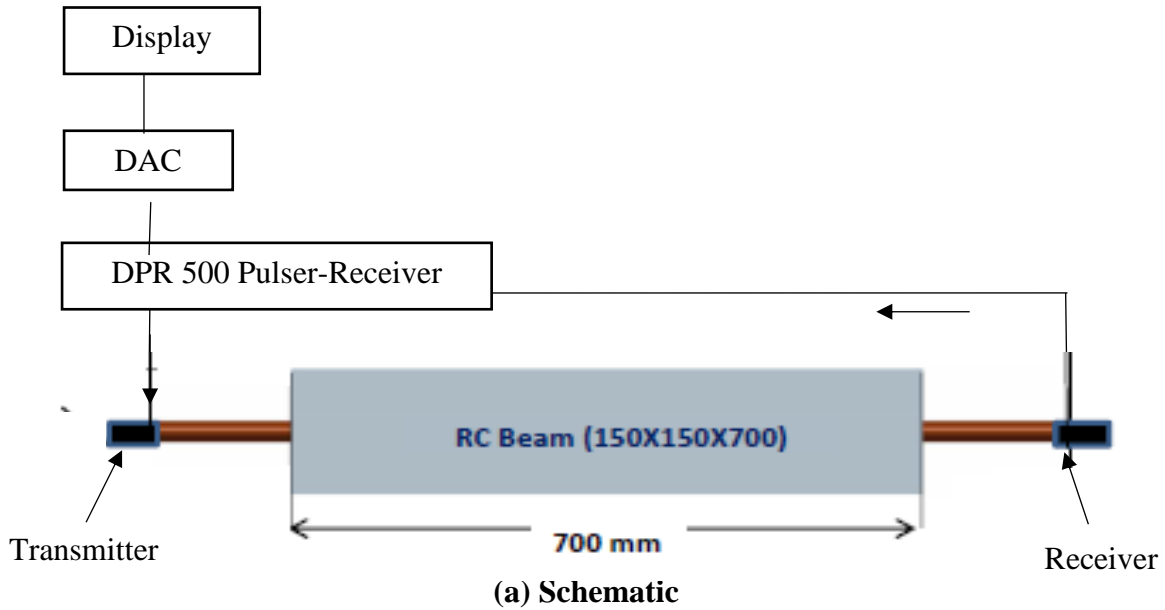
Fig. 3.2 Ultrasonic guided wave monitoring set-up

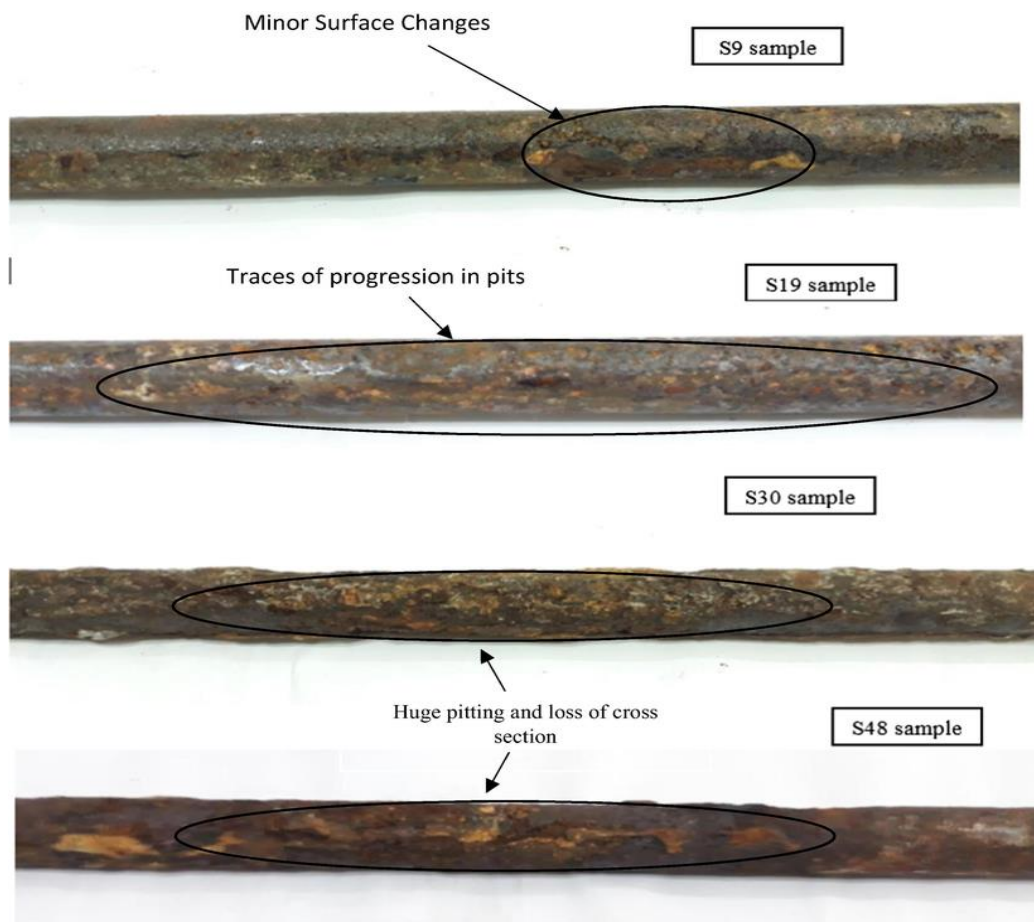
Fig. 4.11 Visual condition of the extracted bars at different ages of corrosion

After the beam samples had undergone corrosion for the desired periods, the bars were extracted. **Fig. 4.11** shows the condition of bars at different days of exposure. At day 9, surface corrosion is clearly visible. Loss of metal is restricted within the central zone at this stage. It may be recalled that at this time only a small crack in concrete was visible and no clear crack pattern had emerged. At day 19, corrosion had spread over a larger area with some instances of pitting. By this time a longitudinal crack was visible on the surface of concrete. At day 30, pitting corrosion is widespread and a substantial loss of metal is visible. A localised reduction in the cross-section of bar is discernible at this stage. At day 48, large parts of the bar were lost and the bar cross-section is very irregular.
