EVALUATION OF PERFORMANCE OF EPOXY BASED COATINGS FOR CORROSION INHIBITION IN REINFORCING BARS

MASTERS OF ENGINEERING IN STRUCTURAL ENGINEERING

THAPAR INSTITUTE
OF ENGINEERING & TECHNOLOGY
(Deemed to be University)

JULY, 2019

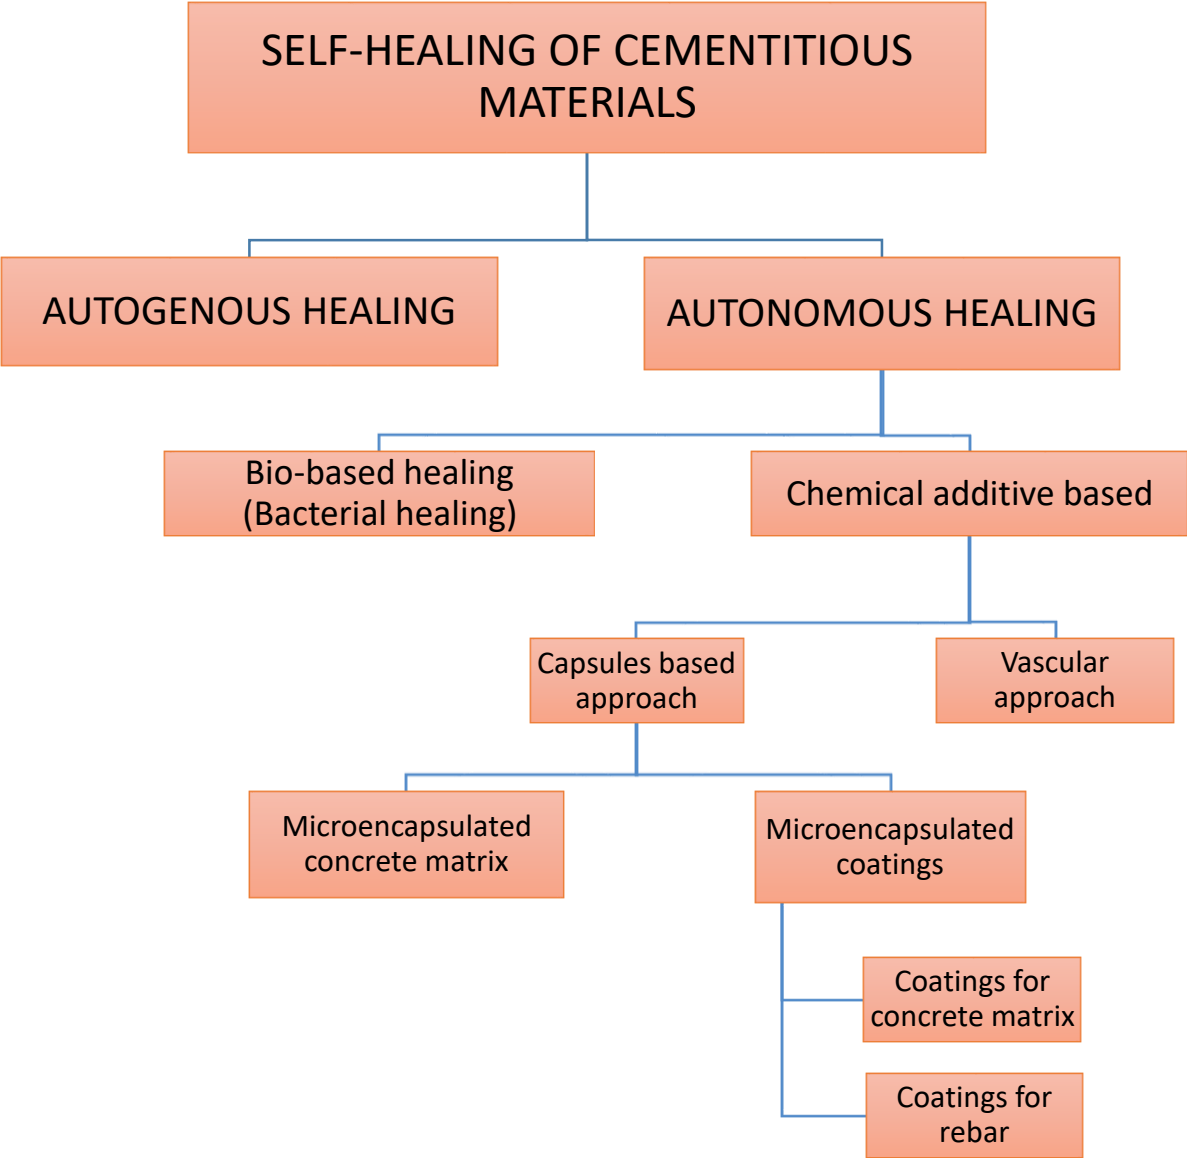
Figure 1.1: Approaches to self-healing in cementitious materials.

Self-healing concrete is defined as a smart material involving self-healing agents, which automatically heals the structure when cracks occur during its serviceability. These self-healing agents are transferred in the structure through microcapsules, hollow fibers or even in the form of organic matter. Self-healing ability of concrete can be enhanced by the integration of biochemical and chemical strategies. Approaches to achieve self-healing in cementitious materials are illustrated in Figure 1.1.

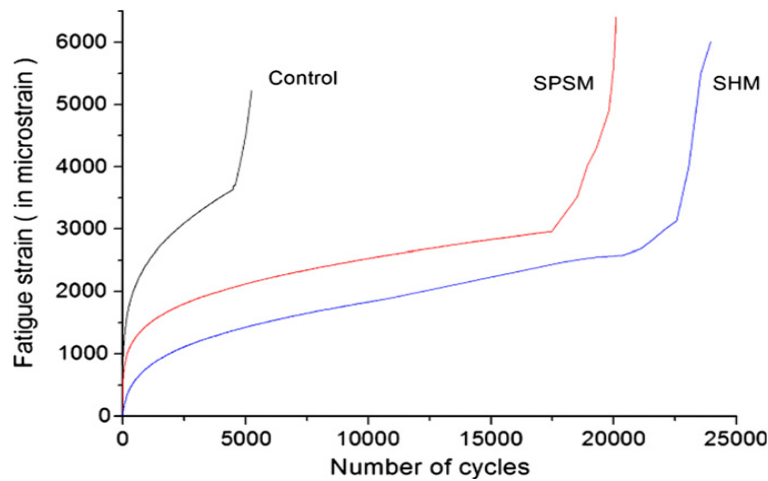
Figure 2.2: Fatigue strain and the number of cycles under uniaxial compression cyclic loading, for SHM, SPSM and for control mortar specimens (Yang et al., 2011).

which fallouts in a substantial increase of irrecoverable strain. Figure 2.2 represents the fatigue behavior of mortar specimen and reported that SHM performed best among all.

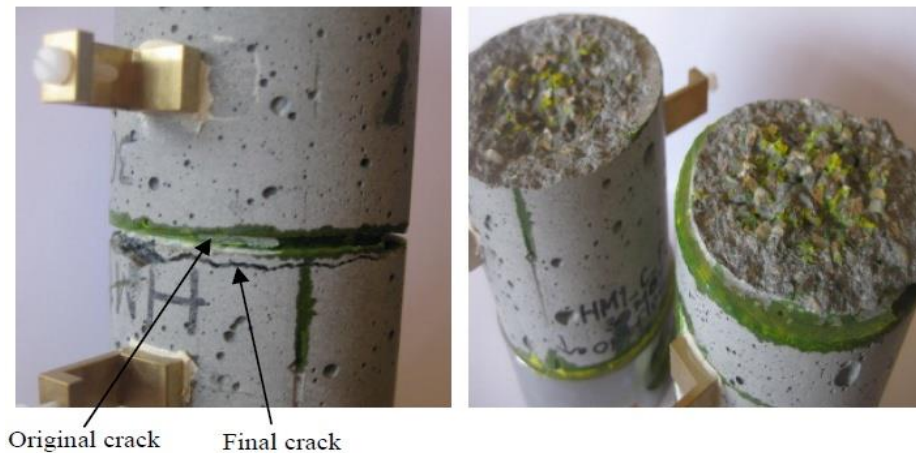
Figure 2.4: Original and final crack pattern after healing and new crack surface due to healing effect (*Sangadji et al., 2012*).

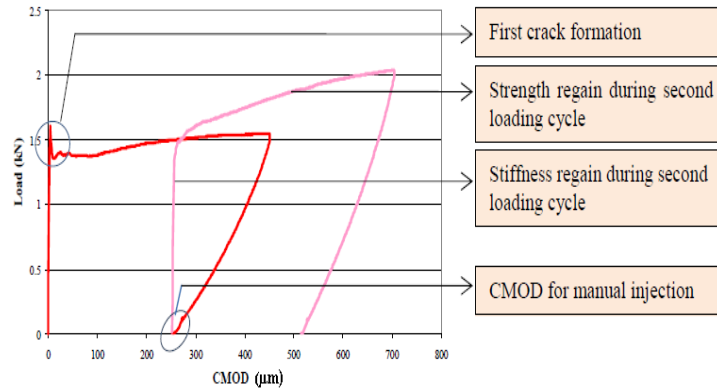
Figure 2.5: Load v/s Crack mouth opening displacement (CMOD) of porous network concrete beam (*Sangadji et al., 2012*).

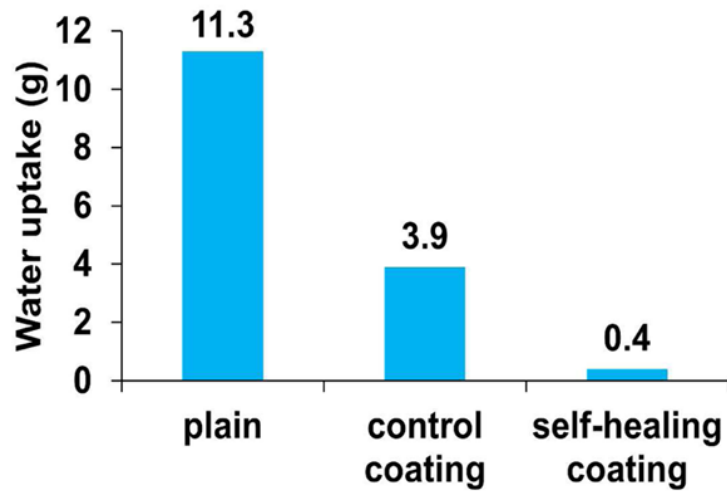
Figure 2.7: Water absorption test results, amount of water uptake in 24hours (*Song et al., 2013*).

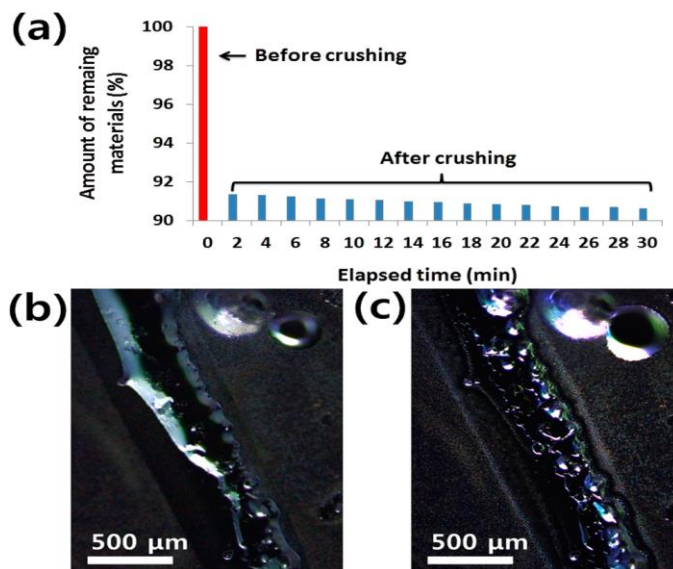
Figure 2.8: (a) Remaining materials v/s time after crushing the microcapsules. (b, c) Optical images: (b) just after scratching and (c) 2 min after scratching (*Yang et al., 2016*).

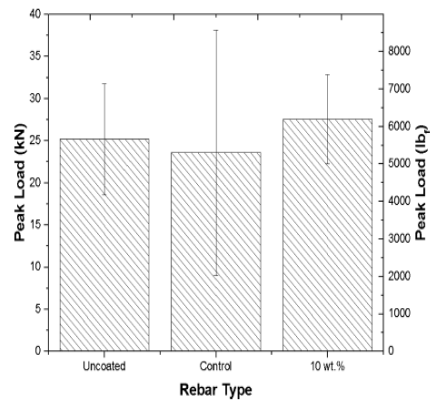
Figure 2.10: Pullout testing results, peak loads for unlike rebar surface conditions (*Chen et al., 2017*).

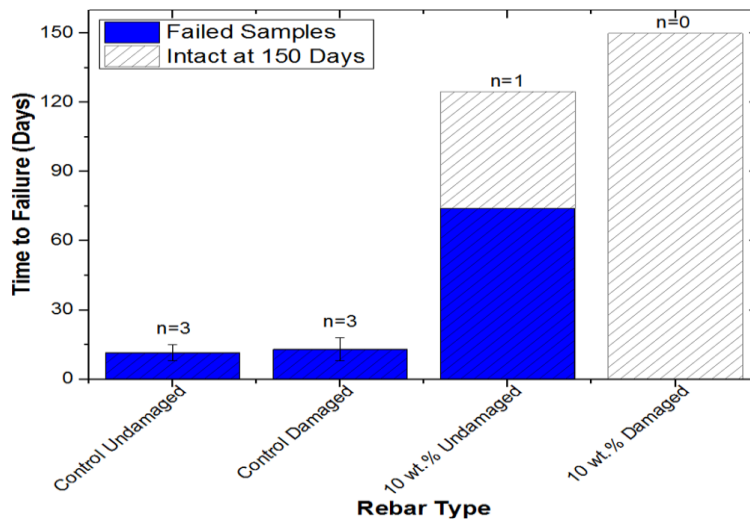
Figure 2.11: Accelerated corrosion testing results. Failed samples represents by solid bars, where n is the number of samples that failed. Hashed bars signifies the samples that were unharmed after 150 days of testing (*Chen et al., 2017*).

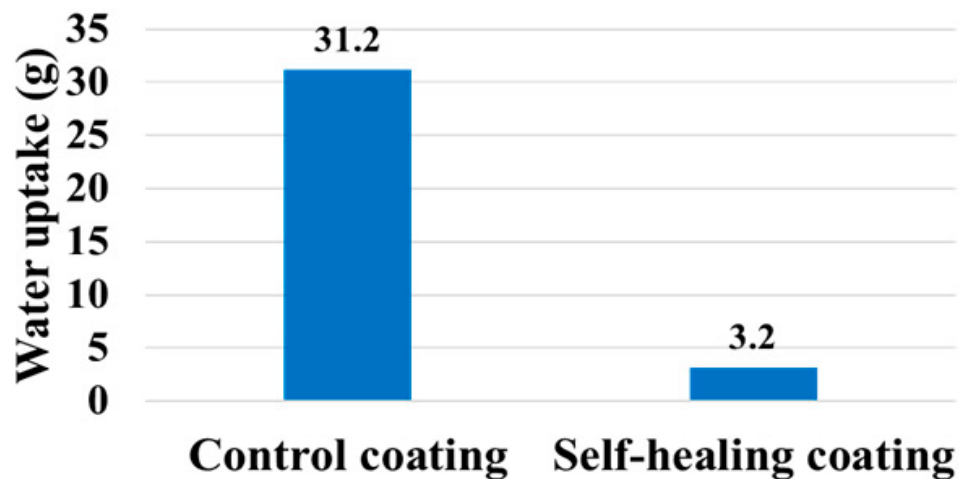
Figure 2.12: Water permeability test results: amount of water uptake in 48 hours (*Kim et al., 2017*).

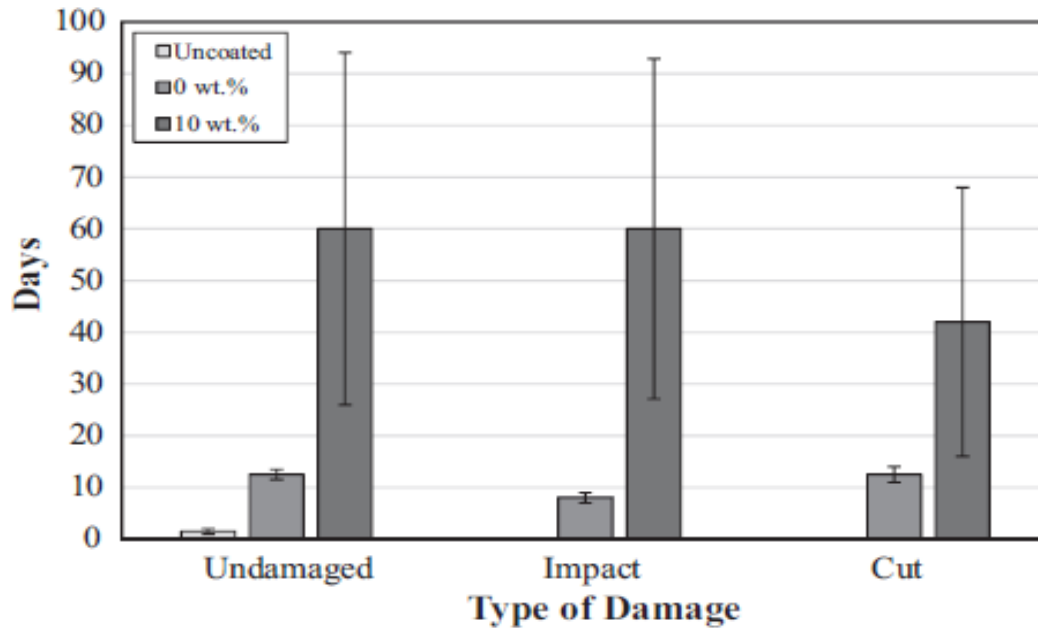
Figure 2.14: Results from corrosion testing of rebar embedded in mortar (Weishaar *et al.*, 2018).

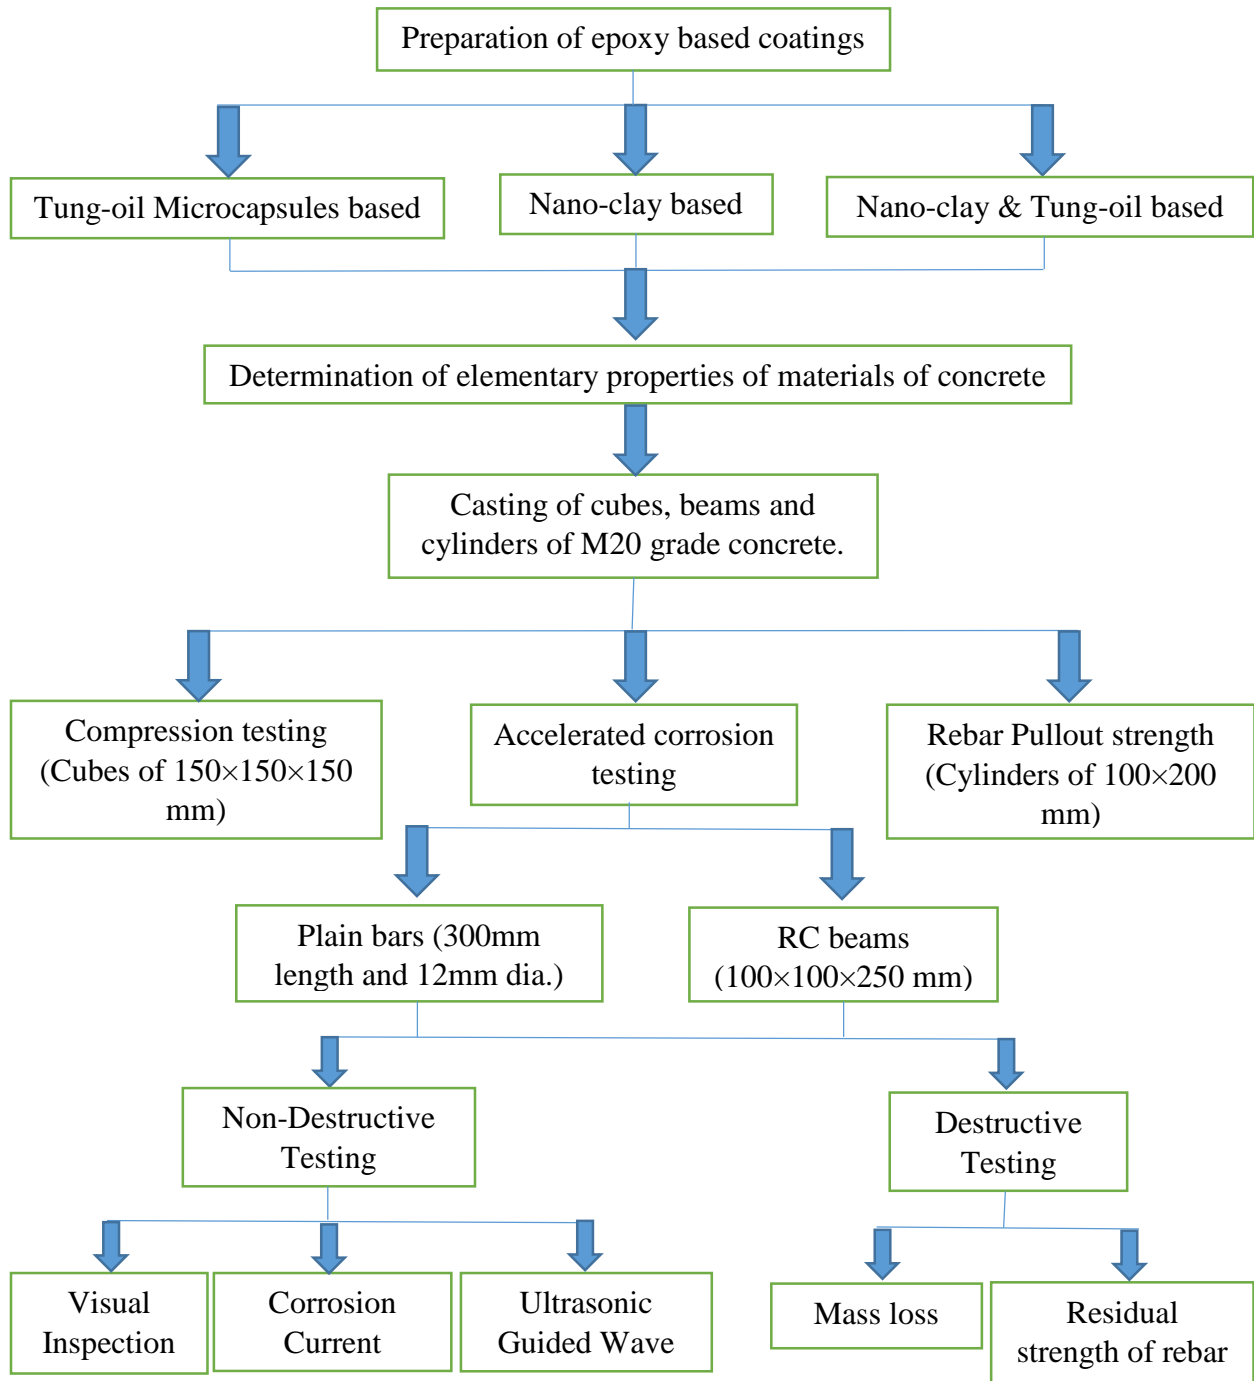
Figure 3.1: Flow chart of operational program.

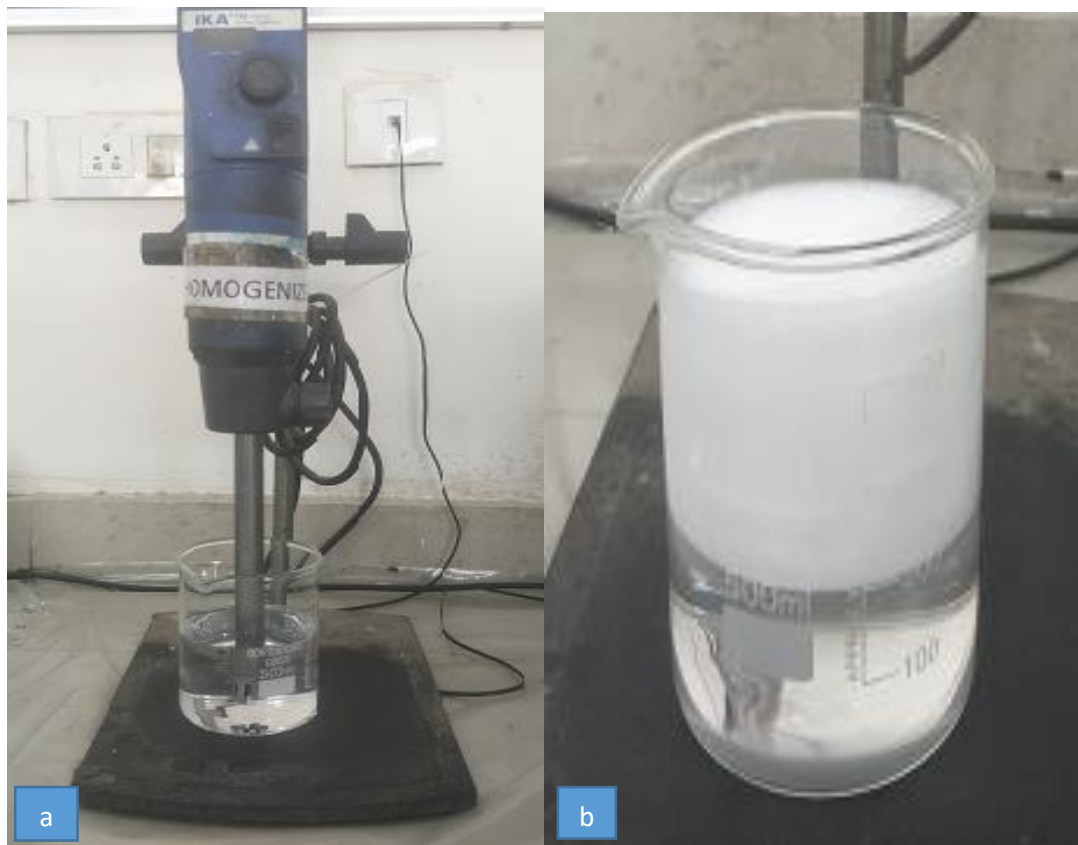
Figure 3.7: (a) Homogenizing of sample, (b) After homogenization.

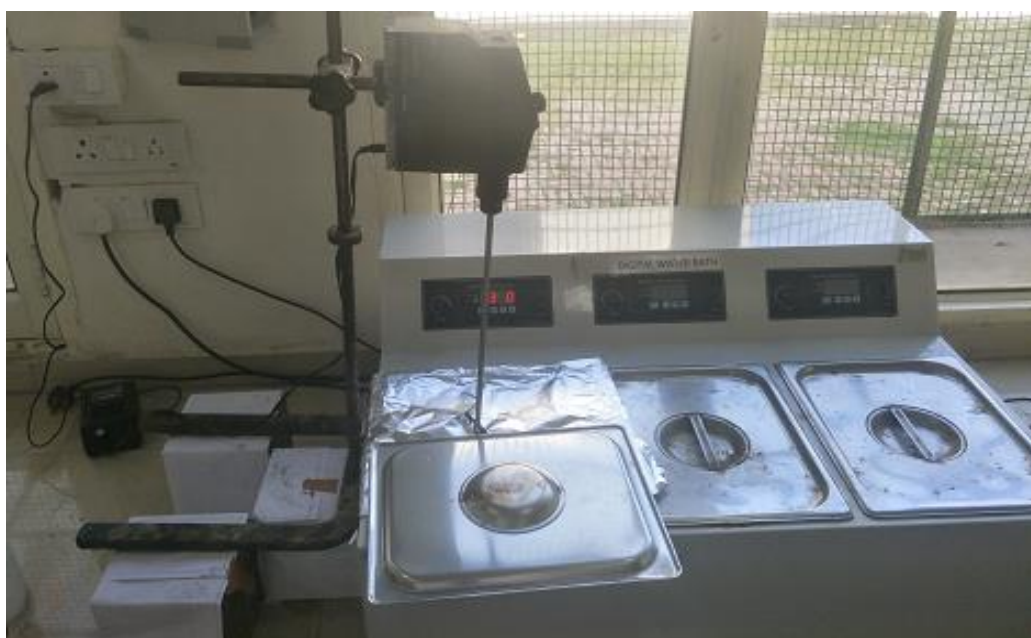
Figure 3.9: Covered solution for the polymerization reaction between Urea-Formaldehyde.

Step 8: In the stabilized solution, add 13gm of 37wt% aqueous solution of formaldehyde. Then raise the water bath temperature to 60 ⁰C for 4 h at 400 rpm to enable the polymerization reaction between urea and formaldehyde and solution is covered (Figure 3.9).

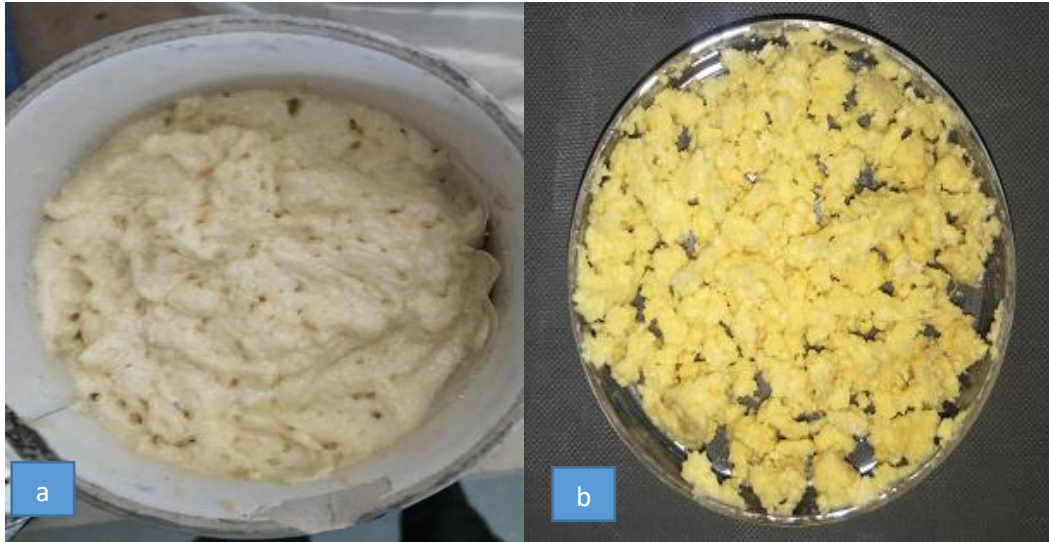
Figure 3.10: Tung-oil microcapsules; (a) Air dried microcapsules, (b) Oven dried microcapsules.

Step 11: Extracted capsules were air dried for 48 hours and then dried out in vacuum-oven at 50°C for 24 h (Figure 3.10) and were ready to be used for coatings of rebar.

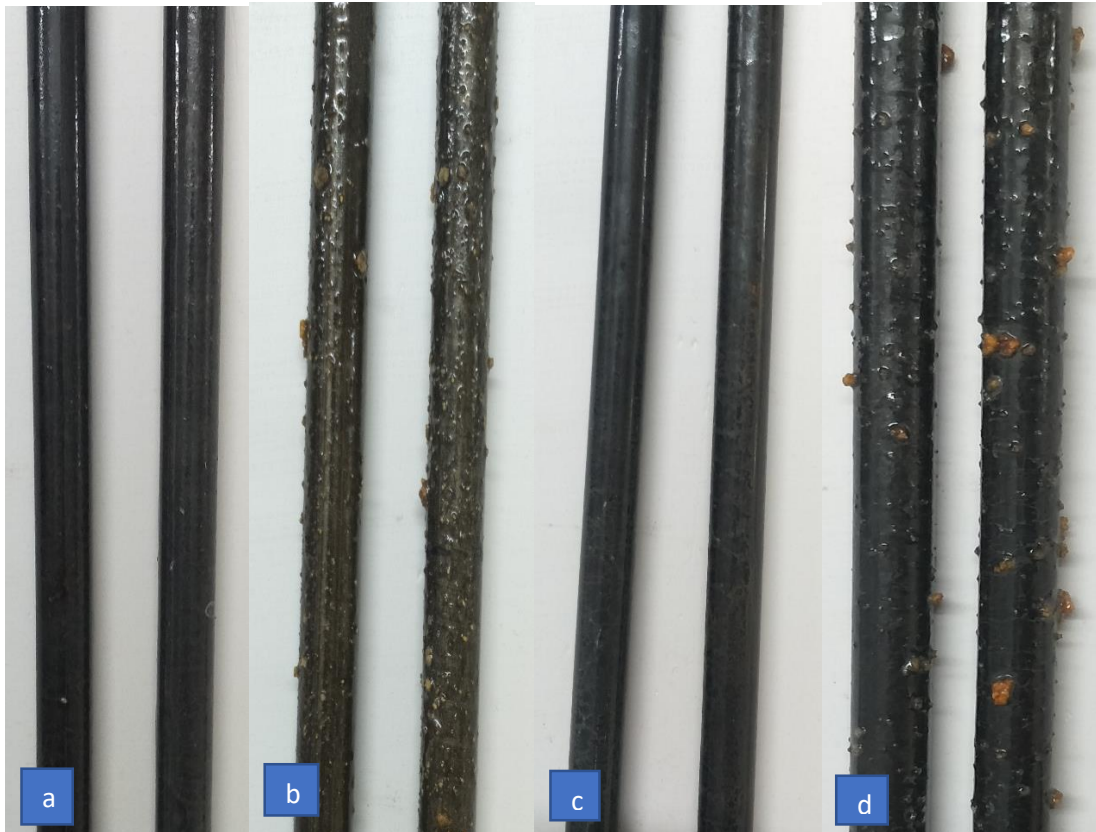
Figure 3.11: Coated rebar; (a) PC, (b) MC, (c) NC, (d) MNC.

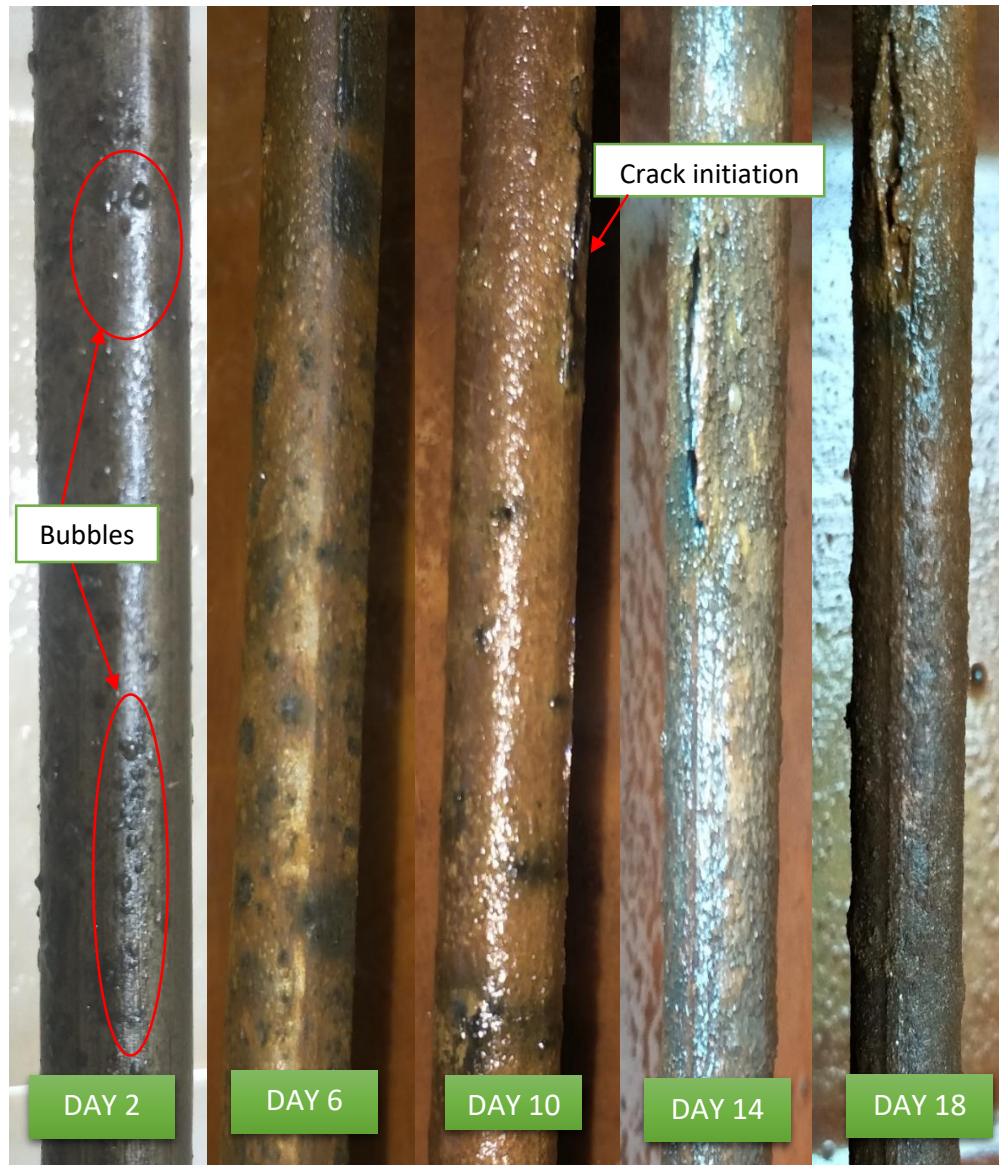
Figure 4.1: Visual observation of PC bars.

days and on 18th day the ultrasonic peak to peak voltage of the waveform for the PC rebar vanished and corrosion test was stopped.

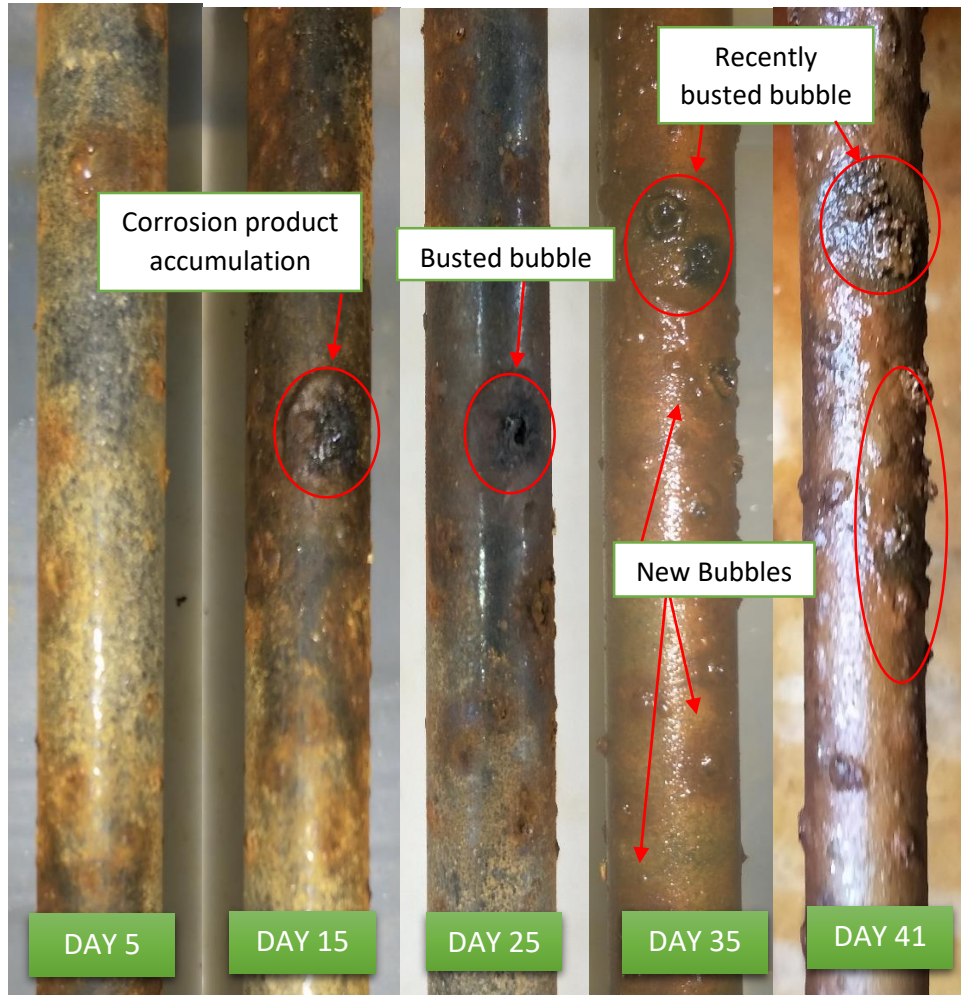
Figure 4.2: Visual observation of NC bars.

on the 41st day, ultrasonic guided wave peak to peak voltage almost vanished and bar was removed from the corrosion testing. There are two things to note: presence of nano-clay in epoxy, in general leads to a poorer surface texture and with nano-clay, the cracks take longer time to propagate.

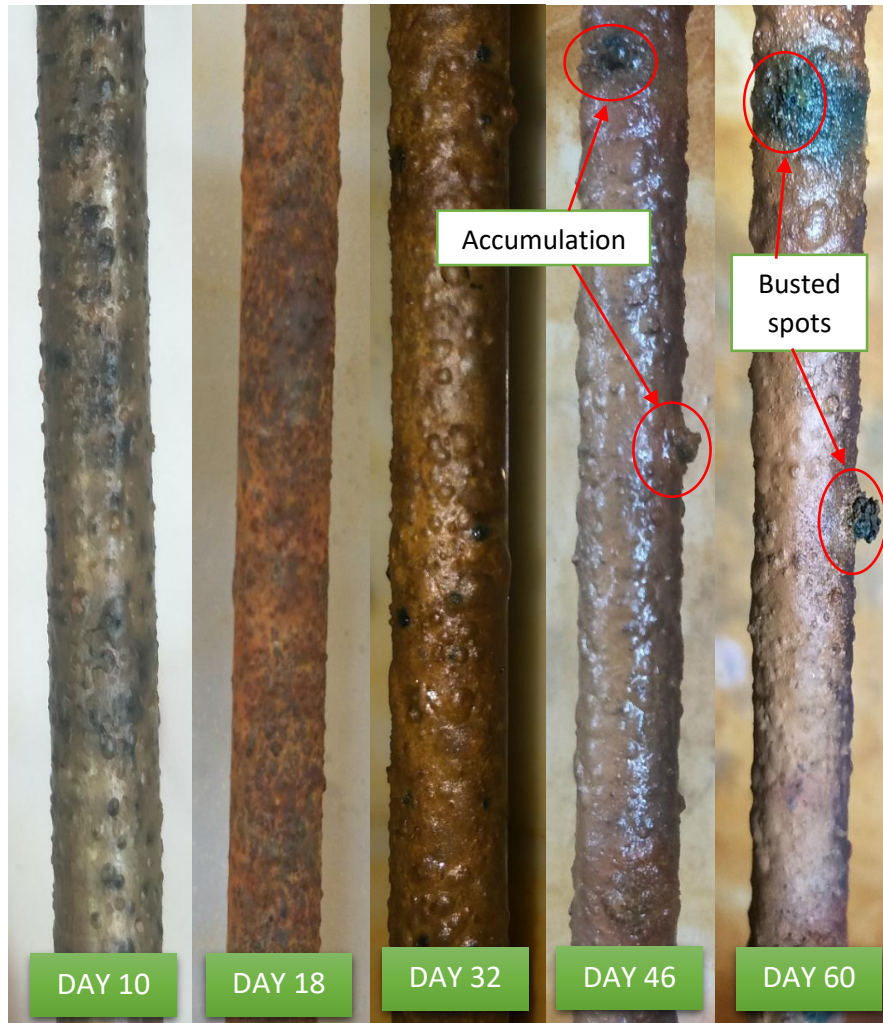
Figure 4.3: Visual observation of MC bars.

days. Even after 60 days of corrosion ultrasonic peak to peak voltage for MC coated rebar did not vanished completely. This shows a significant self-healing effect of microcapsules on the inhibition of corrosion which continued for 60 days. On the 60th day very few spots from where rust travels from anode to cathode and impermeable layer breaks were observed (Figure 4.3).

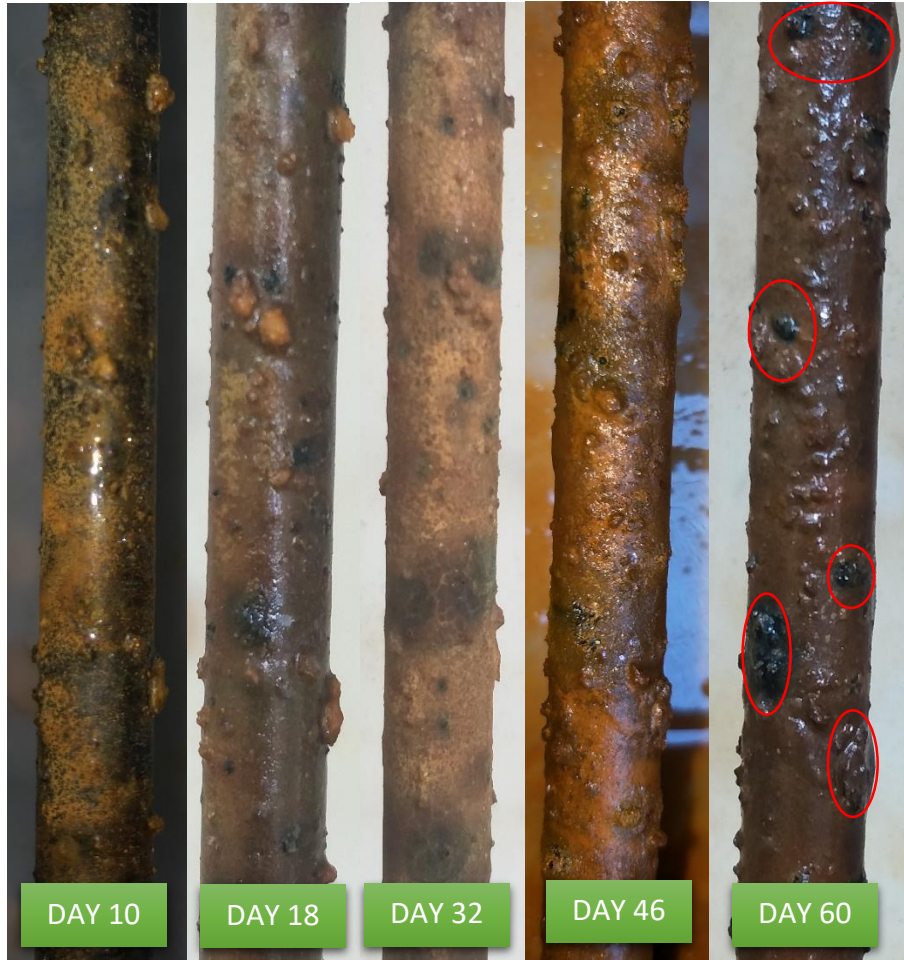
Figure 4.4: Visual observation of MNC bars.

uniformity of corrosion inhibition is not preserved as in MC coated bars and more spots were subjected to corrosion (Figure 4.4, Day 60) as compared to MC rebar. The ultrasonic voltages did not completely dropped even after 60 days but corrosion test was stopped after this time.

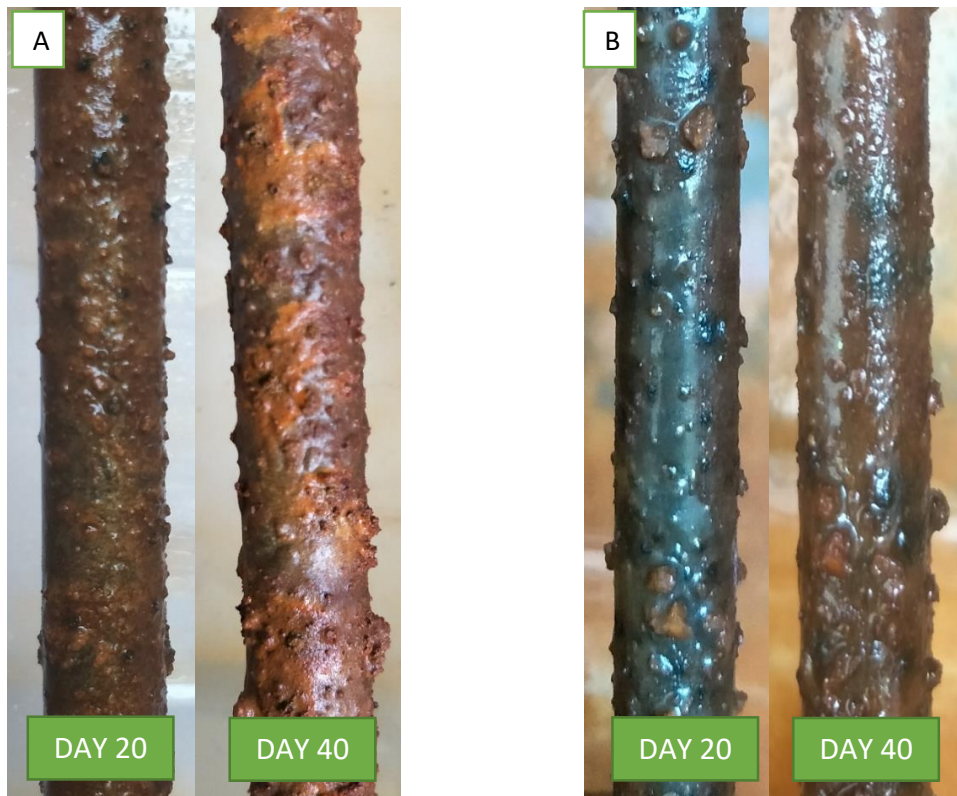
Figure 4.6: Visual observation, (A) MC-D rebar, (B) MNC-D rebar.

60 days and the rebar looks similar to healthy coated rebar after 60 days. This is observed in MC-D as well as MNC-D coated bars. This observation justifies the healing mechanism proposed in this work by tung-oil microcapsules and was beneficial in impeding corrosion successfully. These phenomenon are be further verified quantitatively by non-destructive testing in the form of corrosion current and ultrasonic guided voltages.

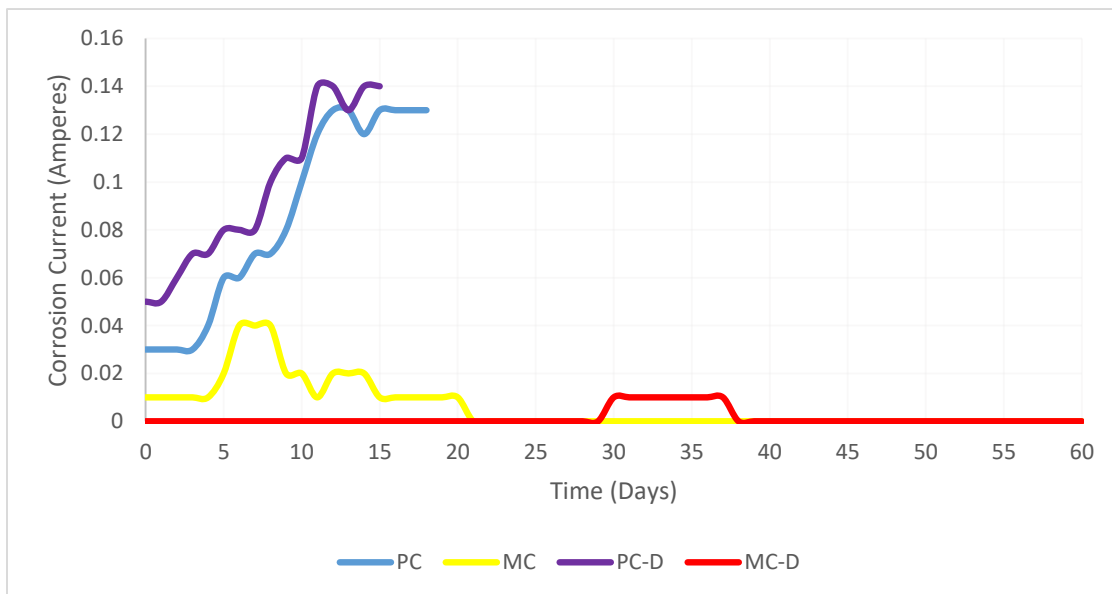
Figure 4.11: Variation in corrosion current in PC and MC rebar with or without damage.

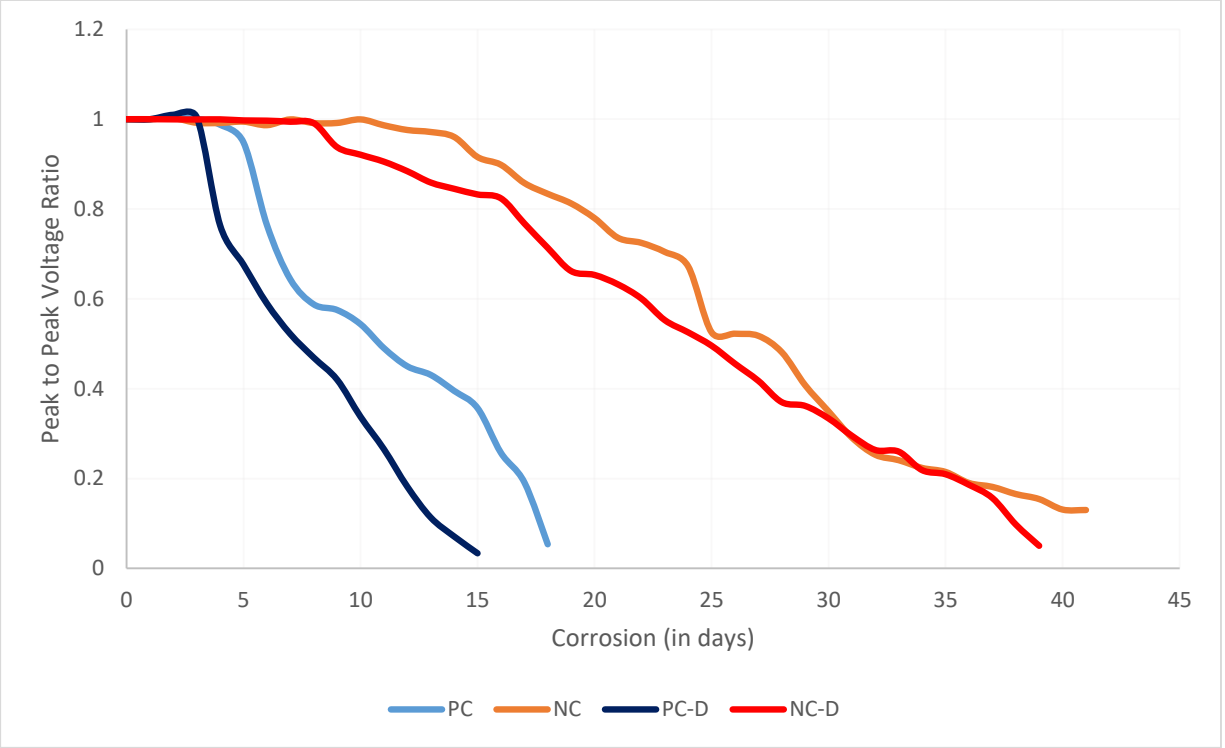
Figure 4.19: Peak to peak voltage ratio-corrosion time variation in PC and NC rebar with or without damage.

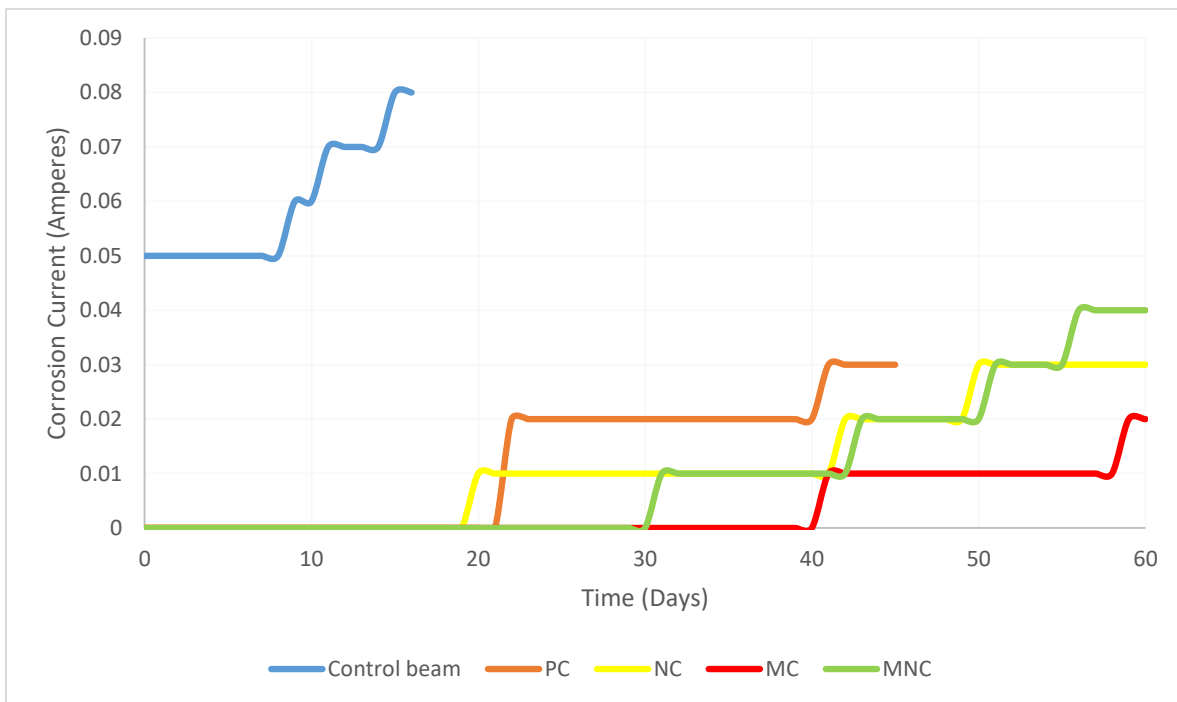
Figure 4.21: Variation in corrosion current in different beams.

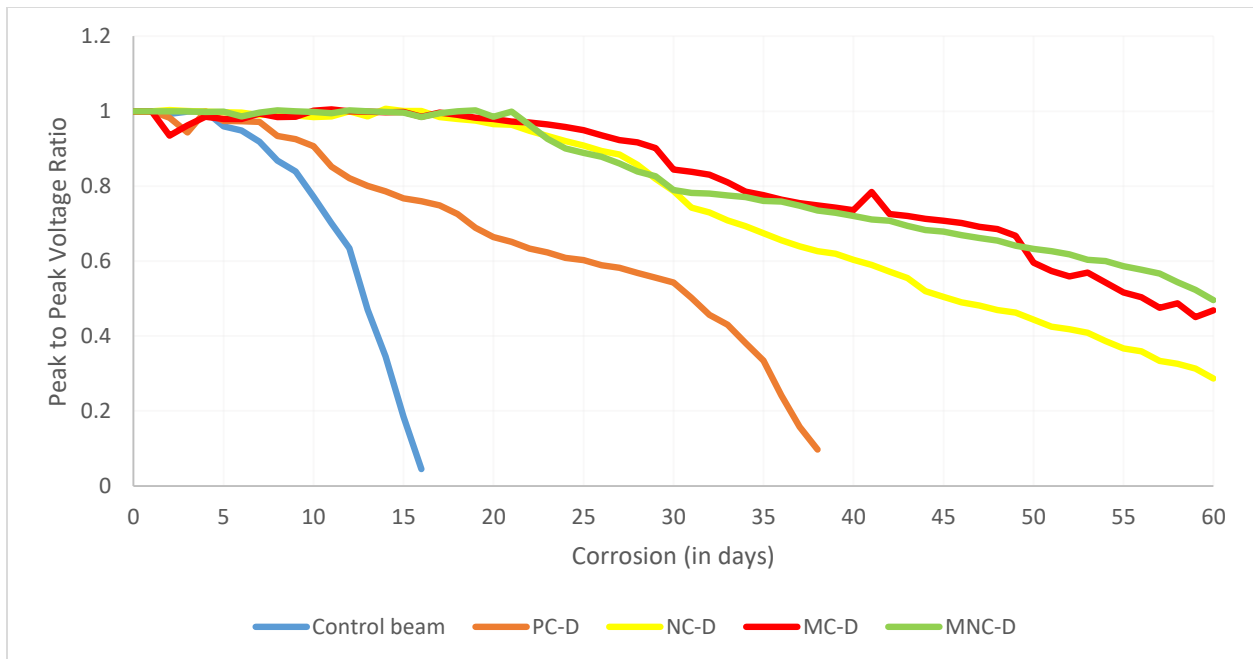
Figure 4.24: Peak to peak voltage ratio-corrosion time variation in coated RC beams and control beam.

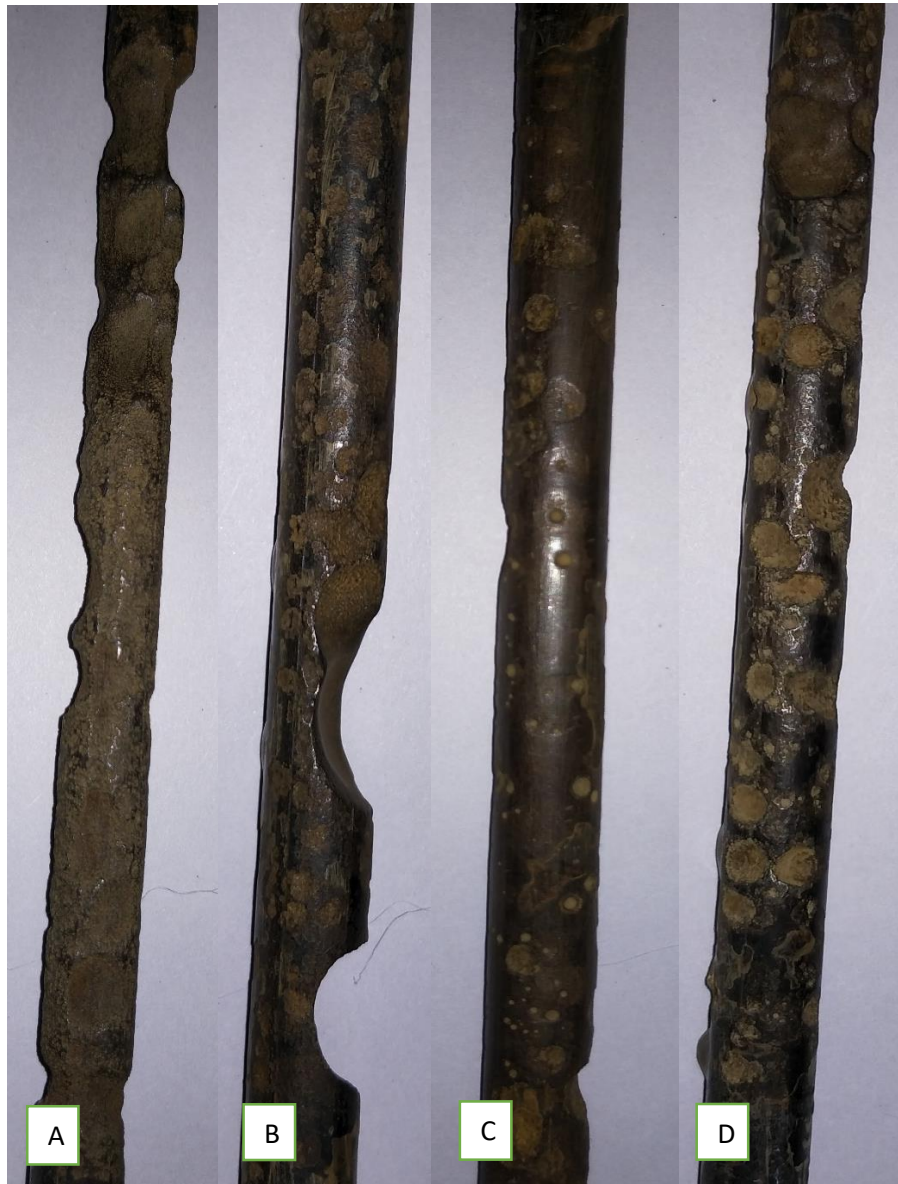
Figure 4.26: Corroded plain mild steel rebar, (A) PC rebar after 18 days, (B) NC rebar after 41 days, (C) MC rebar after 60 days, (D) MNC rebar after 60days of corrosion.
