MONITORING OF DAMAGE IN REINFORCEMENT IN CONCRETE

Thesis

DOCTOR OF PHILOSOPHY

DEPARTMENT OF CIVIL ENGINEERING

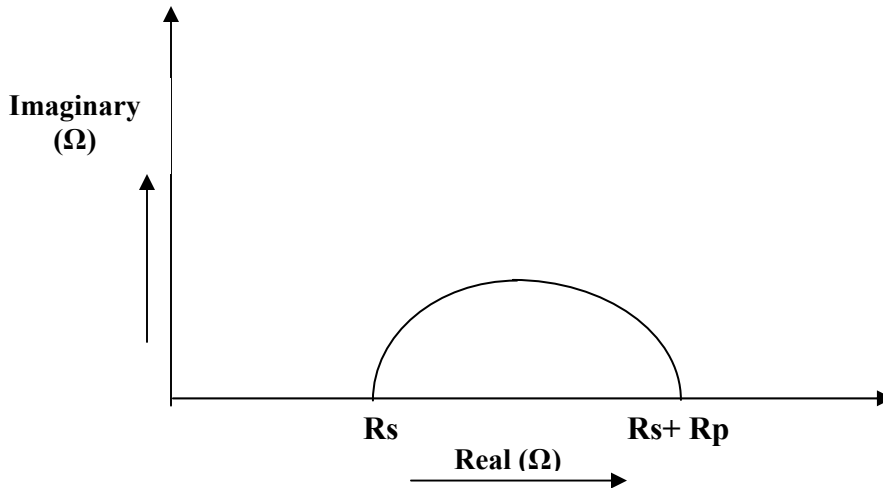
Fig. 3.13: Impedance Plot in the complex plane from simple equivalent circuit (Hong et al., 2007)

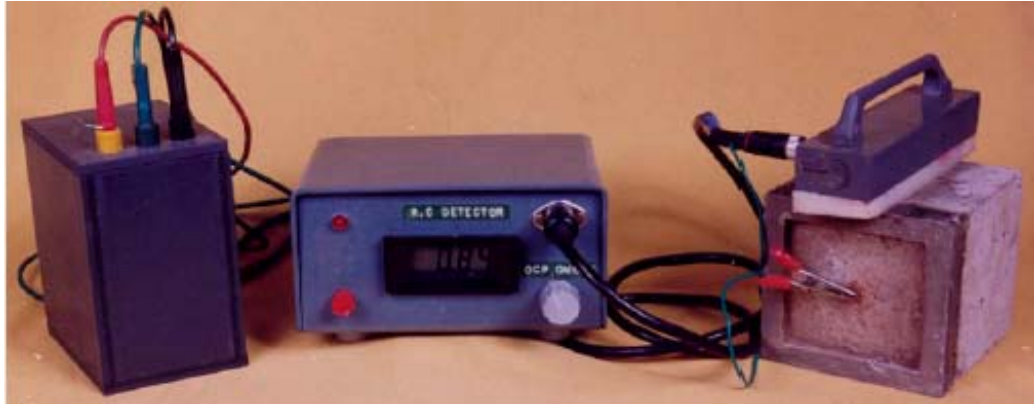
Fig 3.15: Galvanostatic pulse instrument with probe and concrete sample
(Sathiyarayanan et al., 2006)

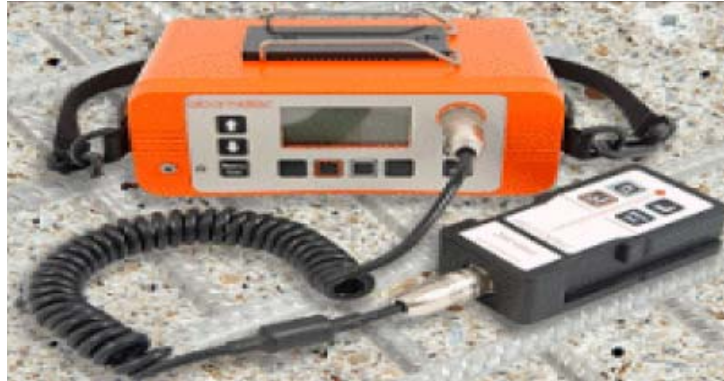
or horizontal. **Fig. 3.17** shows the cover meter used for measuring the cover thickness as well diameter and size of the rebar.

Fig. 3.17: Cover meter (www.googleimages.com)

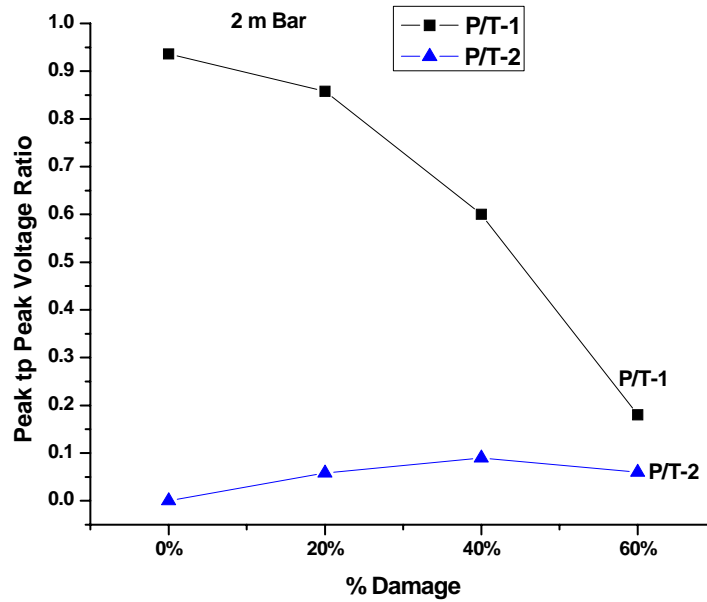
**Fig. 4.10: Peak to peak voltage ratio trends of P/T of 12mm diameter bar (1m, 1.5m, 2.0 m)
(Notch at L/2)**

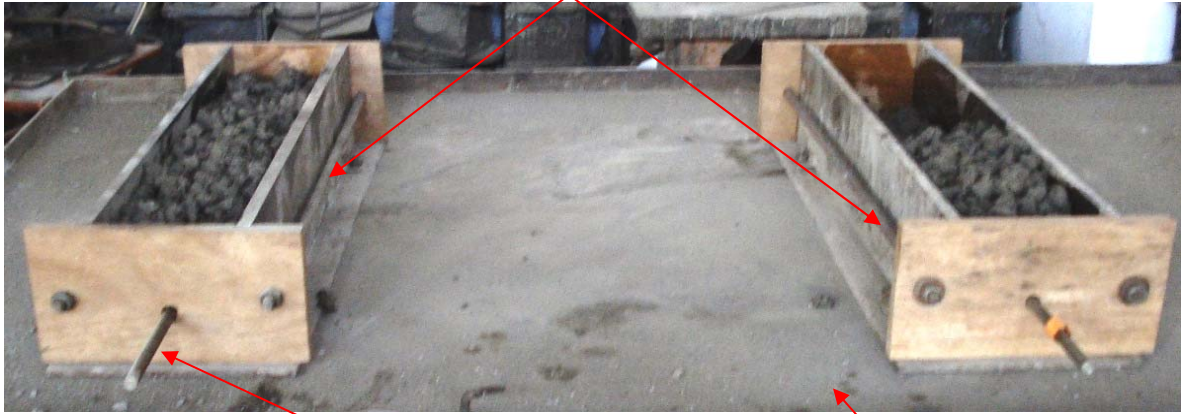
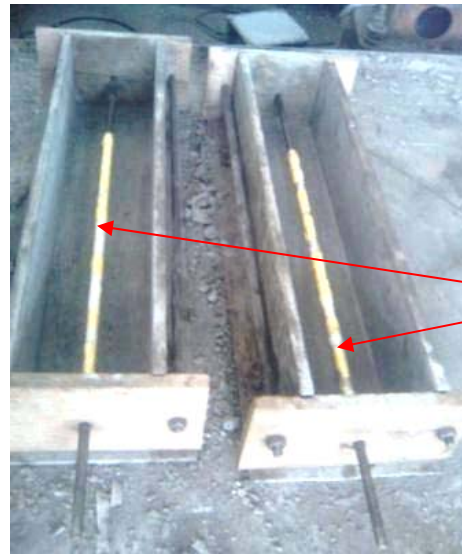
Bar with simulated damage

Fig. 4.16: Bar with simulated notch damage in mould during casting of beams

Bar with double sided tape simulating delamination

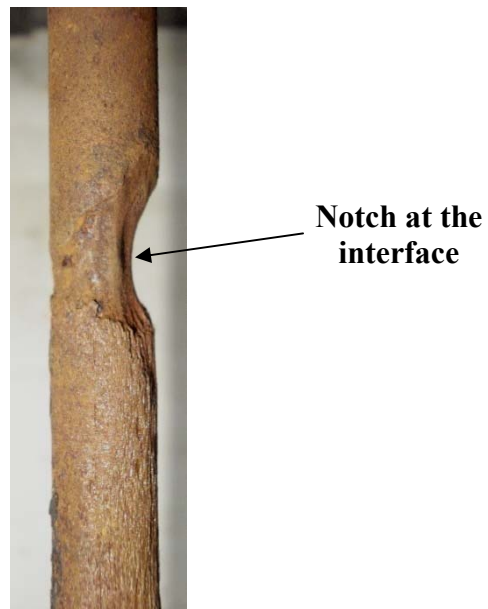
(a) Corroded beam

(b) Extracted bar

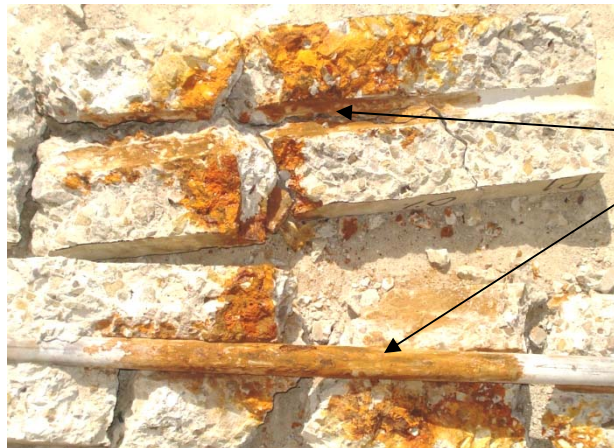
Localized spread of corrosion product in the middle one third length

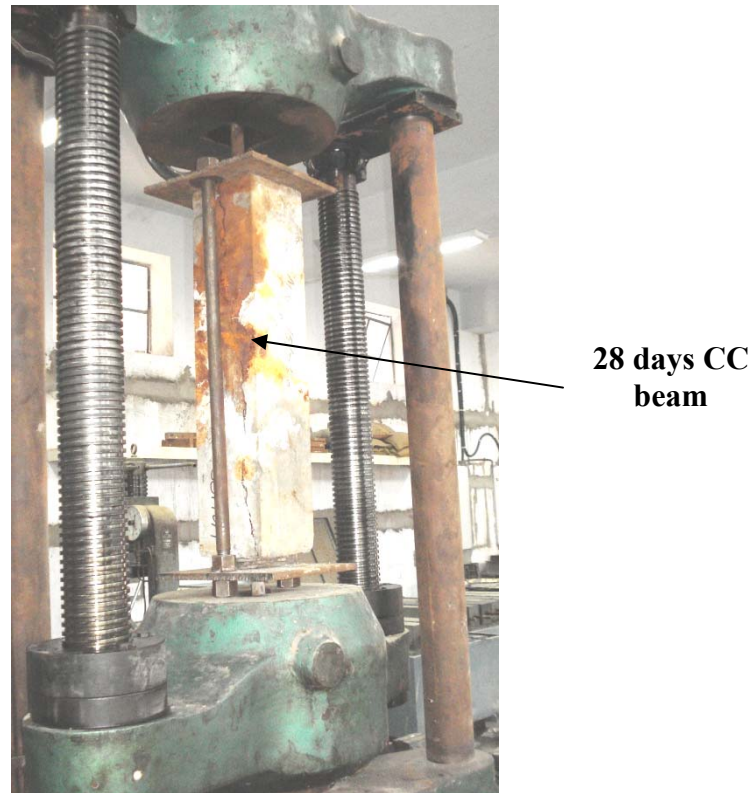
Fig. 5.18: Beam undergoing pull out test in a UTM
