**INVESTIGATION OF EFFECTIVENESS OF VARIOUS CORROSION
PROTECTION METHODS BY ULTRASONIC GUIDED WAVES AND
ACOUSTIC EMISSION TECHNIQUES**

MASTERS OF ENGINEERING

STRUCTURAL ENGINEERING

JULY 2017

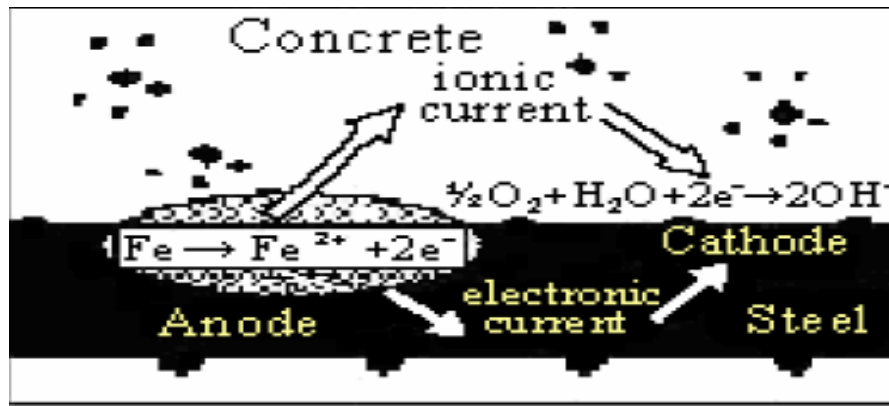
Fig.1.1: Corrosion of reinforcing bar in concrete as an electrochemical process [1]

Corrosion of the reinforcing bar embedded in concrete is an electrochemical process. Corrosion process is declared to be same in action, which occurs in a flash battery. The corroding rebar's surface behave as combined electrode that is a combination of anodes and cathodes connected electrically through the rebar's body itself, on which coupled (anodic and cathodic) reactions occurs. The water present in the pores of concrete works as an aqueous medium i.e., a complex electrolyte. Hence, a reinforcement corrosion cell is created, as presented in **Fig.1.1**.

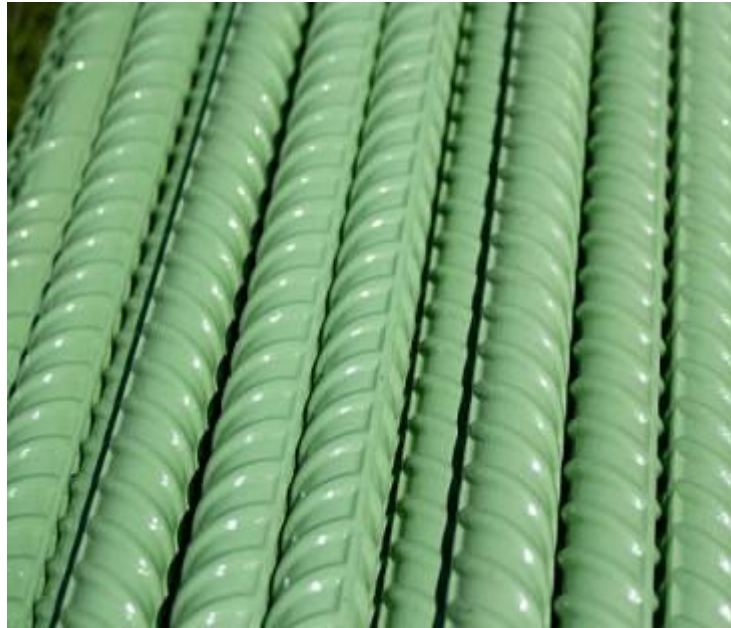
Fig.1.2: Steel bar coated with epoxy [1]

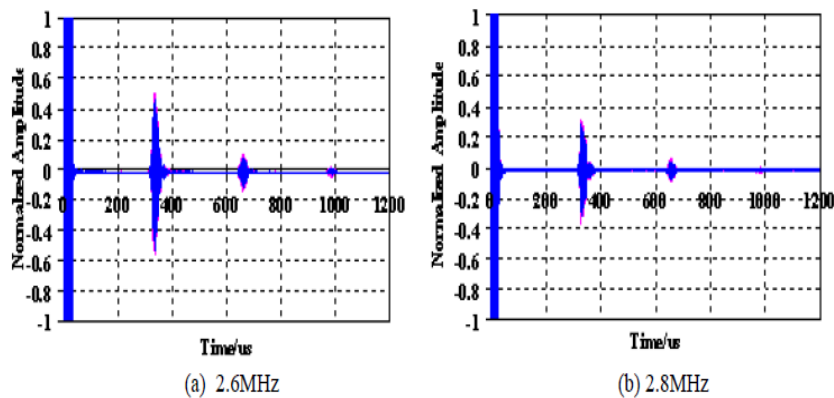
Fig.2.3: Waveforms obtained above 2MHz. [17]

Fig.2.3 exhibits that elevated frequency modes at excitation frequency of 2.6 MHz and 2.8 MHz are not sensitive to the existence of delamination, as there is a small variation in signal amplitude.

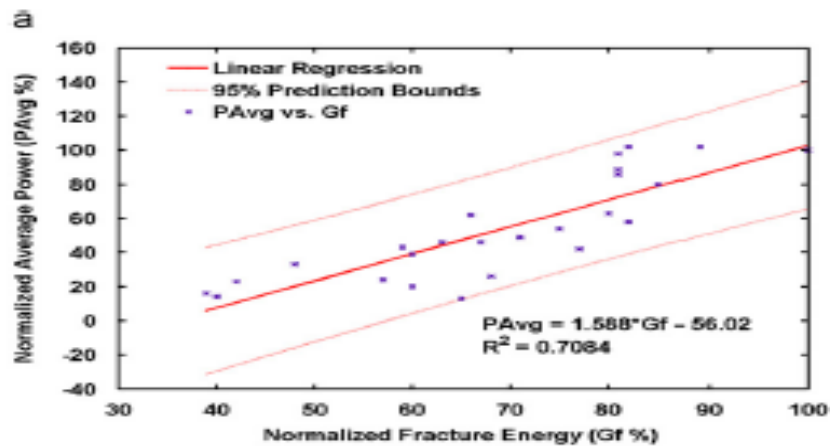
Fig 2.4: Linear regression of non-destructive ultrasonic parameters vs. fracture energy results of CFRP–concrete samples subjected to accelerated aging temperatures: (a) average power (P_{avg}) vs. Fracture energy (Gf). [25]

Mahmoud et al. (2010) explored the application of ultrasonic waves for non-destructive structural health monitoring of CFRP bonded concrete specimens administered to water immersion ageing at under control temperatures of 25-60°. To generate and receive surface waves at the external face of CFRP, narrow-band transducer with center frequency of 110 kHz were used. The amplification, digitization and processing of the signals received by the transducer and processed to dig out the parameters: average power (P_{avg}) and maximum amplitude (V_{max}). Due to water immersion ageing the alteration in these parameters occurred were recorded for 12 weeks. A decline in the measured ultrasonic parameters owing to ageing over time was specified by the results. Mode-11 fracture loading of CFRP concrete samples was lead to some ageing conditions, temperature, a parameter and a synchronous destructive study was carried out and fracture energy was obtained. At every ageing temperature, a correlation analysis was executed in between destructive parameters and the non-destructive parameters (P_{avg} , V_{max}), as shown in **Fig.2.4**.

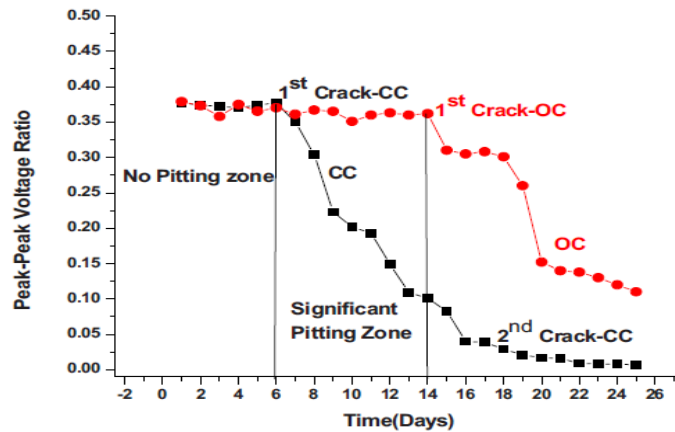
Fig.2.6: Peak-peak voltage ratio with core-seeking mode [28]

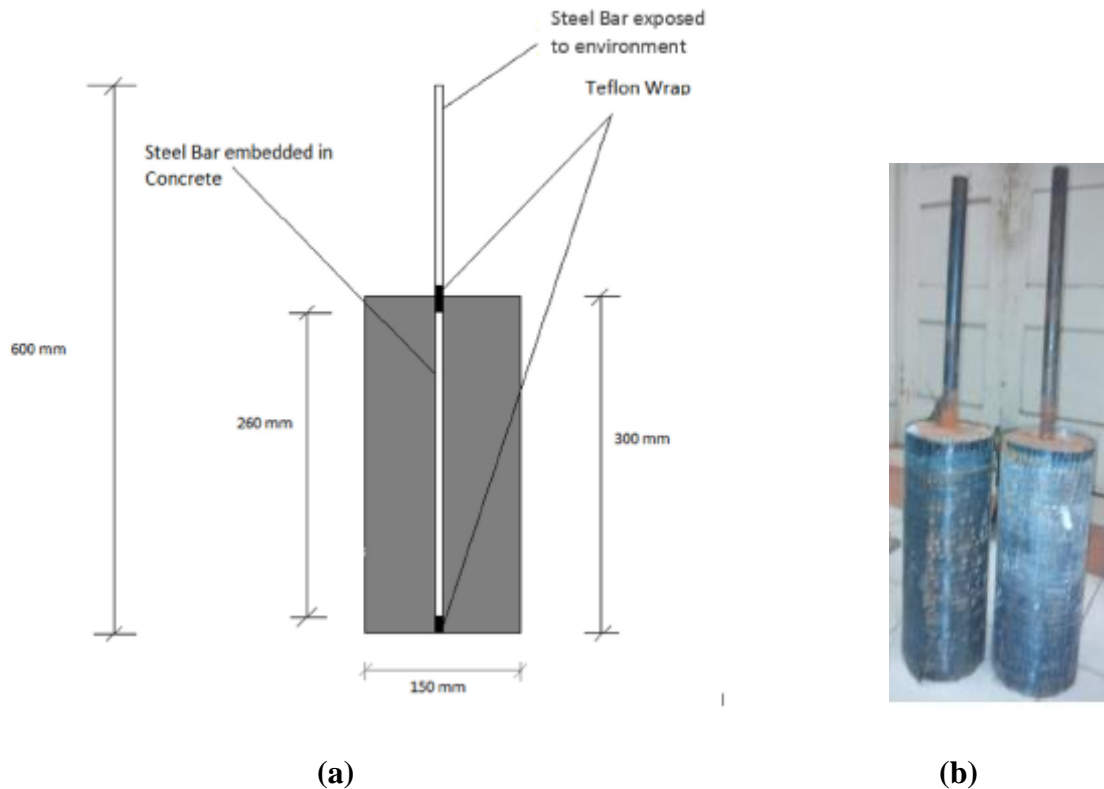
Fig.2.7: (a) Specimen schematic (b) Specimen wrapped with FRP[30]

Both GFRP and CFRP sheet were utilized in study. The fiber sheet was wrapped around specimens to be tested with the fiber along the circumferential direction of cylinders after definite days of introduction to corrosive surroundings.

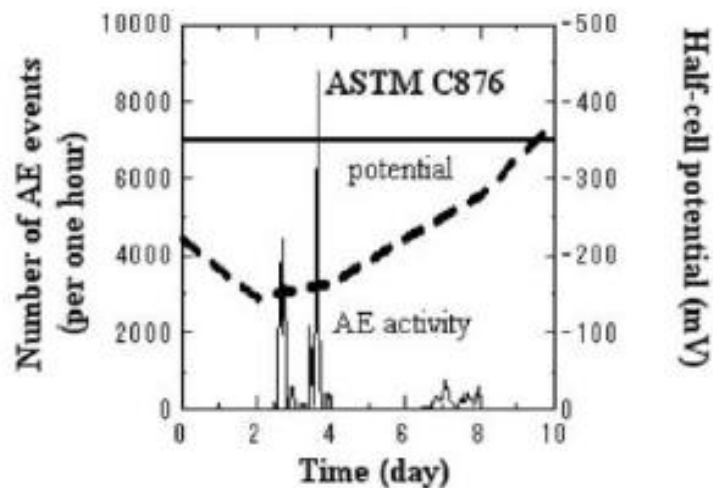
Fig 2.10: AE activities and Half-cell potential in accelerated corrosion [33]

Ohtsu et al., (2007) discussed the process of corrosion in reinforced concrete recognized by Acoustic Emission. The dimensions of RC slabs tested were 300mm x 300mm x 100mm. For longitudinal arrangement, reinforcing steel bars having diameter 13 mm are embedded with 15 mm cover thickness. Both an accelerated corrosion test as well as cyclic wet-dry test was carried out. The measurement of half cell potentials at the surface of the specimen was done by portable corrosion-meter. Immediately after terminating the current, the measurement was done two times a day in the accelerated corrosion test. At various stages, the concentrations of chloride were measured. Firstly, the beginning concentration was recorded by the use of a standard cylinder sample after moisture-curing of 28 days. **Fig.2.10.** show the connection among the AE activity and the half-cell potentials recorded.

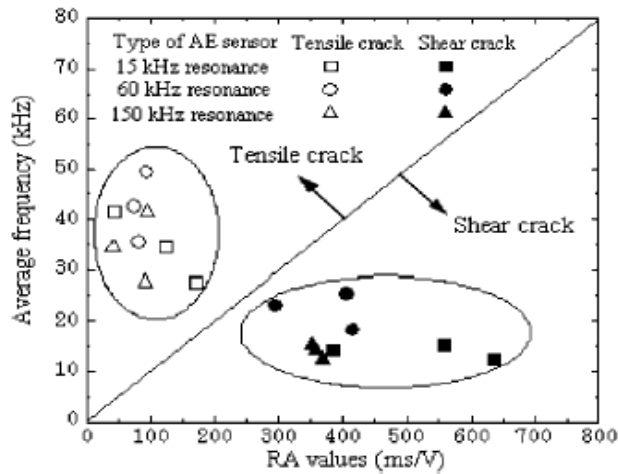
Fig.2.12: Cracks classification by AE indices [33]

To facilitate the second activity, the RA values and the average frequency were examined analytically. Relative to first period as designated by a symbol of arrow, the value of RA becomes high and the value of average frequency is less.

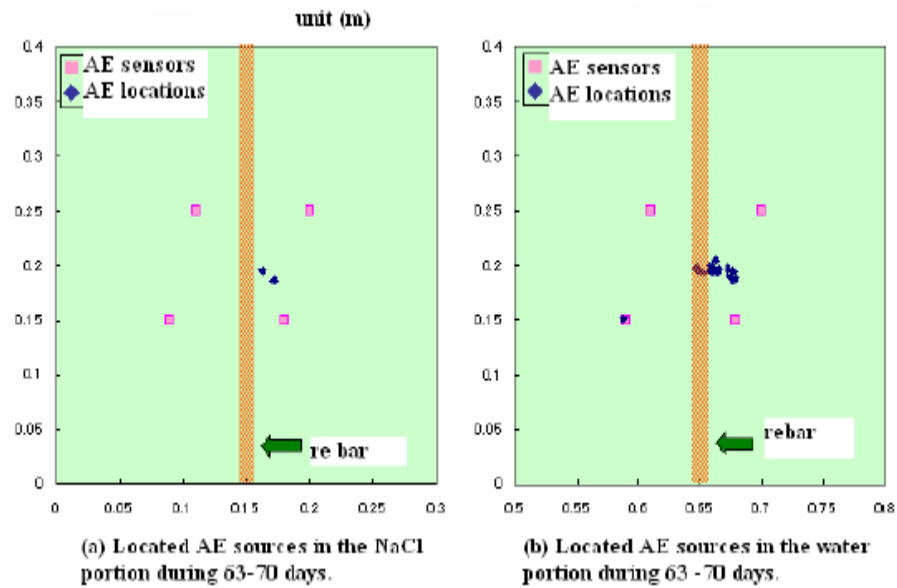
Fig.2.14: AE sources located at 2nd high AE activity in test [34]

Consequently, at the 2nd period of high AE activity, the points of AE source are presented in **Fig.2.14**. This is noticed that AE sources are reasonably located that AE sources are fairly placed just about rebar locations. This implies that in rebar, the activity of corrosion generated due to extension of corrosion products because of concrete cracking is detected readily and positioned by AE method.

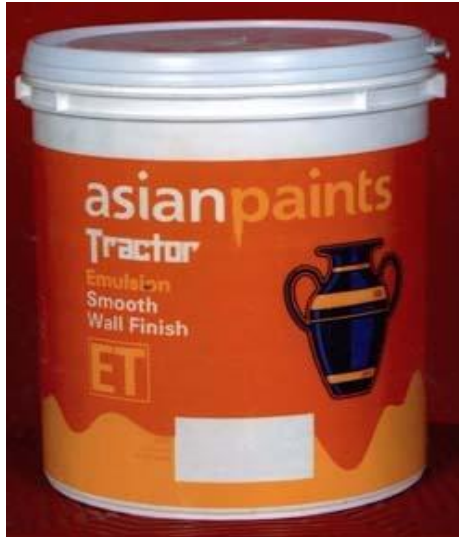
Fig.3.3: Paint used

- **Paint:** The paint used in the testing was manufactured by Asian Paints Ltd. The paint was of grey color. The specific gravity of paint was 1.08. It was applied with the help of a brush on the steel rod to be used. The paint was mixed with the hardener in the ratio of 4:1(paint/hardener). The pigment in the paint was zinc phosphate, binder in the paint was ethyl propenoate. Two layers of paint was applied on the surface of steel before casting in the concrete specimen.

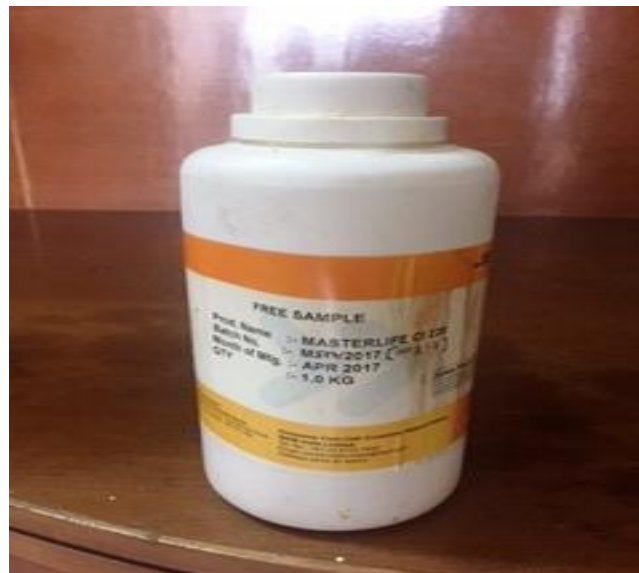
Fig.3.4: Inhibitor used

- **Inhibitor:** The inhibitor used in the study was **Masterlife CI 220** manufactured by **BASF**. It actively inhibits both anodic and cathodic reactions. The recommended usage of this inhibitor is $5\text{L}/\text{m}^3$ of concrete, irrespective of the severity of the exposure environment. It is added in the concrete while mixing. The active ingredient of this inhibitor is a water-based combination of amines and esters.

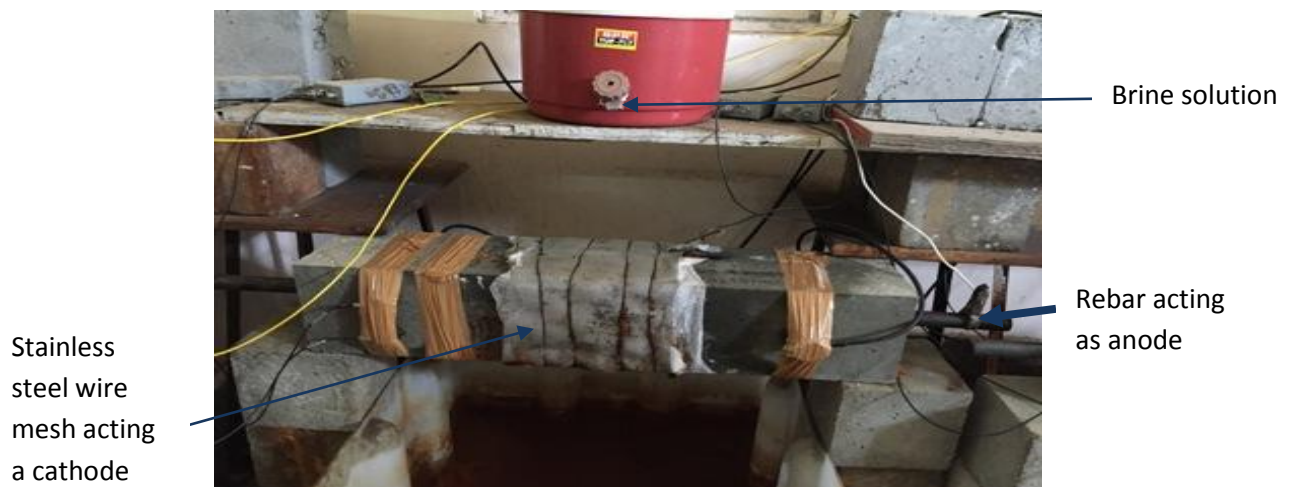
Fig.3.6: Beam showing arrangement for induced corrosion

The corrosion can also be induced by alternate immersion of specimens in sodium chloride (NaCl) solution and drying of the specimens. But impressed anodic current method is the fastest method to induce the corrosion. Middle 300mm length of beam was subjected to brine solution (3.5% NaCl) dripping and the current is impressed by making the rebar as anode and stainless steel wire mesh wrapped in middle 300mm as cathode.

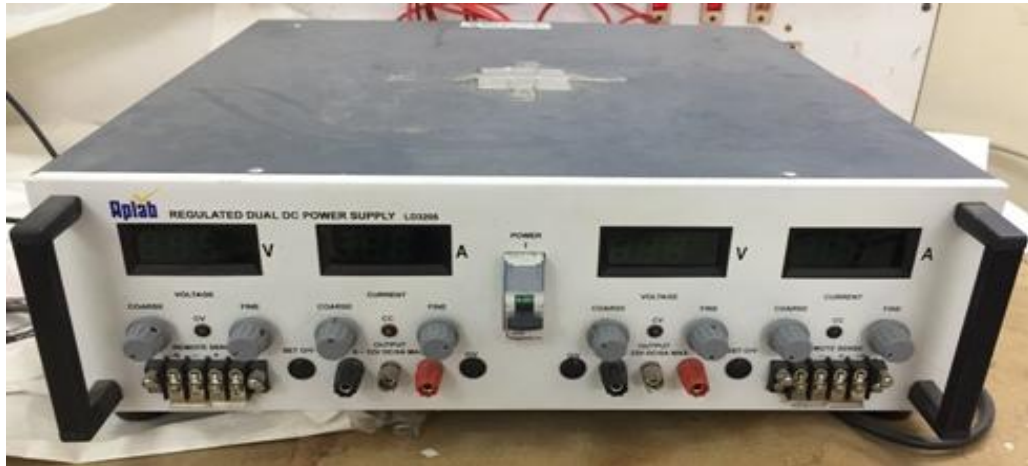
Fig. 3.7: Power supply (Aplab, 64V, 1A Current)

both sides past the concrete. To accelerate the corrosion, a constant voltage of 30V is applied using a power supply system (Aplab Make, 64V,1 A Current) (Fig 3.7).

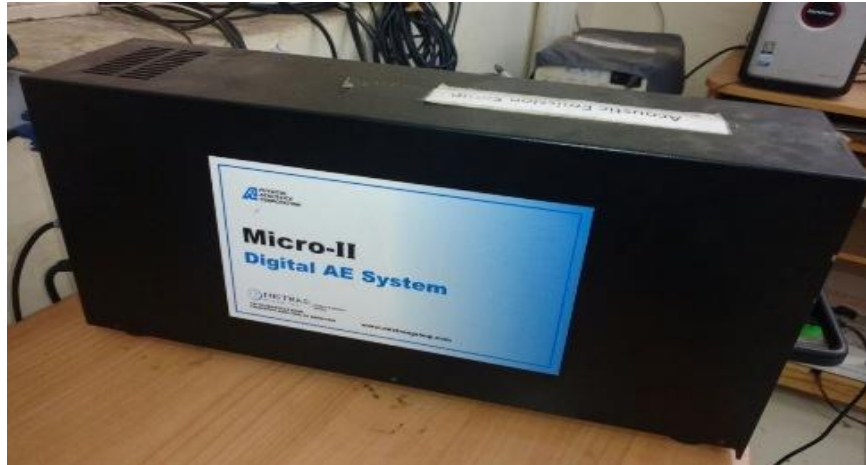
Fig.3.13: Data acquisition set up

In our study, Micro II digital AE system, provided by Physical Acoustics Corporation (PAC) **MISTRAS GROUP** (**Fig.3.13**) was used for AE data acquisition in experimentation.

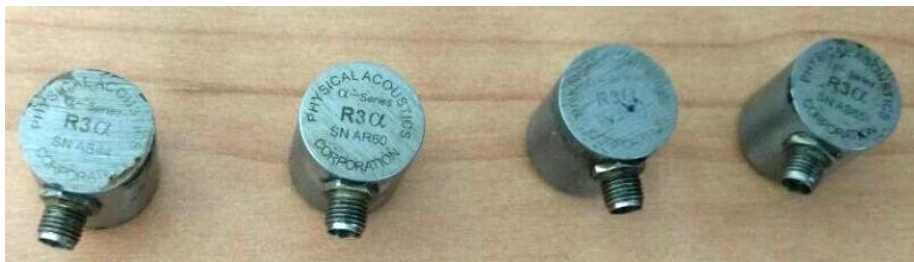
Fig.3.15: R3 α Sensors for acquisition of data

Sensors Specification	R3 α
Range of Operating Frequency	35-100 KHz.
Resonant Frequency	150 KHz
Physical Dimensions	19mm Dia.× 22.4mm Height
Weight	31 Grams
Casing	Stainless Steel

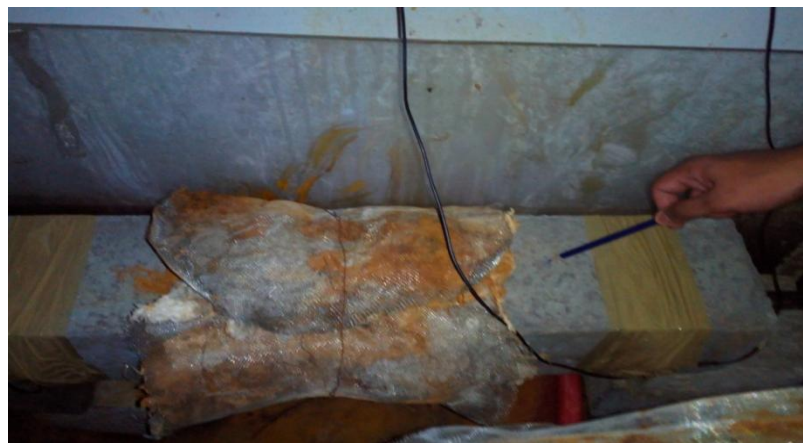
Fig.3.19: Pencil break test during study

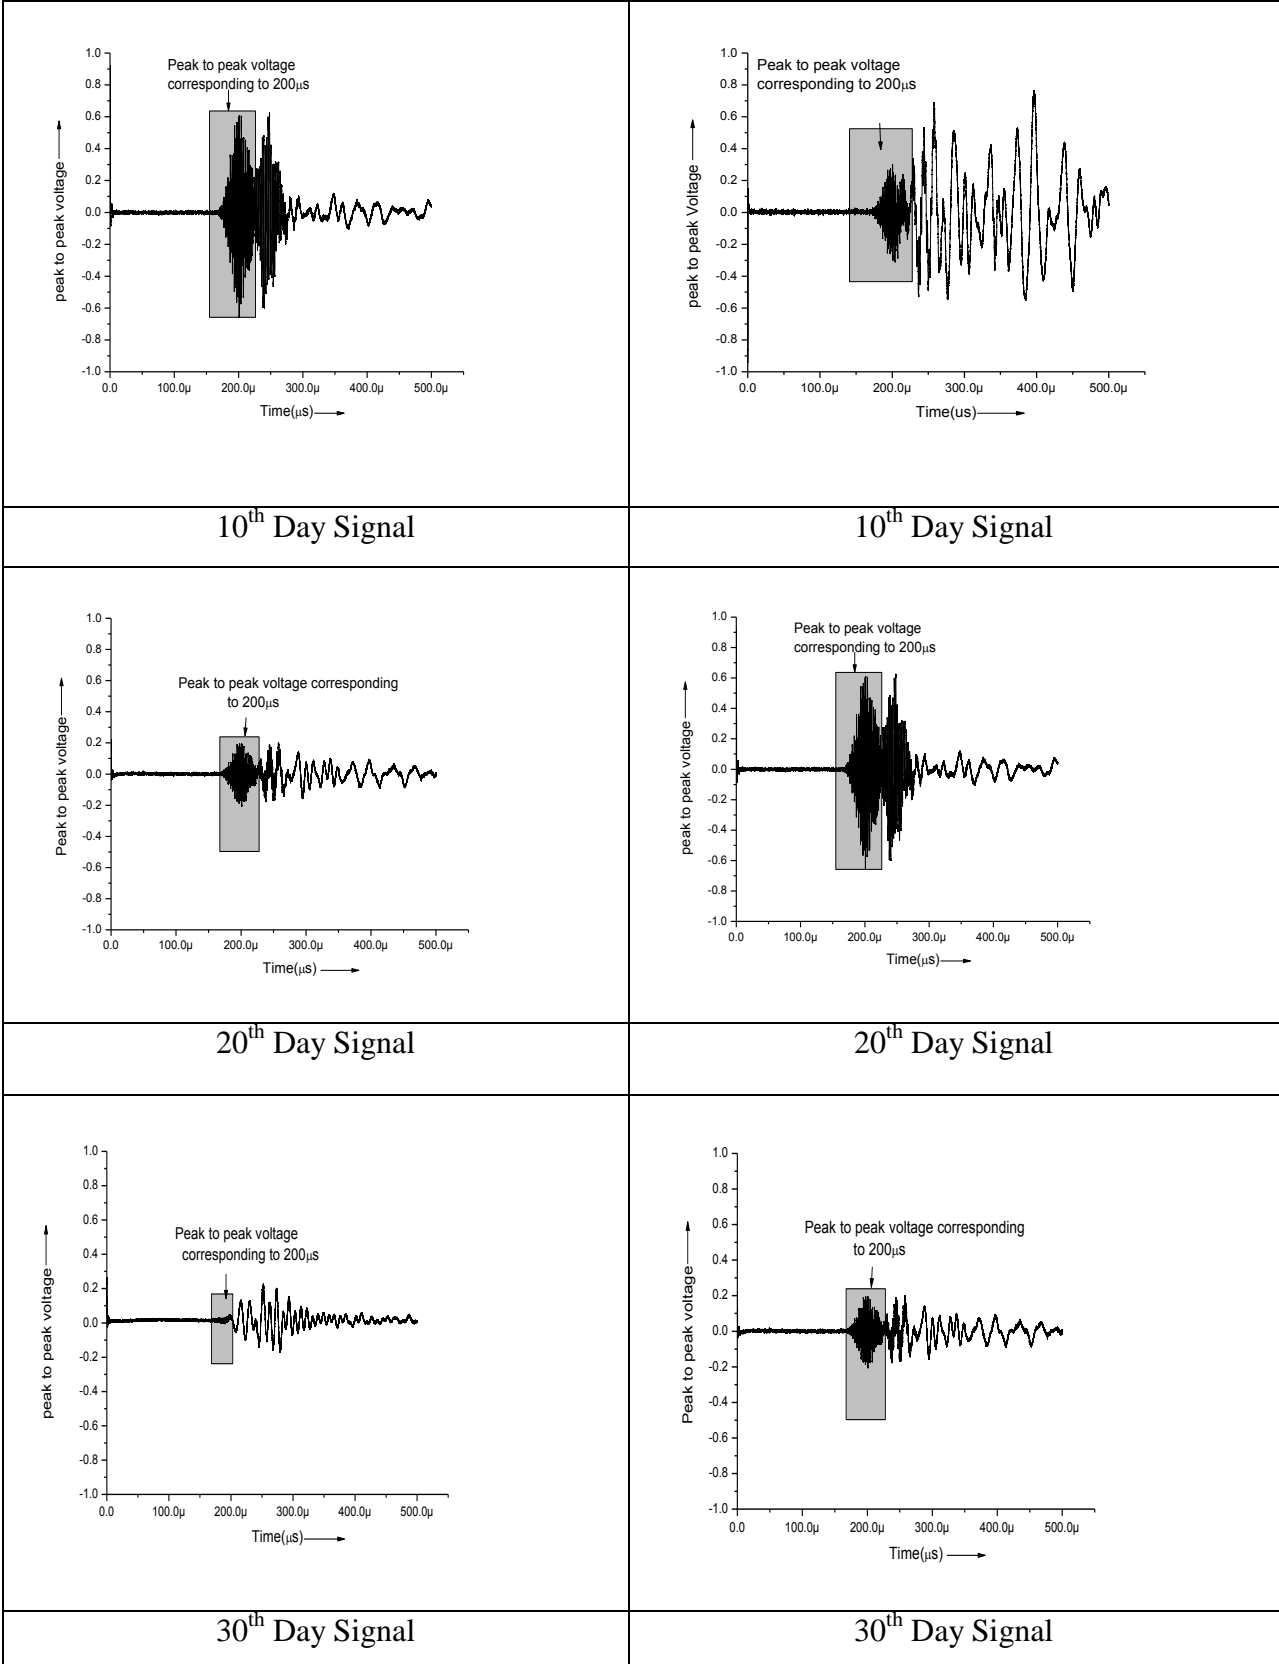
Fig. 4.6: Signature for Specimens B1 and B4 at various Days (L(0,1) mode)

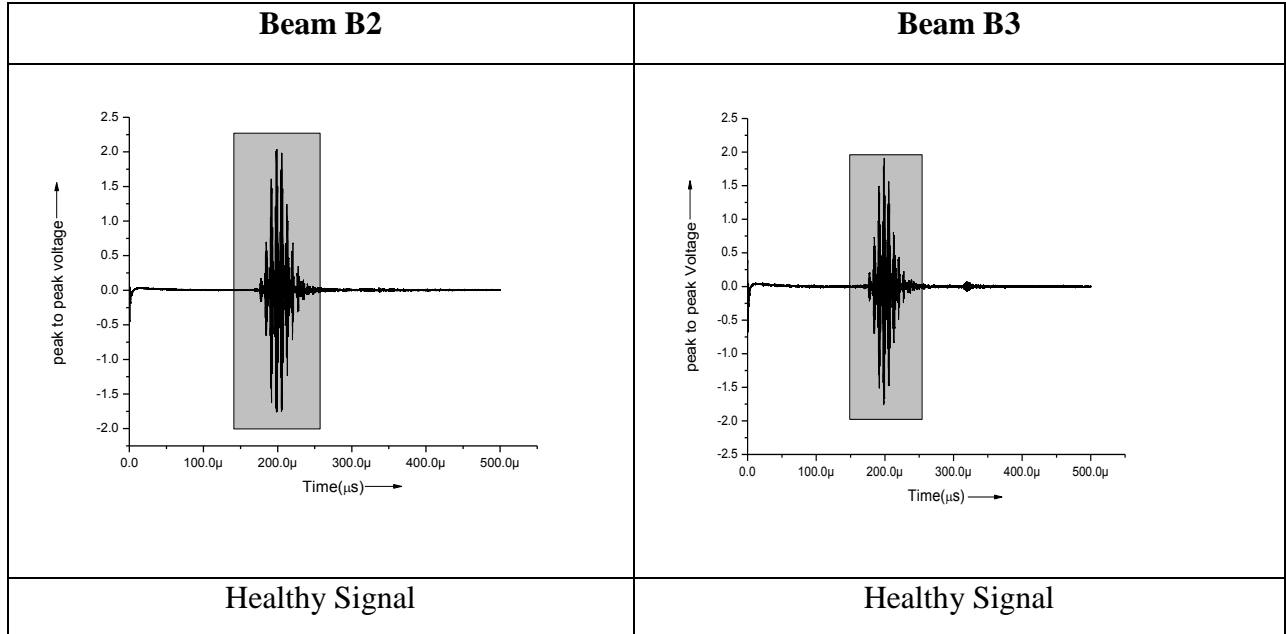
Fig. 4.14: Signatures for specimens B2 and B3 at different days (L(0,7) mode)

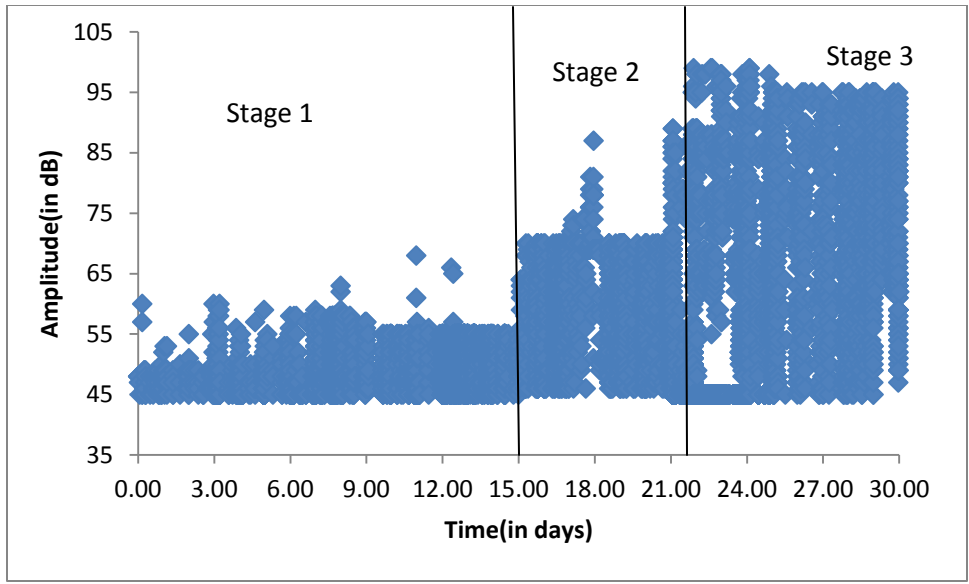
Fig.4.24: Amplitude variation of Specimen B4
