Monitoring Degradation in Concrete Filled Steel Tubular Section Using Guided Waves

Master of Engineering

Thapar University, Patiala

JULY-2016

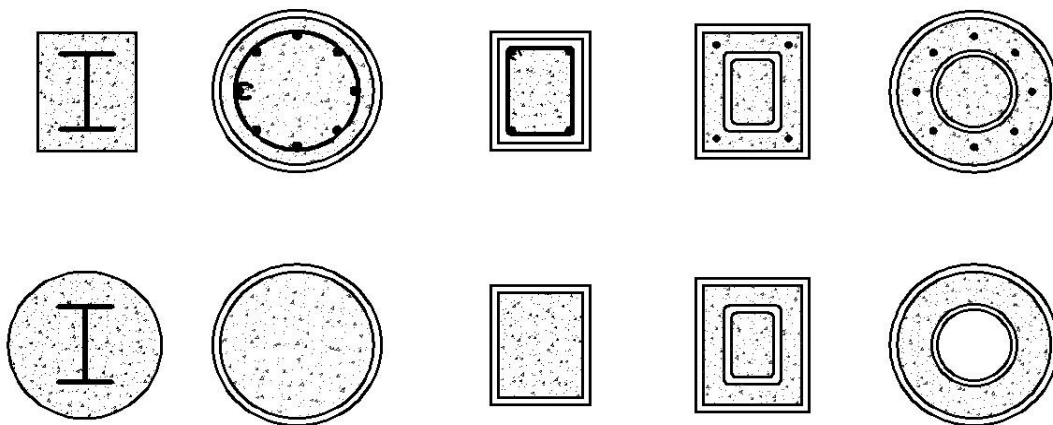
Figure 1.1: Composite Steel and Concrete columns

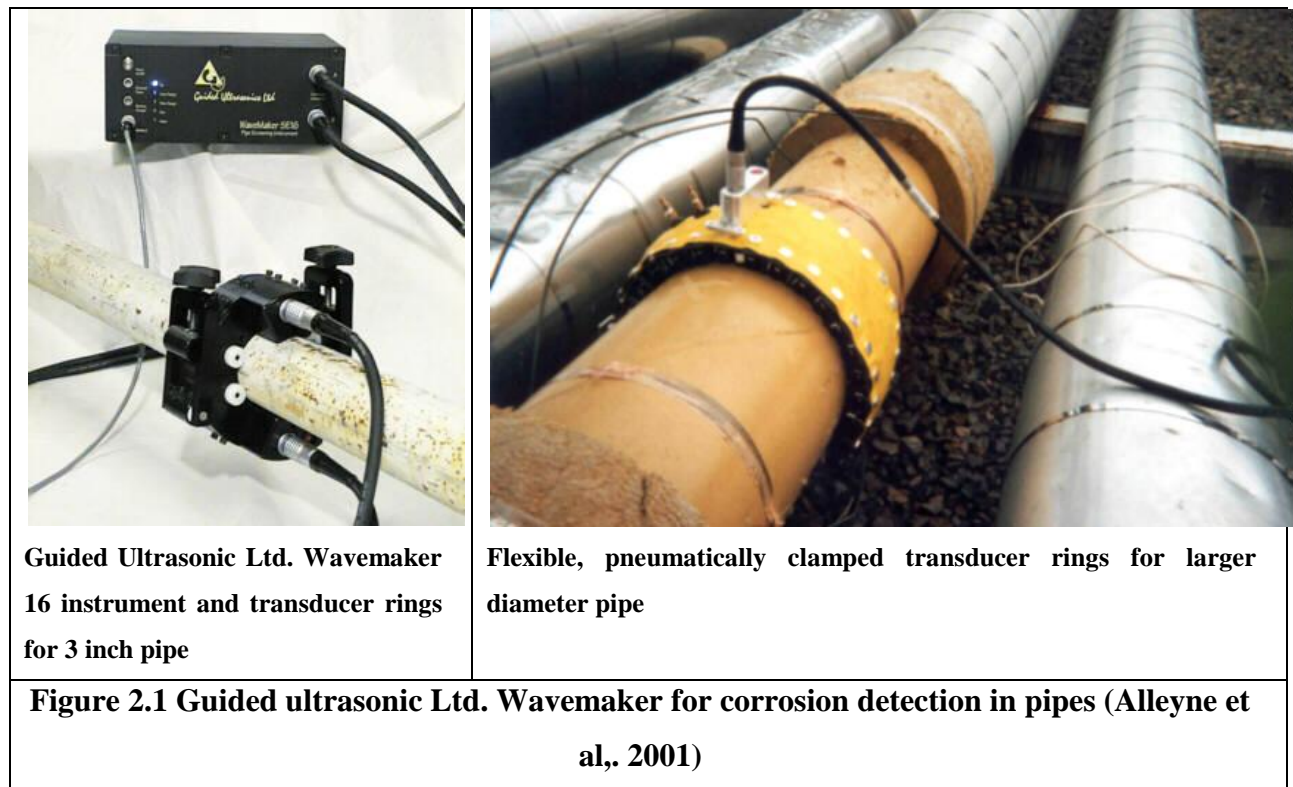
Alleyne et al. (2001) addressed the issues related to inspection of corrosion on pipe network in industrial and civil applications. The main problem in such situations is the accessibility of the structure for inspection and cost of inspection. Authors suggested a use of guide waves for quick investigation of a longer span of pipes. Guided waves were launched from one location on the pipes and reflections if any from the corrosion or other discontinuity were analyzed for its location. Authors used dry coupled piezoelectric transducer system and an inspection span of up to 25 meters on pipelines with 2 to 24 inches. Diameter was reported L(0,2) mode was employed due to factors viz. non-dissipative nature, particle motion largely in axial direction and uniform distribution of strain through pipe wall. Circumferential and radial extents of the depth were correlated with the reflection coefficients. The system yielding good field results also. Cross sectional area loss up to 8-10% could be detected at any given axial position (**Figure 2.1**).

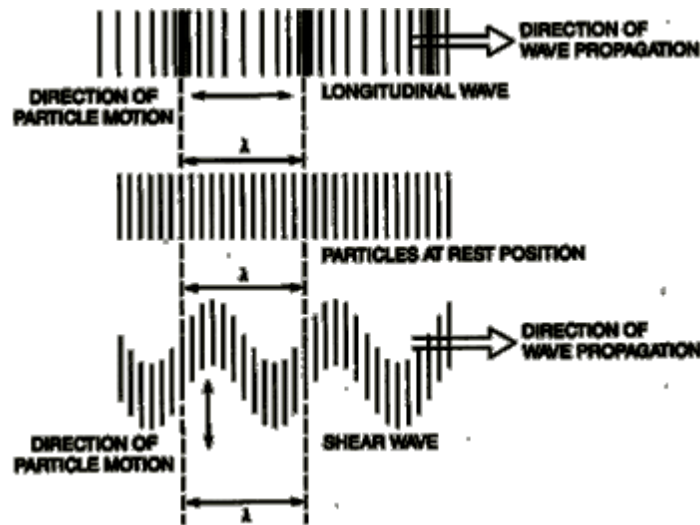
Figure 3.1: Transverse and Longitudinal Wave Propagation(www.ndt.net)

1. **Transverse wave motion:** It is that kind of wave movement in which the particle of the medium vibrates about their mean positions in a direction at right angles to the direction of propagation (motion) of the wave.

2. **Longitudinal wave motion:** It is that kind of wave movement in which the particle of the medium vibrate back and forth about their mean positions parallel to the direction of propagation (motion) of the wave.

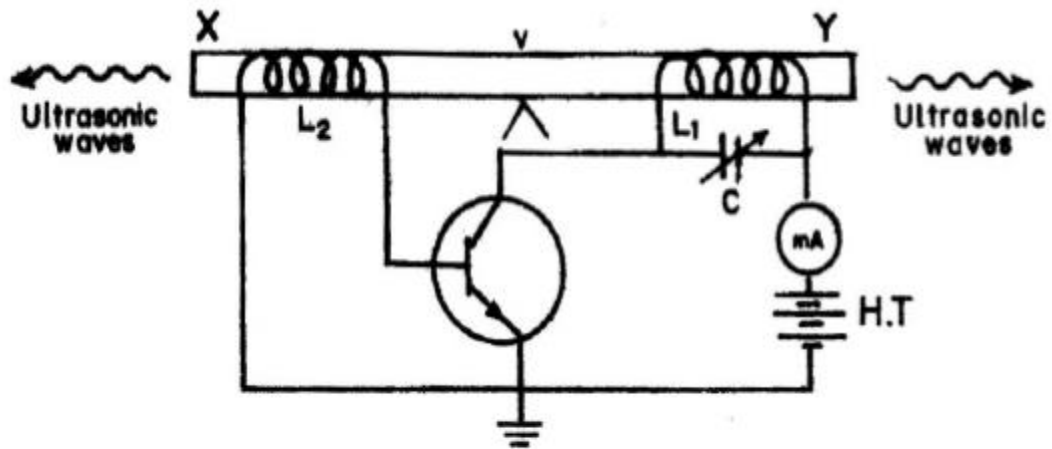
Figure 3.2: Magnetostriction oscillator

- (i) **Magnetostriction Oscillator:-**The production of ultrasonic by this method is based upon magnetostriction effect. Magnetostriction effect, "when a rod of ferro-

magnetic material such as Nickel or Invar is suddenly magnetized, it undergoes a slight change in its length." **Figure 3.2.**

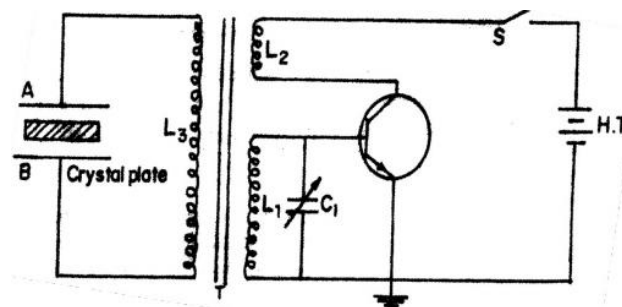
Figure 3.3: Piezo electric oscillator

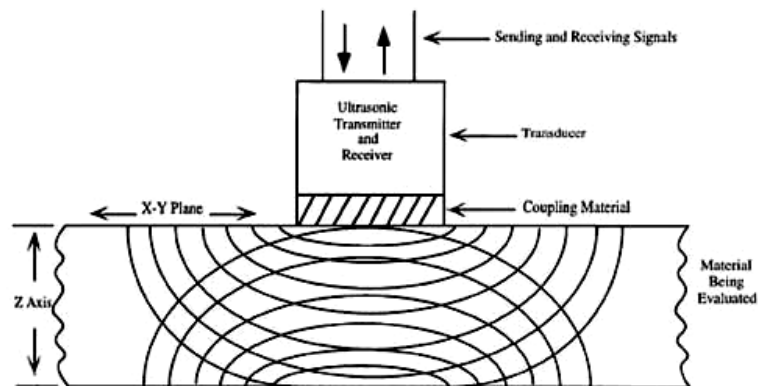
Figure 3.5: Pulse echo method of ultrasonic testing

The pulse echo method permits testing when access to only one side of the material is conceivable.

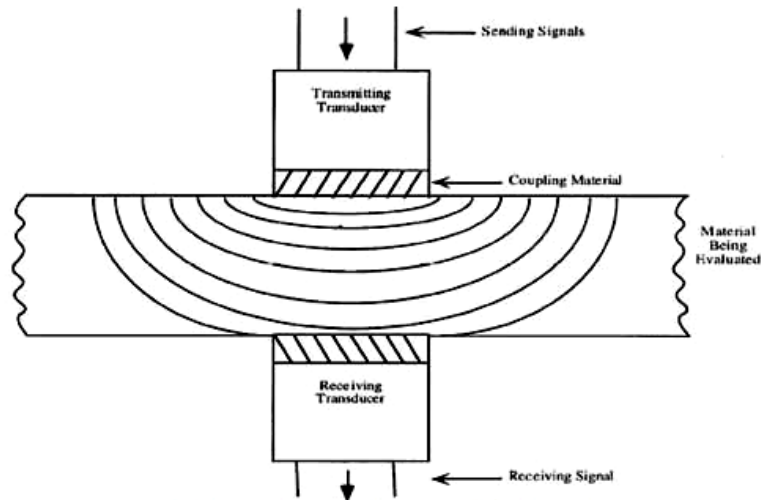
Figure 3.6: Pulse Transmission method of testing

In PT method two transducers were used and they were placed on opposite sides of the specimen. One transducer acts as transmitter (T) while other transducer act as receiver (R) **Figure 3.6.** PE is generally used for detecting and localizing the defect in specimen. PT is employed for sizing defect. By correlating the change in amplitude of input and the received signals, the relative severity of the flaw can be assessed.

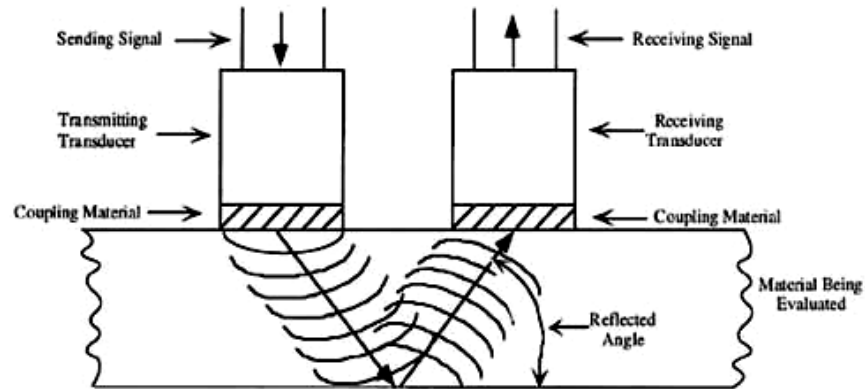
Figure 3.7: Pitch-catch Method of ultrasonic testing

Like PT method, this method also employs two transducers. However, in this case the transducers are placed on one side of specimen only. In PE and PT methods transducers are generally oriented normally to the specimen surface. But, in PC method, ultrasonic energy may be transmitted at an angle and received as reflected energy returning at reflected angle. PC method is usually employed for specimen where only one side is accessible **Figure 3.7.**

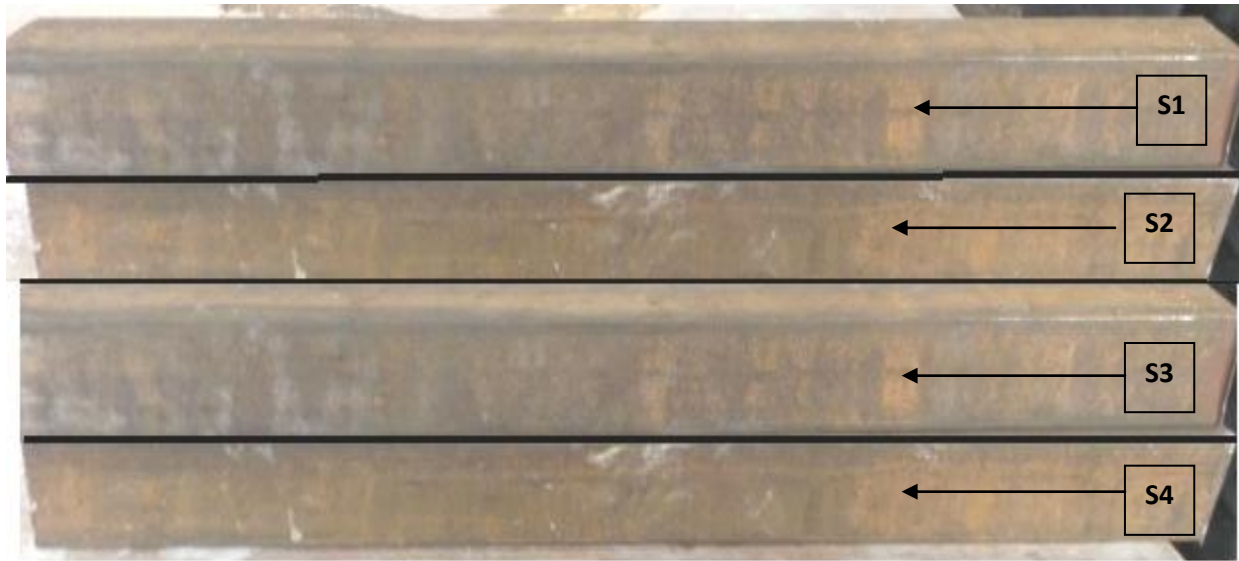
Figure 4.1: Actual CFST specimens

The square empty steel tubes affirming to IS 4923 - 1997 and IS 1161-1998 having a cross-segment of 72mm x 72mm have been used in this as a part of the study. The thickness and length of the square empty steel tubes is 3.2mm and 600mm respectively. These empty steel tubes were filled with regularly utilized M-25 grade concrete with configuration blend extents of bond, sand and stone totals as 1:1.375 (FA):1.539 (20mm CA) :1.510 (10mm CA) by weight arranged with water bond proportion of 0.44 percent. For holding and curing purpose the steel tube was left unfilled by 25 mm on each side of the segment. The CFST specimens were cured for 28 days.

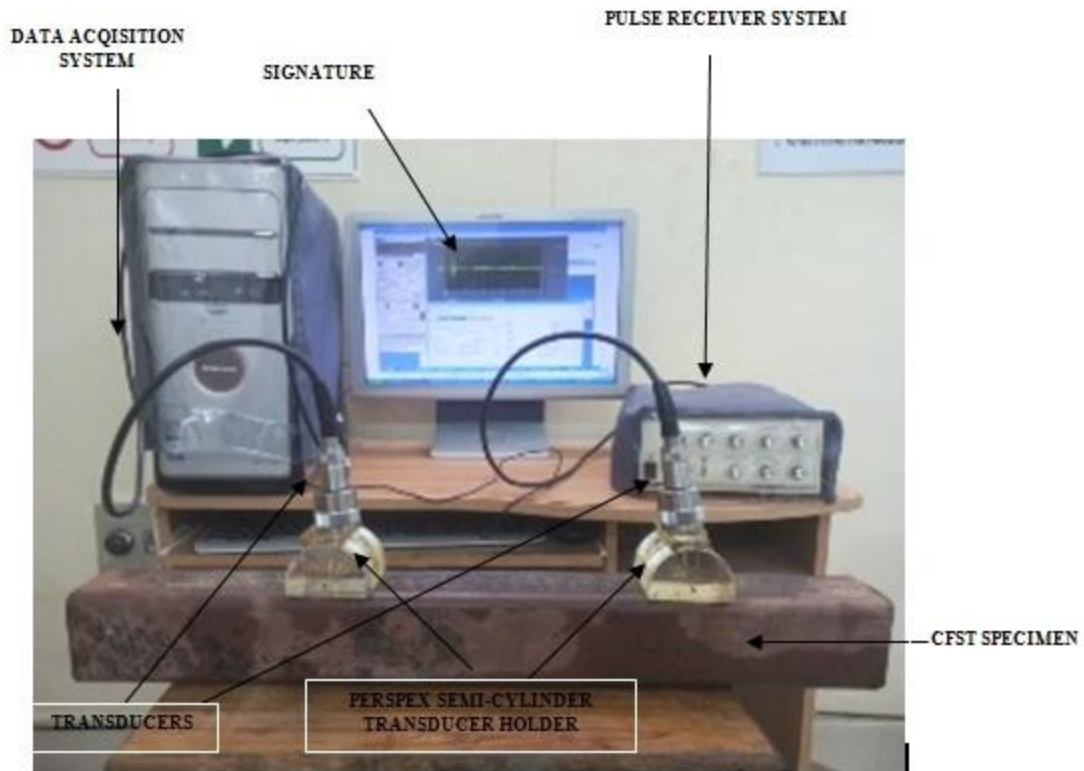
Figure 4.2: Actual Ultrasonic Testing set-up

The ultrasonic testing (UT) setup comprises of DPR500Pulser/Receiver (PR) transducer (Karl Dutsch Make), transducers (Olympus NDTTContact), and the data acquisition card and display device. The pressure transducers are driven by the PR which creates ultrasonic pulse through the concrete container of CFST segment. The ultra-sonic excitation is a wave got when PR is at most extreme information voltage of 900 Volt. The ultrasonic waves created by the transmitter transducer go through the encompassing steel and concrete in the container of CFST point to produce the comparing Lamb wave mode. The tests are to be put at a fitting partition from the plate illustration which is termed as wave travelling way. It is the separation went in Perspex before the wave hits the top surface of the CFST segment. Transmitter transducer sends the ultrasonic wave through a coupling medium (Perspex) and is received by the receiving transducer. The propagating waves are the wave transmission signals showed as Voltage-time (V-t) graph. In this study, transducers of 0.5 MHz are utilized **Figure 4.2.**

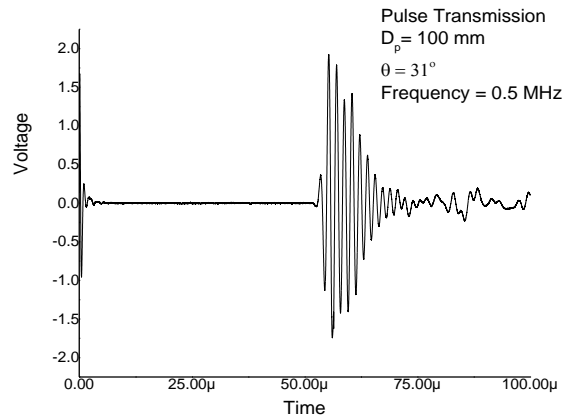
(a)PT signatures at 0.5 MHz frequency

Figure 4.4: Pulse Transmission signature at $\theta=31^\circ$

Ultrasonic testing of CFST in pulse transmission mode comprises of mounting the probes on cylindrical Perspex blokes (of radii equal to $D_w=40$ mm) in pitch catch orientation separated by suitable distance , The input energy is transmitted into the steel structure and is guided by the structure geometry to propagate further along the steel concrete interface n solid media. Guided waves propagating through the concrete (largely heterogeneous medium) are continuously loose energy to concrete due to material attenuation. These leaky guided waves travelling through the steel are captured by the receiver probe. These pulses are further conditioned by the PR unit and are displayed on the screen. The distance transverse by the guided wave through the structure is termed here as propagation distance (D_p). **Figure 4.4** show the PT signatures obtained using 0.5 MHz has only one clear peak.

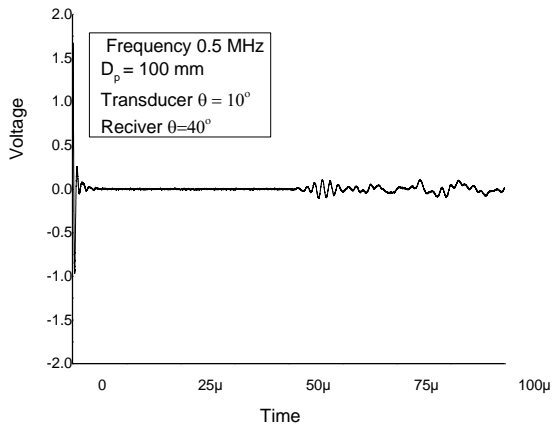
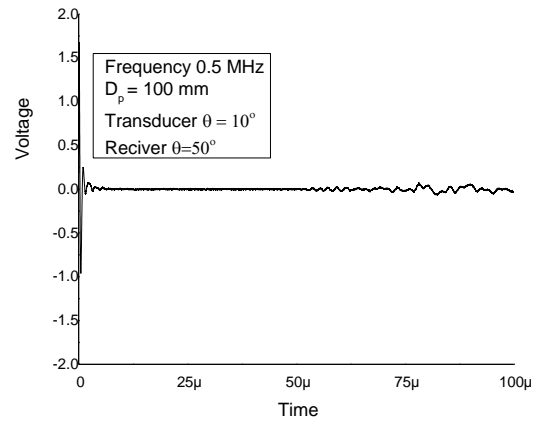
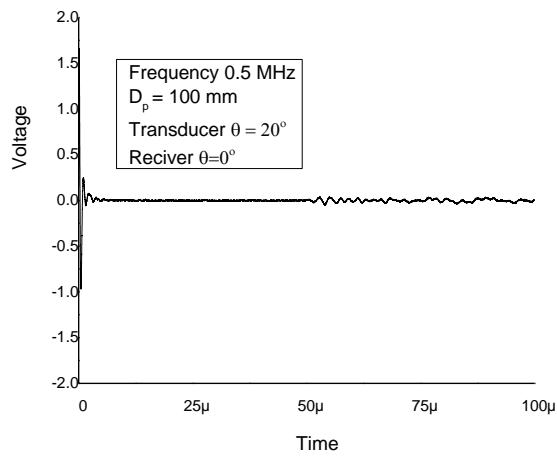
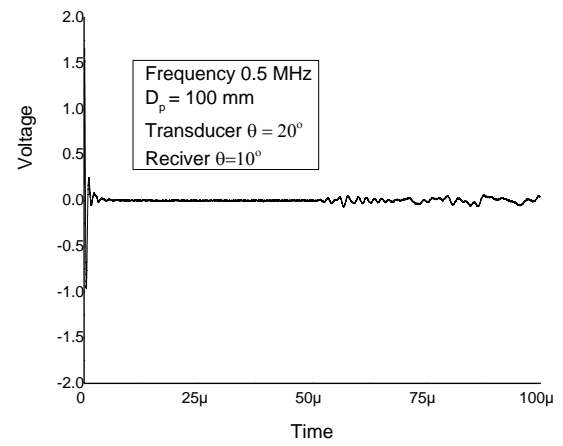
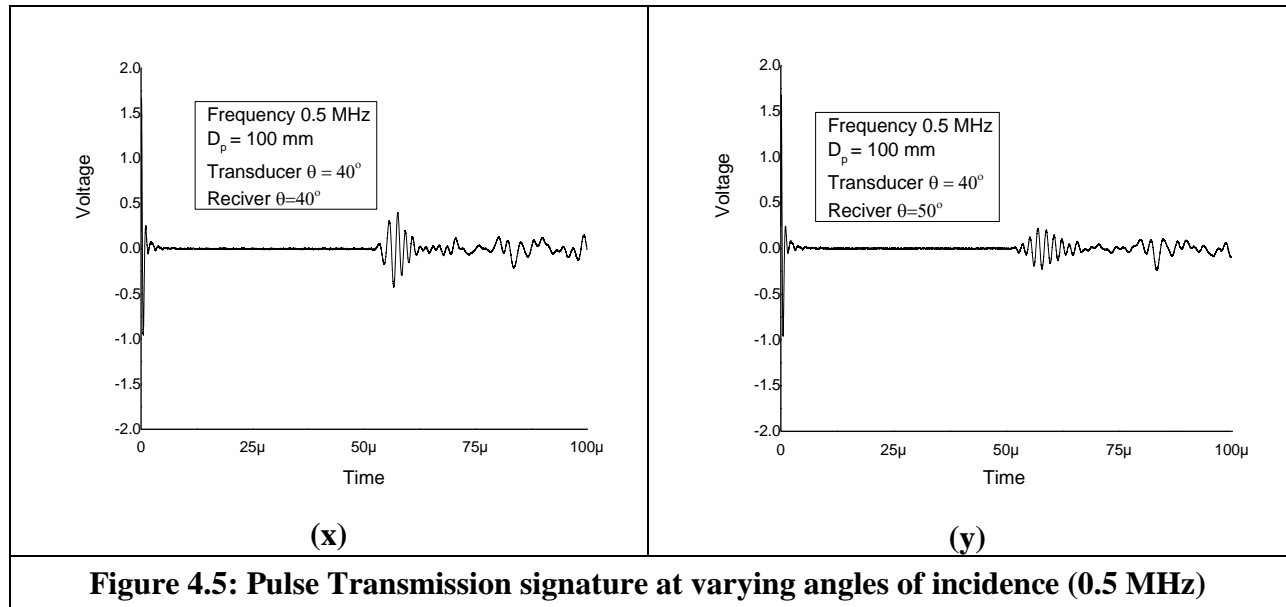
Figure 4.5 show the PT signatures obtained at different at different angle of incidence using 0.5 MHz frequency. At 0.5 MHz frequency, when angle of incidence is in the range of 0° to 20° (**Figure 4.5 a-i**), a weak signal is obtained. At 30° (**Figure 4.5 p**) a sharp peak is obtained at $52\mu\text{s}$. For 30° and 31° angles, this peak becomes even sharper and appears at $57\mu\text{s}$ and $68\mu\text{s}$ respectively. Additionally, traces of smaller amplitude peak on the left side can be seen at $51\mu\text{s}$. as θ increases to 40° , 50° and 60° , the peak on the left side gets stronger and appear around $70\mu\text{s}$, whereas the peak on the right side gets fainter and finally disappears. With further increase in θ (30° and beyond) all peaks gradually diminish (**Figure 4.5 t-v**).

Variations in the PT signature clearly indicate that for a selected frequency of excitation and CFST structure, the propagation characteristics like signal shape and its amplitude and time of arrival of the transmitted pulse are substantially influenced by varying the angle of incidence.

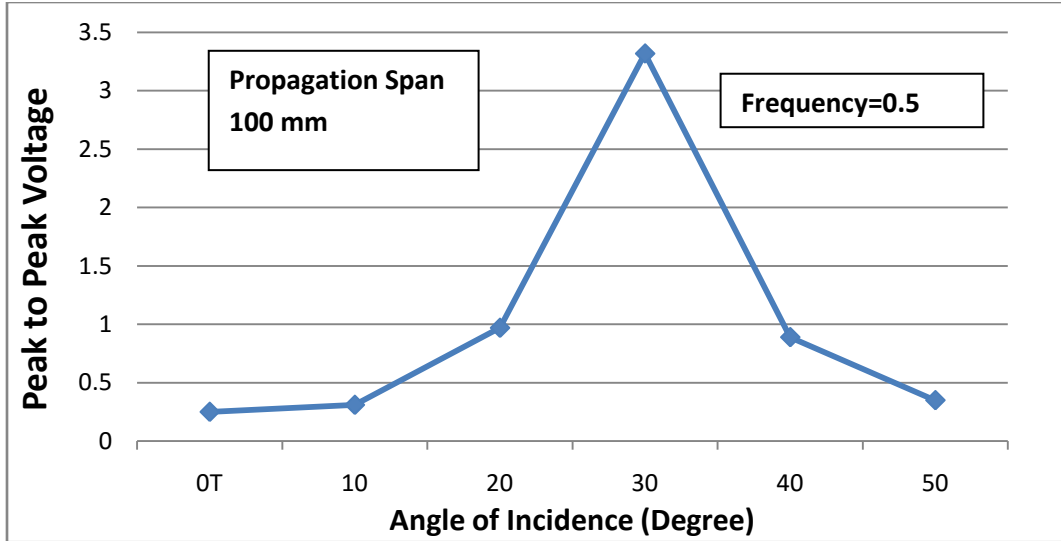
Figure 4.6: Angle of Incidence (θ) vs. V_p of transmitted pulse

Figure 4.6 shows the plot of peak-peak voltage (v_p) of the received signal at different angles of incidence from 0.5 MHz It clearly indicates distinctive bands in v_p - θ plots where signal fidelity is best and this range can be further exploited for investigation of CFST structures. At 0.5 MHz frequency (**Figure 4.6**) range of 30° and 31° at which v_p of the transmitted pulse is distinctively higher.

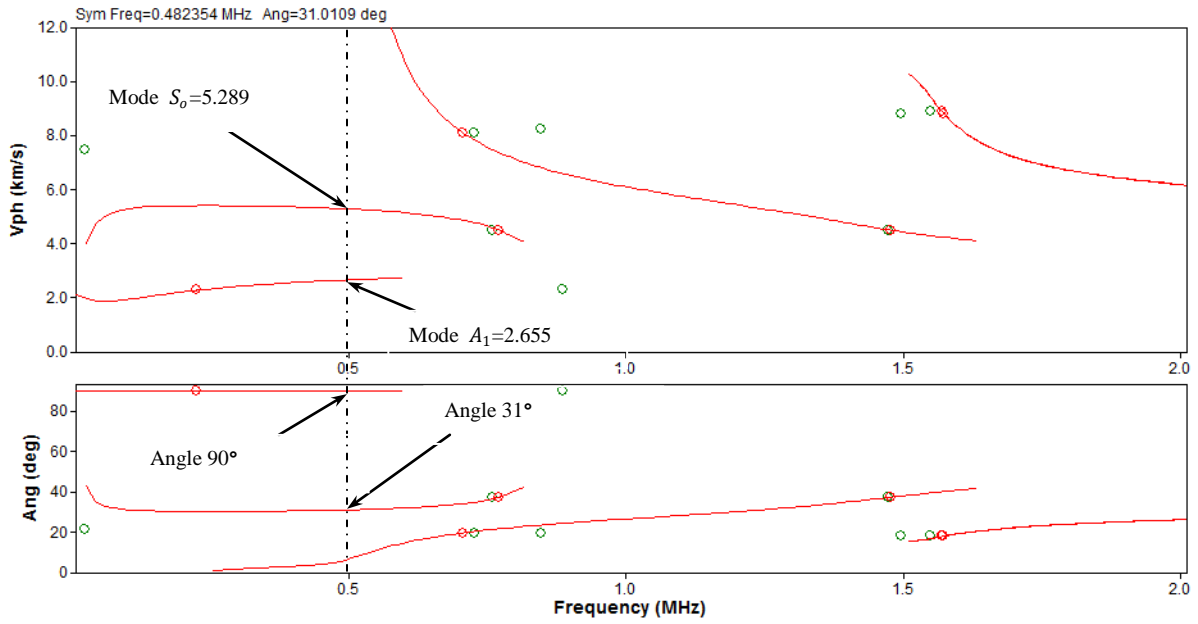
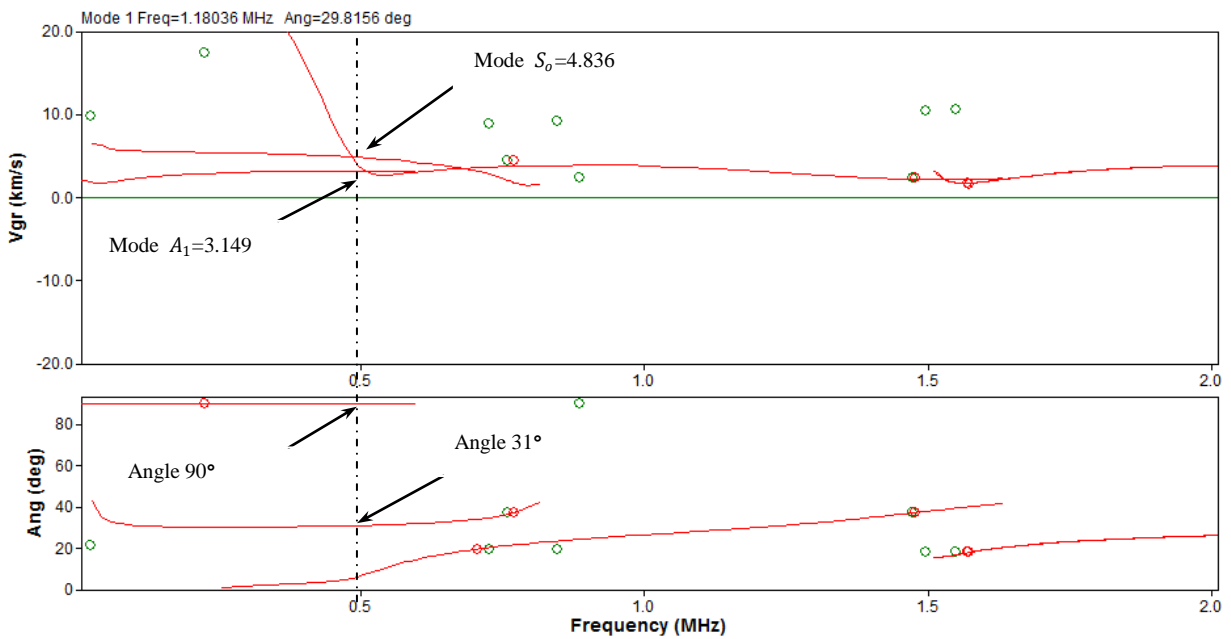
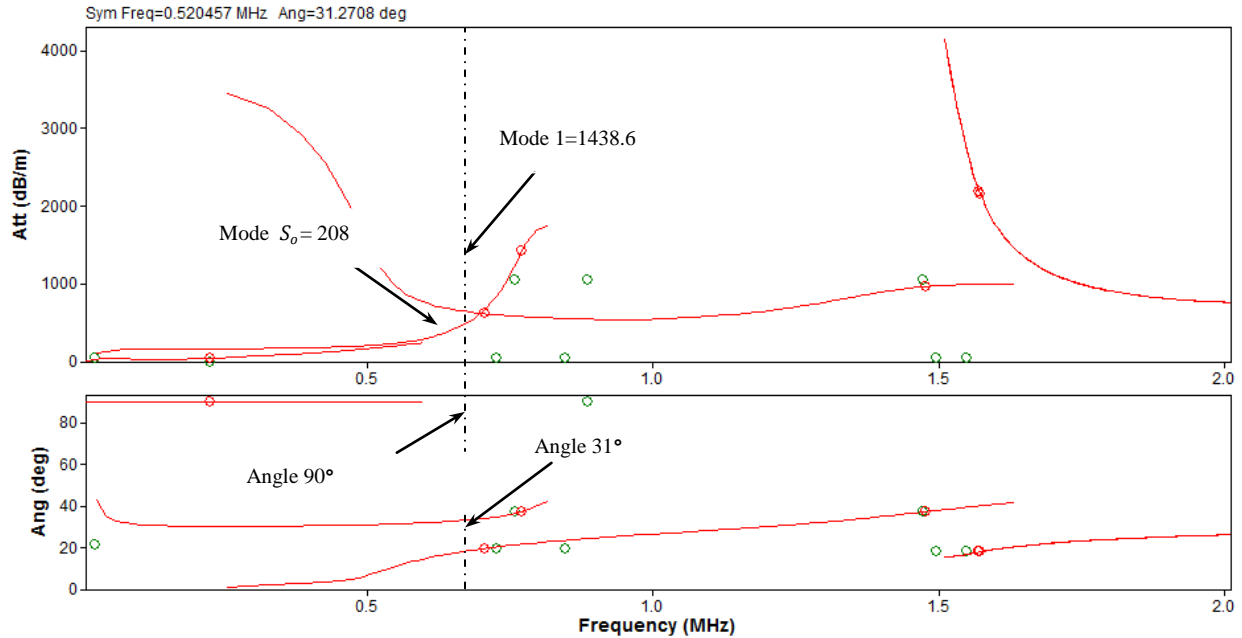
(a) Phase Velocity, angle vs. Frequency

(b) Group velocity, angle and Frequency

(c) Attenuation, angle and Frequency

Figure 4.7: Dispersion curves for 3.2 mm steel tube with Perspex.

time of the mode. At higher values of θ (30° - 34°) this peak vanishes which is also supported by the dispersion curves that no lamb wave mode is feasible beyond 50° .

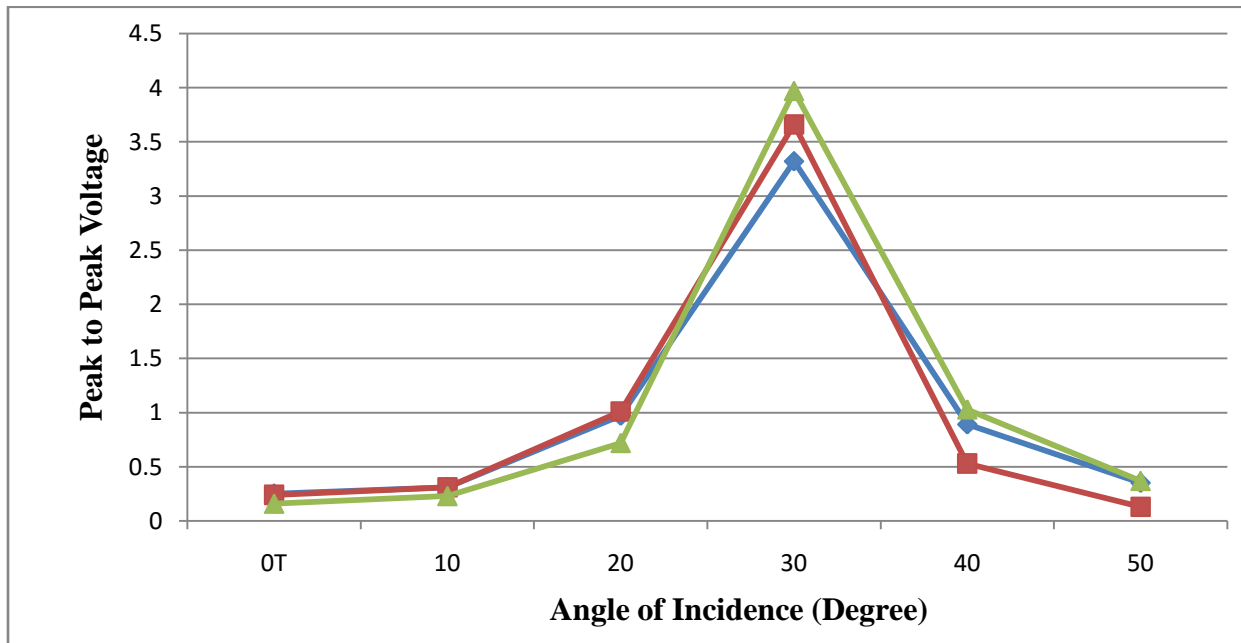
Figure 4.9: Angle of incidence (θ) vs. Transmitted Pulse Amplitude at Varying Propagation Spans.

In this section, the effect of propagation distance on the transmitted signal strength is studied. At different angles of incidence, D_p has been varied from 120 mm to 40 mm. during this experiment, operating parameters like dB setting, Low pass Filter (LPF), High Pass Filter (HPF) settings etc. for the PR unit are kept at the same level in order to avoid any external biasing. It has been observed that for some values of angles on incidence, lamb waves are too weak to traverse through the given span. In such cases signal is too weak or undetectable. **Figure 4.8** shows V_p of transmitted pulse corresponding to the different angles of incidence at variable propagation distances. For a given angle of incidence, the amplitude of the transmitted pulse decreases with increase in the propagation distance. This can be primarily attributed to the more leakage of energy into surrounding water and increased material attenuation due to increased propagation distance. It clearly, suggests that change in the propagation distance has no effect on the trends of transmitted pulse amplitudes (**figure 4.8**).

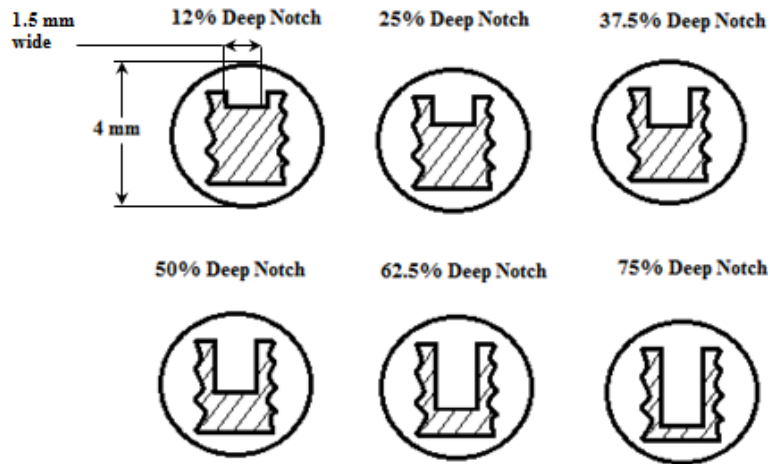
Figure 5.1: Notch Geometry Details (1.5 wide and depths varying from 0.5 mm to 3 mm with 0.5 increments)

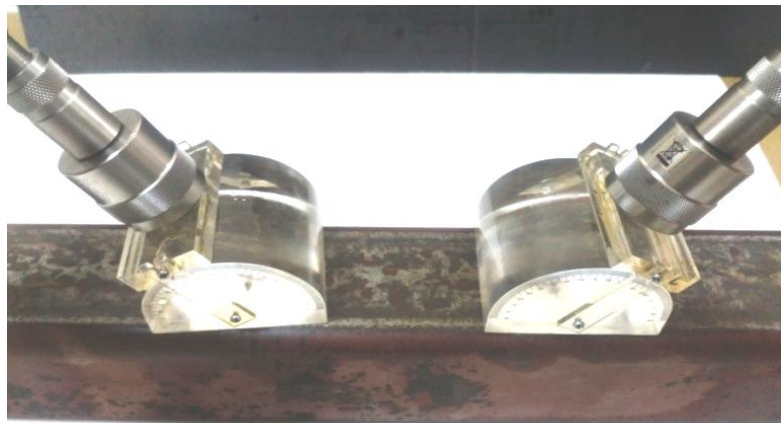
Figure 5.2: Transducers are placed at 31° angle on Perspex semi cylinder with pitch catch orientation

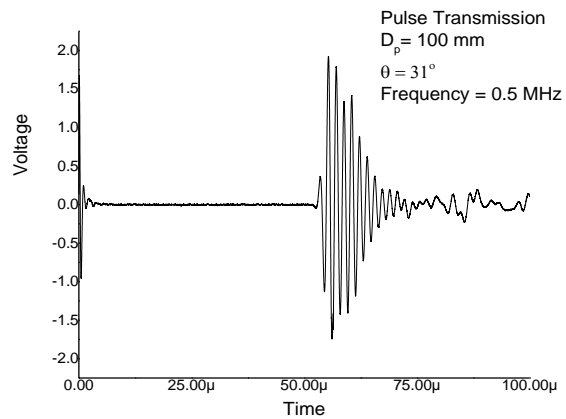
Figure 5.3: Pulse Transmission signature at $\theta=31^\circ$

The specimens were tested in PT mode after setting the transducer. PT signatures with healthy specimen are recorded with S_0 Mode at frequency 0.5 MHz rated transducer. A specific mode can be obtained by placing transducer at a particular angle of incidence (**Table 4.1**). **Figure 5.3** shows PT signature in healthy specimen with S_0 Mode at frequency 0.5 MHz rated transducer.

Ultrasonic pulse transmission signatures were recorded in healthy CFST specimens **Figure 5.3** and compared with the signatures obtained with increased debonding using S_0 mode at 0.5 MHz. PT signatures recorded using S_0 mode at 0.5 MHz with increasing debond are shown in **Figure 5.5**. It is observed that there is increase in the ultrasonic signal as the area of

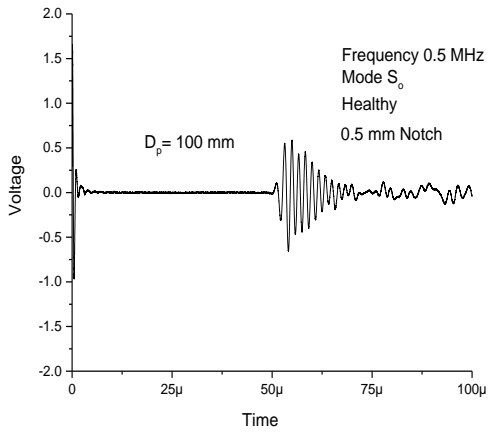
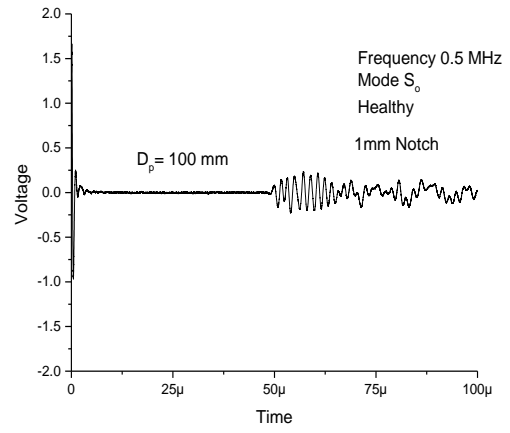
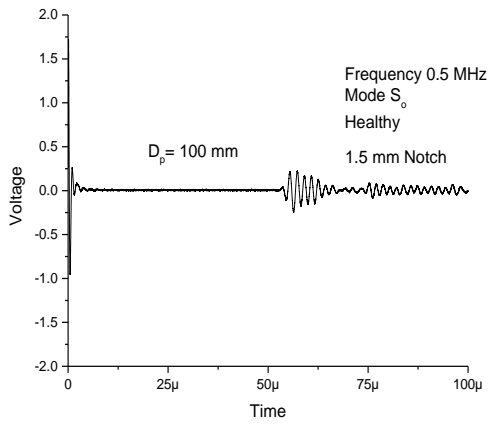
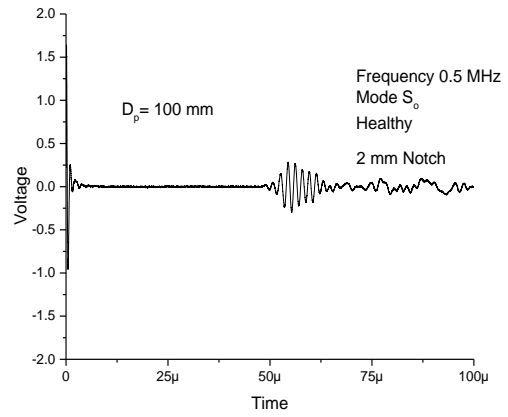
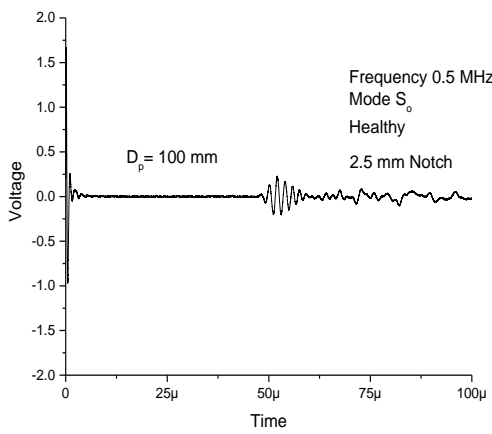
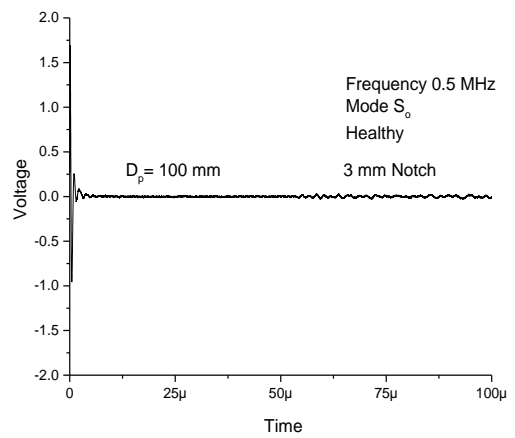
Figure 5.4: Pulse Transmission signature with varying depth of Notches

PT signals are likely to change due to presence of damage on the specimen. PT signals have unique signal distribution across the specimen thickness, each signal formed due to unique response of ultrasonic wave to notches of varying depths. In order to exploit the lamb wave mode is expected NDE tool, it is important to select those modes which are more sensitive to the type of defects being investigated. Modes which can exhibits to largest variations in signal amplitude of the transmitted pulse for a notched specimen vis-à-vis healthy specimen are most suitable and are preferred.

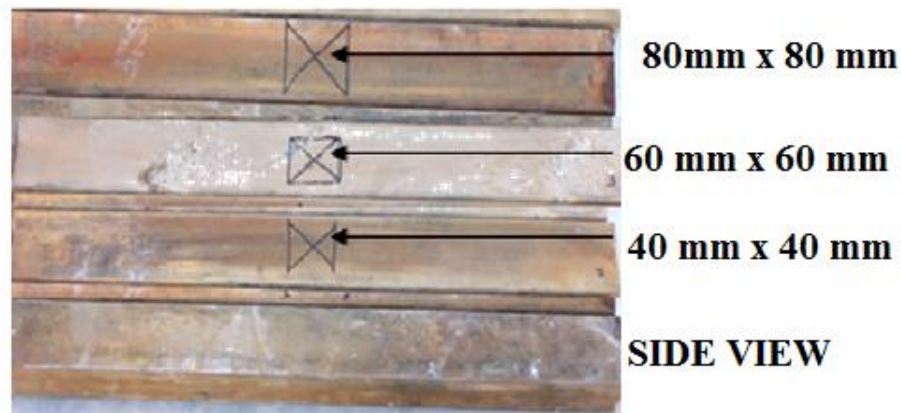
Figure. 5.5 Simulated debond specimens

For debond/delamination investigation, another set of CFST specimens with increasing length of debond between tube and concrete was prepared. Debonding/delamination between steel and concrete was created by pasting square sized PVC sheets of various sizes 40mm x 40mm (S1), 60mm x 60mm (S2) to inner surface of hollow pipe in the middle portion of steel tube prior to filling the concrete inside (**Figure. 5.5**). This indicated increasing debonds between steel tube and concrete of CFST section. The PT signatures were also taken on these simulated debond samples and compared with healthy signal to study the effect of delamination on PT signals.

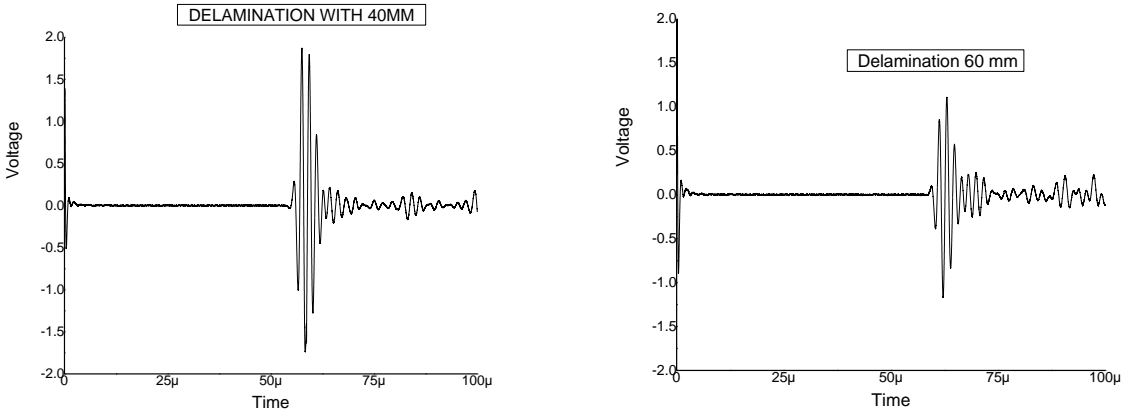
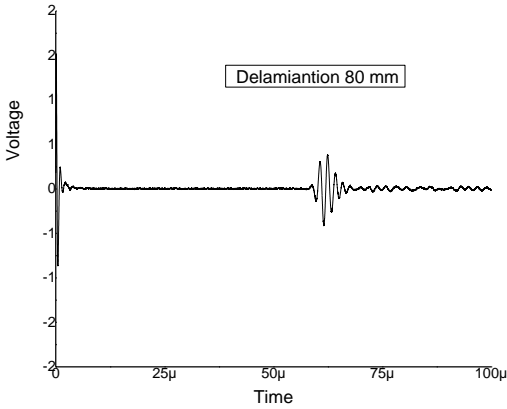
(a) Specimen with Delamination 40 mm and (b) Specimen with Delamination 60 mm

(c) Specimen with Delamination 80 mm

Figure. 5.6 PT signatures with increasing delamination (S₀ mode at 0.5 MHz frequency).

delamination increases. As the debond increases, there is a rise of 38.4 % in S1, 56.8% in S2 and 94.3% in S3 as compared to healthy signal. This is due to reduction in leakage of signal with increase in delamination causing rise in signal strength. Hence, increase in signal strength points towards delamination of the tube from surrounding concrete. Quantitative change in signal amplitude can be used to correlate with the extent of delamination. Hence, increase in debond is marked by rise in signal strength is well picked up by the low frequency mode. The investigation using the 0.5MHz low frequency modes are further used for picking up actual corrosion in CFST sections.

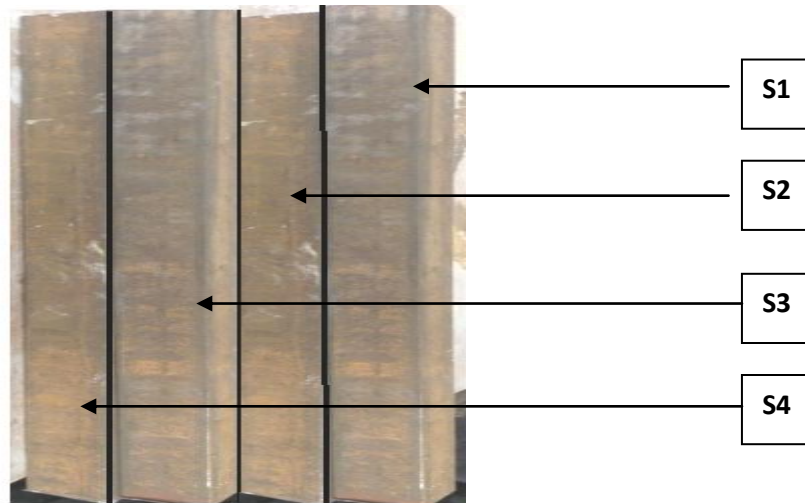
Figure 6.1: Actual CFST specimens used in accelerated corrosion monitoring Experiment

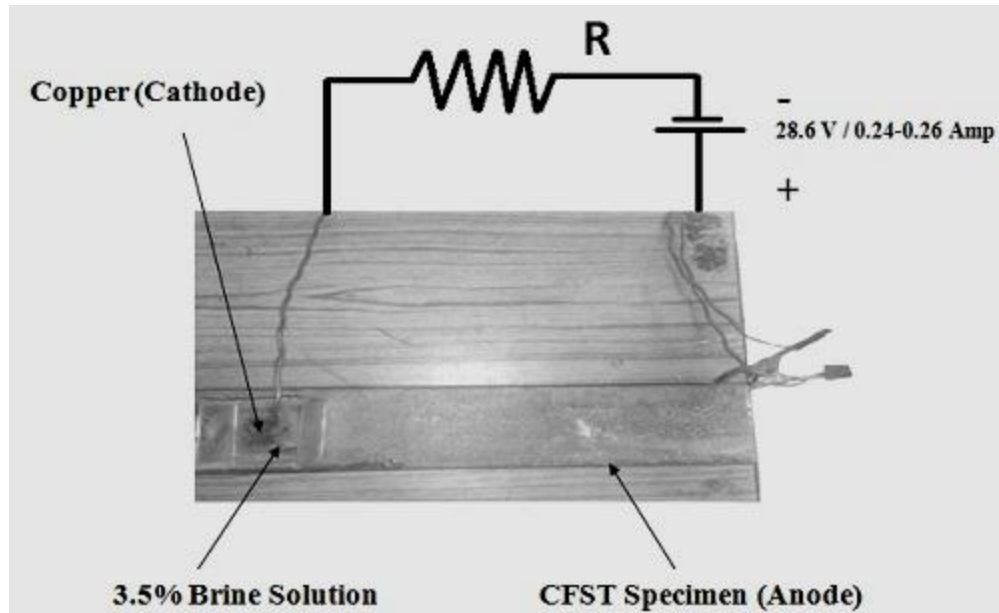
Figure 6.2: Accelerated Corrosion Set-Up

The acrylic tank is dismounted after every 24 hours of exposure to accelerated chloride corrosion. Ultrasonic scanning of the specimen in corroded condition using S_o mode is done to observe the changes in PT signatures. Mass of specimen is also recorded in each cycle to find out loss in mass due to corrosion after every day. After the ultrasonic scanning, the tank is remounted on the specimen and the process of accelerated chloride corrosion is continued. This procedure has been repeated till PT signature vanished or the CFST gave way.

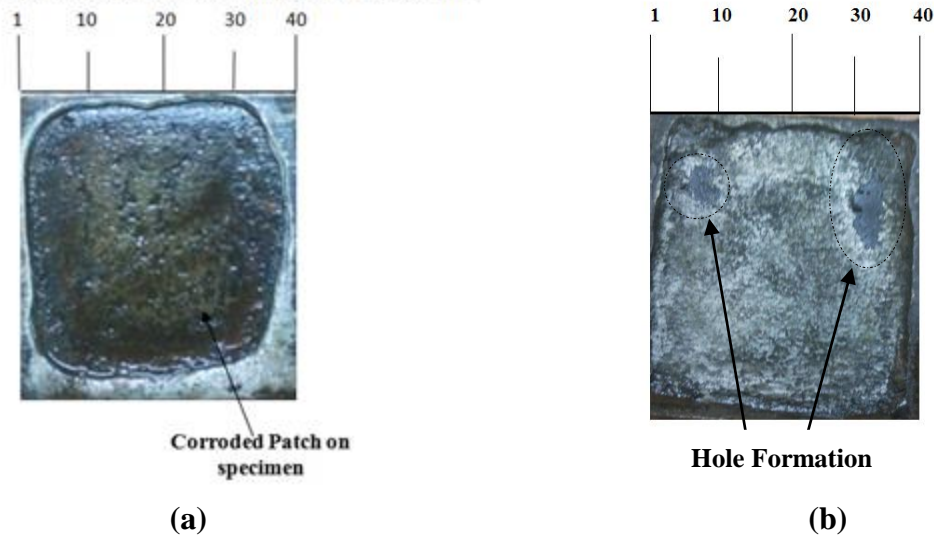
Fig. 6.3 Accelerated corrosion in the plate (a) after 5 days (b) after 8 days

Figure 6.5 shows V_n at different area on the specimen using the S_o mode with progressive days of corrosion. The transmitted signature weakens with increasing exposure to corrosive environment showing material loss due to corrosion. Most extreme drop in voltage amplitude is seen at area marked 10-20 on the specimen. (**Figure6.3b**)

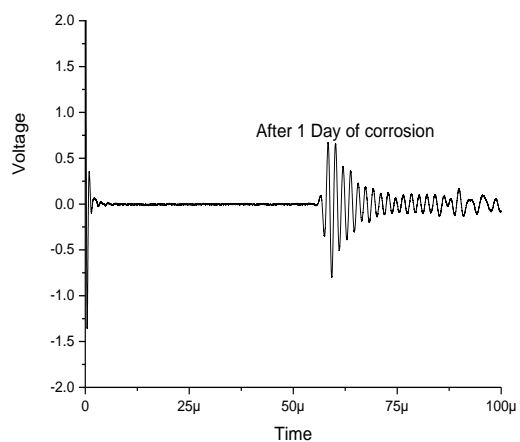
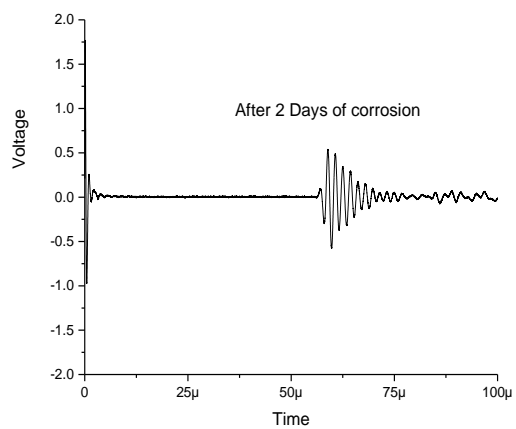
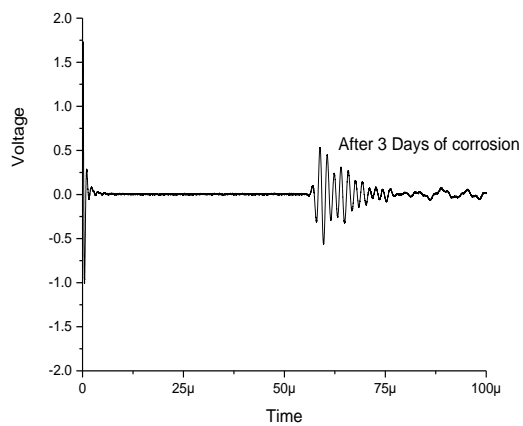
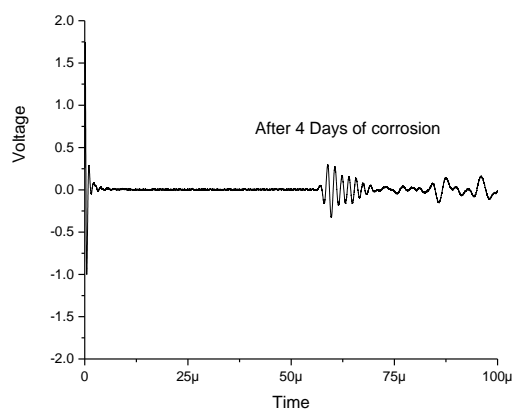
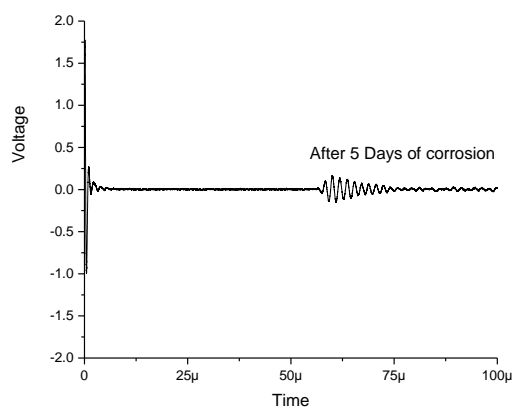
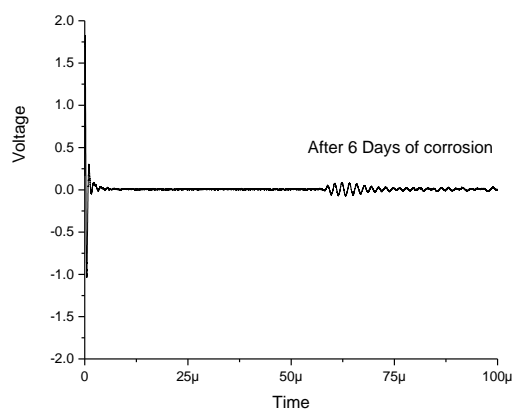
Figure 6.4: PT signature using core sensitive mode at location 0-40 in specimen undergoing accelerated corrosion.

Sharp peak representing S_o mode at 0.5 MHz is fading rapidly with the increasing experience of corrosion. The decline in the signal amplitude is sharp in initial 6 days indicating its suitability to detect on set and initial phase of surface corrosion effectively. Further from 6-8 days, the signal drop was not very significant.

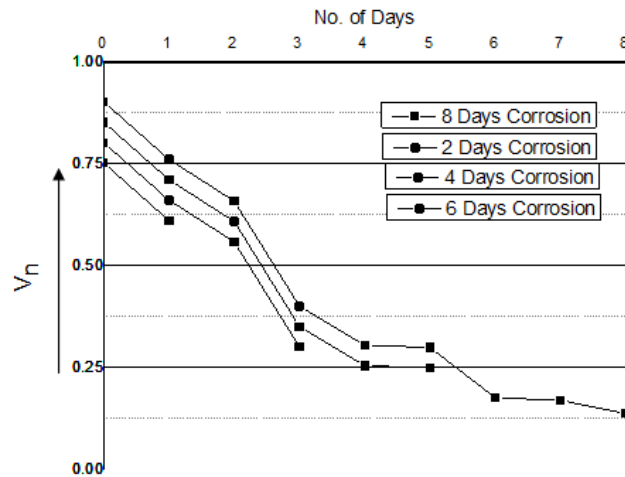
Fig. 6.5: V_n for specimen undergoing corrosion to different ages using S_o mode at 0.5 MHz

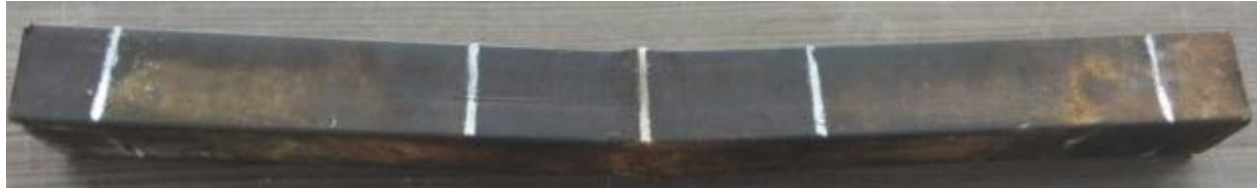
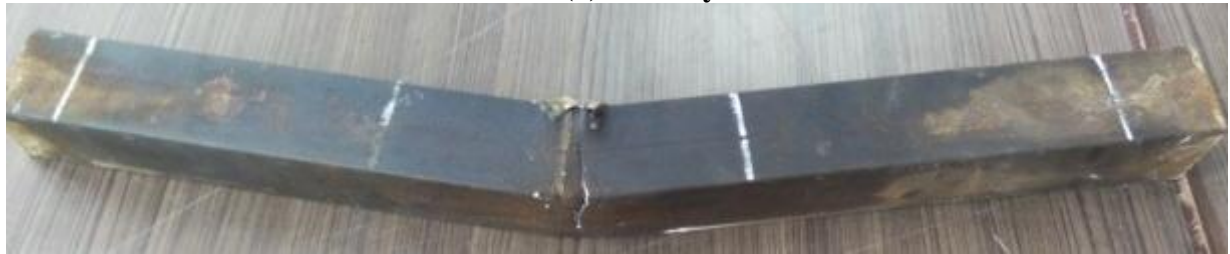
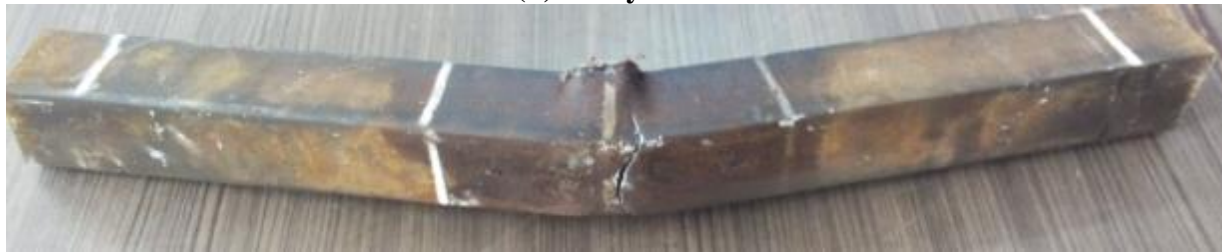
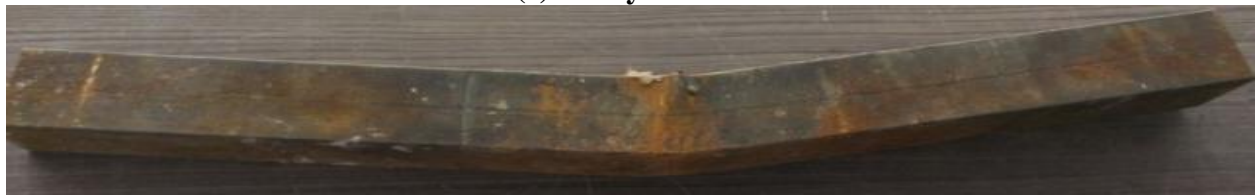
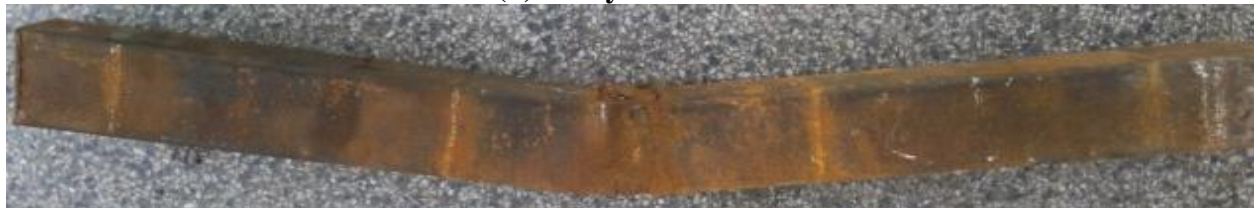
Fig. 6.6: Flexural Testing of (a) Healthy (b) 8 days corroded (c) 6 days Corroded (c) 4 days corroded (d) 2 days corroded CFST specimens.

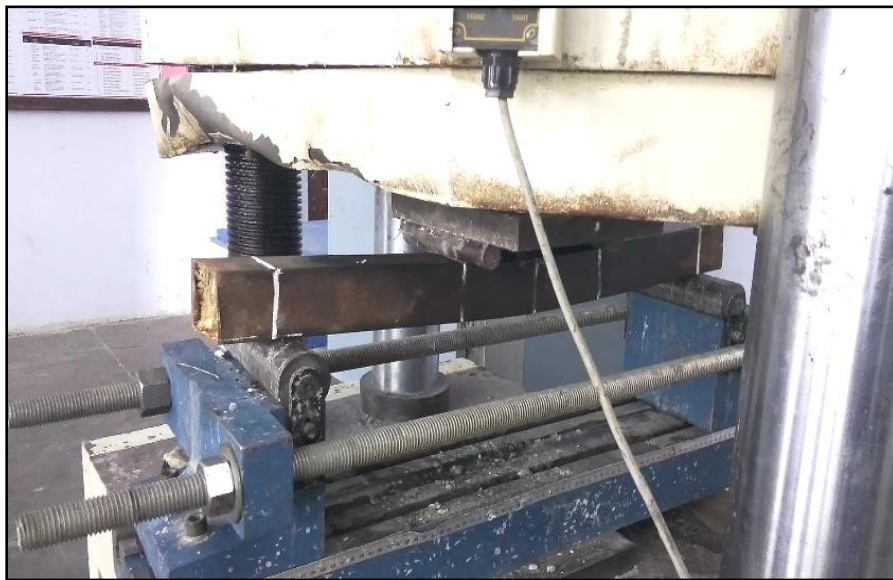
. **Figure 6.7: Destructive Testing**
