Monitoring Degradation in Concrete Filled Steel Tubular Section Using Guided Waves

Master of Engineering

Thapar University, Patiala

JULY-2016

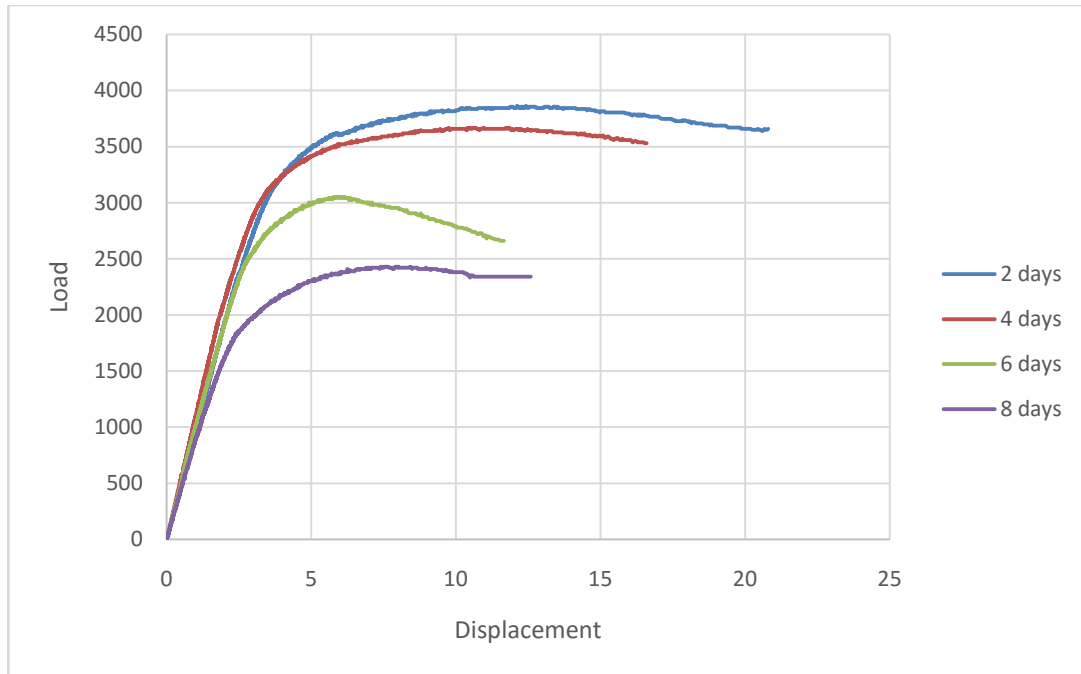
Figure 6.8: Load Deflection curves for CFST specimen at different ages of corrosion

Loss in mass of specimen due to exposure to corrosion at different period was calculated along with the load-deflection curve behavior after the time of exposure was done. After a specified period of time the acrylic tank was removed and the specimen is cleaned with acetone to dislodge all corrosive products. Specimens are weighed to evaluate remaining mass. This action is done for all four specimens with every 24 hours of accelerated exposure of corrosion. The load deflection curve of all specimens is plotted in **Figure 6.7**. Stresses can be calculated by using original cross-sectional area of the specimen and strain can be calculated using extensometer. Healthy specimen shows a well defined ductile behavior with elastic and plastic region but corroded specimen shows the load deflection curves decreases representing lower strength in the samples. As no. of days to corrosion exposure increases, flexural strength of CFST decreases. We can observe from graph that after eight days of corrosion the flexural strength is very low because corrosion exposure was maximum. After second day, initial phase of corrosion starts so flexural strength of specimen was high. Flexural strength of specimen after sixth day rapidly falls due to corrosion was at its maximum extent. Hence, a huge loss in strength of corroded specimen, initially the properties of specimen were unaffected but as further load are gradually increase the elastic modulus and stiffness of specimen goes affected. This shows the catastrophic effect of pitting corrosion.
