# **EFFECT OF REINFORCEMENT CORROSION ON STATIC AND DYNAMIC BEHAVIOUR OF RC BEAMS**

**MASTER OF ENGINEERING  
IN  
STRUCTURAL ENGINEERING**

**DEPARTMENT OF CIVIL ENGINEERING,  
THAPAR UNIVERSITY,  
PATIALA-147004, INDIA**

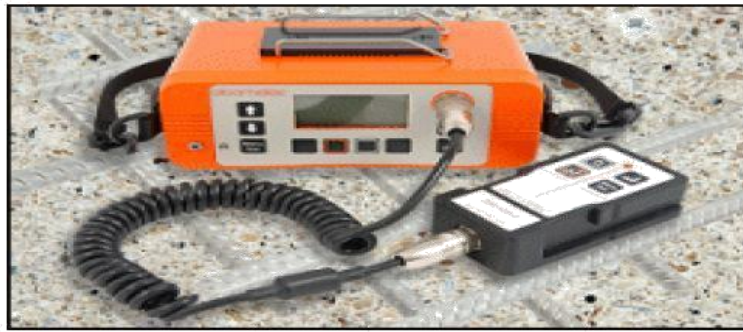
**Fig 1.5: Cover meter (Song and Saraswathy, 2007)**

**Cover Thickness Measurement:** This NDT technique employs a device known as cover meter to measure the concrete cover for detecting rebar size, position and direction. **Fig.1.5** shows a cover meter to monitor corrosion of reinforcing steel:

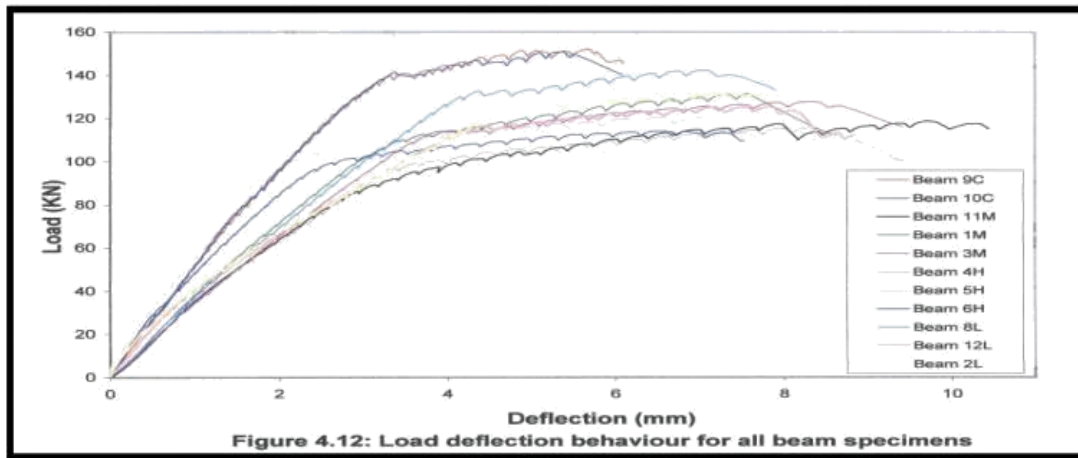
**Fig 2.2 Load Deflection Behavior for all beam specimens (Joyce, 2008)**

**Joyce.T.A.,(2008)** carried out experiments to study the **Effect of reinforcement corrosion on flexure behaviour of RC beams**. The corrosion of steel was isolated in the flexural region in order to eliminate contributions from stirrup corrosion and loss of bond within the development length. It was determined that the flexural capacity of beams decreases as level of corrosion increases.

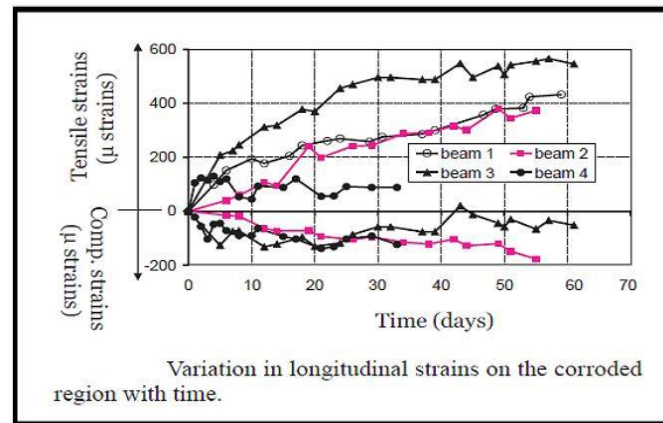
**Fig 2.4 Variation in longitudinal strains on the corroded region with time.**

**Fig 2.4** above shows that longitudinal tensile strains on a beam that had transverse cracks from applied load (beam 3) are higher than strains on corroded beams without flexural cracks (beams 1 and 2). After 55 days of corrosion, tensile strains on beam 3 were about 1.5 times higher than strains on beams 1 and 2. Unexpectedly, tensile strains on beams 1 and 2 were almost the same but significantly higher than strains on beam 4. Measured strains indicate that; 1. Longitudinal tensile strains are influenced by the applied load but mostly by the level of corrosion of steel bars. 2. Longitudinal tensile strains of corroded beams increase monotonically with time at a decreasing rate. **Fig 2.5** below shows that depth of the neutral axis is independent of the level of corrosion for beams free from flexural cracks and beams free from corrosion but significantly reduces with an increase in degree of corrosion for corroded beams with flexural cracks as shown below.

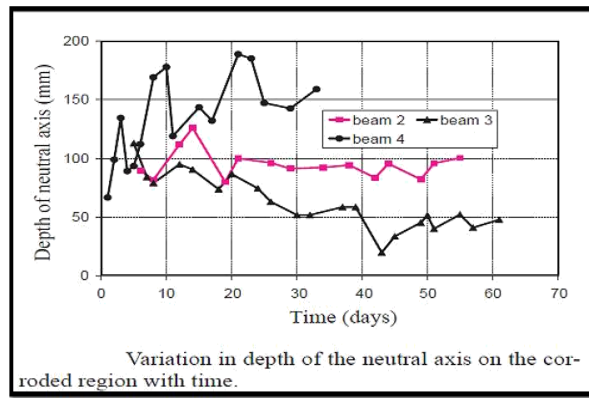
**Fig 2.5** Variation in depth of the neutral axis on the corroded region with Time (Malumbela et al.,2009)

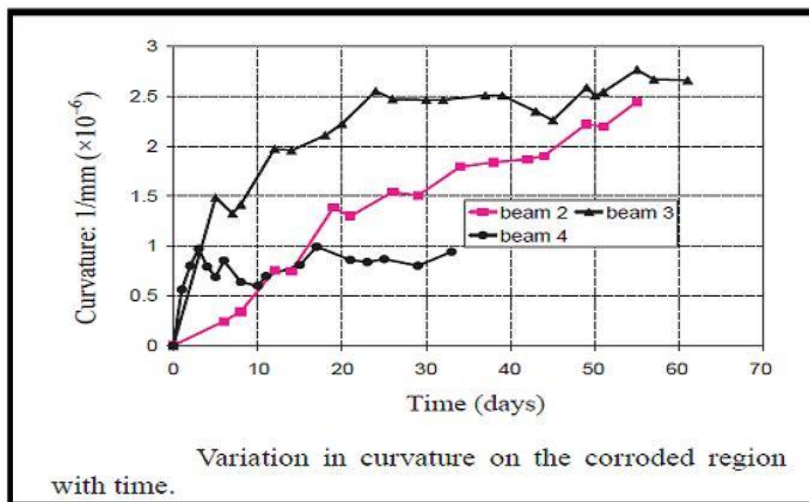
**Fig 2.6** Variation in curvature on the corroded region with time. ( Malumbela et al., 2009)

**Fig 2.6** below shows that curvatures of corroded beams increase monotonically with degree of corrosion but at a decreasing rate.

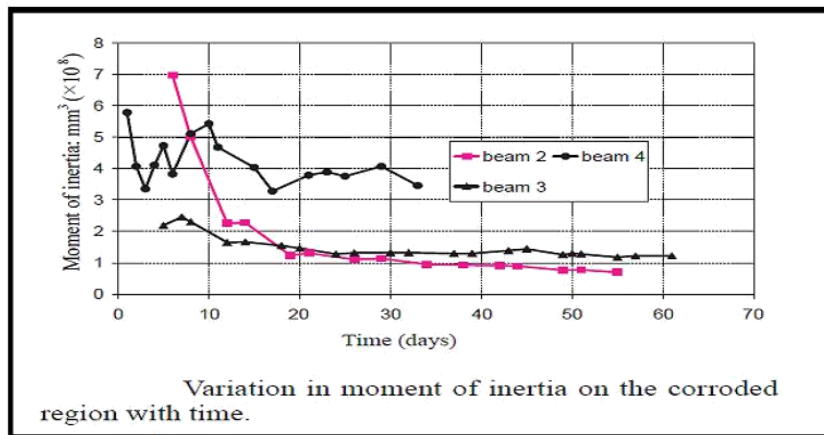
**Fig 2.7 Variation in moment of inertia on the corroded region with time ( Malumbela et al.,2009)**

1. The effective moment of inertia of corroded beams decreases monotonically with time of electrolysis but at a decreasing rate.
2. For corroded beams, the effective moment of inertia of beams with flexural cracks is almost the same as the effective moment of inertia of beams free from flexural cracks

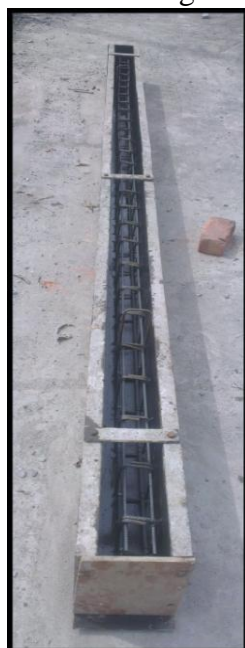
**Fig 3.2 Beam mould with reinforcement cage**

The casting of beams was done in single stage. The beams were cast in mould of size 127 x 227 x 4100 mm. Entire beam mould is first oiled so that the beam can be easily removed from the mould after 24 hours. Spacers of size 25mm are used to provide uniform cover to the reinforcement. When the bars have been placed in position as per design, concrete mix is poured in the mould and the beam is vibrated using a needle vibrator, to ensure the proper compaction. The vibration is done until the mould is completely filled and there is no gap left. The beams are then removed from the mould after 48 hours. After demoulding, the beams were cured for 28 days using jute bags. **Fig 3.2** and **Fig 3.3** shows the beams before and after casting.

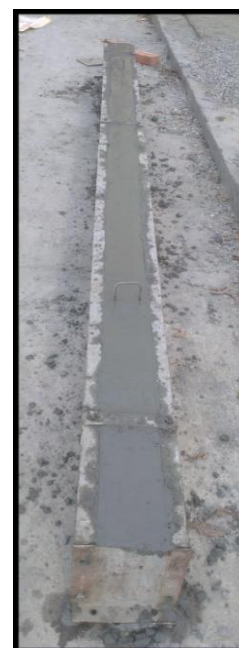
**Fig 3.3 Beam after casting**

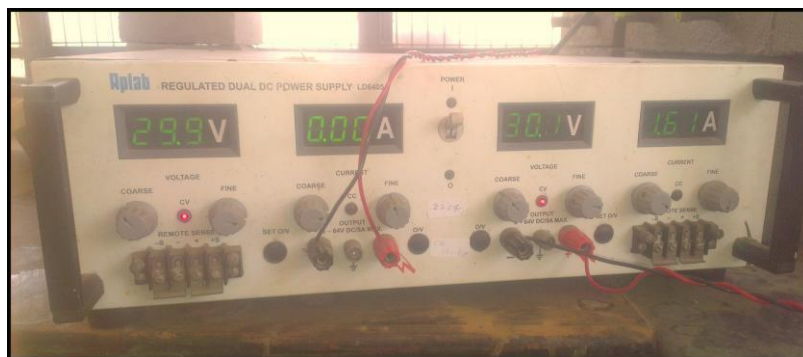
**Fig 3.4 DC Regulated Dual Power Supply Source(constant voltage)**

Out of all four beams, three beams were corroded using impressed current technique for 7 days, 15 days and 24 days respectively. Initially one control beam was subjected to the accelerated corrosion until the longitudinal crack spread in the whole length of the beam, which took 24 days. And then the test matrix for the corrosion was further decided. So, rest two beams were subjected to 7 days and 15 days representing different levels of corrosion. The corrosion of reinforcing steel was accelerated by impressed current technique. This was done through an integrated system incorporating a DC rectifier with a built-in ammeter to monitor the current and voltage to control the current intensity. Sciencetech Dual Power Supply with a maximum output of 2A at 30V was used **Fig 3.4** . This method of corrosion was employed to reach advanced stages of deterioration in a relatively short time. At a time two beams were connected in series for corrosion process. Central 1.5 m portion of concrete beams were subjected to corrosive environment. It was done by continuous sprinkling of 3.5 % NaCl solution. This type of arrangement was selected to assure that the corrosion product formed is not washed away and cracks are formed in the concrete specimens. The direction of the current was adjusted so that the reinforcing steel became an anode and a stainless steel wire mesh wrapped all around concrete beams at centre 1.5m served as a cathode.

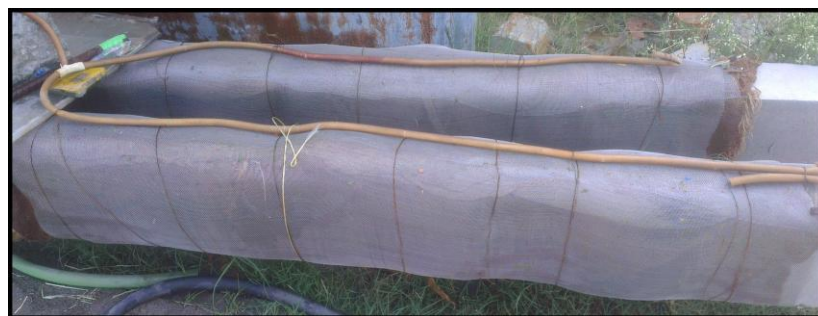
**Fig 3.5 Stainless steel wire mesh wrapped around central 1.5 m part of Concrete beam served as cathode**

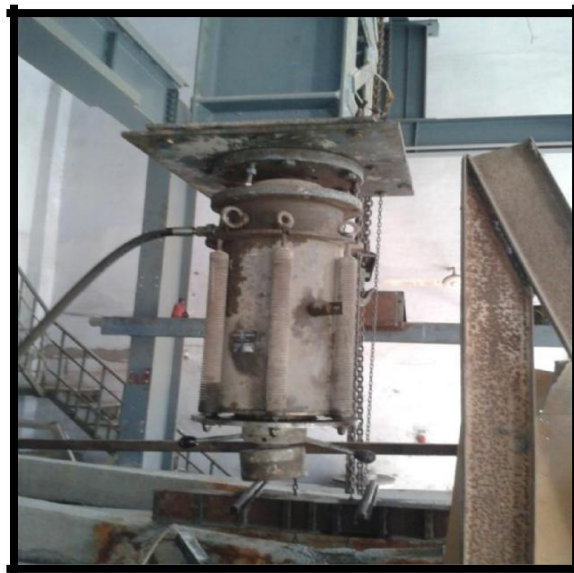
**Fig 3.6 Hydraulic operated jack**

After all the beams were corroded to different levels of corrosion and dynamic characteristics are studied, load -deflection behavior of beam was study to relate the effect of corrosion on RC beams. All the four beams were tested under simply supported end conditions. Ultimate load **P- $\Delta$  tests** were performed in the laboratory to determine the load-carrying capacity of the beam specimens. The loading arrangement used was four-point loading. This arrangement allows for a central region having virtually constant moment without any shear force. Hydraulic operated jack in **Fig 3.6** and corresponding Data acquisition system in **Fig 3.7** is shown below:-

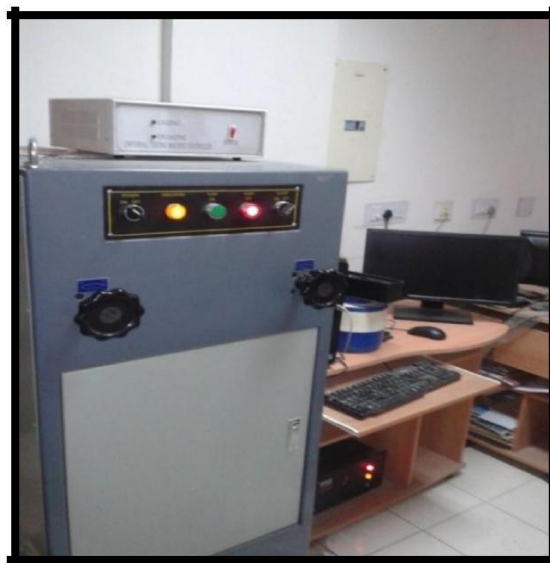
**Fig 3.7 Data acquisition system**

The load is applied to the beam with the help of load cell and load value is obtained from the data acquisition system, which is attached with the load cell .Two LVDT's are placed at the center and at a distance of span/4 from the end of beams to record the deflection against the loading as shown in **Fig 3.8**

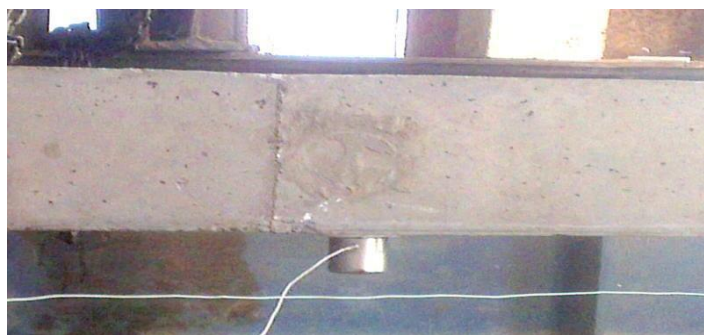
**Fig 3.9**

**Fig 3.9 Accelerometer placed below at centre position of beam**

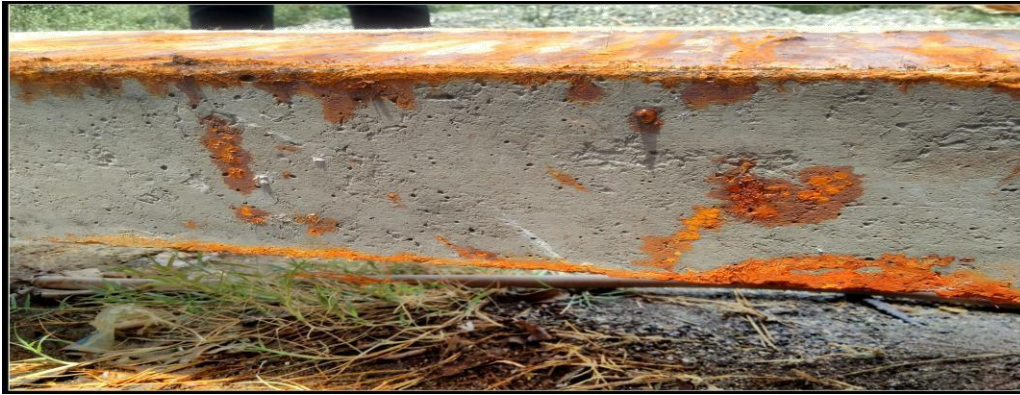
**Fig 4.1 Bottom face of C-7**

A beam undergoing accelerated corrosion for 7 days shows reddish brown patches of corrosion product on the three sides of beam at centre 1.5m portion of beam as shown in **Fig 4.1** It was noticed that no cracks were generated on surface of beam after 7 days corrosion. It was observed that at 7 days corroded beam shows small corrosion products with liquid oozes from the surface and no cracks as compared to other beam

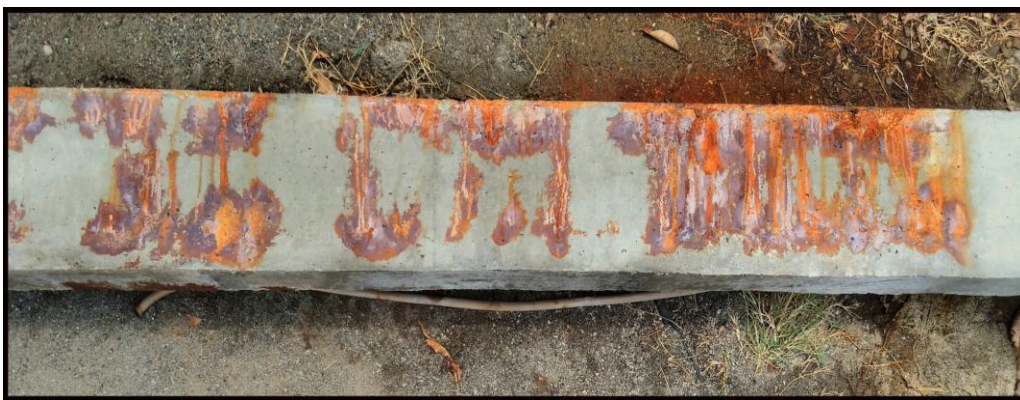
**Fig 4.2 Right side of front face of C-7**

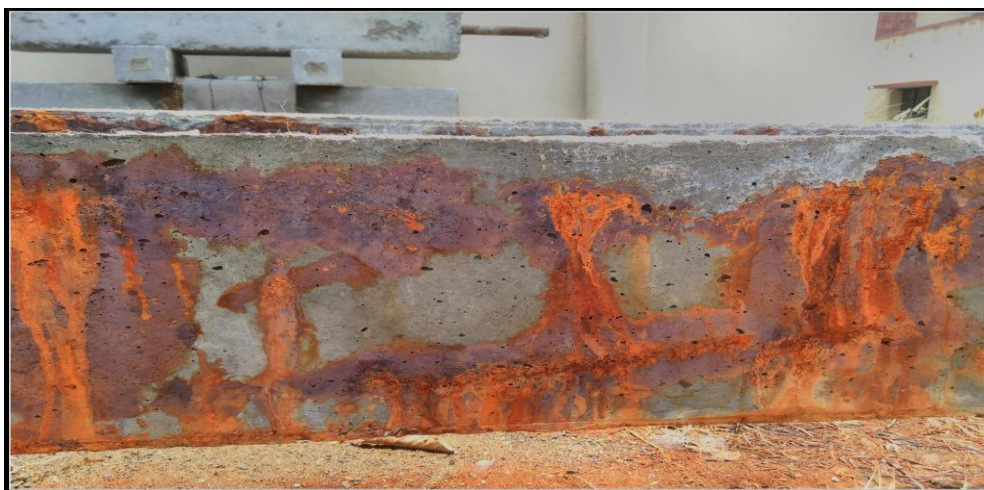
**Fig 4. 3 Red brownish products observed along the side**

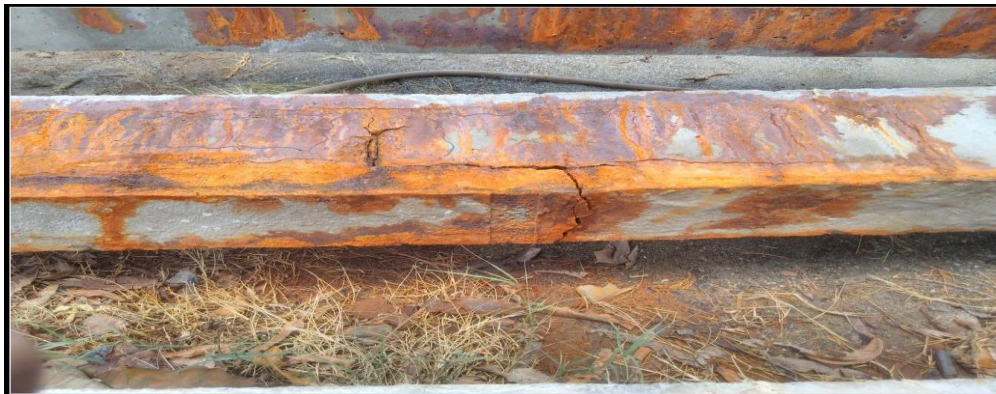
**Fig 4.4 Bottom face of C-15**

Beam undergoing corrosion for 15 days shows reddish brown patches on four sides at centre 1.5m portion of the beam along with cracks on bottom and side faces. At the bottom of the C-15 beam flexural crack at centre with bending of beam was observed along with red brownish colored corrosion products as shown in **Fig 4.5**. At the front side face of the beam vertical cracks were observed originating from tension face towards compression face as shown in **Fig 4.6**. At the back side face of the beam it was observed that full centre 1.5m portion of the beam was covered with reddish brown patches, and longitudinal crack was observed on the surface throughout the centre 1.5m portion of the beam. A reddish brown liquid oozes out from the sides of beam with spalling of concrete is observed on back face of beam as shown in **Fig 4.8 and 4.9**

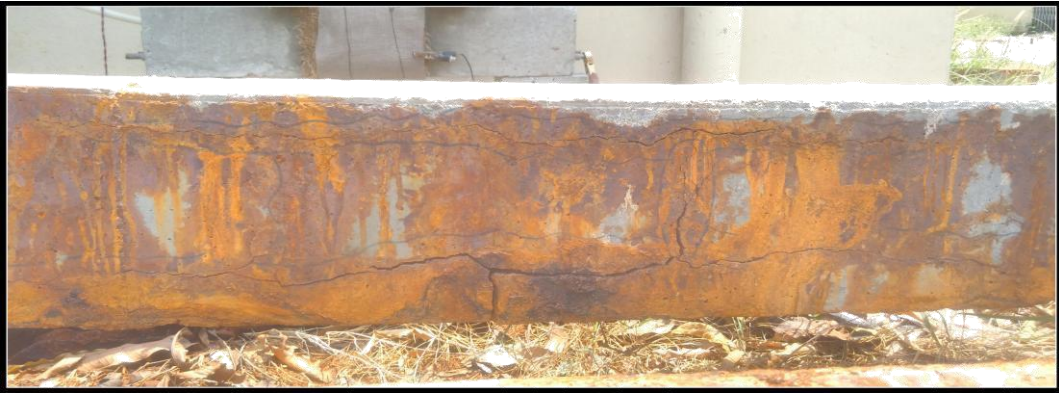
**Fig 4.6 Longitudnal and tranverse cracks at right face of C-15**

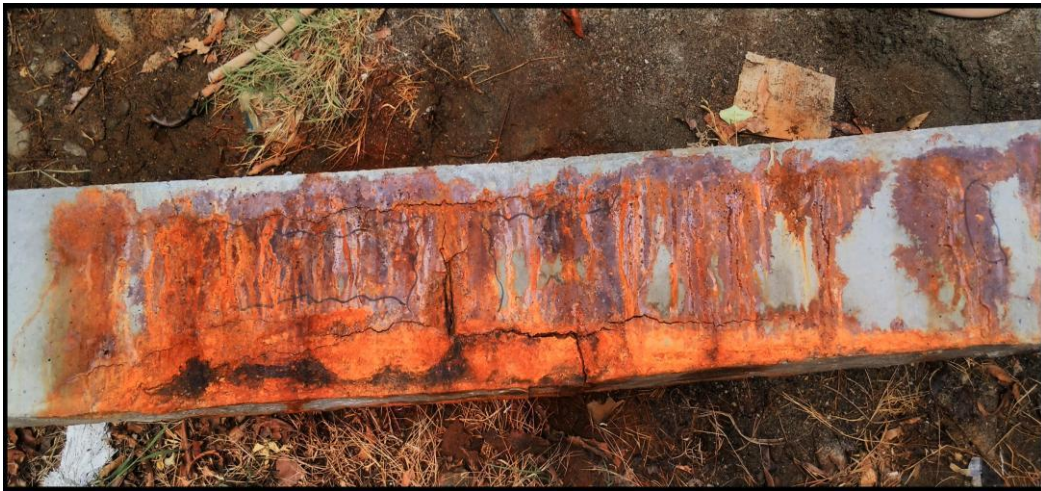
**Fig 4.7 Cracks on left face of C-15**

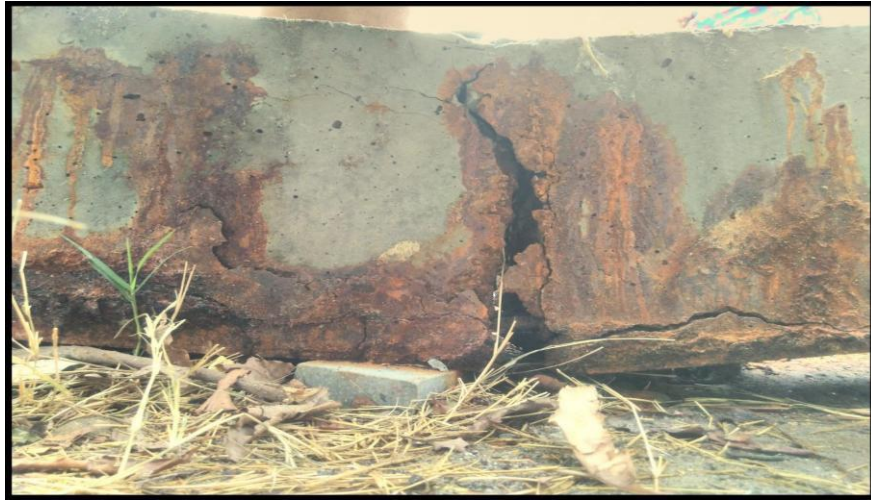
**Fig 4.10 Long vertical crack at centre of beam results in breaking of beam**

Beams undergoing corrosion for 24 days shows dark reddish brown corrosion products with reddish brown liquid oozes out from the cracks on all faces of the beam at centre 1.5m portion. Corrosion products formed in C-24 beam was in large volume than in other cases. At the front face of C-24 beam big vertical crack was observed throughout the centre 1.5m portion of the beam as shown in **Fig 4.10** results into breaking of beam from the center part. At the front side face also longitudinal crack was observed throughout the centre 1.5m portion along the tension bar as shown in **Fig 4.11**. At the back face small vertical and horizontal cracks were observed with major vertical crack at centre. At the bottom face of beam large corrosion products were noticed but no major crack generated. It was noted that deterioration of C-24 beam due to corrosion was more than the other beams.

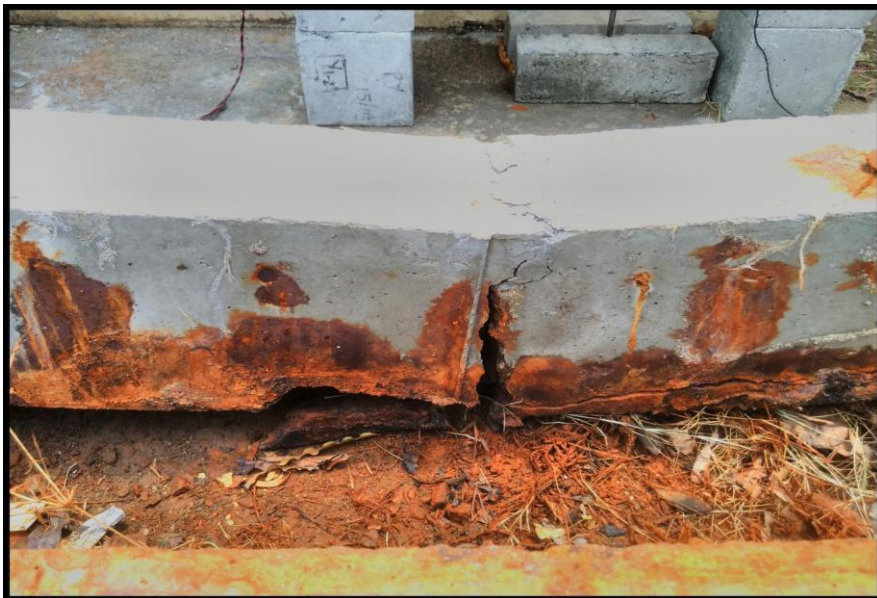
**Fig 4.11 Dark reddish brown corrosion products**

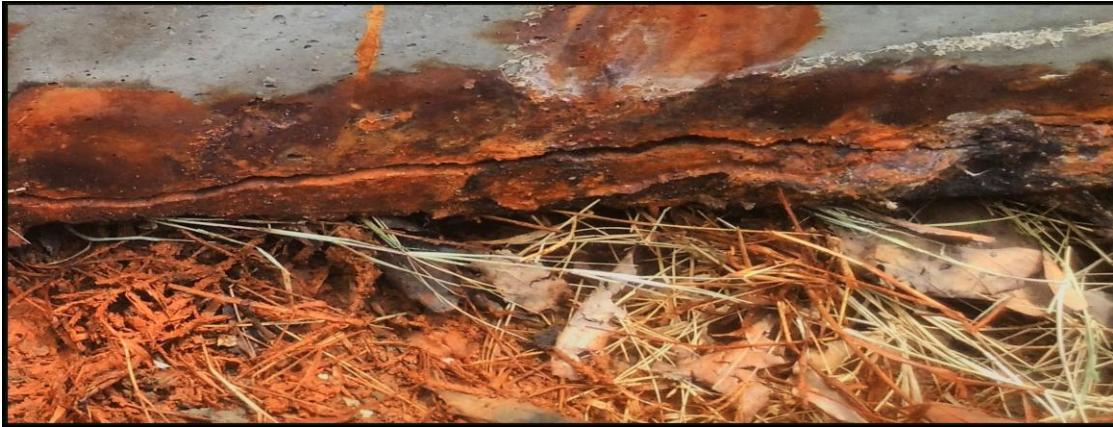
**Fig 4.12** Long horizontal cracks at the bottom side of front face

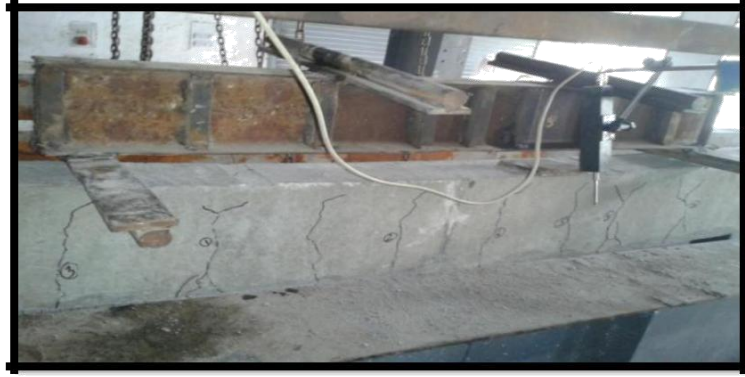
**Fig 4.13 Flexure Cracks on side face of C-0 beam**

The control beam (C-0) was tested under four point loading. The setup ensures pure bending in the central third portion of the beam. The beam was as shown in **Fig 4.13** and loads were applied till the failure and beam stop taking further load. It may be noted that the beam sections were under reinforced and steel yielded before concrete. The first crack appears at a load of 22.5KN near the left point load, accompanied by number of flexure cracks at the side face of control beam. As the load on the beam further increased the beam finally failed at 26KN. Almost all cracks were vertical near top and bottom edge, sub cracks were developed connecting to main cracks. So experimentally it was observed that ultimate load for the control beam is 26 KN with ultimate deflection at mid-span as 80.08mm and at span/4 deflection is 36mm as shown in **Fig 4.14 and 4.15** . Load deflection values and corresponding stiffness values at L/2 at different points are showed in **Table 4.1**. The load deflection response of the control un-corroded beam at L/2 and L/4 is shown in **Fig 4.14 and 4.15**

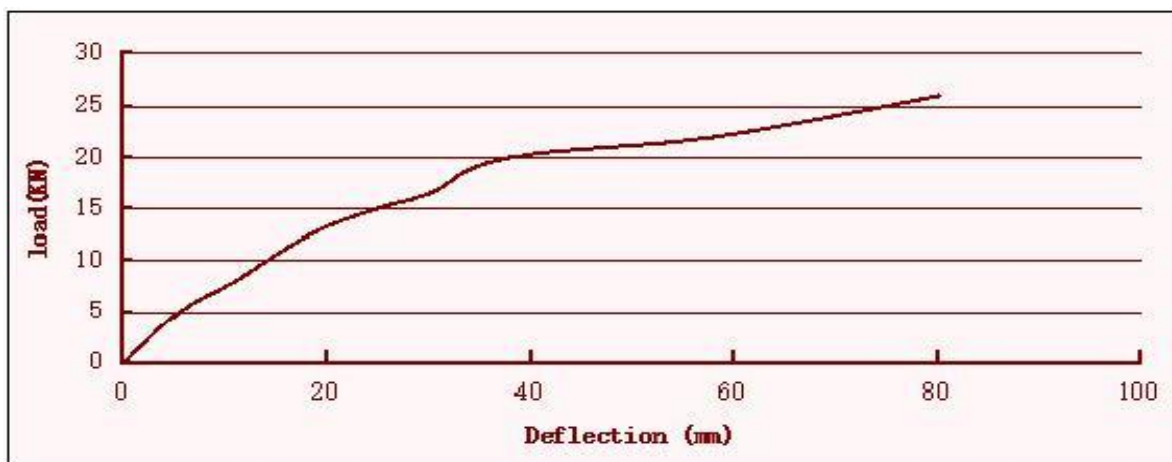
**Fig 4.14 Load deflection curve of control beam control beam C-0 At L/2**

S.No.	Load (kN)	Deflection at L/2	
		Deflection (mm)	Stiffness (N/m)
1	0	0	0
2	5	5.2	0.96
3	8	10.9	0.73
4	12.4	18	0.68
5	15.1	25	0.60
6	16.4	30	0.54
7	20	38	0.52
8	22	58	0.37
9	26	80.08	0.32

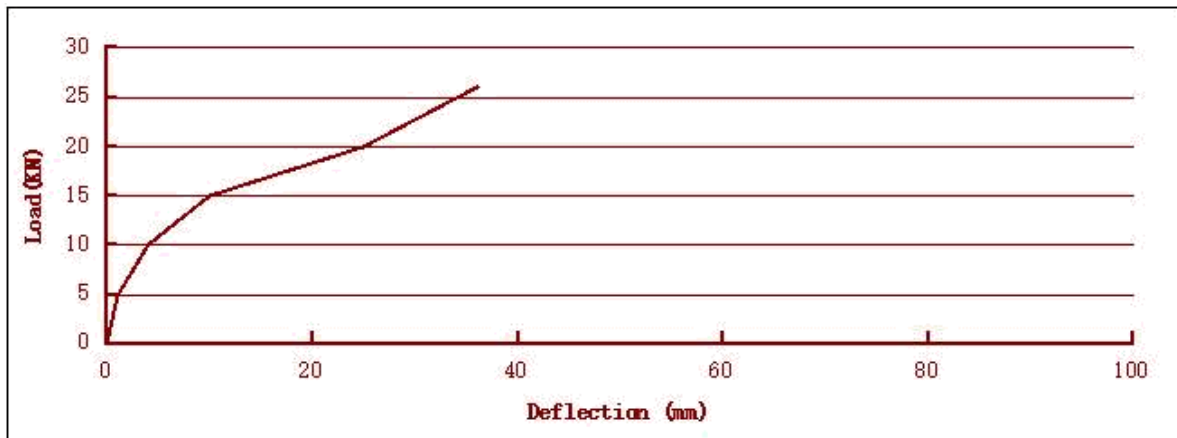
**Fig 4.15 Load deflection curve of control beam C-0 At L/4**

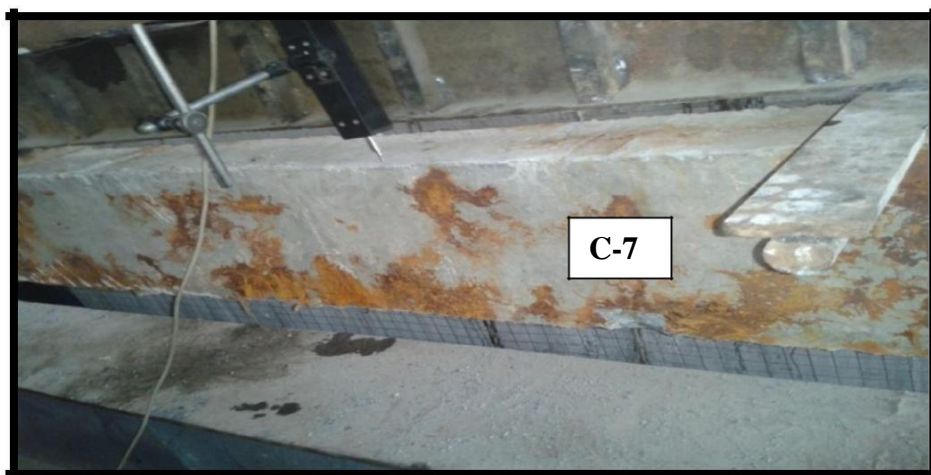
**Fig 4.16 Side face of C-7 Beam before load**

**Fig 4.16** shows beam with 7 days corrosion having no previous corrosion cracks as discussed earlier was tested under static loading. First crack appeared at a load of 19.02KN at centre of the beam near tension zone. Load is further increased the cracks widened and start progressing towards the compression zone and beam suddenly failed at load of 23 KN from extreme tensile face at centre as shown in **Fig 4.17**. No additional cracks appear on the surface of beam. **Table 4.2** shows load deflection values at different points and corresponding stiffness values at L/2 deflection. **Fig 4.18 ,4.19** show the graphical representation of load deflection behavior of C-7 beam. P-Δ curves indicated that there is a decrease in load carrying capacity and deflection capacity as compared to control beam. It was noticed from the results that there is decrease in load carrying capacity of C -7 beam as compared to control beam.

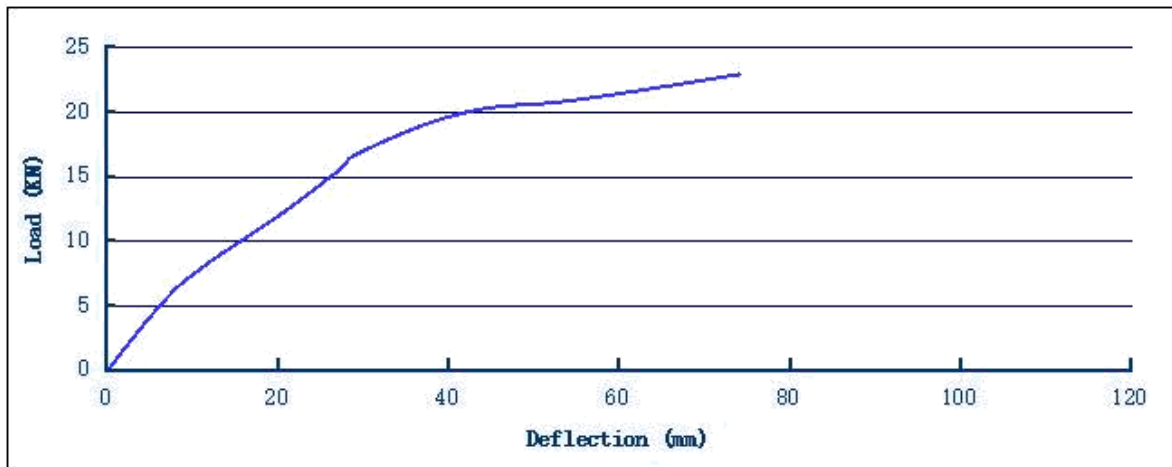
**Fig 4.18 Load deflection of corroded beam after 7days at L/2 span**

S.No.	Load (kN)	Deflection at L/2	
		Deflection (mm)	Stiffness (N/m)
1	0	0	0
2	5	6	0.83
3	8	11	0.72
4	12	20	0.6
5	15.5	27	0.57
6	17	30	0.56
7	20	42	0.47
8	21	55	0.38
9	23	74	0.31

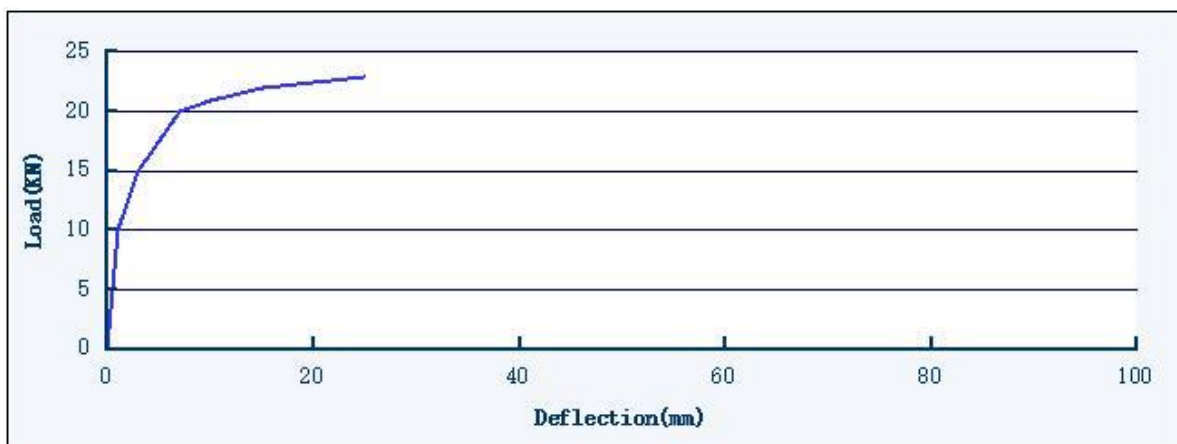
**Fig 4.19 Load deflection curve for corroded beam after 7 days at L/4 span**

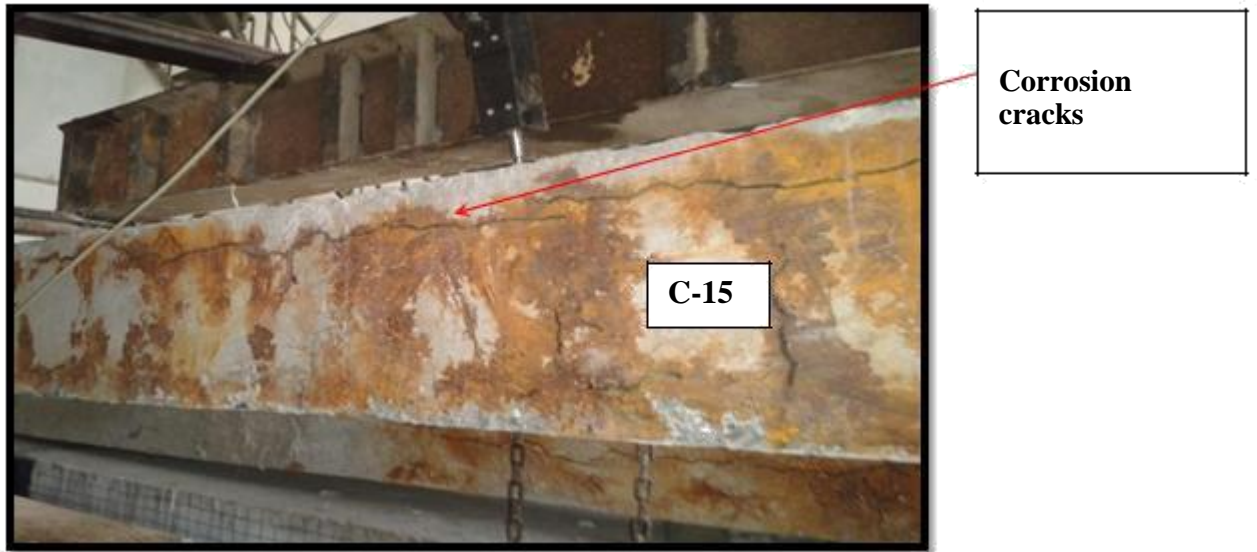
**Fig 4.20 Side face of C-15 Beam before loading**

Beam undergoing corrosion for 15 days shows longitudinal crack throughout the corrosion region and some vertical cracks on side face before loading as shown in **Fig 4.20**. It was observed that first vertical crack appeared at a load of 16 KN near the centre of beam on side face, with widening of longitudinal crack at the centre and as the load on beam was increased, vertical crack from tension zone propagates towards the compression face till the longitudinal crack and finally beam fails at a load of 17.5 KN with a huge crack at centre of beam and further widening of the vertical crack and crushing of concrete from the extreme tensile face as shown in **Fig 4.21**. At ultimate load ultimate deflection noted at centre was 58 mm and at span/4 was 19.68 mm. **Table 4.3** shows load deflection behaviour and corresponding stiffness values at different points. It was observed from the curves shown in **Fig 4.22 and 4.23** that there is a decrease in load carrying capacity and deflection capacity of C-15 beam as compared to C-7 beam, control beam.

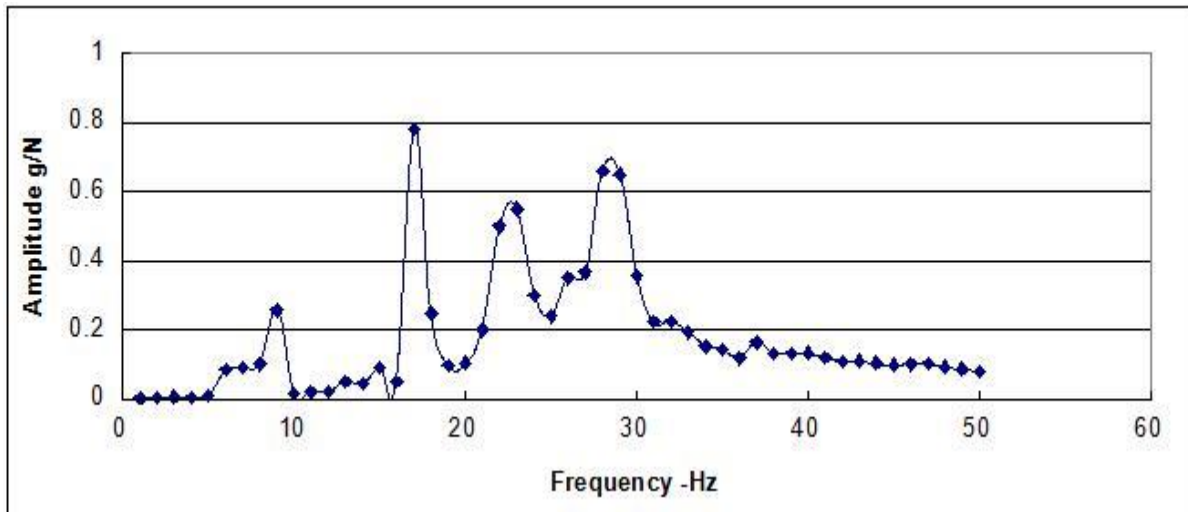
**Fig 4.27** FRF record of corroded beam to 15 days

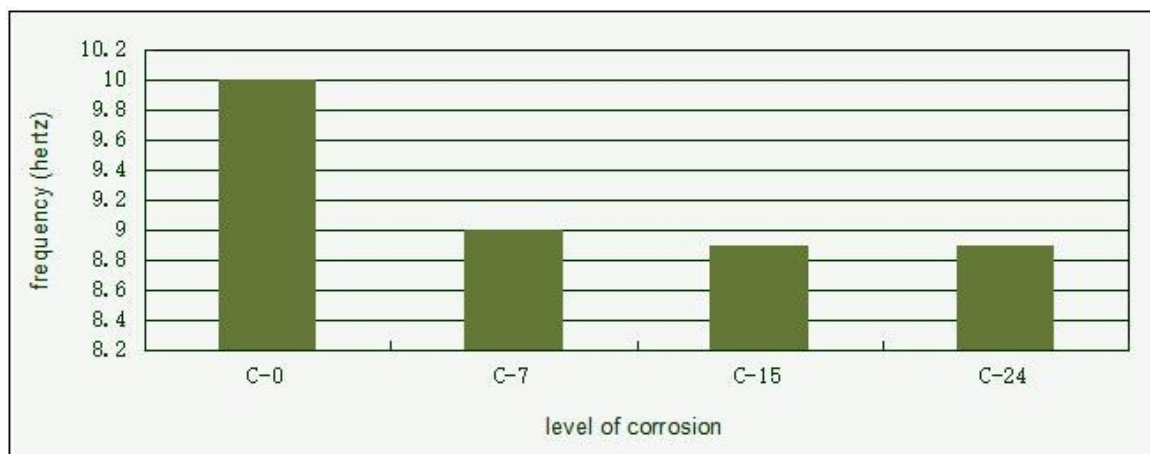
**Fig 4.29 Bar chart showing relation between level of corrosion with frequency**

Fig 4.29 shows graphically the variation of frequency with different levels of corrosion

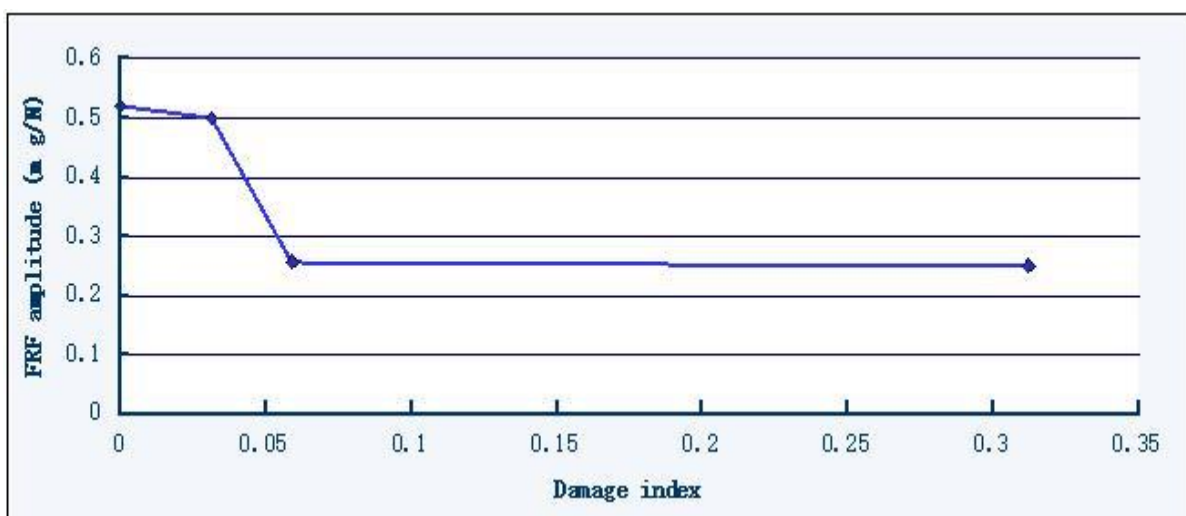
**Fig 4.31 Graph showing relation between damage index and FRF magnitude**
