**ACCIDENT STUDIES AND ROAD SAFETY AUDIT**  
**FOR URBAN ROAD NETWORK OF**  
**PATIALA CITY**

**MASTERS OF ENGINEERING**  
**IN**  
**INFRASTRUCTURE ENGINEERING**

DEPARTMENT OF CIVIL ENGINEERING  
THAPAR INSTITUTE OF ENGINEERING & TECHNOLOGY  
(A DEEMED TO BE UNIVERSITY), PATIALA, PUNJAB.  
JUNE 2018

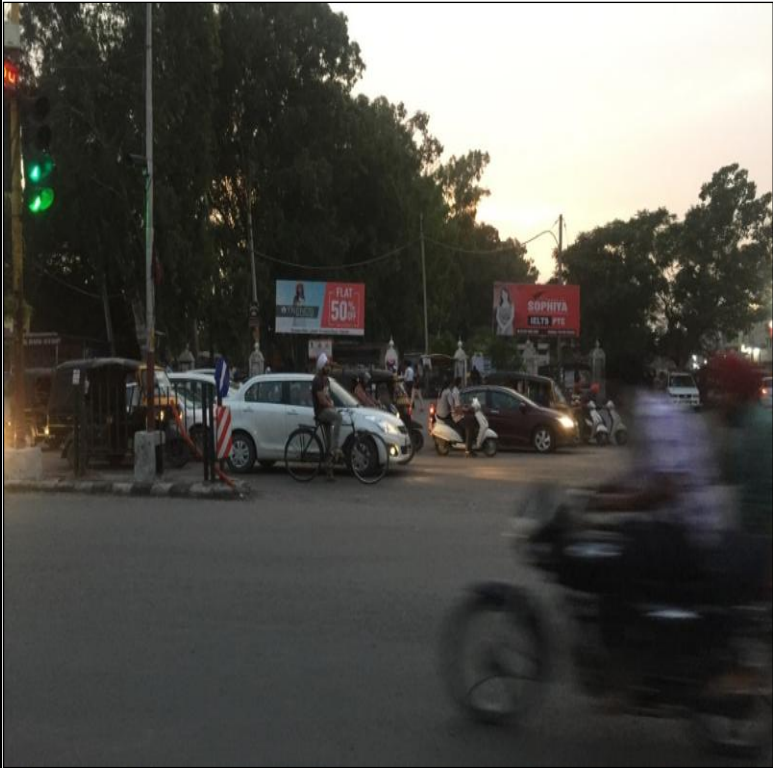
LOCATION- 1 DUKHNIVIRAN CHOWK			
Sr No	Picture	Reason for accident	Mitigation Measures
1

<p>i)As zebra crossing was not there therefore vehicles were standing beyond the divider line during the red light.</p> <p>ii)No sign for pedestrian walking.</p>	<p>Zebra crossing marking should be made as per IRC 103:2012 “Guidelines for pedestrian’s facilities” with accompanied by a “STOP” line at a distance of a 1 m for signaled intersection as per IRC 35-2015 ‘Code of Practice for Road Markings’. The width of pedestrians crossing should be between 2 to 4 m.</p>

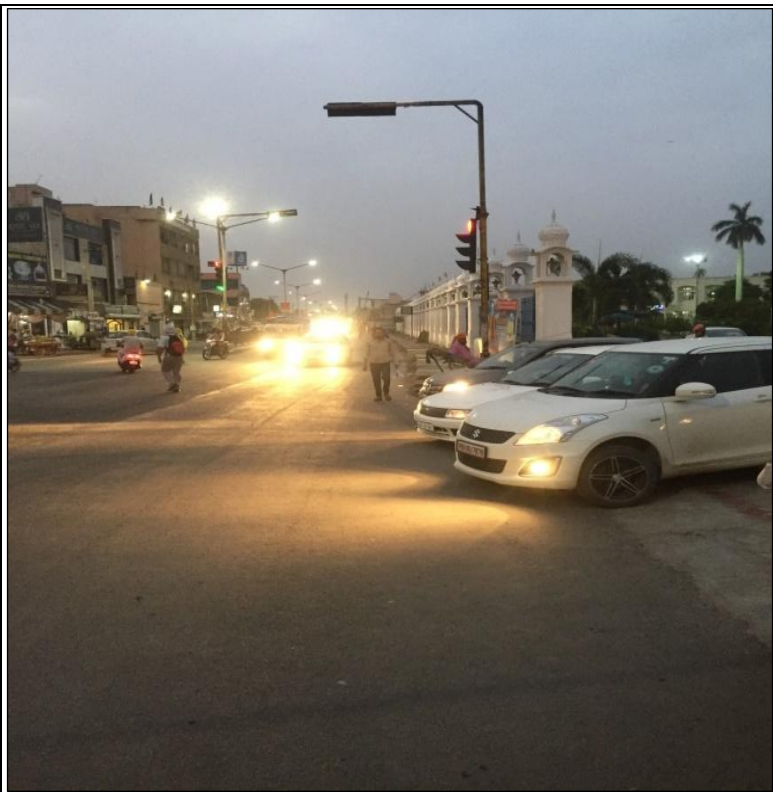
<p>2</p>

<p>i) Traffic congestion on Dukhnivira n exit was making difficult for the vehicle movement from Sirhind road to Bus Stand.</p> <p>ii)NO markings on road surface</p>	<p>A white line should be made on main road representing right of way behind which every vehicle has to stand during red light.</p> <p>Markings should be made according to IRC 35 - 2015.</p>
<p>3</p>

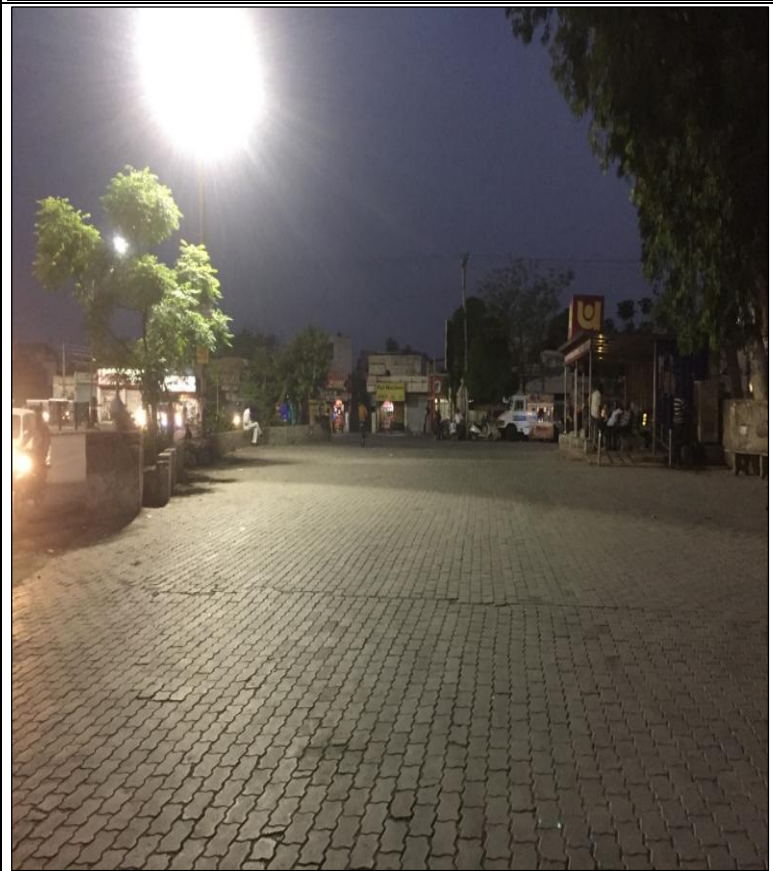
<p>i) In spite of having large area no island was provided for vehicular movement from Bus Stand to Nabha Road.</p> <p>ii) Unnecessar y area provided for bus stop resulting in decreasing road vehicular density.</p>	<p>i) Formation of island for left to left turn vehicular movement.</p> <p>ii) Reducing the bus stop area and increasing the width of main road will decrease congestion.</p>

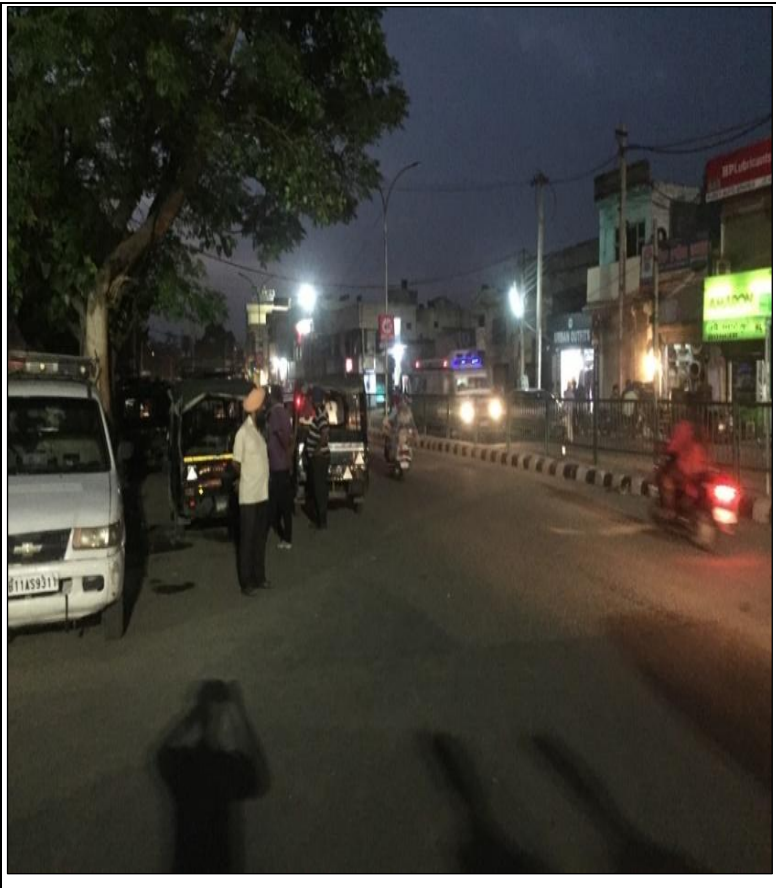
<p>6</p>

<p>i) Autos waiting for passengers on Sirhind road further making the road more congested.</p> <p>ii) No footpath was there on any of the road on this junction.</p>	<p>i) Proper place /space should be provided to autos where they can stand so that vehicles and pedestrians can get proper right of way.</p> <p>ii) Footpath for pedestrians is very important in all the sides of roads.</p>
----------	---	--	---

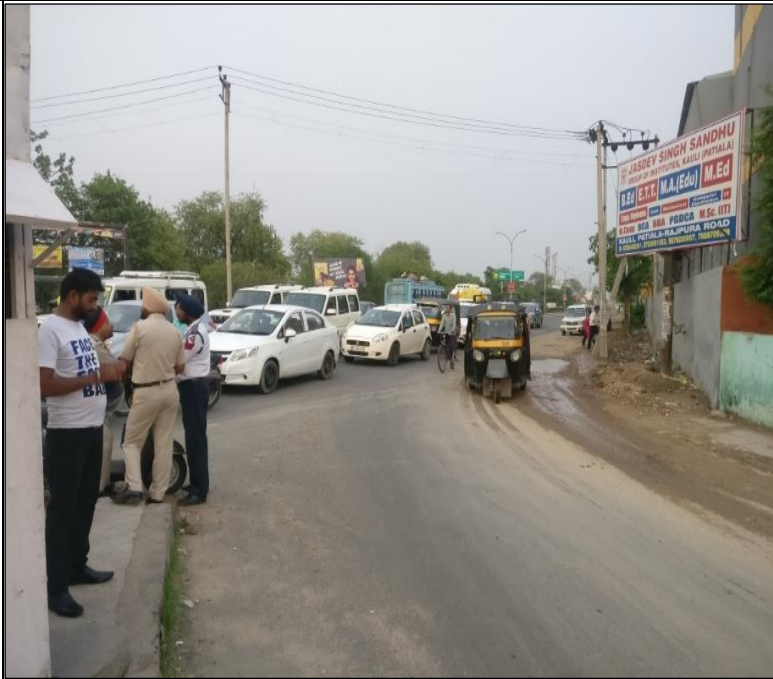
<p>1</p>

<p>Unpaved shoulders near the left hand turning making the vehicle to use unpaved path.</p>	<p>i)Shoulders should be maintained properly so that vehicles can properly move on the road section.</p>
<p>2</p>

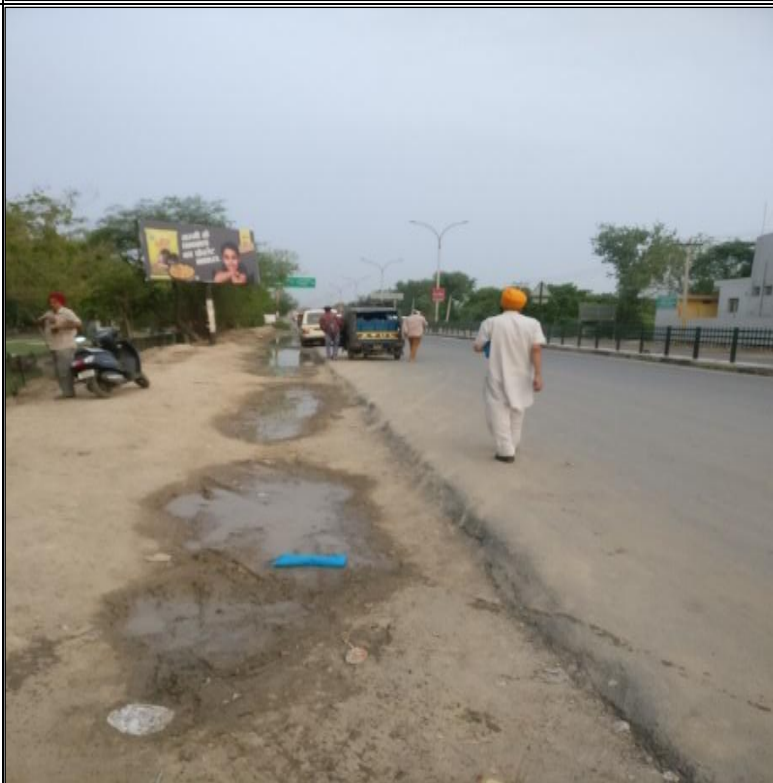
<p>i) Unpaved shoulders with mud accumulation after rain was making it hard for pedestrians to walk on shoulders i.e they were using main roads.</p> <p>ii)Poor drainage system.</p>	<p>i) Adequate width, of shoulders should be provided on all existing road so that sufficient space for parking of vehicles and for emergency stops of vehicles away from the carriageway.</p> <p>ii)Proper railings with delineators can be provided</p>

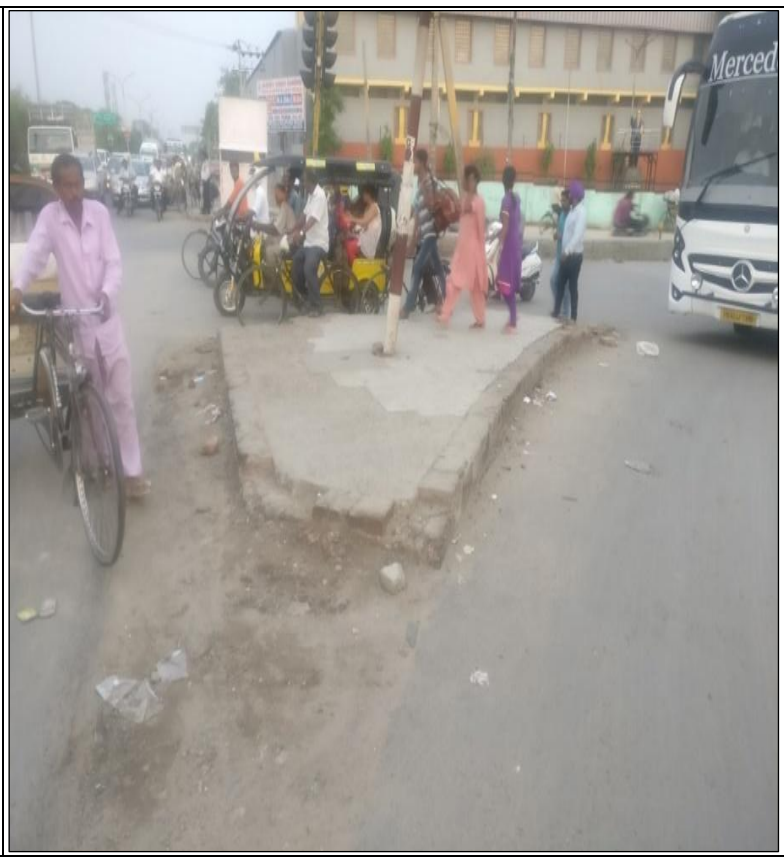
<p>3</p>

<p>Condition of islands were worse than worst.</p> <p>ii) No rumble strips was provided.</p>	<p>Proper islands should be made so that peoples can follow proper path while taking turn.</p> <p>ii) Use of rumble strips before entering to main road can be done to alert the drivers.</p>
<p>4</p>

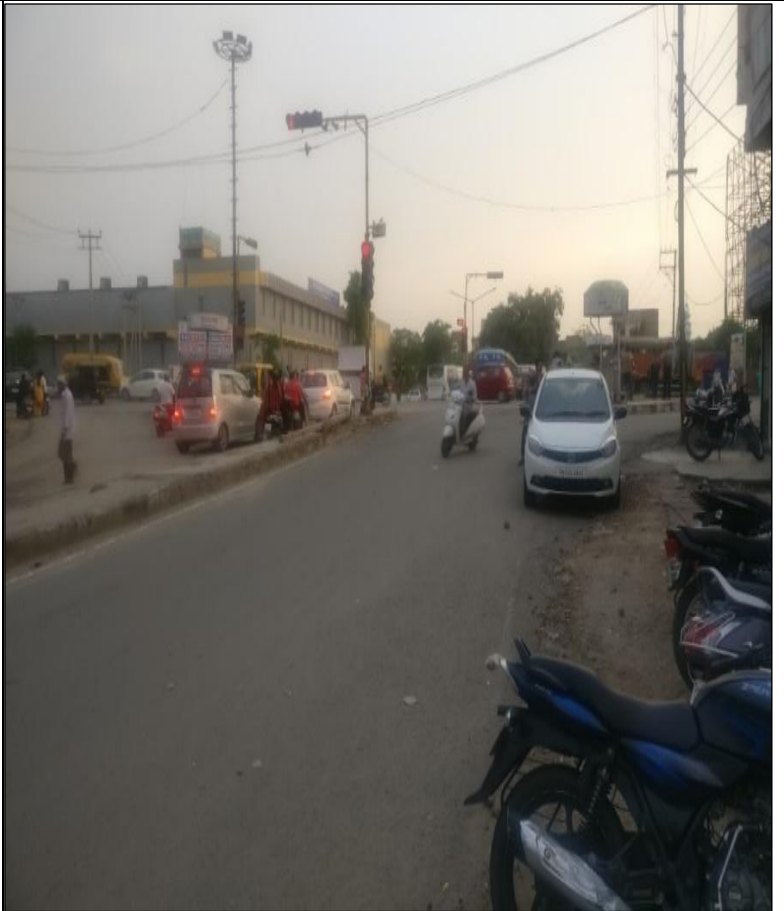
<p>i) No road divider fence was there.</p> <p>ii) No speed limit sign for fast moving vehicles.</p> <p>iii) No zebra crossing.</p>	<p>i) Road surfacing can be provided with proper sight lines and speed limit sign boards can be provided beyond 90 m distance.</p> <p>ii) Proper railings with delineators can be provided.</p> <p>iii) There is no provision of Pedestrian crossings</p>

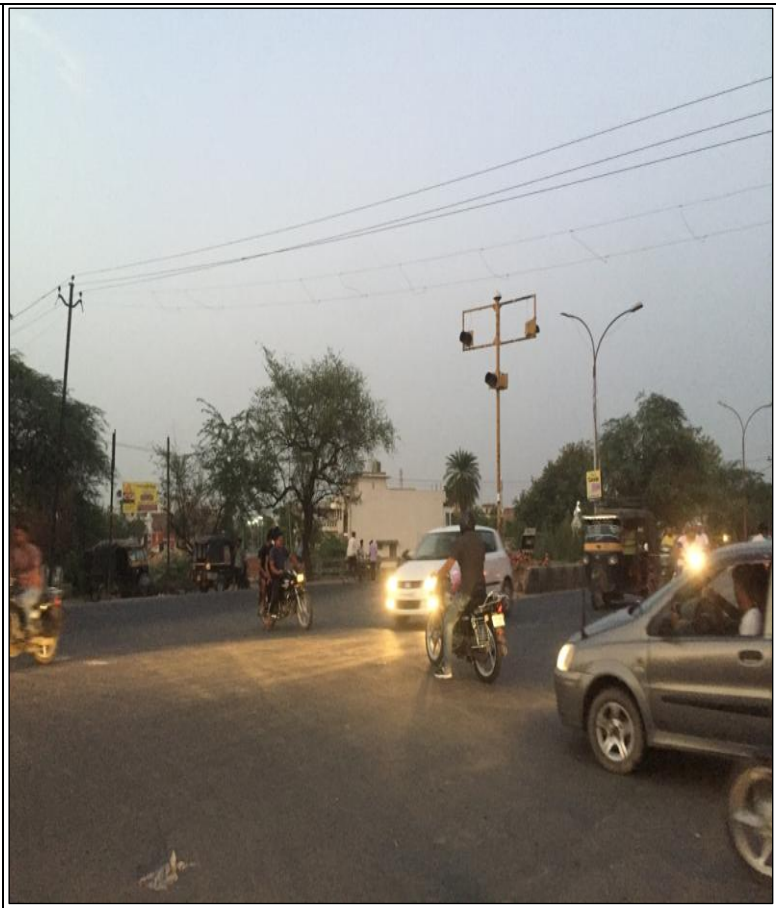
<p>1</p>

<p>i) Carelessness movement of vehicles was there due to no traffic signal were provided.</p> <p>ii) There was no provision for pedestrian crossing</p> <p>iii) Lack of traffic signs (Regulatory, Warning and Informatory signs) and pavement markings.</p>	<p>i) Road surfacing can be provided with proper sight lines and speed limit sign boards and other sign board can be provided as per IRC 67-2012 Code provisions.</p> <p>ii) Proper markings should be there for pedestrians and vehicles as per IRC 35-2015.</p>
<p>2</p>

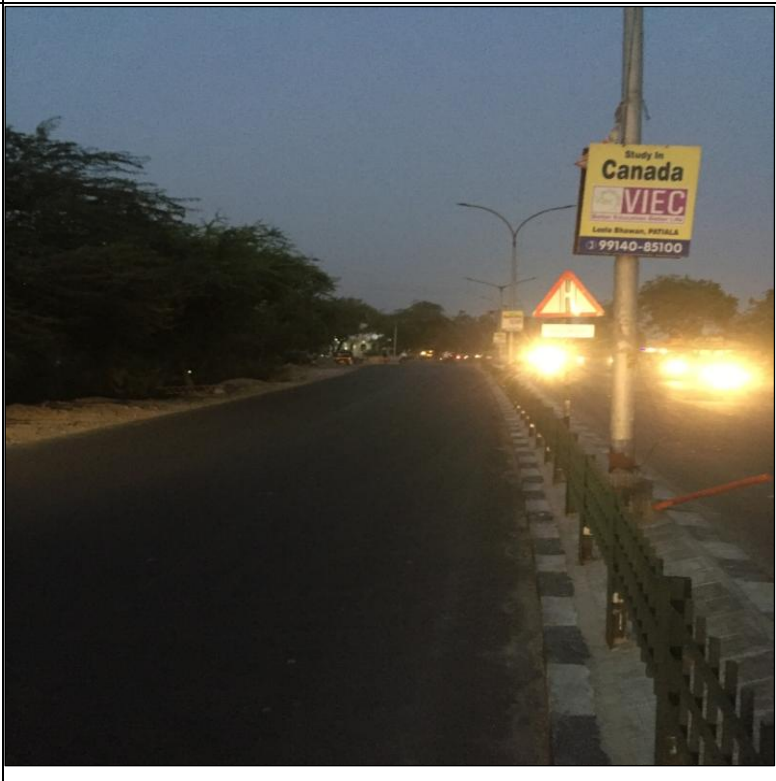
<p>i) Bad visibility of sign boards.</p> <p>ii) Medians were not safe.</p> <p>iii) Street lights were not working.</p>	<p>i) It is essential that drivers and other road users have an unobstructed view of road signs.</p> <p>ii) The medians should be safe enough if any vehicle gets stuck to it, it does not cause severe injury</p> <p>iii) Proper lighting should be</p>

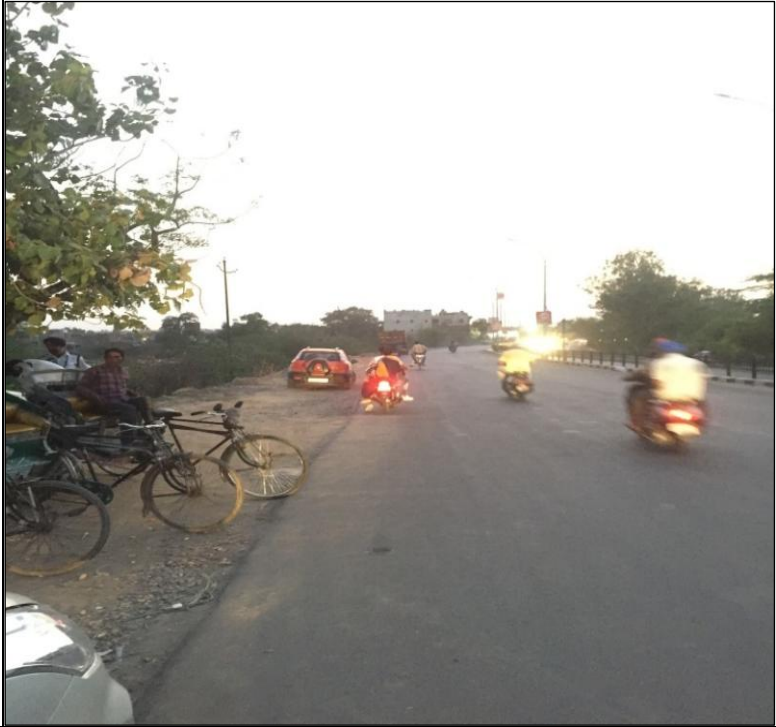
i) No footpath for pedestrians.	<p>i) Road side parking prohibition sign board to be provided.</p> <p>ii) Proper footpath should be there for pedestrians.</p>
4

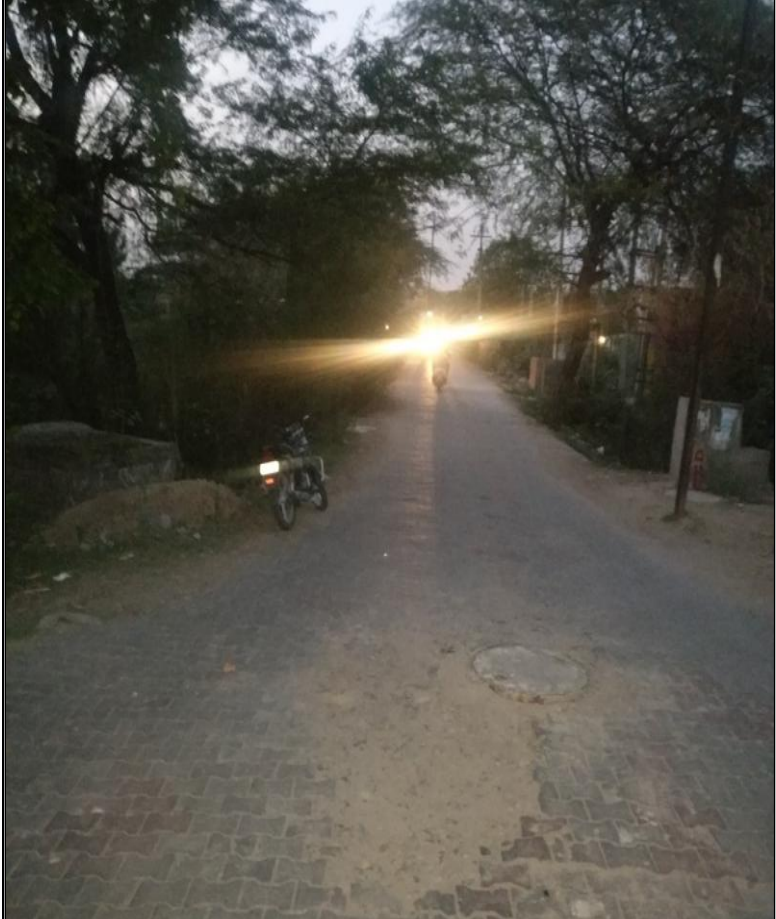
Absence of advance stop sign and speed breaker at the roads which were approaches to main lane.	<p>i) Pavement markings with speed breakers can be provided at all link roads.</p> <p>ii) Speed Breaker and its sign should be used to warn the drivers of the presence of the speed breaker. This sign should be posted 50-60 m in advance of the speed breaker location</p>

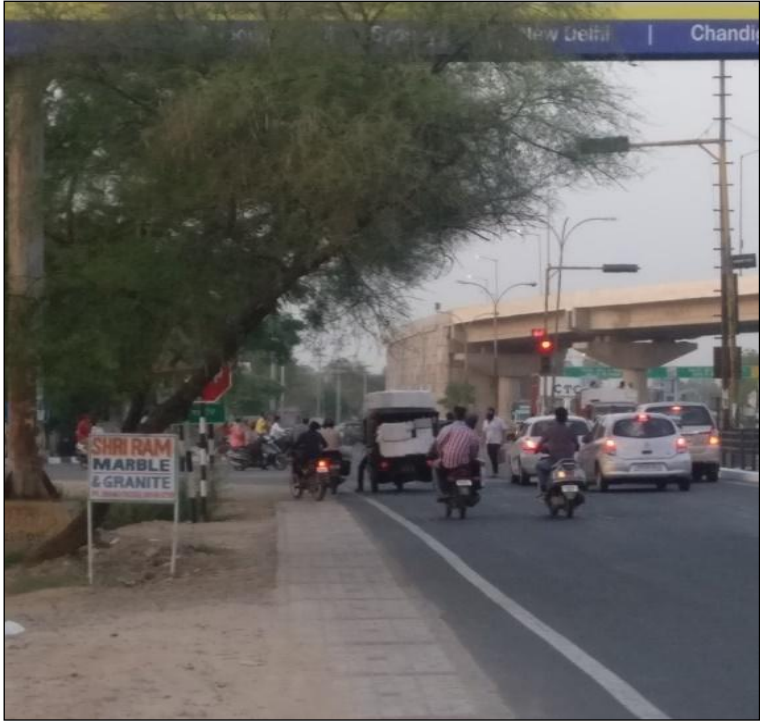
<p>1</p>

<p>i) STOP sign and T intersection sign were fully covered with tree branches.</p> <p>ii) No stop line.</p>	<p>i) STOP sign shall be installed on the left side of the approach.</p> <p>ii) Stop signs should be sited as close to the stop line as possible but not in such a position as to impair visibility along the major road. Normally, these should be fixed 1.5 m in advance of the stop line as per IRC 067-2012</p> <p>iii) Branches of tree should be cut timely.</p>

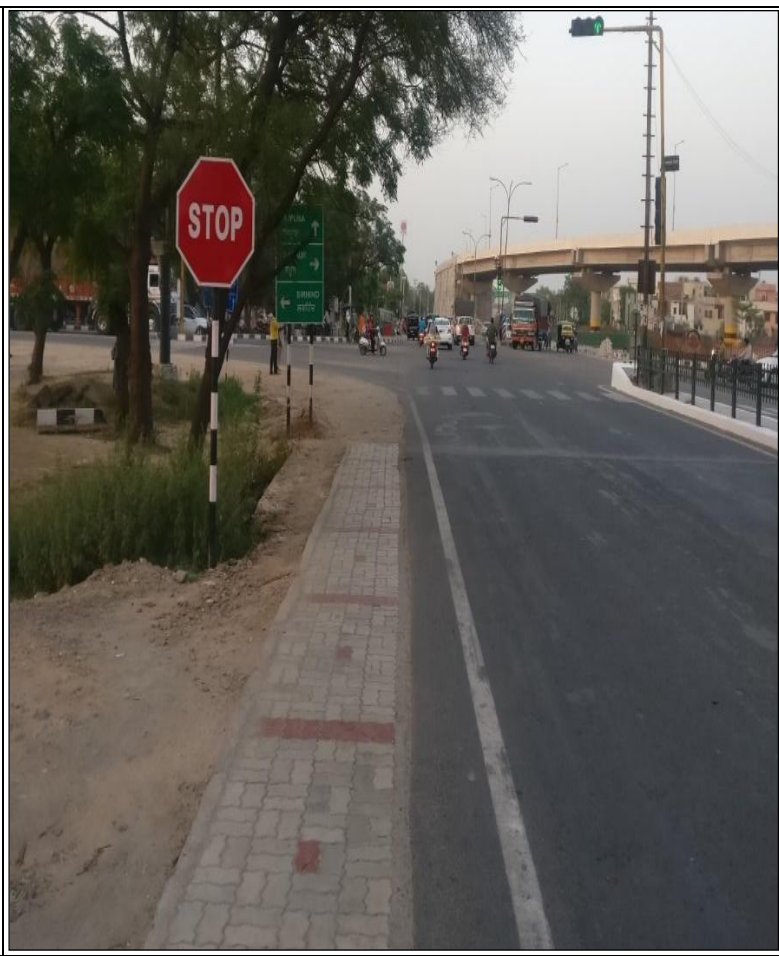
<p>2</p>

<p>i) Informatory board was behind the tree branches.</p> <p>ii) There was no rumble strips on road joining the main highways.</p>	<p>i) Informatory sign should be clear to vehicles from very far away. It should be placed according to IRC067-2012.</p> <p>ii) Proper rumble strips should be provided by posting suitable advance warning sign on the road side located 40 m in advance of the rumble strips.</p>
<p>3</p>

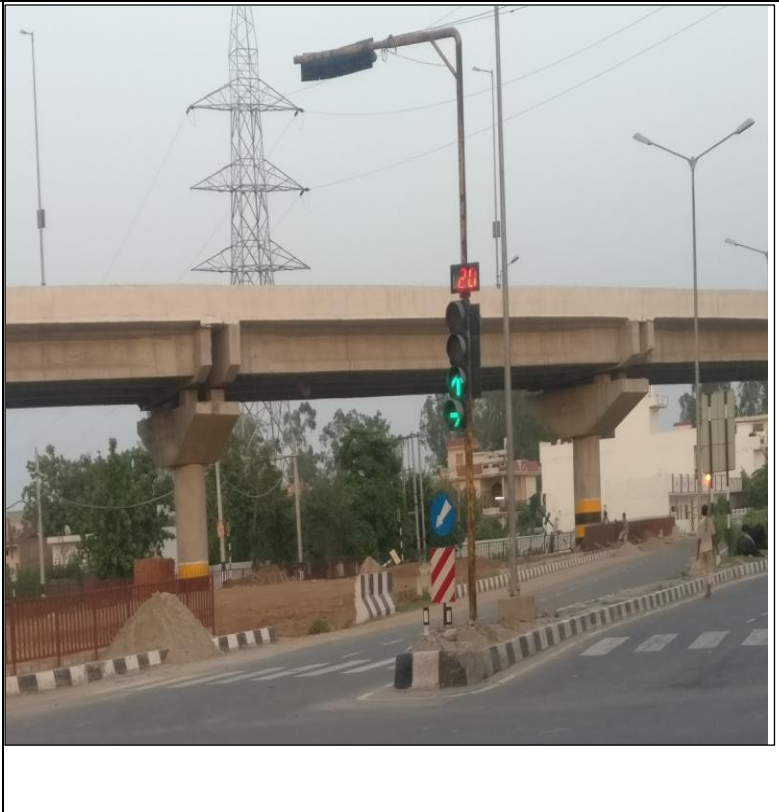
<p>i) Presence of loose material on paved shoulder at various locations highway.</p> <p>ii) Lack of speed control measures on project highway.</p>	<p>No loose materials should be present on road surface. If construction work is going on than proper fencing should be done.</p> <p>ii) Speed of vehicles should be checked at regular intervals and punishment should be given who</p>

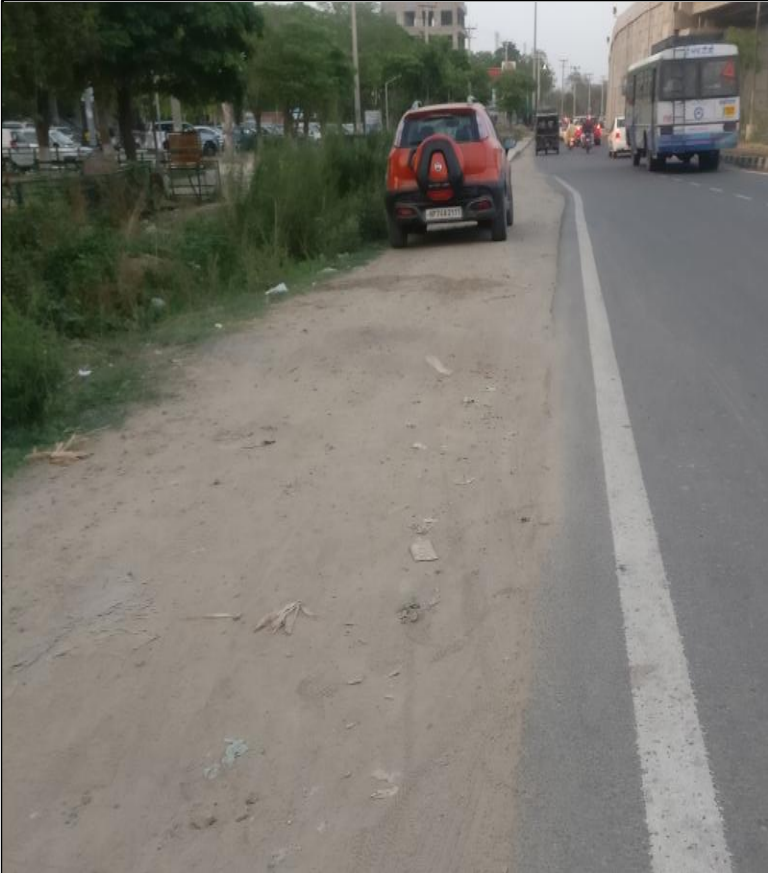
<p>i) No speed limit or any other caution sign was present.</p> <p>ii) Footpath was absent.</p>	<p>Adequate speed limit sign boards as per IRC067-2012.</p> <p>ii) Inadequate width, of shoulders on all existing road which is not sufficient for parking of disabled vehicles and space for emergency stops for vehicles away from the carriageway.</p>

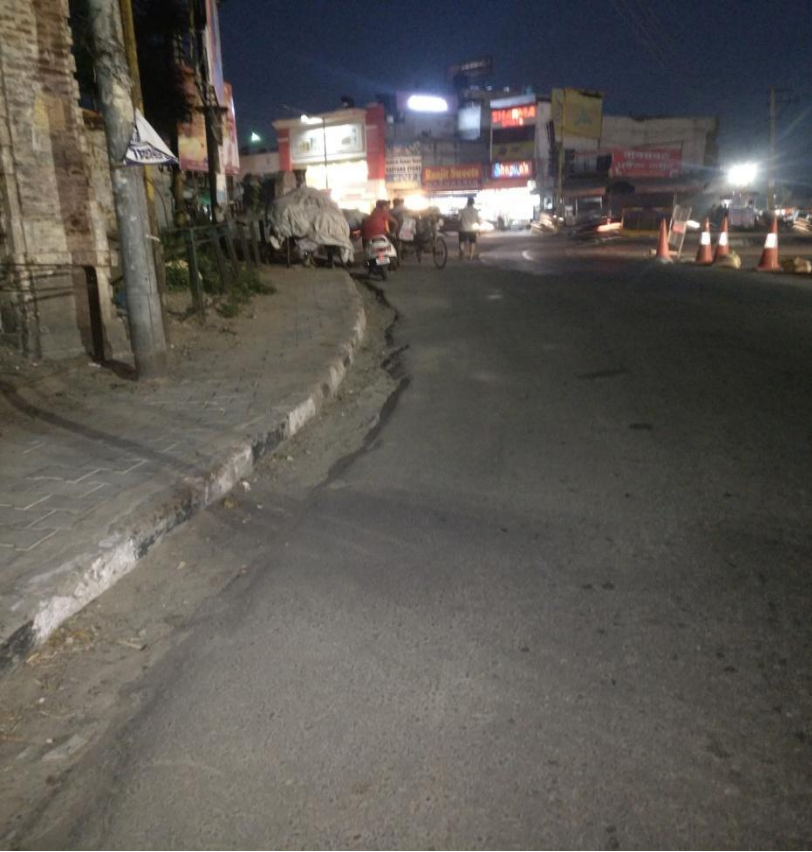
<p>The junction has no footpath in three legged .On mall road it was having but of varying width from 1 m to 3 m. The quality of footpaths was of substandard and was disconnected at various places causing discomfort to pedestrians and especially for the disabled. The lighting was also missing at the pedestrian paths.</p>	<p>Dedicated and continuous footpaths with minimum width of 1.8 m throughout the corridor .This will ensure comfortable movement of pedestrians without any obstructions.</p>
2

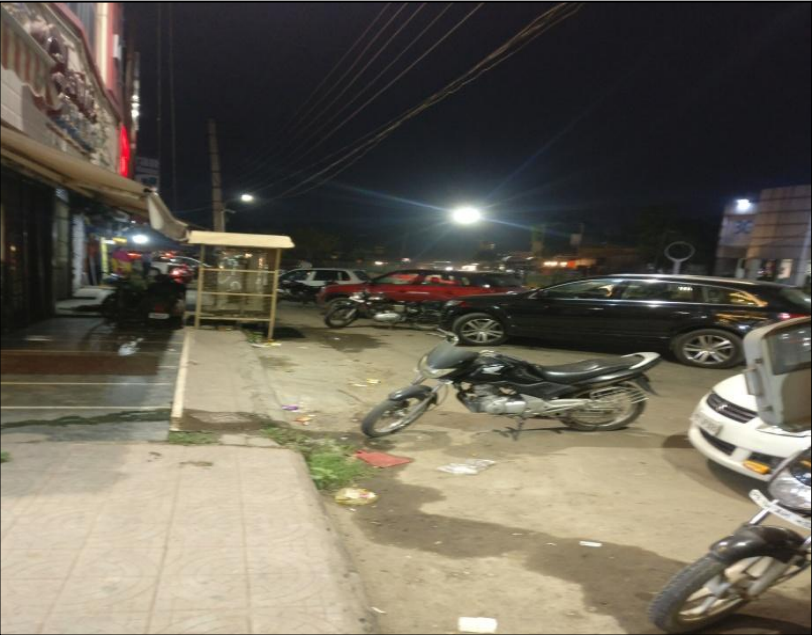
<p>Encroachment on footpaths – The whole junction lacking a good quality pedestrian infrastructure and where ever it was present, often it is occupied by parked vehicles There were no parking space designated on</p>	<p>Organized parking bays The vacant space available is to be used for parking both the two wheelers and four wheelers. Thus parallel or perpendicular parking, whichever is suitable on</p>

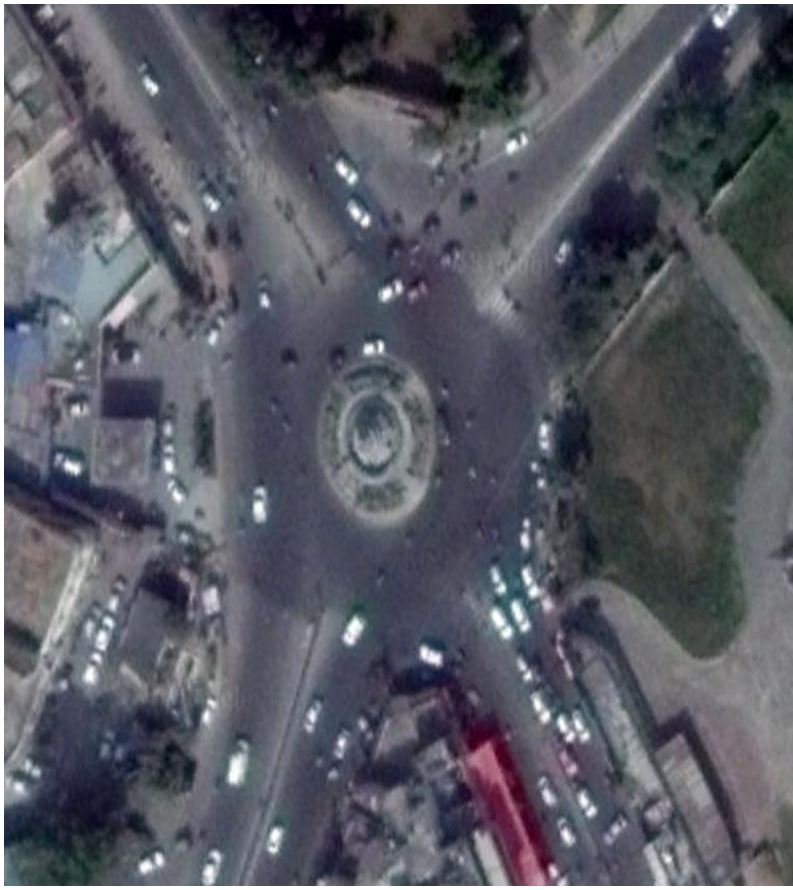
<p>An aerial view of a busy intersection at night, showing multiple lanes of traffic and a central roundabout area. The scene is filled with the lights of cars and street lamps, highlighting the complexity of the junction.</p>	<p>There was no crossing for pedestrians on any of the intersection</p>	<p>For easing the movements of pedestrians and for controlling the traffic speed raised crossings should be proposed on all the arms merging on to a particular junction.</p>

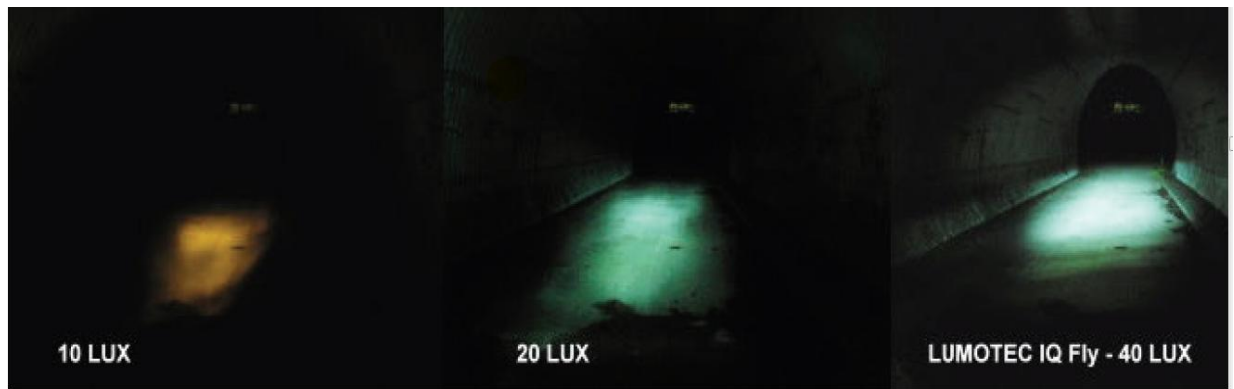
Figure5. 2 Shows Visibility after Dark in LUX

1. Fill the Checklist A -1.1 – “Speed Measure” of different vehicles at every 10 min interval and then calculate the average speed by averaging all the speed obtained in a particular column.
2. After filling Checklist, A-1.1 fills the Checklist A-1.2 “Footpath and Pedestrian accessibility”. In this audit has to be done frequently after every 100 m on a 500 m stretch. Also, an audit has to be conducted in both the directions of the road.
3. Checklist A-1.3 deals with the “Cycle Accessibility”. In this audit has to be done frequently after every 300 m on a 1500-meter stretch.
4. Checklist A-1.4 deals with the “Lighting for Pedestrians”. Figure shows the visibility to ride at night. Lighting intensity of 40 lux along the road surface whereas across the crossing it is 50 lux.

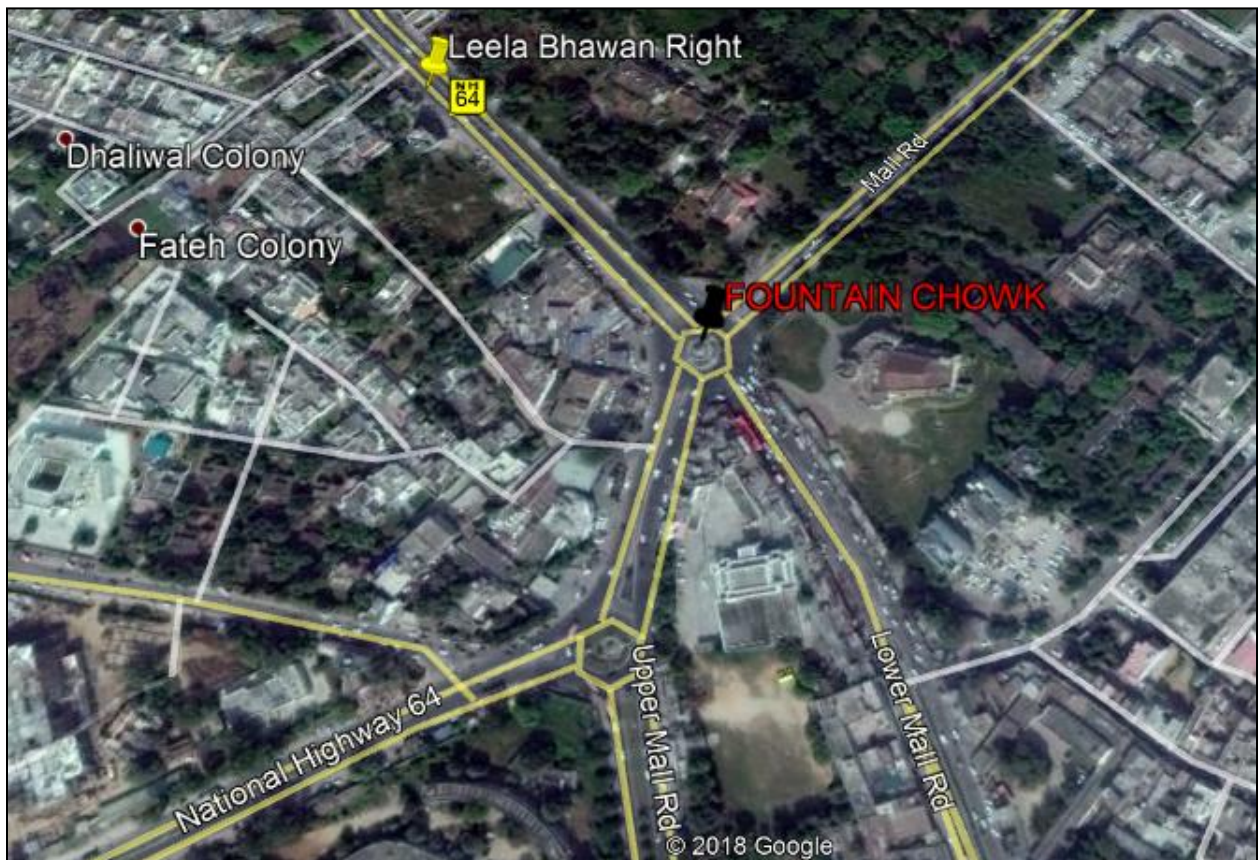
Figure5.5 Road section from Fountain Chowk to Leela Bhawan Right

After auditing left hand side right hand side have to be audited. Name should be written of all the persons involved in auditing and map location should be there. Fig 5.5 shows the Fountain Chowk to Leela Bhawan Right section.

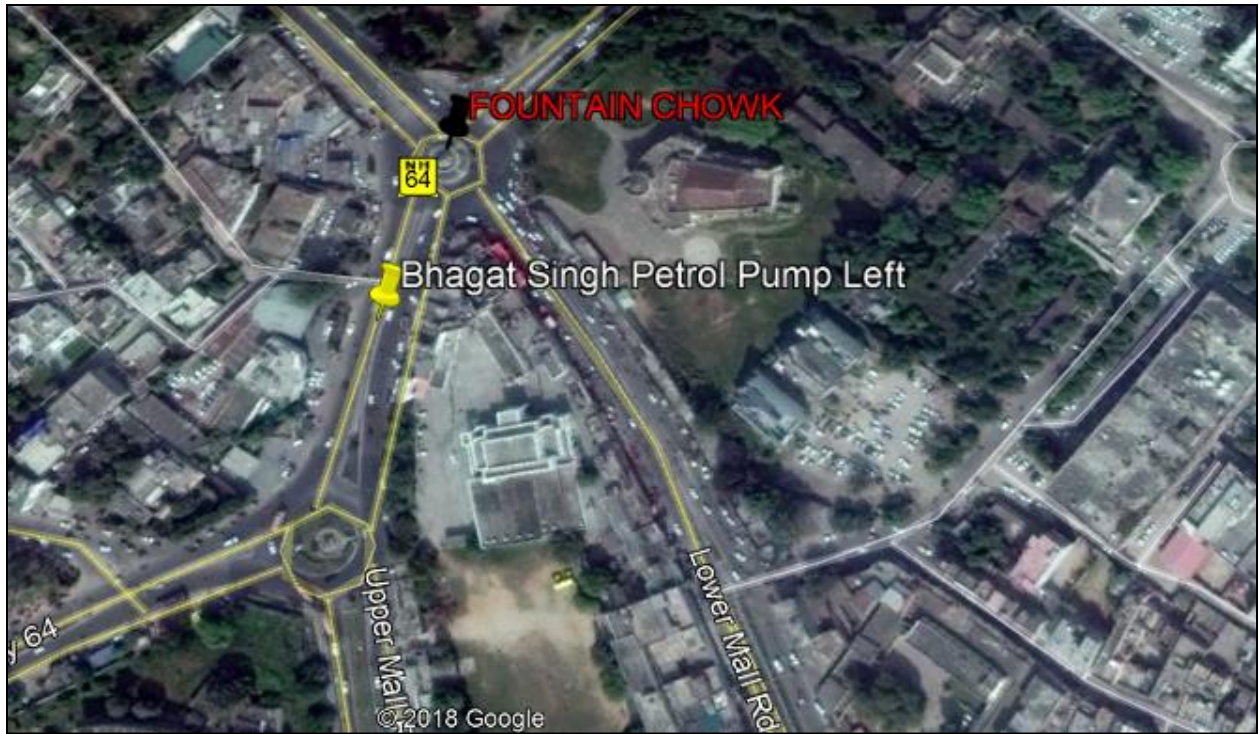
Figure5.6 Road section from Fountain Chowk to Bhagat Singh Petrol Pump Left

After Auditing fountain chowk to Leela Bhawan road, now fountain chowk to Bhagat Singh petrol pump road has been audited. Fig 5.6 shows the Fountain Chowk to Bhagat Singh Petrol Pump Left section.

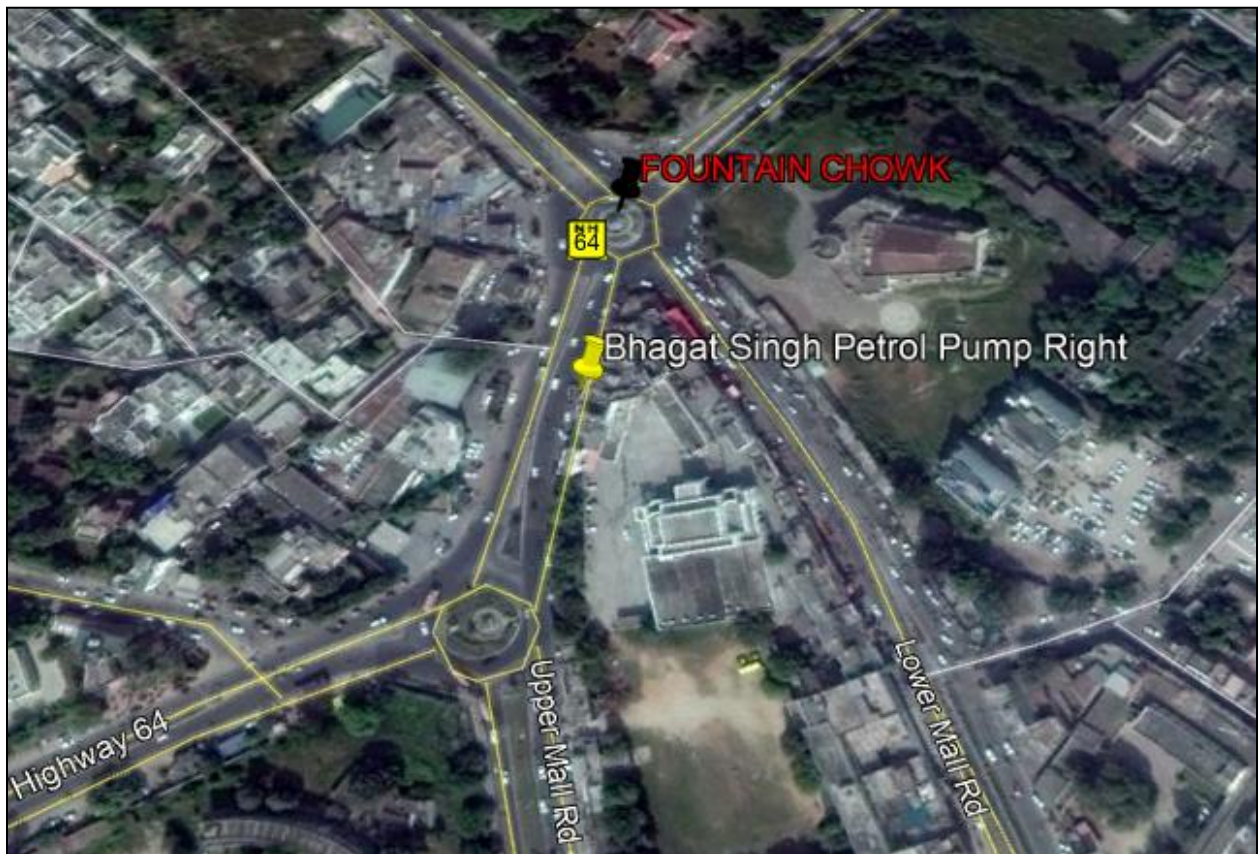
Figure 5.7 Road section from Fountain Chowk to Bhagat Singh Petrol Pump Right

After auditing Fountain chowk to Bhagat Petrol Pump Left auditing has to be done on another side of the road i.e. from Fountain chowk to Bhagat Petrol pump Right side .Name of all the persons involved in auditing should be noted down and map location has to be given. Fig 5.7 shows the Fountain Chowk to Bhagat Singh Petrol Pump Right section.

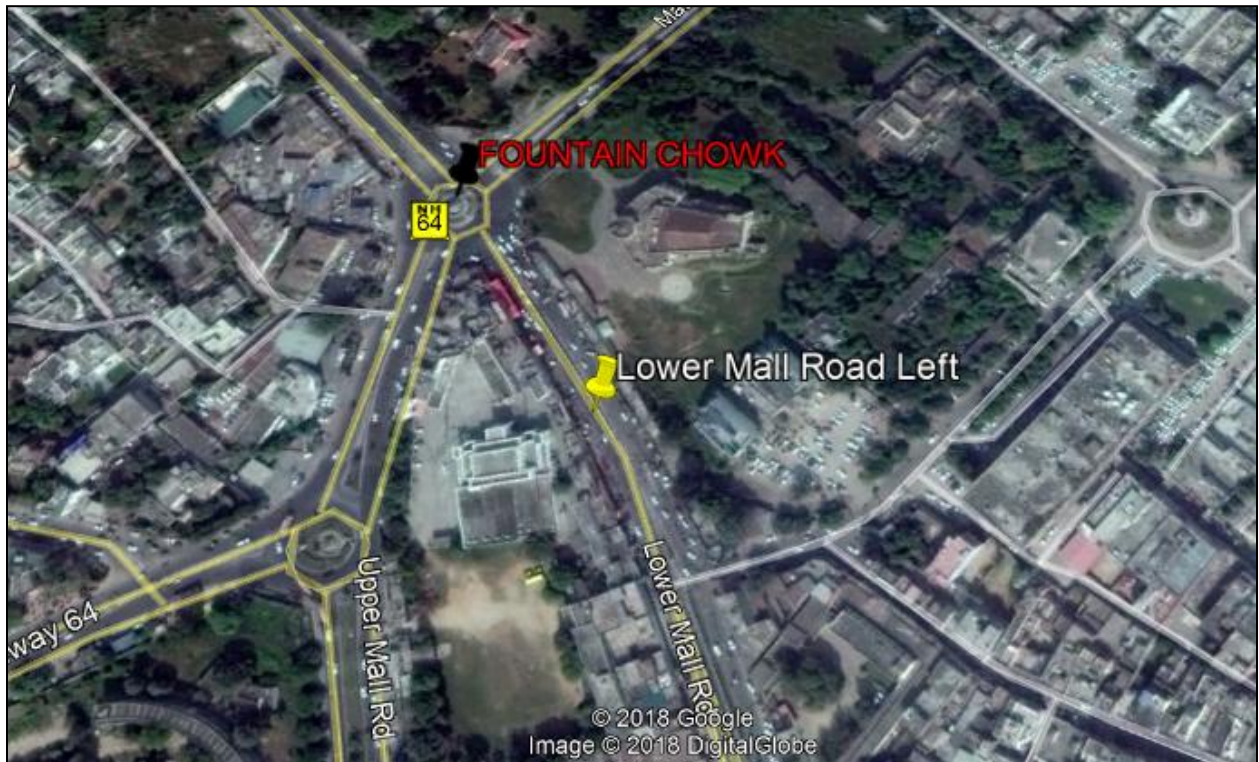
Figure5.8 Road section from Fountain Chowk to Lower Mall Road Left

First taking Lower Mall Road Left section.

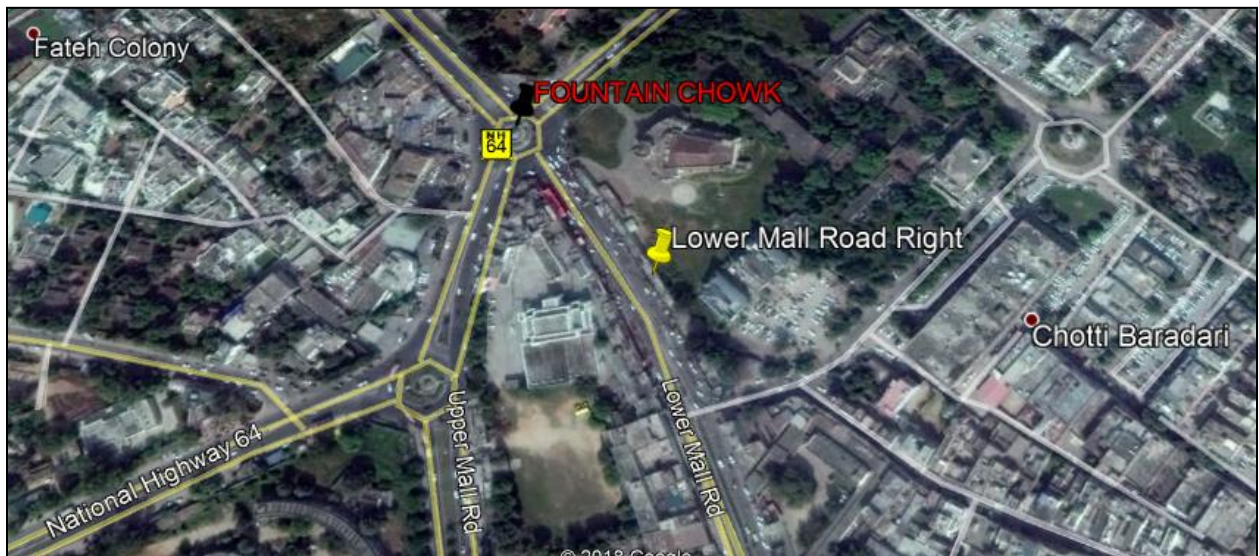
Figure5.9 Road section from Fountain Chowk to Lower Mall Road Right

After auditing Fountain Chowk to Lower Mall Road Left auditing has been done on another side of the road i.e. from Fountain chowk to Lower Mall Road Right side.Name of all the persons involved in auditing should be noted down and map location has been given. Fig 5.8 shows the fountain chowk to Lower Mall Road Right Section.

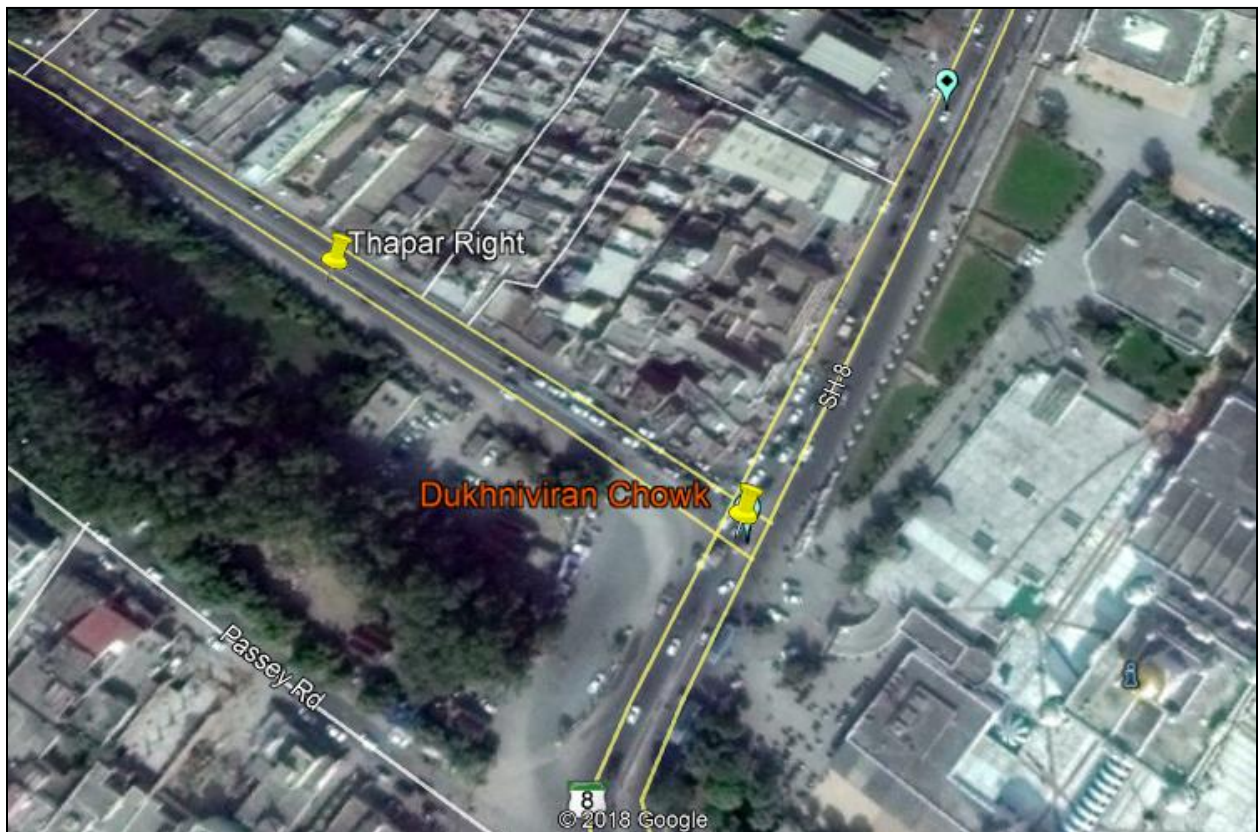
Figure5.13 Road section from Dukh Nivaran Chowk towards Thapar Right

Name of all the persons involved in auditing should be noted down and map location has to be given. Fig 5.13 shows the section from Dukh Nivaran towards Thapar right.

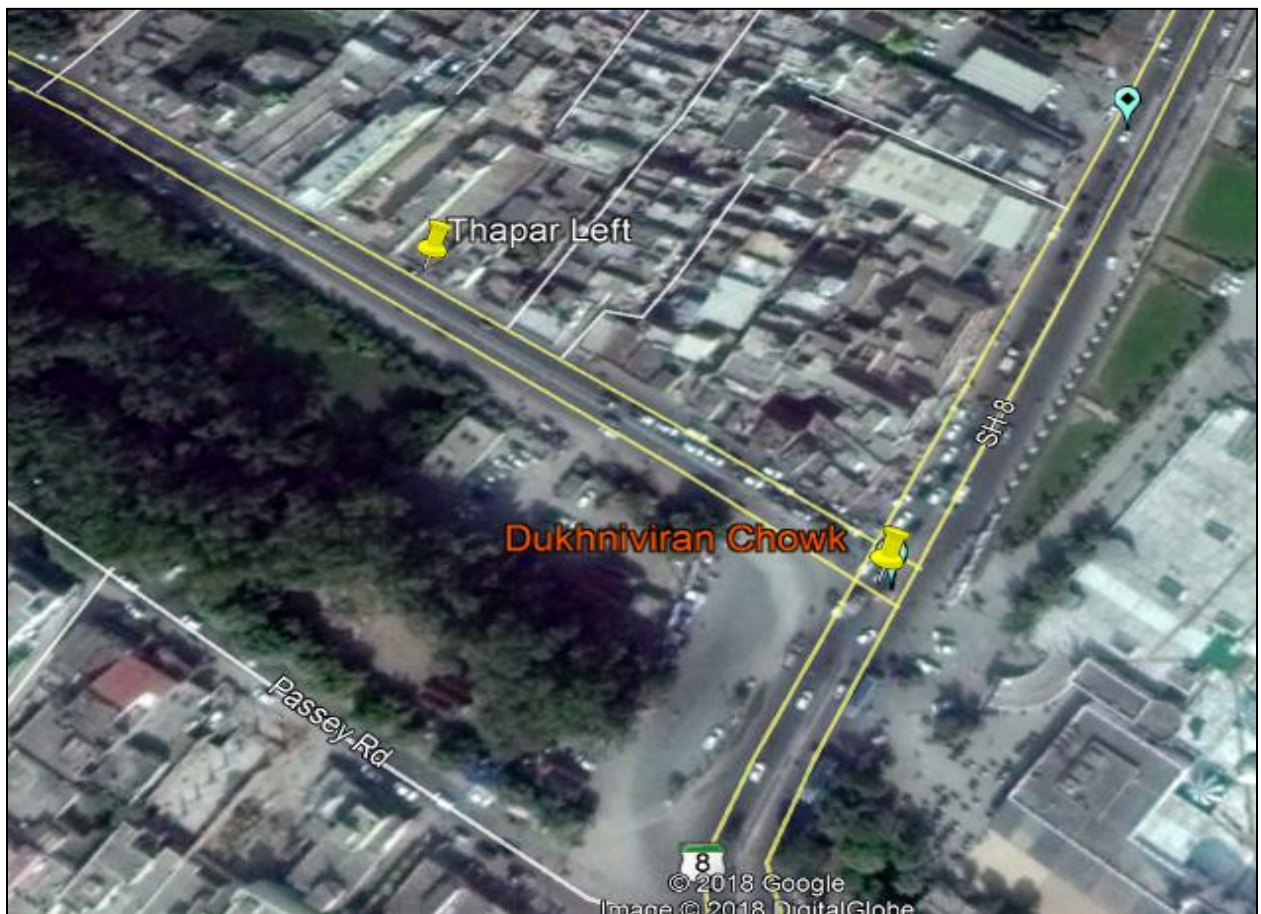
Figure5.14 Road section from Dukh Nivaran Chowk towards Thapar Left

Name of all the persons involved in auditing should be noted down and map location has been given . Fig 5.14 shows the Dukh Nivaran chowk towards Thapar left section.
