**ACCIDENT STUDIES AND ROAD SAFETY AUDIT**  
**FOR URBAN ROAD NETWORK OF**  
**PATIALA CITY**

**MASTERS OF ENGINEERING**  
**IN**  
**INFRASTRUCTURE ENGINEERING**

DEPARTMENT OF CIVIL ENGINEERING  
THAPAR INSTITUTE OF ENGINEERING & TECHNOLOGY  
(A DEEMED TO BE UNIVERSITY), PATIALA, PUNJAB.  
JUNE 2018

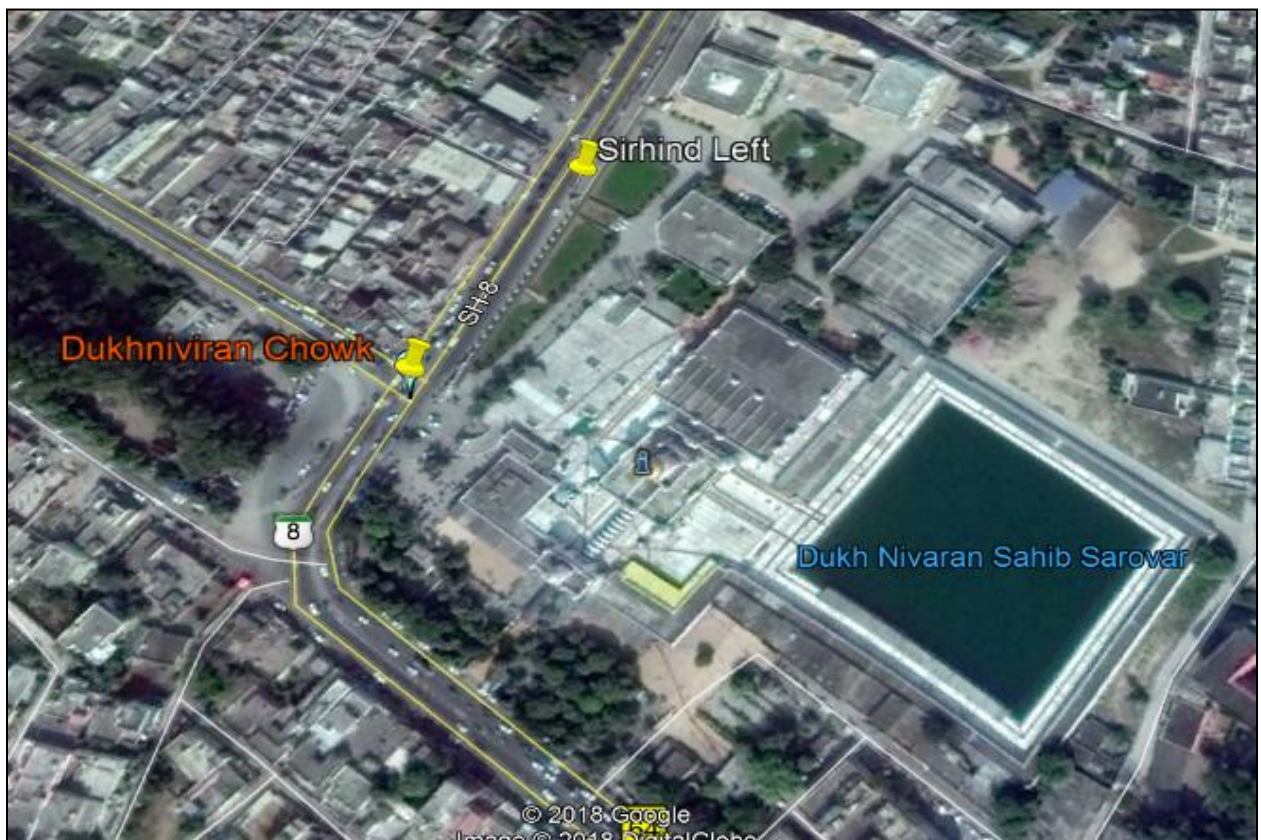
Figure5.16 Road section from Dukh Nivaran Chowk towards Sirhind Left

After auditing Dukh Nivaran Chowk towards Sirhind Right auditing has to be done on another side of the road i.e. from Dukh Nivaran Chowk to Sirhind Left side. Name of all the persons involved in auditing should be noted down and map location has to be given. Fig 5.16 gives the Section from Dukh Nivaran chowk towards Sirhind Left.

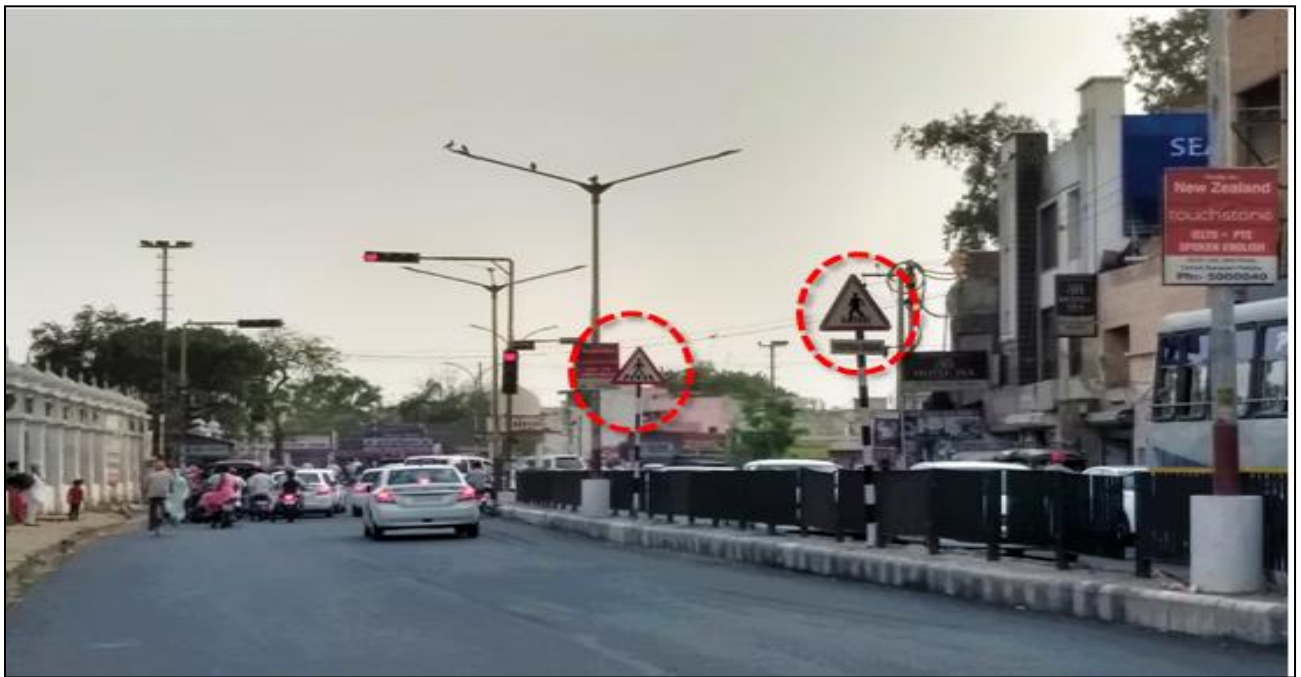
Figure 5.17 Safety at intersection of Dukh Nivaran

- After analyzing all the Tables from 5.78 to 5.83, the final score comes out to be 30 which represent the road section as poor according to clause 5.3.2 (point 9).
- Earlier the score comes to be 39 when we audited Dukh Nivaran Chowk towards Sirhind Right part and after auditing Dukh Nivaran Chowk towards Sirhind Left part the scores comes to be 35.5. Therefore, 35.5 will be the score of Dukh Nivaran Chowk towards Sirhind section.
- Now total score of Dukh Nivaran chowk comes out to be the average of all the legged of that intersection i.e.  $(28.25+35.5)/2 = 31.87$ .
- This score shows the fountain chowk intersection belong to poor category clause 5.3.2 (point 9). Fig 5.17 shows the safety at intersection of Dukh Nivaran.

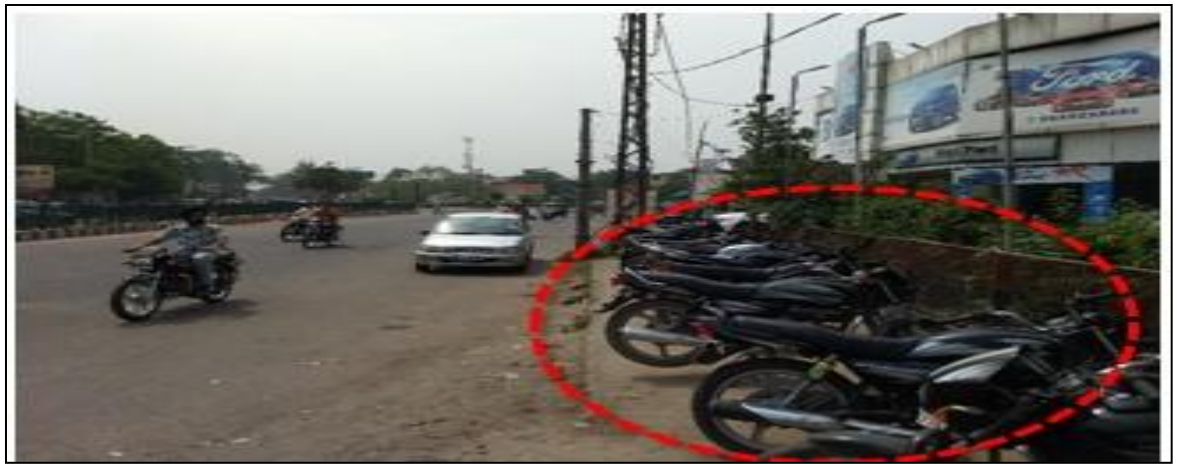
Figure5.19 Pedestrian infrastructure

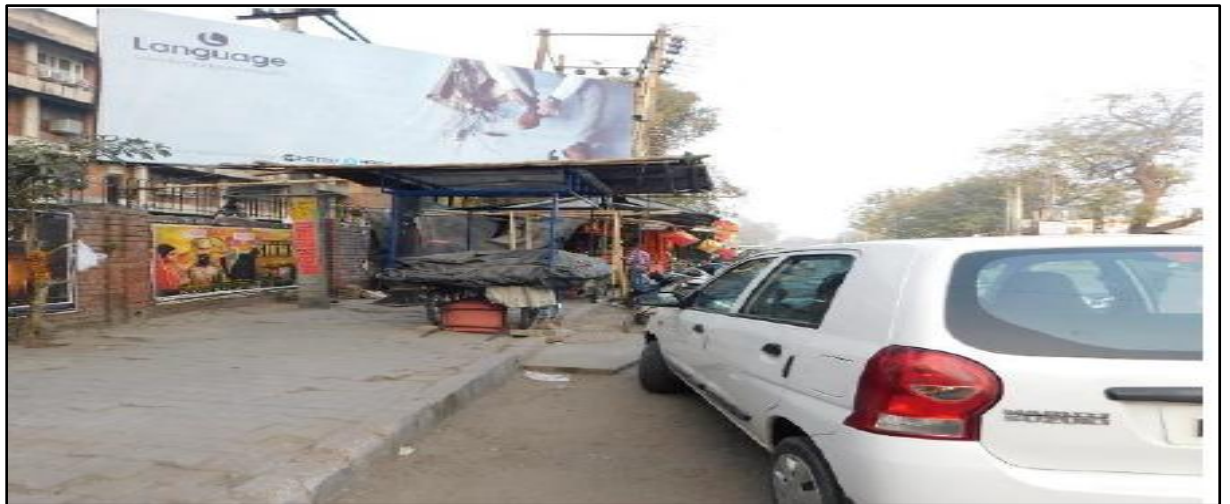
Figure5.20 Hawkers encroachment on foot paths

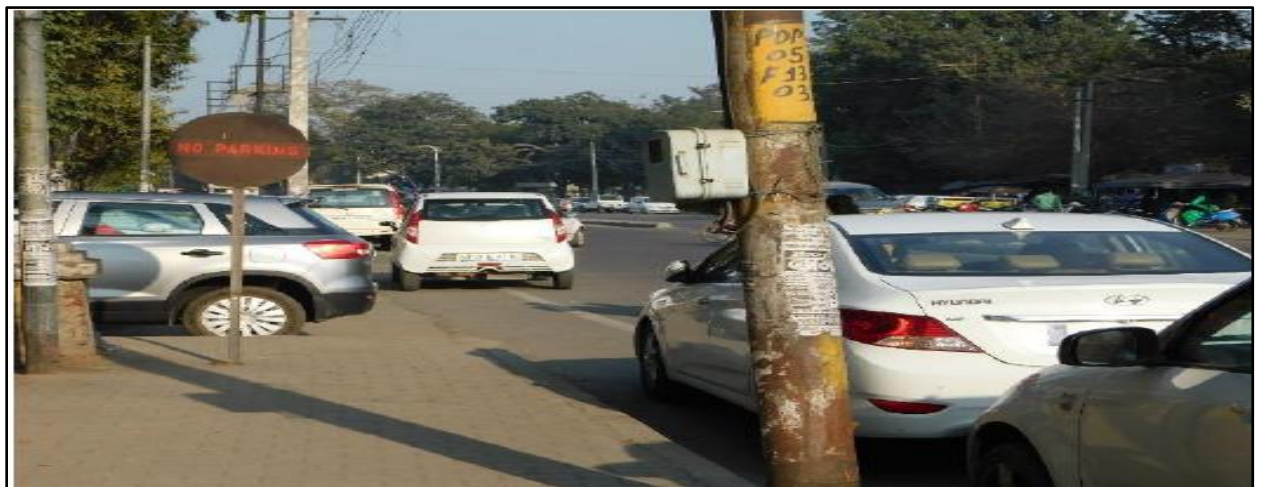
Figure5.21 Parking encroachment on footpaths of Mall Road
