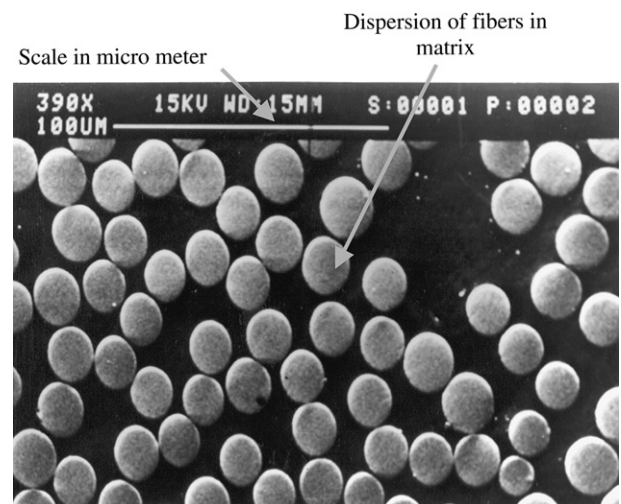
The micrograph of original sheet composite is given in Fig. 2. The magnification scale, 100 μm here, is presented by a marked line length on the micrograph. The fibers within the matrix are fairly distributed. There is no clustering of fibers. To find microcracks, air bubbles and defects in the fresh sheet composite it was magnified 878 times (Fig. 3). Here it can be seen that there are no air bubbles and micro cracks in the matrix. It can also be seen in Fig. 3 that the fibers have different diameters and average

Fig. 2. Distribution of E-glass fibers in original GFRP sheet (X390: magnified 390 times and showing a line scale of 100 μm).

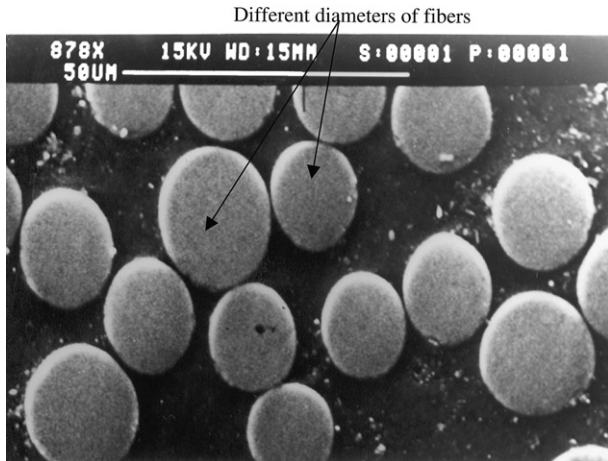
diameter is approximately 20 μm . The fiber volume fraction was estimated at 17.6%. The volume fraction is low as the epoxy thickness is more i.e. 1.647 mm over 0.353 thick sheet. Composites were prepared by hand lay up. It can be concluded that the epoxy has wetted the fiber uniformly and spread evenly on the sheet. Thus the sheet composites used for external bonding on concrete were free from any defects and the fibers were fairly dispersed in the matrix.

Fig. 3. Size of fibers and absence of defects in original sheet.

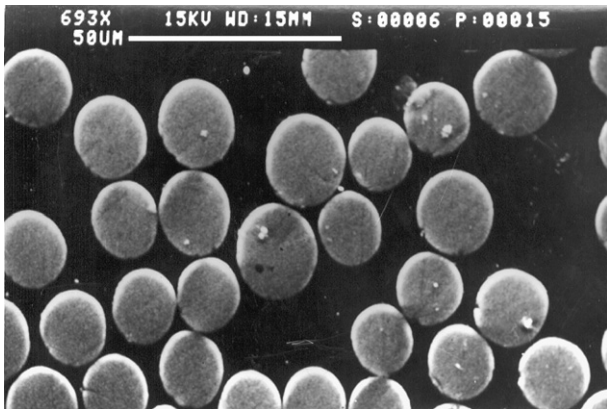
months. The sheets did not loose their strength but surprisingly showed an increase of about 6%. Most of the areas in the scan showed no sign of degradation of both matrix and fibers as seen in the Fig. 12. Very few spots could be located where damages could be observed as shown in Fig. 13. Here the matrix has started disintegrating with partial or negligible damages to the fibers. The increase in the strength of the sheet composite was 29.5% in six months of outdoor conditioning in comparison to 6% in nine months of conditioning outdoor. This can happen only when the strength of the epoxy as a whole increases due to cross linking [21] in outdoor conditioning. The over all strength of composite sheet reduced due to local disintegration of the matrix and fibers with time. More outdoor conditioning time is likely to deteriorate the strength of the sheet. Eight specimens were scanned and it was seen that the nature of the damage is same but quantum of damage is negligible at 12 months.

Fig. 12. Micrograph of undamaged area (ASB12-470).

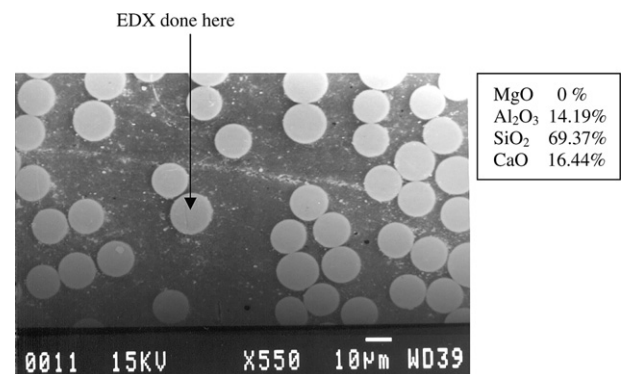
To compare the chemical composition of E-glass fibers EDX was done at the centre of the E-glass fiber. The samples were taken from the fresh sheet and sheet conditioned in tank for three months and nine months, respectively in the tank at 60 °C. Chemical compositions obtained by EDX for SB0, SB3 and SB9 have been given along with the micrographs as shown in Figs. 14a–14c. The silica content in E-glass fiber is 69.37%, 70.26% and 67.70%. The average silica content is 69.11% with a standard deviation

Fig. 14a. EDX done on fiber of specimen taken from sheet bonded to fresh beam (SB0-470).

parison with average values of 69.11% and 16.9% in the undamaged fiber (Figs. 14a(a)–(c)). Thus, silica and calcium content in the damaged area is very much less than that in the undamaged fiber. This is only possible if the molecular structure of the fiber gets broken wherever it is coming in contact with some degenerating agent. This agent displaces silica and calcium from the healthy fibers. EDX taken outside the damaged fiber showed calcium as 100 %. The free calcium can only originate from alkali. The alkali, Ca(OH)₂, is formed due to hydration of cement and is in free form in the voids of the concrete. This suggests that the sheet matrix is penetrated by the alkali.

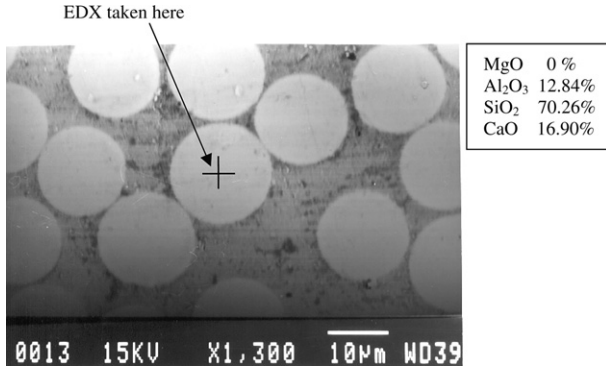
Fig. 14b. EDX done on undamaged fiber of specimen taken from sheet bonded to conditioned beam SB3-470.

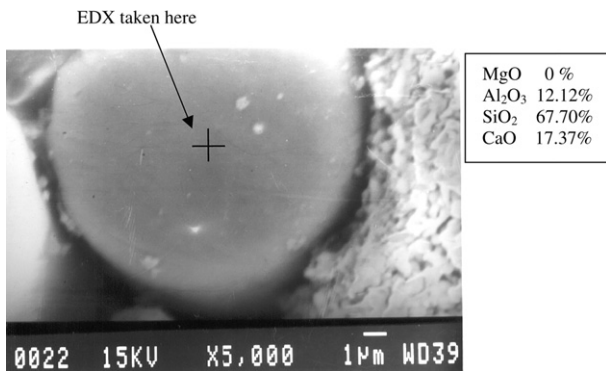
Fig. 14c. EDX done on undamaged fiber of specimen taken from sheet bonded to conditioned beam SB9-470.
