STRENGTH AND FRACTURE STUDIES OF STEAM TURBINE BLADE

**A Thesis Submitted in partial fulfillment of requirement for the award of the
degree of**

Master of Technology

Materials Science and Engineering

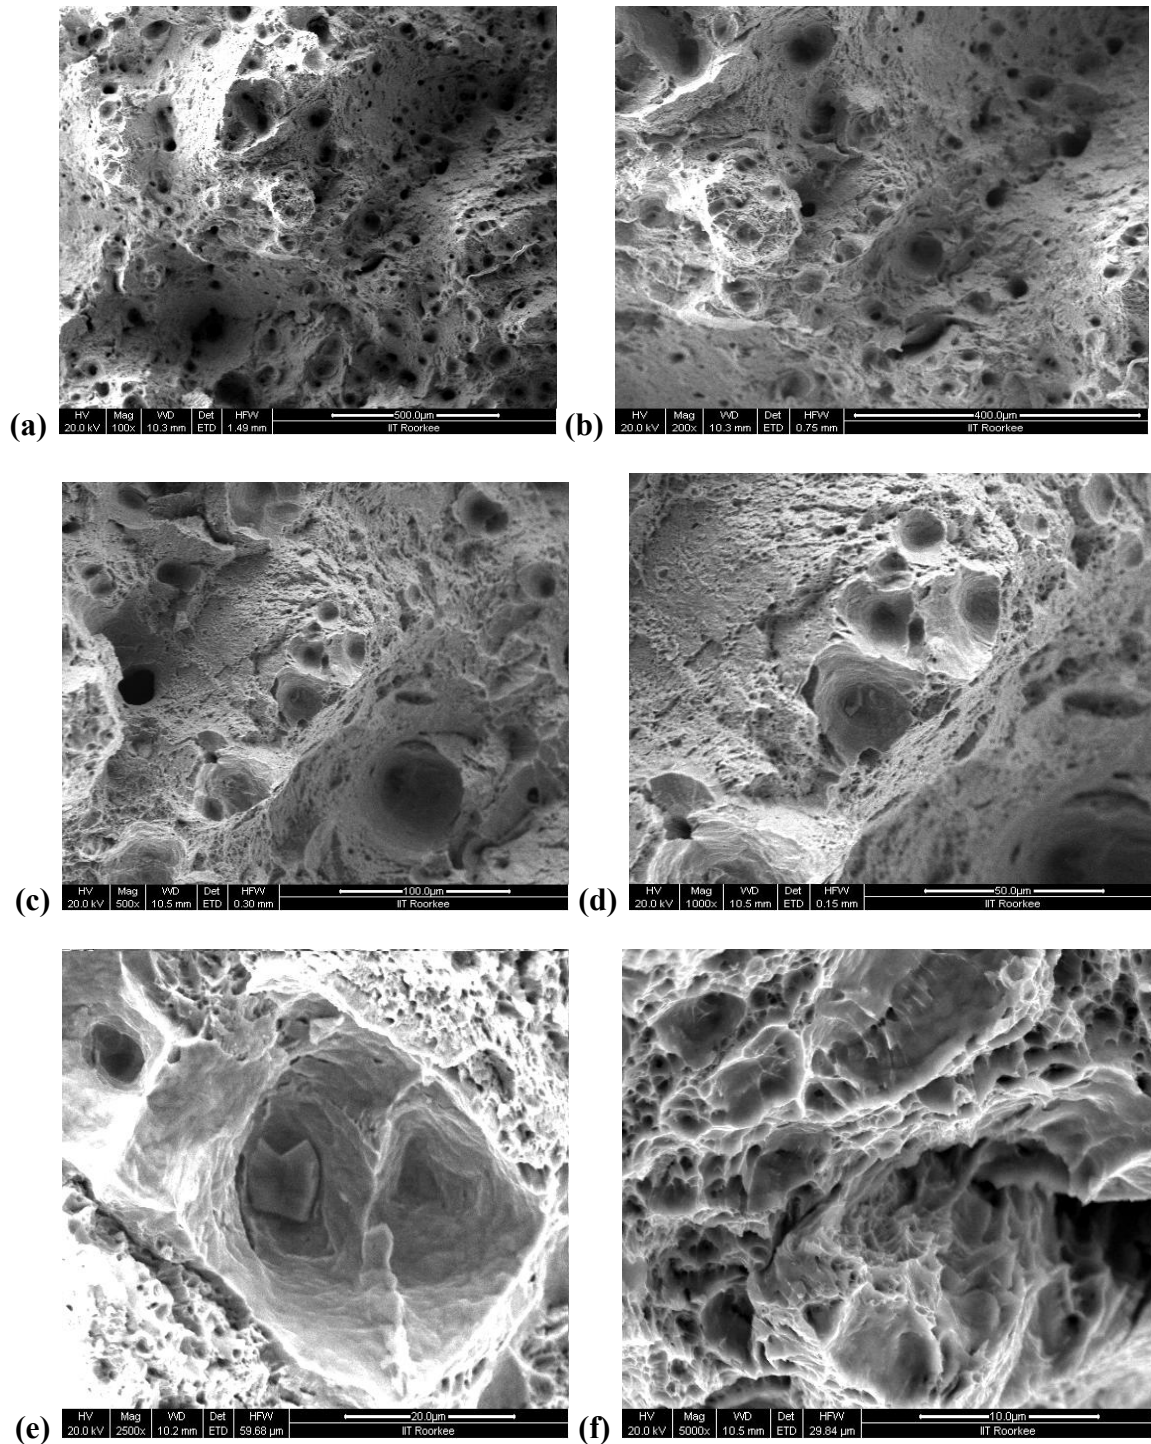
Figure 4.4 SEM micrographs of sample 2 at

(a) 100x (b) 200x (c) 500x (d) 1000x (e) 2500x (f) 5000x

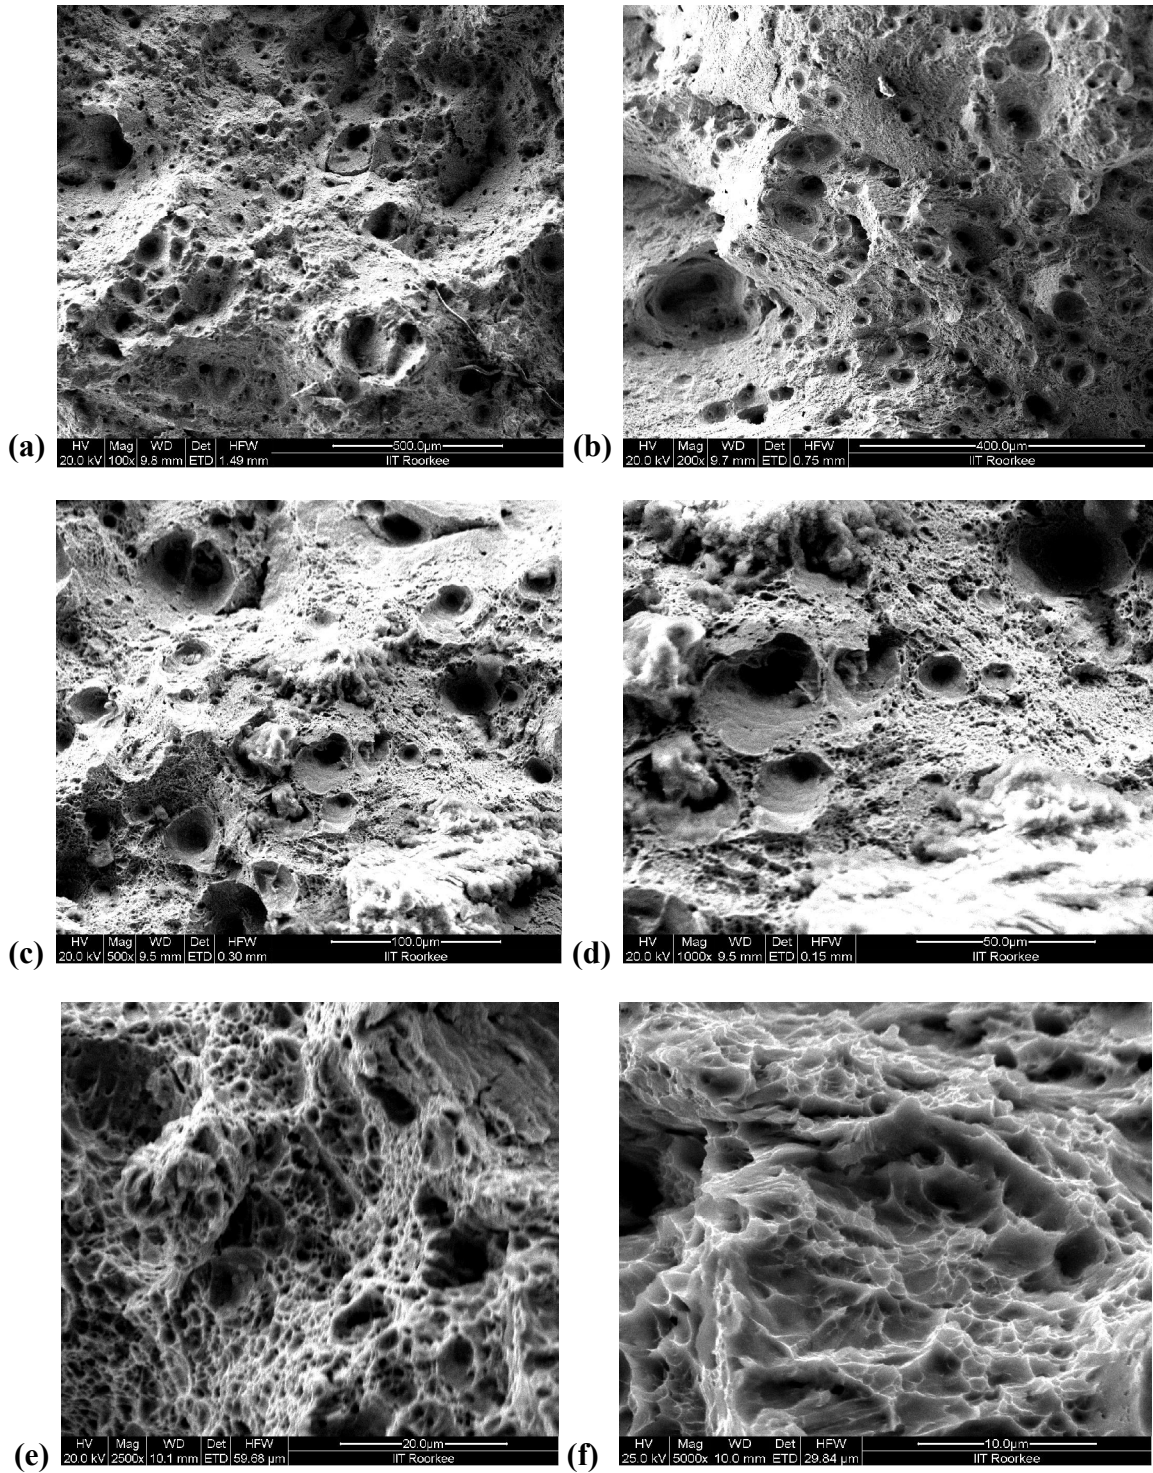
Figure 4.6 SEM micrographs of sample 2 at

(a) 100x (b) 200x (c) 500x (d) 1000x (e) 2500x (f) 5000x

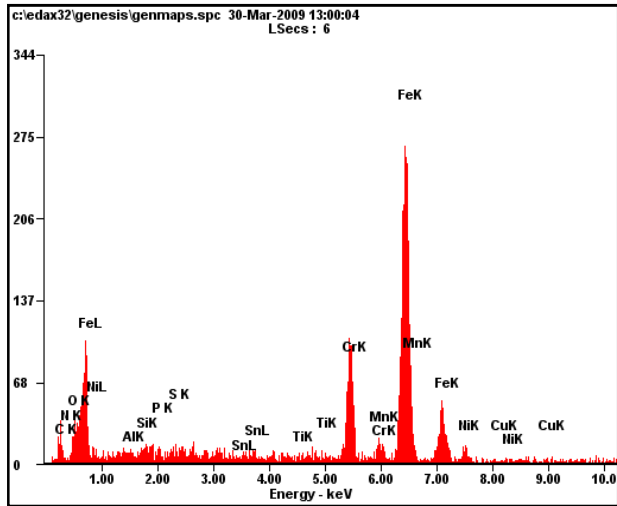
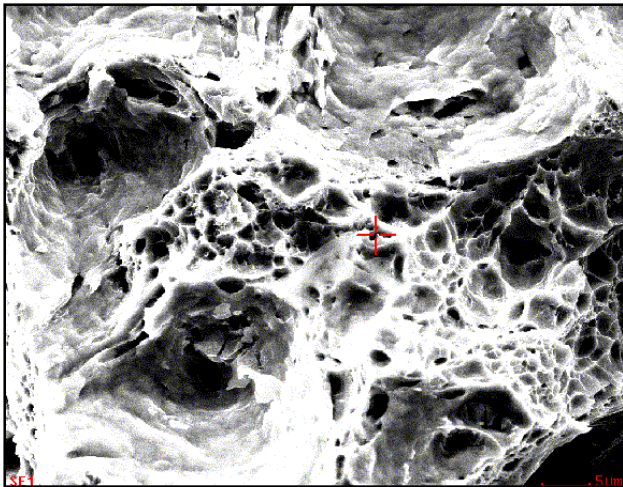
Figure 4.7.1 EDS of sample 1

The Energy Dispersive Spectroscopy (EDS) analysis of the blade samples were carried out by the SEM samples at different- different magnifications and points. EDS analysis reviewed that sample contains different composition. This is presented in figure 4.7.1 to 4.7.4 for sample 1, figure 4.8.1 to 4.8.4 for sample 2 and figure 4.9.1 to 4.9.4 for sample 3. The important features obtained from this analysis are that the oxide and sulfide inclusions are present.

<i>Element</i>	<i>Wt%</i>	<i>At%</i>
<i>CK</i>	12.37	34.73
<i>NK</i>	01.50	03.62
<i>OK</i>	06.19	13.05
<i>AlK</i>	00.60	00.75
<i>SiK</i>	01.28	01.54
<i>PK</i>	00.66	00.72
<i>SK</i>	00.47	00.50
<i>SnL</i>	00.70	00.20
<i>TiK</i>	00.47	00.33
<i>CrK</i>	11.33	07.35
<i>MnK</i>	00.92	00.57
<i>FeK</i>	53.90	32.54
<i>NiK</i>	02.85	01.64
<i>CuK</i>	00.55	00.29
<i>MoK</i>	06.19	02.18
<i>Matrix</i>	Correction	ZAF

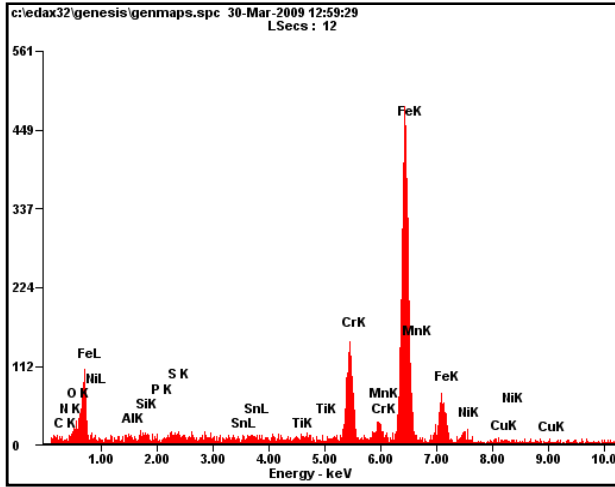
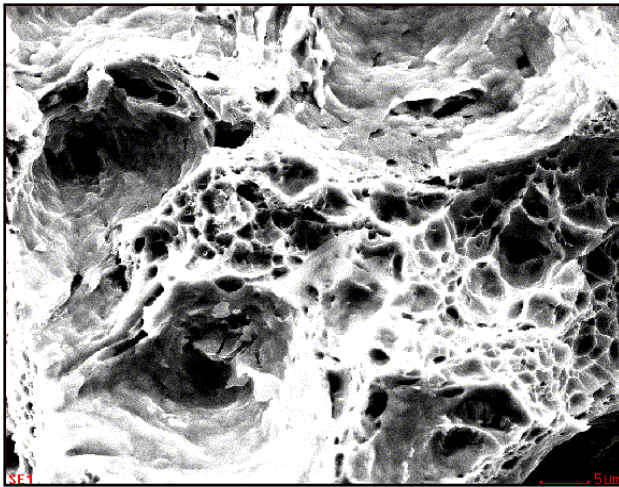
Figure 4.7.2 EDS of sample 1

<i>Element</i>	<i>Wt%</i>	<i>At%</i>
<i>CK</i>	01.53	06.28
<i>NK</i>	00.67	02.35
<i>OK</i>	03.15	09.75
<i>AlK</i>	00.41	00.75
<i>SiK</i>	00.84	01.49
<i>PK</i>	00.21	00.33
<i>SK</i>	00.53	00.82
<i>SnL</i>	00.43	00.18
<i>TiK</i>	00.62	00.64
<i>CrK</i>	12.32	11.72
<i>MnK</i>	01.30	01.17
<i>FeK</i>	62.41	55.29
<i>NiK</i>	02.97	02.50
<i>CuK</i>	00.87	00.67
<i>MoK</i>	11.75	06.06
<i>Matrix</i>	Correction	ZAF

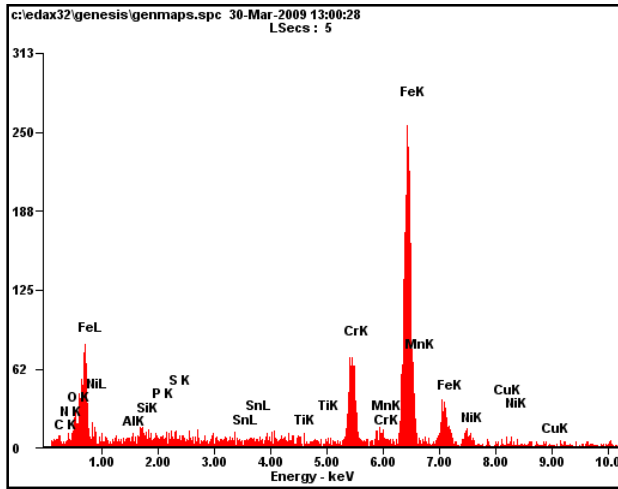
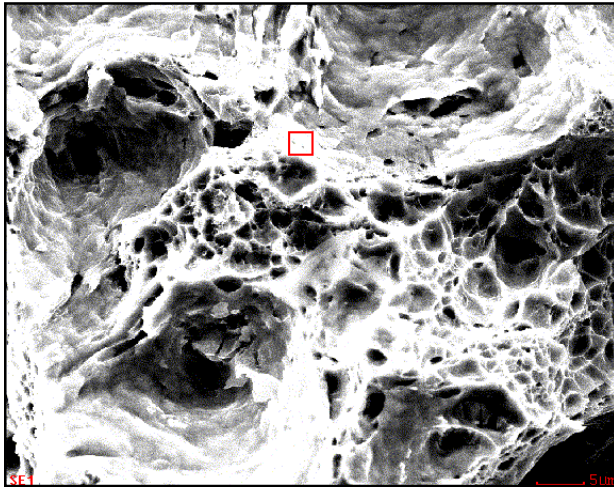
Figure 4.7.3 EDS of sample 1

<i>Element</i>	<i>Wt%</i>	<i>At%</i>
<i>CK</i>	05.70	19.79
<i>NK</i>	00.93	02.77
<i>OK</i>	05.30	13.80
<i>AlK</i>	00.60	00.93
<i>SiK</i>	01.17	01.73
<i>PK</i>	00.49	00.66
<i>SK</i>	00.49	00.63
<i>SnL</i>	00.94	00.33
<i>TiK</i>	00.59	00.52
<i>CrK</i>	10.96	08.79
<i>MnK</i>	00.60	00.46
<i>FeK</i>	55.20	41.19
<i>NiK</i>	03.12	02.22
<i>CuK</i>	00.68	00.45
<i>MoK</i>	13.22	05.74
<i>Matrix</i>	Correction	ZAF

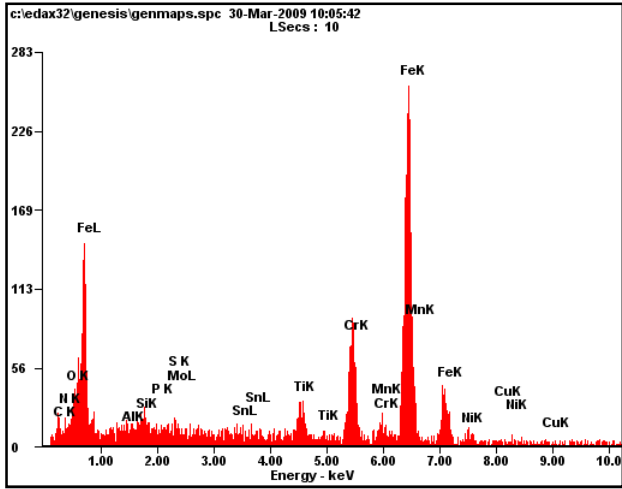
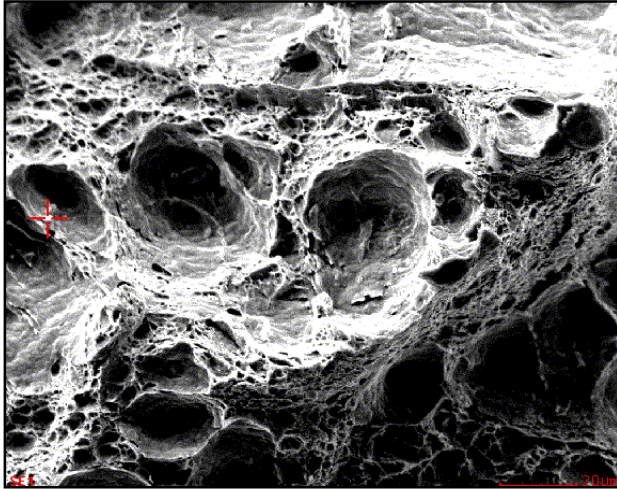
Figure 4.7.4 EDS of sample 1

<i>Element</i>	<i>Wt%</i>	<i>At%</i>
<i>CK</i>	05.69	18.39
<i>NK</i>	03.44	09.53
<i>OK</i>	04.43	10.75
<i>AlK</i>	00.57	00.83
<i>SiK</i>	00.98	01.35
<i>PK</i>	00.11	00.14
<i>MoL</i>	01.04	00.42
<i>SK</i>	00.13	00.16
<i>SnL</i>	01.50	00.49
<i>TiK</i>	03.37	02.74
<i>CrK</i>	12.67	09.47
<i>MnK</i>	00.99	00.70
<i>FeK</i>	60.74	42.23
<i>NiK</i>	03.29	02.18
<i>CuK</i>	01.04	00.64
<i>Matrix</i>	Correction	ZAF

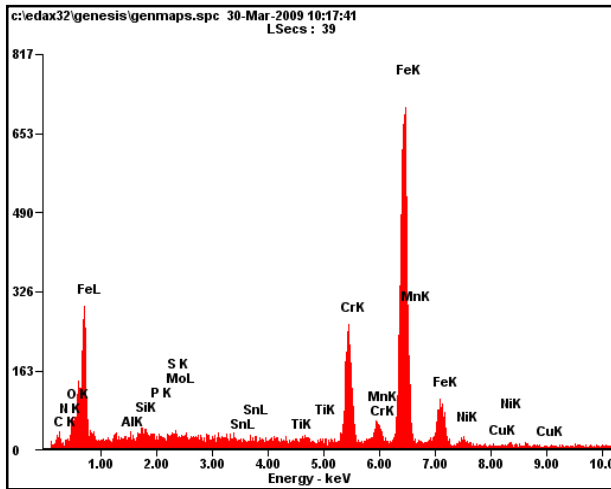
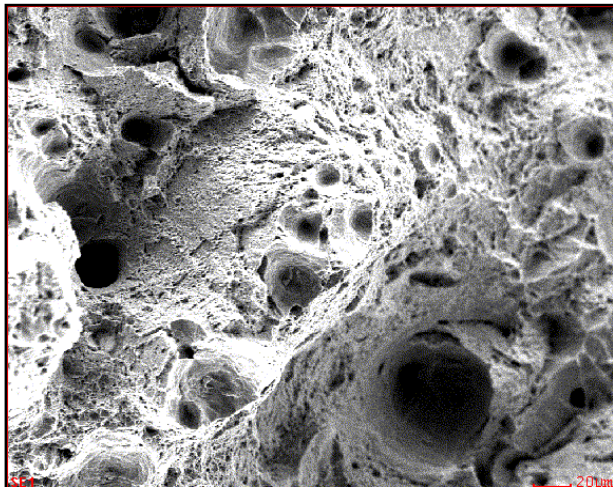
Figure 4.8.1 EDS of sample 2

<i>Element</i>	<i>Wt%</i>	<i>At%</i>
<i>CK</i>	02.07	08.16
<i>NK</i>	00.76	02.58
<i>OK</i>	02.76	08.18
<i>AlK</i>	00.17	00.29
<i>SiK</i>	00.83	01.39
<i>PK</i>	00.23	00.35
<i>MoL</i>	01.51	00.74
<i>SK</i>	00.00	00.00
<i>SnL</i>	00.42	00.17
<i>TiK</i>	00.23	00.22
<i>CrK</i>	14.26	12.98
<i>MnK</i>	01.19	01.03
<i>FeK</i>	72.49	61.44
<i>NiK</i>	02.83	02.28
<i>CuK</i>	00.24	00.18
<i>Matrix</i>	Correction	ZAF

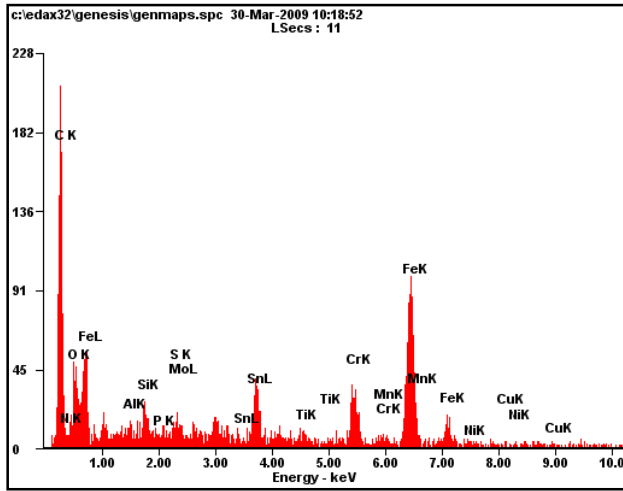
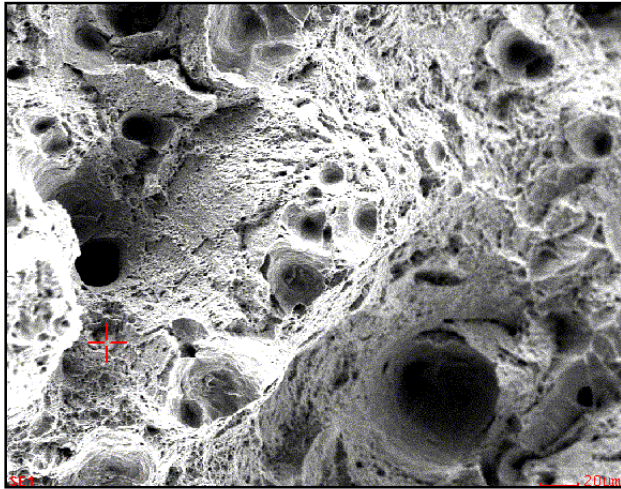
Figure 4.8.2 EDS of sample 2

<i>Element</i>	<i>Wt%</i>	<i>At%</i>
<i>CK</i>	48.60	72.50
<i>NK</i>	02.36	03.02
<i>OK</i>	10.25	11.48
<i>AlK</i>	00.50	00.33
<i>SiK</i>	01.17	00.75
<i>PK</i>	00.32	00.19
<i>MoL</i>	01.36	00.25
<i>SK</i>	00.07	00.04
<i>SnL</i>	00.41	00.06
<i>TiK</i>	00.94	00.35
<i>CrK</i>	05.88	02.03
<i>MnK</i>	01.04	00.34
<i>FeK</i>	26.00	08.34
<i>NiK</i>	00.76	00.23
<i>CuK</i>	00.34	00.09
<i>Matrix</i>	Correction	ZAF

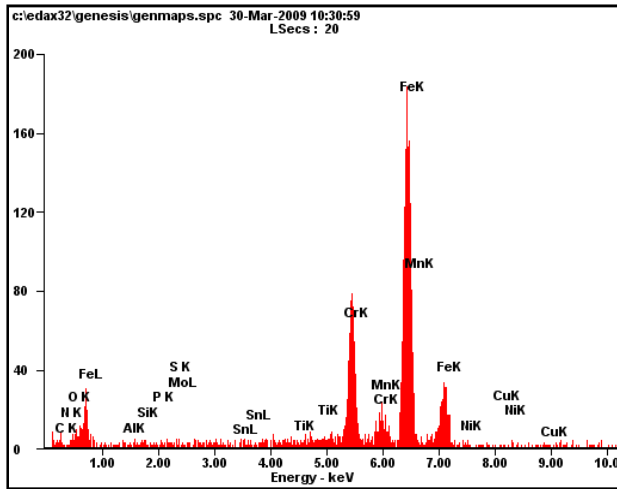
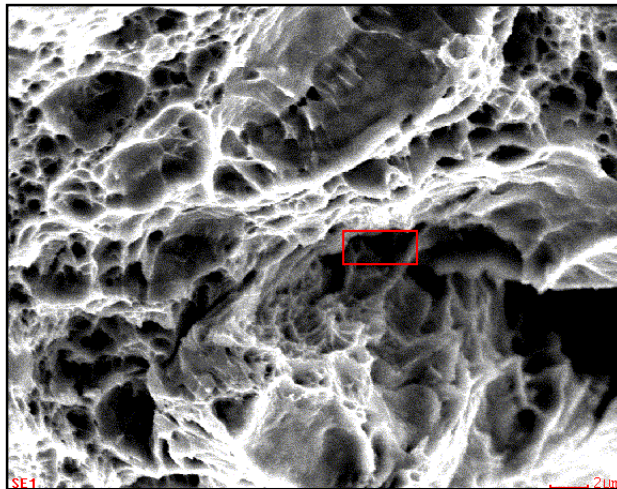
Figure 4.8.3 EDS of sample 2

<i>Element</i>	<i>Wt%</i>	<i>At%</i>
<i>CK</i>	03.29	12.97
<i>NK</i>	00.49	01.67
<i>OK</i>	01.01	02.99
<i>AlK</i>	00.36	00.62
<i>SiK</i>	00.42	00.71
<i>PK</i>	00.19	00.29
<i>MoL</i>	00.69	00.34
<i>SK</i>	00.07	00.10
<i>SnL</i>	00.00	00.00
<i>TiK</i>	00.52	00.51
<i>CrK</i>	16.59	15.09
<i>MnK</i>	02.48	02.14
<i>FeK</i>	73.89	62.57
<i>NiK</i>	00.00	00.00
<i>CuK</i>	00.00	00.00
<i>Matrix</i>	Correction	ZAF

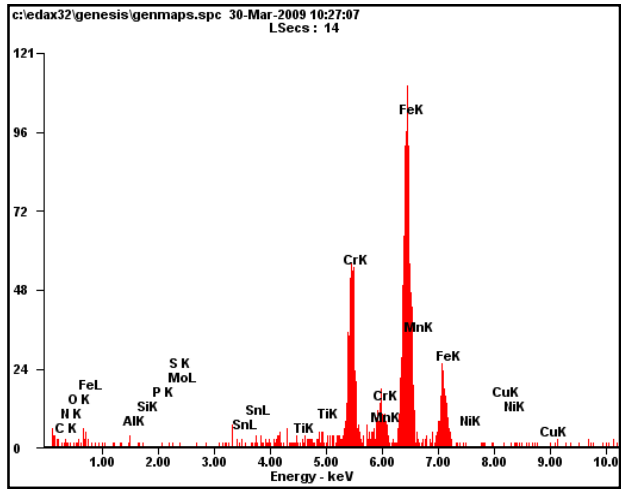
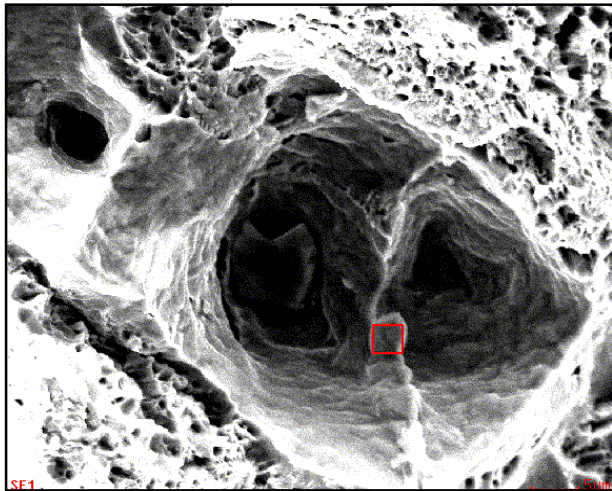
Figure 4.8.4 EDS of sample 2

<i>Element</i>	<i>Wt%</i>	<i>At%</i>
<i>CK</i>	02.00	08.34
<i>NK</i>	00.47	01.67
<i>OK</i>	00.30	00.95
<i>AlK</i>	00.00	00.00
<i>SiK</i>	00.00	00.00
<i>PK</i>	00.00	00.00
<i>MoL</i>	00.00	00.00
<i>SK</i>	00.29	00.45
<i>SnL</i>	00.00	00.00
<i>TiK</i>	00.13	00.14
<i>CrK</i>	23.02	22.19
<i>MnK</i>	02.51	02.29
<i>FeK</i>	71.29	63.98
<i>NiK</i>	00.00	00.00
<i>CuK</i>	00.00	00.00
<i>Matrix</i>	Correction	ZAF

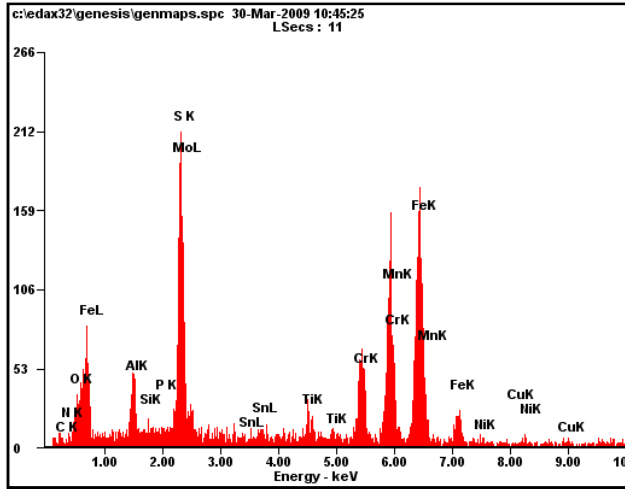
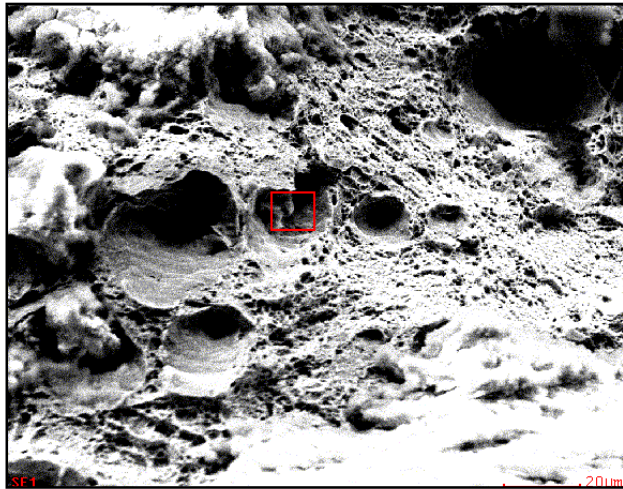
Figure 4.9.1 EDS of sample 3

<i>Element</i>	<i>Wt%</i>	<i>At%</i>
<i>CK</i>	03.12	10.52
<i>NK</i>	01.36	03.94
<i>OK</i>	04.58	11.58
<i>AlK</i>	03.33	05.00
<i>SiK</i>	00.36	00.52
<i>PK</i>	00.34	00.45
<i>MoL</i>	05.15	02.17
<i>SK</i>	10.84	13.68
<i>SnL</i>	00.51	00.17
<i>TiK</i>	02.53	02.14
<i>CrK</i>	09.74	07.58
<i>MnK</i>	21.03	15.48
<i>FeK</i>	34.80	25.21
<i>NiK</i>	01.73	01.19
<i>CuK</i>	00.57	00.36
<i>Matrix</i>	Correction	ZAF

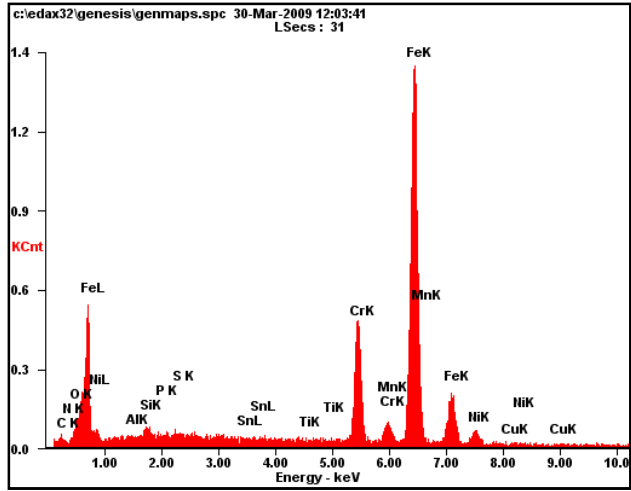
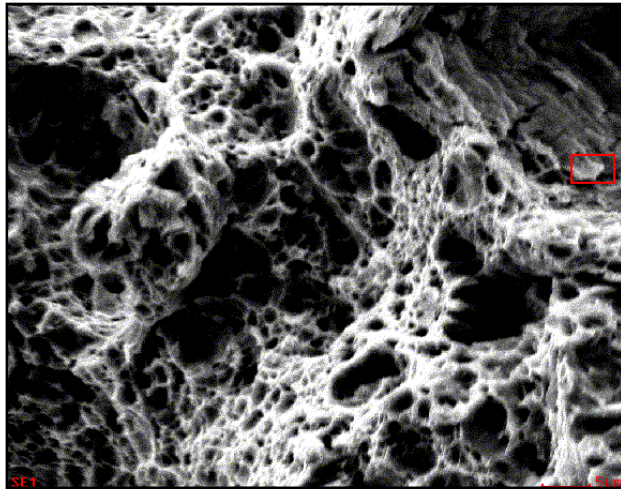
Figure 4.9.2 EDS of sample 3

<i>Element</i>	<i>Wt%</i>	<i>At%</i>
<i>CK</i>	03.12	10.52
<i>NK</i>	01.36	03.94
<i>OK</i>	04.58	11.58
<i>AlK</i>	03.33	05.00
<i>SiK</i>	00.36	00.52
<i>PK</i>	00.34	00.45
<i>MoL</i>	05.15	02.17
<i>SK</i>	10.84	13.68
<i>SnL</i>	00.51	00.17
<i>TiK</i>	02.53	02.14
<i>CrK</i>	09.74	07.58
<i>MnK</i>	21.03	15.48
<i>FeK</i>	34.80	25.21
<i>NiK</i>	01.73	01.19
<i>CuK</i>	00.57	00.36
<i>Matrix</i>	Correction	ZAF

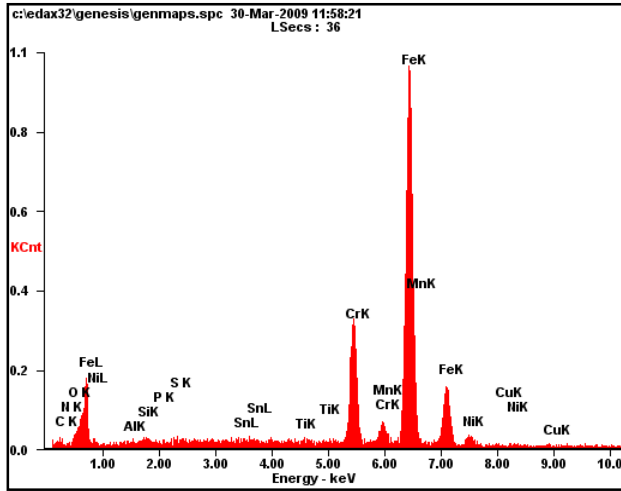
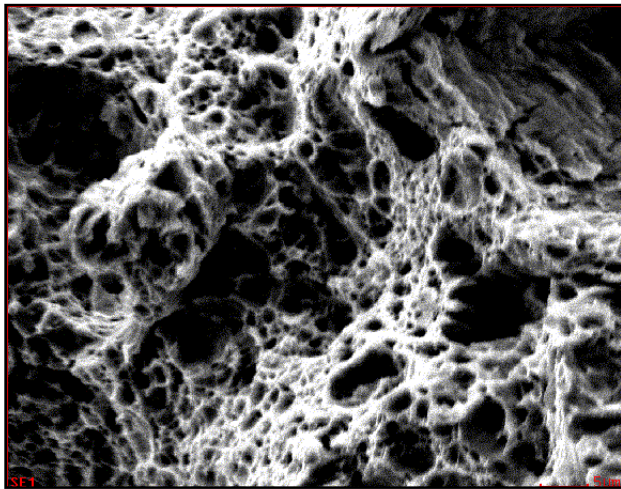
Figure 4.9.3 EDS of sample 3

<i>Element</i>	<i>Wt%</i>	<i>At%</i>
<i>CK</i>	03.24	12.07
<i>NK</i>	00.32	01.03
<i>OK</i>	04.36	12.19
<i>AlK</i>	00.83	01.37
<i>SiK</i>	01.57	02.51
<i>PK</i>	00.70	01.02
<i>SK</i>	00.74	01.04
<i>SnL</i>	01.00	00.38
<i>TiK</i>	00.41	00.39
<i>CrK</i>	12.88	11.08
<i>MnK</i>	01.07	00.87
<i>FeK</i>	62.51	50.08
<i>NiK</i>	03.50	02.67
<i>CuK</i>	00.43	00.30
<i>MoK</i>	06.43	03.00
<i>Matrix</i>	Correction	ZAF
